**ESTABLISHMENT OF A RESIDENTIAL DEVELOPMENT ON ERF 8892, FIRWOODS,  
PAARL, WESTERN CAPE**

DEA&DP Ref: 16/3/3/1/B3/28/1032/22

**FORMAL ECO AUDIT REPORT**

13 May 2025

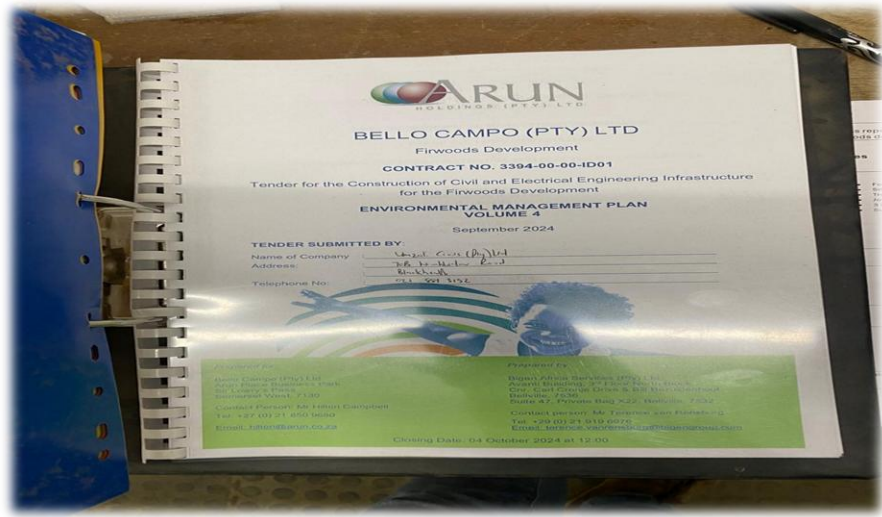
| Site demarcation and development | The project area and construction footprint are set out according to the Environmental Authorisation. The construction site is clearly demarcated with existing fencing and contained within the footprint of the property boundaries. | Compliant |

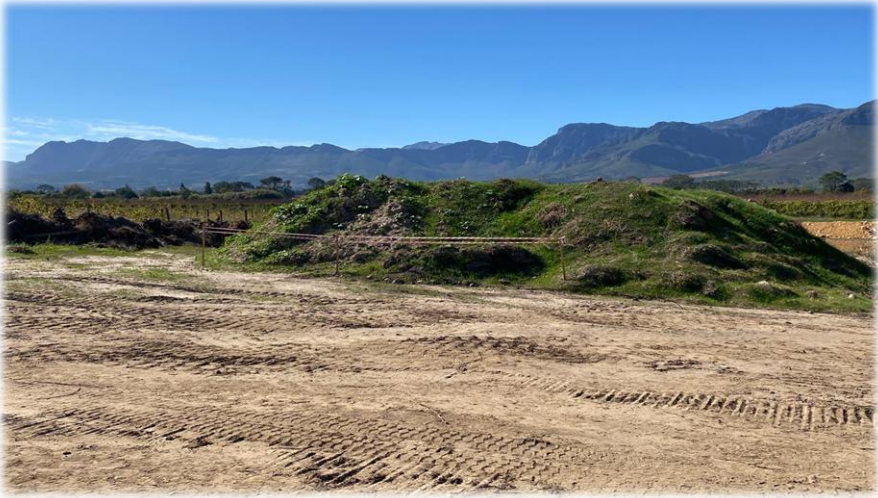
| <b>Stockpiles</b> | <p>Temporary stockpiled material is stockpiled in such as way to minimize the spread of materials.</p> <p>Soil stockpiles are within the demarcated construction footprint. Plant material, topsoil and sub-soil is stockpiled and windrowed separately to avoid contamination.</p> <p>Topsoil is temporarily stockpiled and neatly windrowed next to the excavation area until it can be moved to a designated topsoil stockpile area.</p> | Compliant |

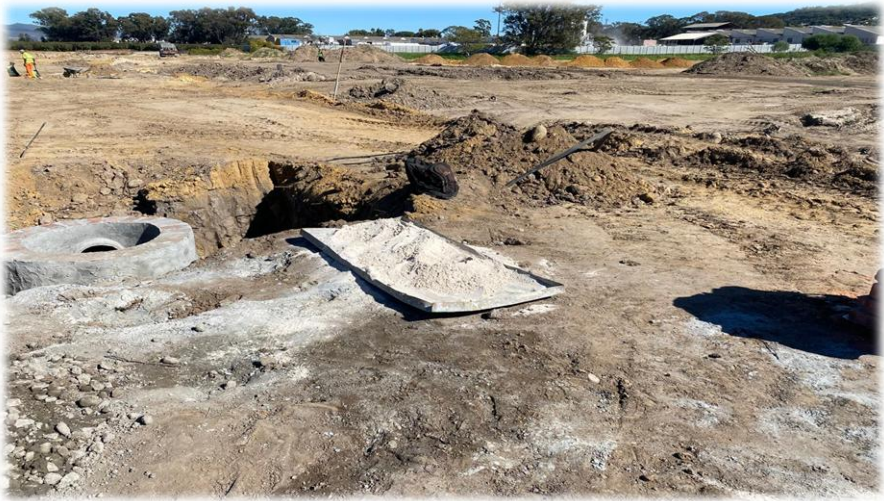
| <b>Cement</b> | <p>Method statements for cement batching have been provided to the ECO.</p> <p>Cement batching was active during the time of the audit and was sufficiently done in a wheelbarrow.</p> <p>No concrete spills and/or remains were noted during the audit.</p> | <p>Compliant</p> |

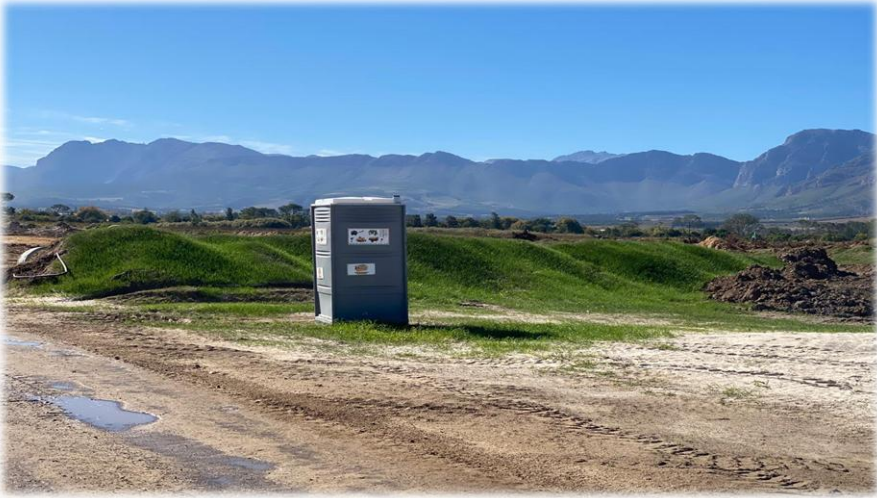
| <b>Toilets and ablution facilities</b> | <p>Ablution facilities were provided for the employees at the site camp area and both the working area in the form of portable chemical toilets. The toilets were within 150m of the working area.</p> <p>The contractor will ensure that the toilets are cleaned and emptied before builders break and other public holidays</p> | Complaint |

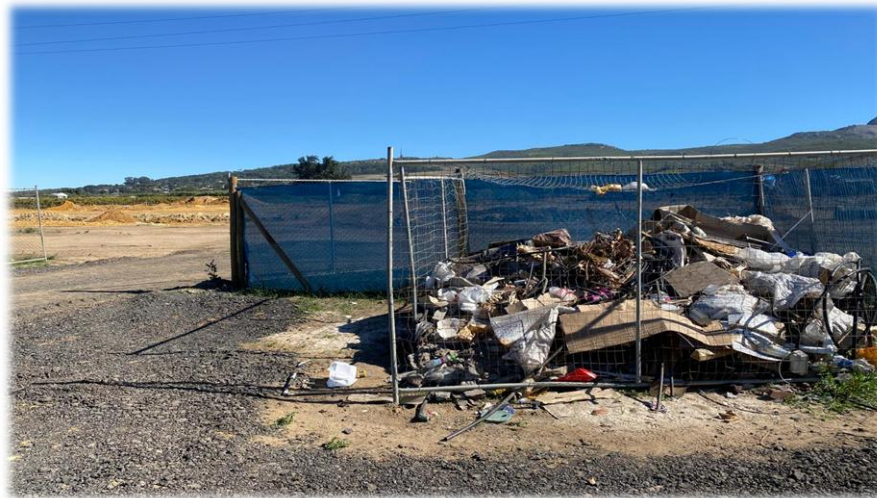
| <p><b>Waste management</b></p> | <p>The site was neat and tidy during the time of the audit.</p> <p>Waste is properly managed on-site. A waste storage site was located within the site camp area and the construction site is neat and tidy.</p> <p>No litter was noted during the audit.</p> <p>Waste disposal slips should please be kept on file at the site and forwarded to the ECO.</p> <p>Rubble found during excavation is stored on site until it can be crushed and used for fill material.</p> <p>Memorandum of understanding for the waste minimization plan has been signed.</p> | <p>Compliant</p> |

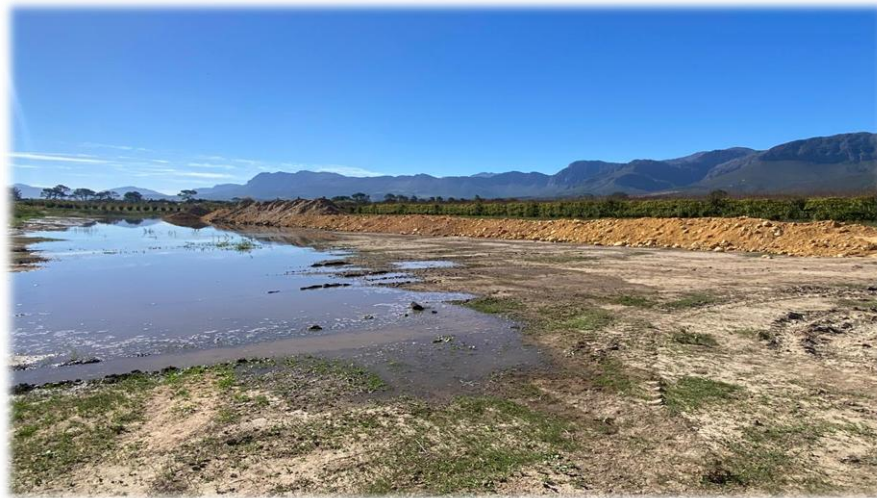
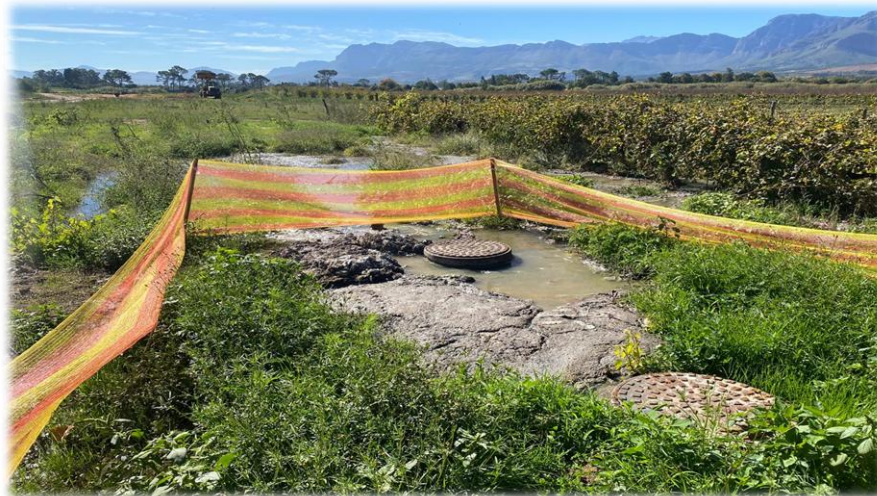
It should be noted that an old municipal sewer line on the property has overflowed at the manholes during the recent high rain periods. The contractor instantly contacted the Drakenstein Municipality and the council, as it is their infrastructure and will be responsible for remediation. To prevent runoff of sewage to enter the Berg River, the contractor created a berm to contain the spill which adequately contained the wastewater.

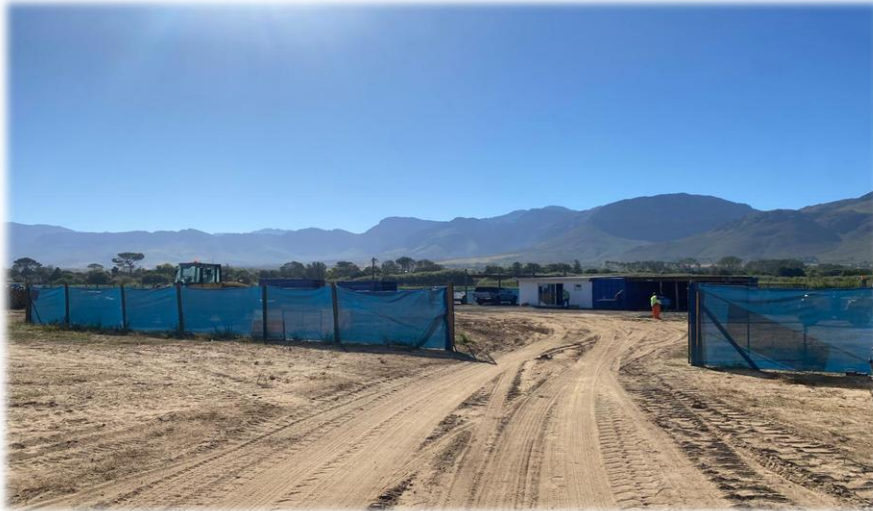
| <b>Visual impact</b> | <p>Shade cloth is utilized to cordon off the site camp area in accordance with the EMPr.</p> <p>Rubble and litter must be removed every two weeks or more often as the need arises and be disposed of at a registered landfill site as designated by the Drakenstein Municipality, Solid Waste removal department.</p> | Compliant |

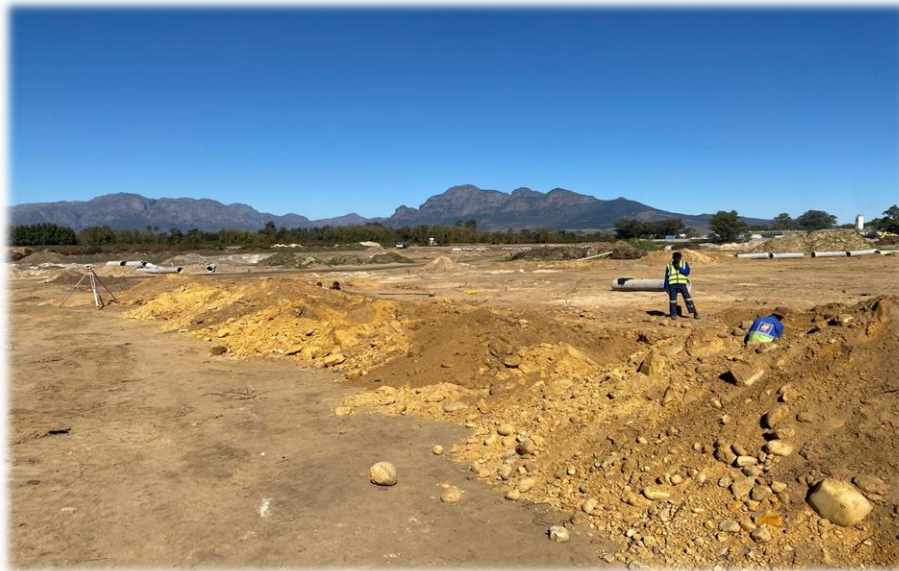
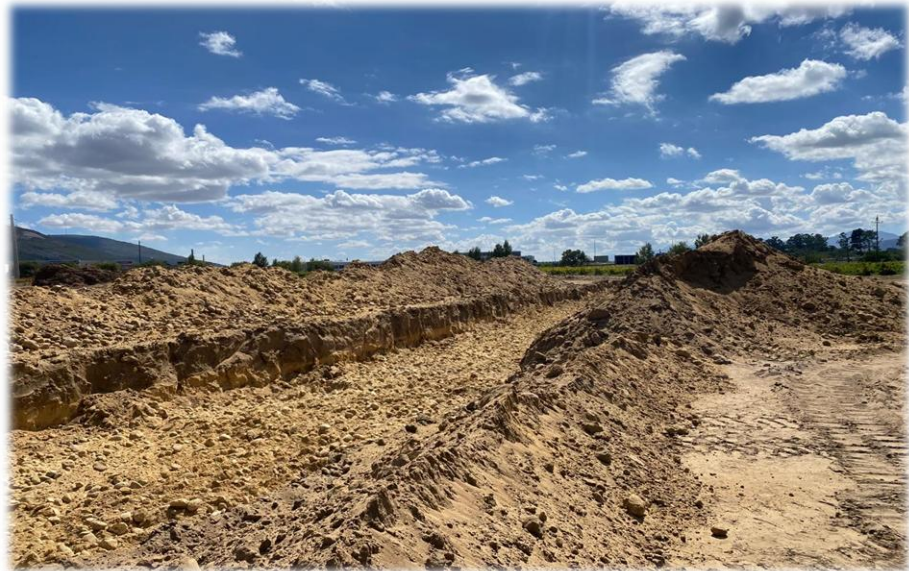
The contractors have cleared the working areas and are currently busy with sewer services. This includes trenching, laying of pipes and installation of manholes. The contractors will start with the laying of internal roads.
