## **Freshwater Rehabilitation, Maintenance and Management Plan (FRMMP):**

# **Calcutta, Farm 29, Stellenbosch, Western Cape**

**Stellenbosch Municipality**

**Date: November 2023**

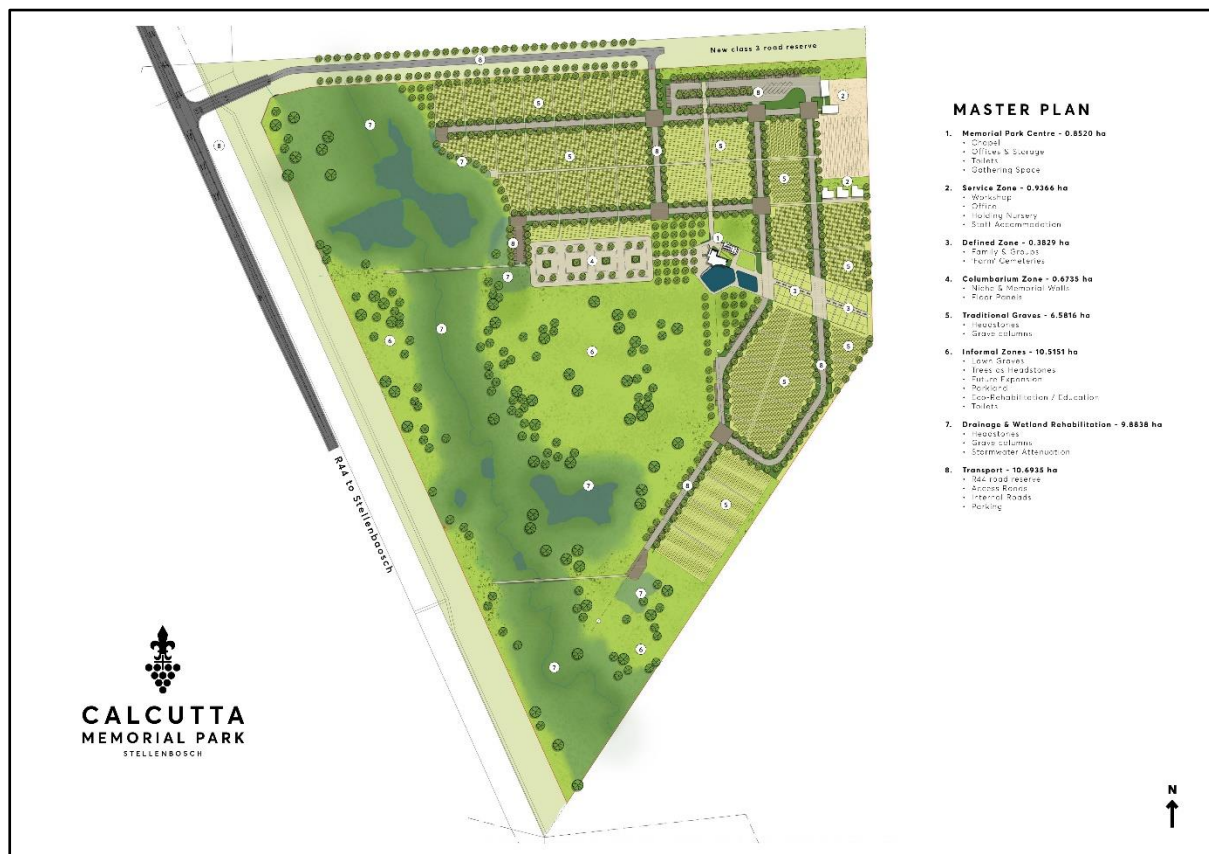
Figure 2: The proposed site layout.

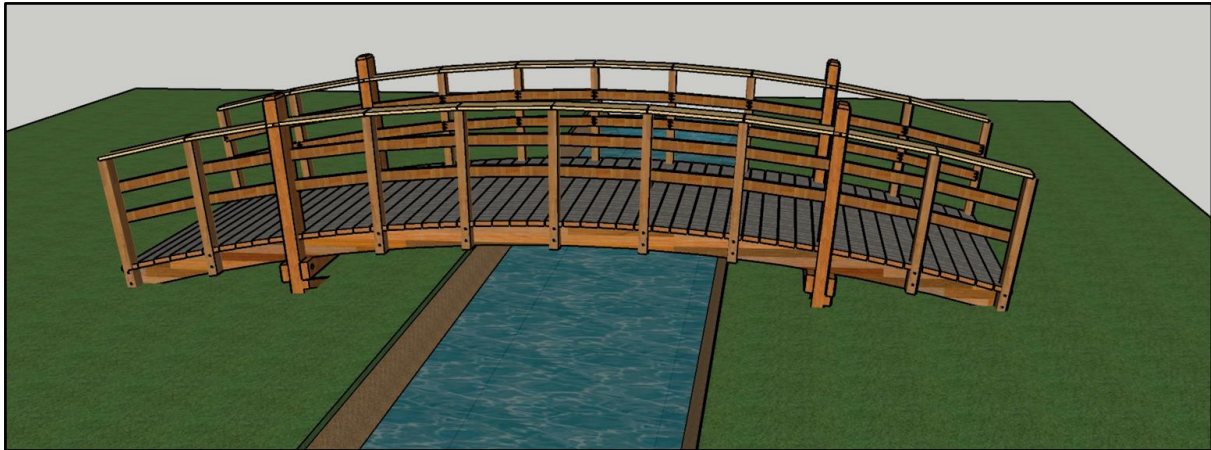
**Figure 4: Example of the design for the pedestrian crossings illustrating a potential design that does not require construction within the channel bank.**

Two pedestrian bridges over the ephemeral drainage line are proposed. Any repairs to the bridges must utilise materials and techniques that are in accordance with the mitigation measures described in the impact assessment. In other words:

- Do not use any materials containing Copper Chrome Arsenate (CCA) which is commonly used to treat timber.
- Ensure that the vehicle crossing is no wider than 3m and that the pedestrian bridges are no wider than 1.8m.
- Should replacement of the pedestrian bridges be required in future, ensure that no excavation occurs within 1m of the channel bank.
- Ensure that no part of the grass-blocked vehicle crossing protrudes more than 20mm above the bed of the drainage line.
