# DRAFT ENVIRONMENTAL MANAGEMENT PROGRAMME

PERIODIC MAINTENANCE AND RESEALING OF TRUNK  
ROADS 33/4 AND 34/2 BETWEEN DE RUST AND  
PRINCE ALBERT.

**DATE:** 7 July 2020

**SES PROJECT REF NO:** EMP/DR/PA/TR33/TR34  
**EIA REF:** 14/12/16/3/3/1/2104

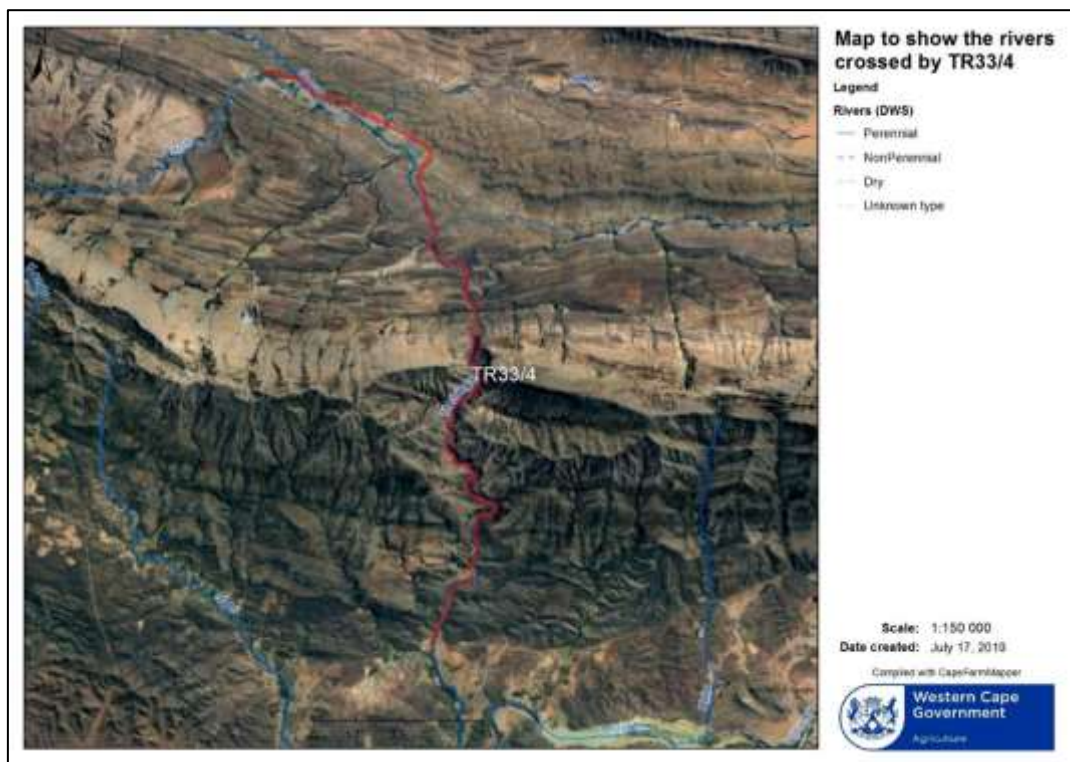
**Figure 4:** Map to indicate how TR33/4 traverses the Meirings and Groot river.

Please refer to Figures 4 and 5 for the locality of the abovementioned rivers in relation to TR33/4 and TR34/2.

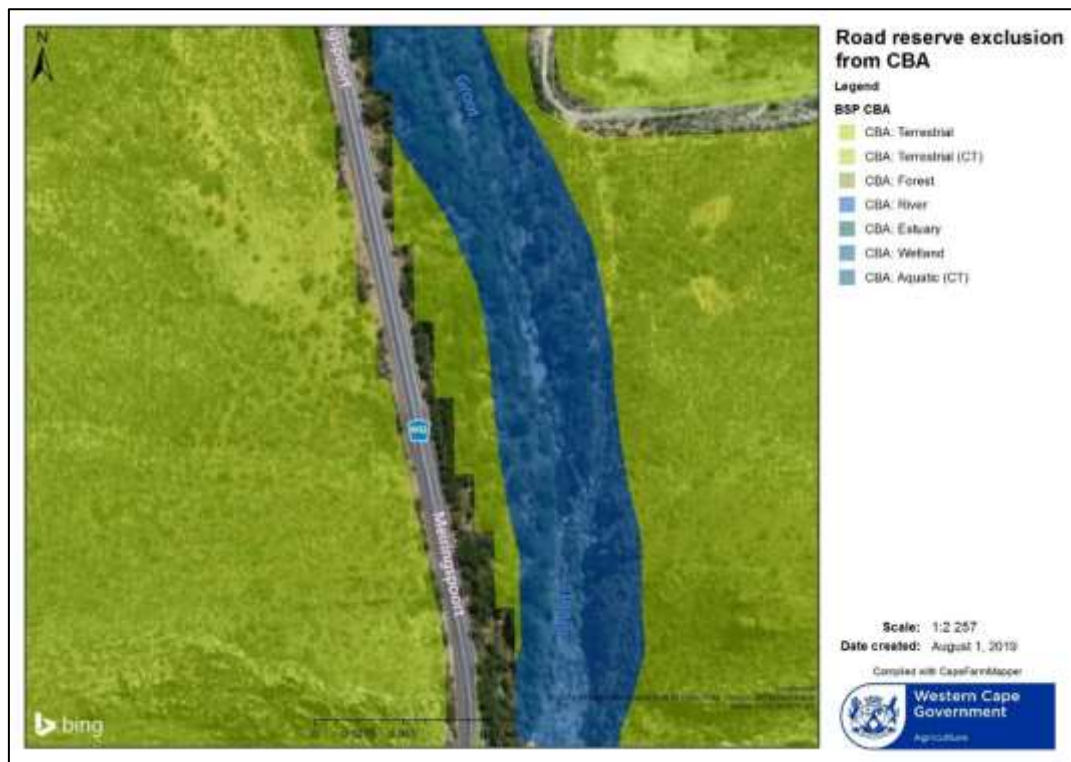
**Figure 9:** Map to show how the road reserve of TR33/4 is excluded from the CBA.

It is essential to note that the relative ESA and CBA areas fall outside of the road reserve and are essentially excluded. As seen in figures 8 and 9.

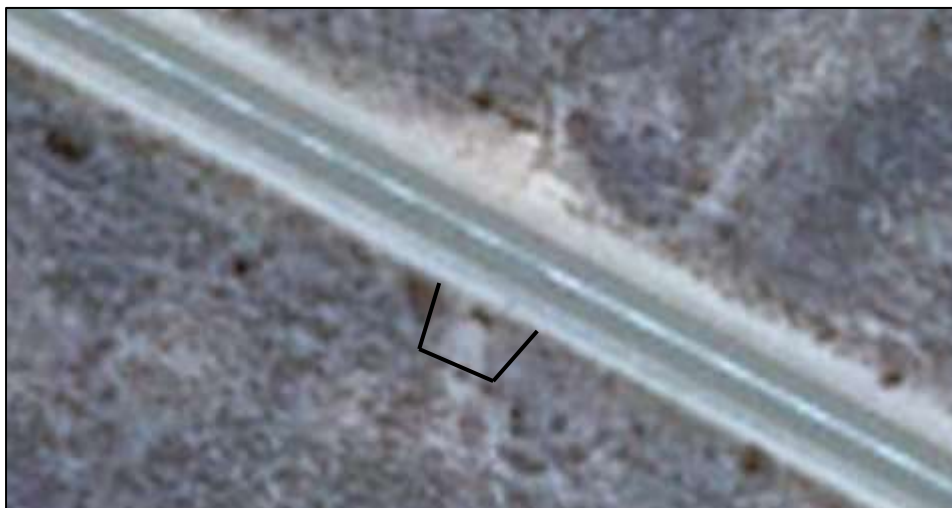
**Small Culverts or areas with flat embankments** Figure 13 shows an example of site access for culverts where the embankment is relatively flat. As seen from the image, the least amount of disturbance to the environment because of site access will occur if the site is accessed directly from the road level.

**Figure 13:** Demarcation example for areas with little to no embankment slope

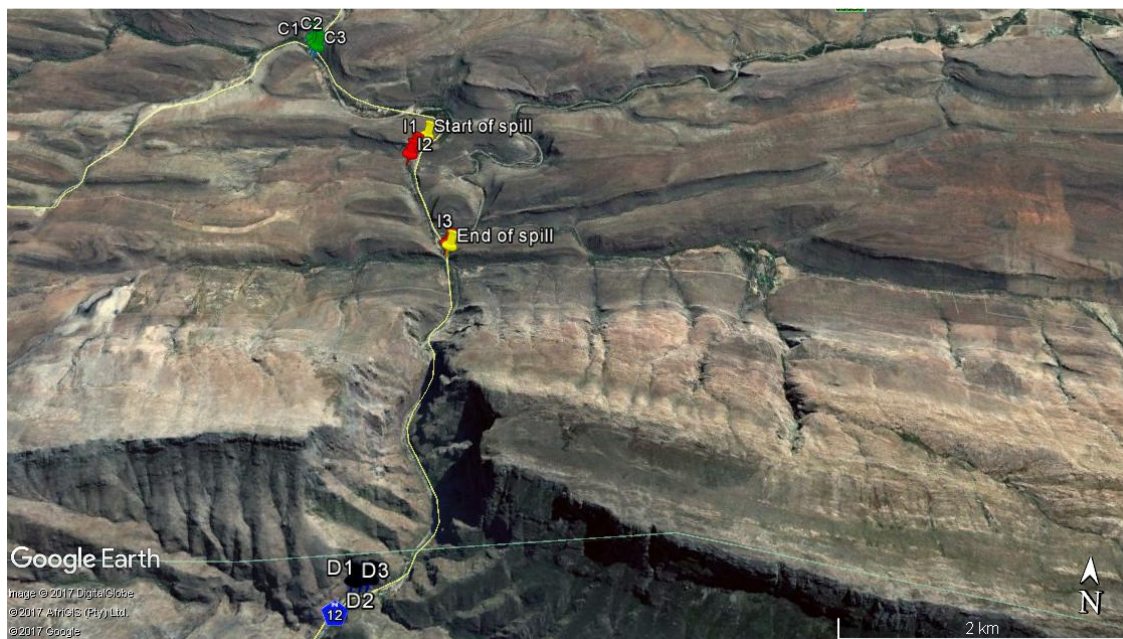
**Figure 2:** Locality of the sampling sites within the control (C1-C3), impacted (I1-I3) and downstream (D1-D3) areas

The Groot River was sampled at nine sites within three zones in the river (Figure 2). These zones were a control zone (located upstream of the contaminated zone), an impact zone (between the spill site and the furthest downstream containment berm) and a downstream site located some distance downstream of the end of the impact zone (Table 1). Sampling was conducted for four sampling intervals: (1) two weeks after the spill - September 2017, (2) three months after - December 2017, (3) nine months after - June 2018 and (4) one year after - October 2018. In each zone, three replicate fyke net efforts were conducted to determine the fish community composition and to investigate whether there were differences between the three zones. Fyke nets were deployed for a soak time of 16 hours. All nets had a base width of 600mm and 4mm mesh size. All fish that were collected were measured and both fork length (FL) and total length (TL) was recorded, and catch per unit effort (CPUE) was calculated for each site. Habitat characteristics were noted for each site and water quality parameters (pH, temperature, conductivity and dissolved oxygen) were collected along with SASS5 sampling (reported separately).

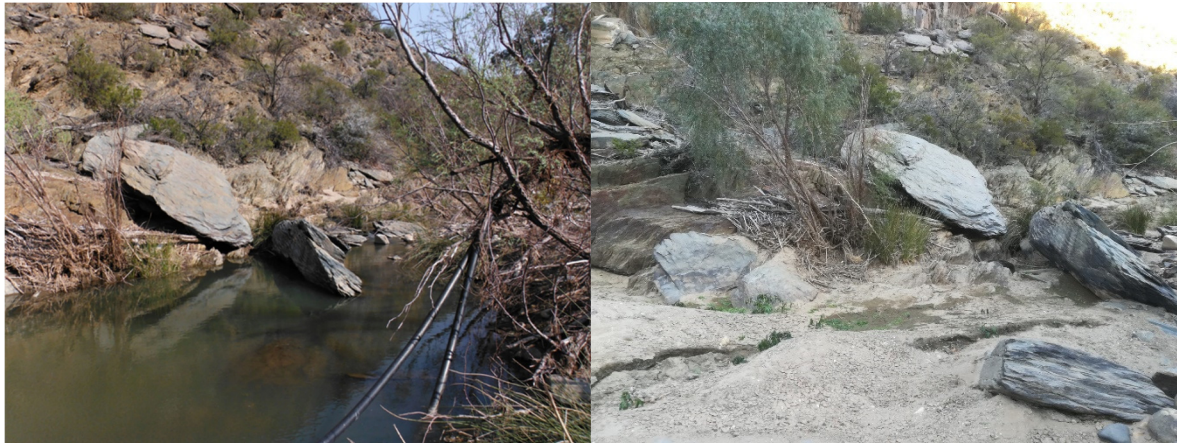
**Figure 3:** Site 2 (C2) of the control zone during September 2017 and June 2018 indicating the impacts of severe drought and possible water abstraction.

The sites in the control zone was located directly downstream of a causeway on the farm Middelwater towards the northern end of the Meiringspoort. For the initial September 2017 survey the river was flowing well and consisted of a number of medium sized pools (30-40 m long, max depth  $\pm 1.2$ m). The water was slightly turbid at the time of sampling. Pool substrate was mostly gravel, sand and mud that was covered in periphyton with some rocky riffle areas between. As with pool habitat, the majority of shallower habitat also had sand and mud substrate. Some of the pools also had some shale bedrock substrate but this was not common. Periphyton was present on all bedrock substrate. All pools had moderate amounts of undercut banks and root wads and marginal vegetation consisting of sedges. Woody debris was present in all pools. By the time of the December 2017 survey, the river had very little flow and the furthest upstream control site had dried up. Pool volume was severely reduced and only two sites were suitable for deploying nets. By June 2018 the entire control zone had dried up and no sampling could be conducted (Figure 3). The river was flowing again by October 2018 but pool volume was still reduced relative to the initial sampling event of September 2017.

The impact of drought is very evident in both the control and the impacted zones and this confounds the impacts of the diesel spill. The control zone started to dry up during December 2017 and was completely dry during the June 2018 survey (Figure 3). Despite reduced flow and associated impacts on habitat, the control zone had the highest CPUE value of all three zones (Figure 9) during December 2017 (Figure 9). This can largely be attributed to successful spawning, illustrated by the dominance of the young of year size class detected during sampling (Figure 5b). It is very likely that some if not all of these fish have perished as a result of this section of river drying up completely during the winter of 2018. While the river was flowing again in October 2018, pool volume was still reduced compared to September 2017 and only two fish were caught, illustrating the severe effects of intermittent droughts on the distribution of threatened native fishes of the region. The few fish observed in the control zone in October 2017 has likely recolonised this section of river from upstream sources (upper Groot River and Aaps River) where populations of both redbfin exist (Jordaan and Gouws, 2017). The upstream source populations of redbfins are also likely to be the source of the *P. tenuis* individuals that was observed in the impacted zone of the Groot River during the December 2017 survey. When considering the CPUE and size distribution data collected from the downstream zone for all four sample events, there is no evidence to date that suggests significant impacts on the fish community downstream of the spill zone. While a reduction in CPUE was observed between the September 2017 and December 2017 sample events, a CPUE of over 500 fish/netting effort was observed for the June 2018 sample event. The fish that were sampled was also dominated by young of year and juvenile size classes (<60mm TL), presenting evidence for successful recruitment during the past spawning season.

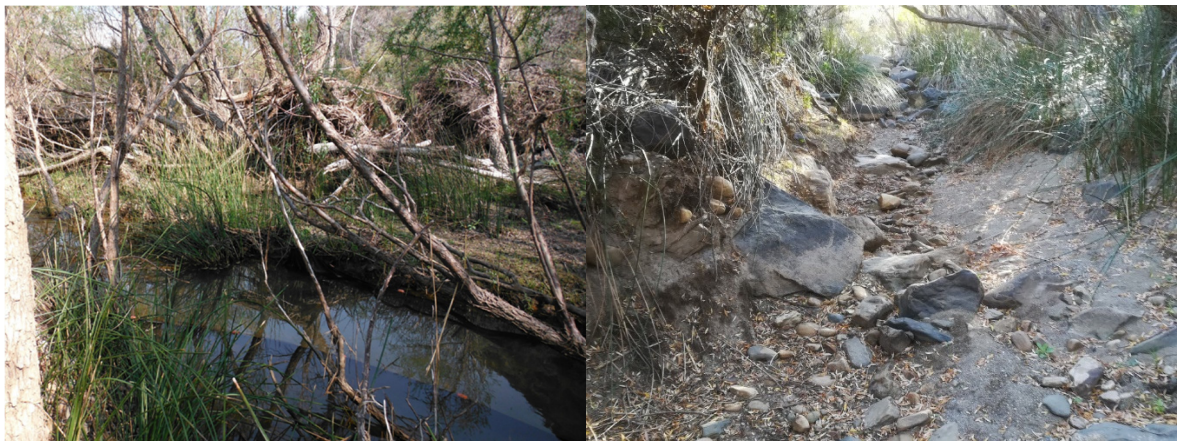
**Figure 4:** Site 2 (I1) of the impact zone during September 2017 and June 2018 indicating the impacts of severe drought and possible water abstraction.

Three sites were selected in the impacted zone, with two sites located near the upper end of the spill zone and the third site located at the end of the spill zone immediately upstream from the furthest downstream containment berm. For the September 2017 survey, the habitat at the first site was a small and relatively shallow pool (approximately 2m wide and less than 10m long) with a cobble substrate and abundant woody debris and marginal vegetation. In contrast, the other two netting areas were associated with large and deep pools in the river. These pools were characterised by a sand and mud substrate and the middle site (I2) had large shale bedrock banks on the left bank. Both sites had relatively turbid water and slow flow and marginal vegetation consisting of sedges. The drought effects observed at the control zone in December 2017 was also evident in the impact zone at this time as both the upstream and downstream sites were dry. Also, similar to the control zone, pool volume was reduced compared to the September 2017 sampling event. By June 2018 all three sampling sites within the impact zone had dried up and no sampling could be conducted (Figure 4). It must be noted that some water remained in the impacted zone close to sites I2 and I3, but these sites were not sampled due to very deep mud substrates which complicated setting and retrieving of nets. The river was flowing again by October 2018 but pool volume was still reduced relative to the initial sampling event of September 2017.

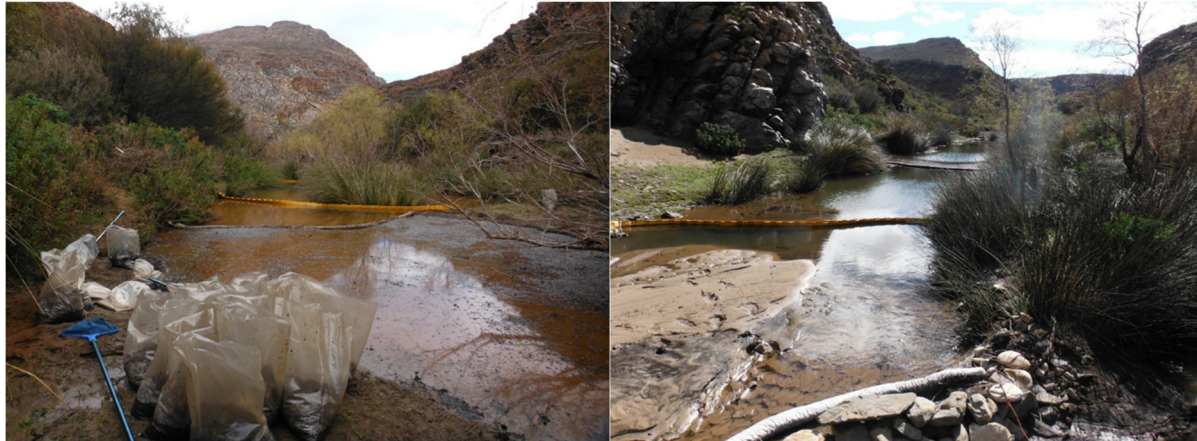
**Figure 6:** Containment berms and clean-up of contaminated soil (left) and furthest downstream containment berm (right)

When inspecting the spill zone two days after the incident, several containment berms were observed in the affected zone and clean-up of contaminated soil was underway (Figure 6). The river was low at the time of the site visit with visible flow in riffle areas. It appeared that the spill had been contained by the furthest downstream berm (Figure 6). The SpillTech team reported that the area did receive rain but it appeared not to significantly affect the river's flow rate. No signs of affected animals were initially observed (with the exception of a dead duck and a dead frog), but dead and moribund *P. asper* were detected at approximately 14:00 on Friday 18 August in a small pool in the affected area. The first dead fish were thus observed roughly four days after the spill.
