**THE PERIODIC MAINTENANCE OF TRUNK ROAD 33/4 (DE RUST-KLAARSTROOM) AND TRUNK ROAD 34/2 (PRINCE ALBERT-KLAARSTROOM),  
WESTERN CAPE**

DEA&DP Ref: 14/12/16/3/3/1/2226 (EA)

**FORMAL ECO AUDIT REPORT**

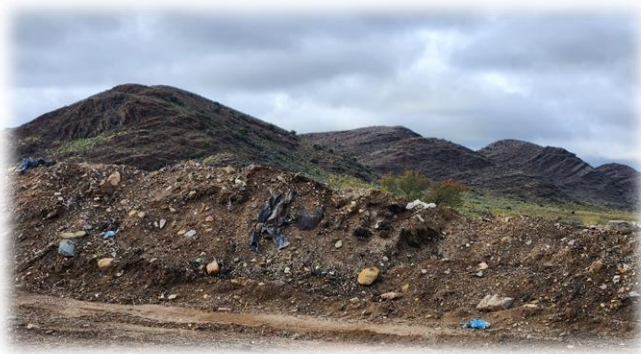
Bitumen remains were still noted next to the site camp area at Klaarstroom. All bitumen remains must please be removed.

The contractor is requested to please confirm where bitumen remains are disposed of.

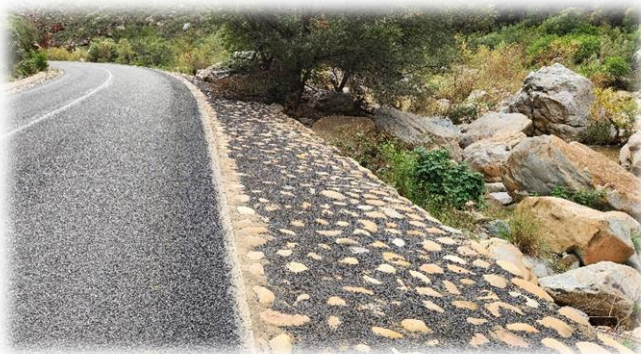
Excess seal stone were still found next to the road within the poort. The contractor was advised to please remove the excess seal stone as soon as possible.

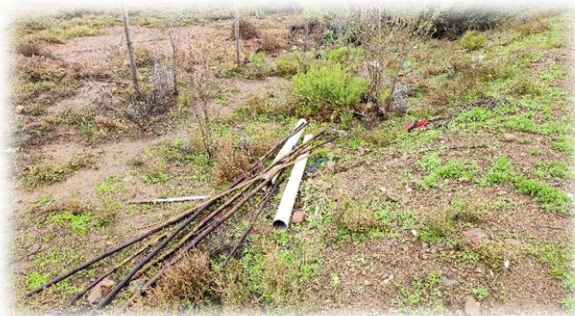
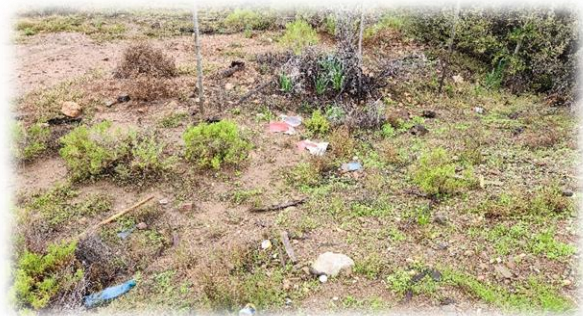
Litter was seen at Km 25 at the culvert, the contractor was advised to please ensure a bin is placed on site and to dispose of the litter. **Previously reported finding.**

Proof of litter disposal is required to be forwarded to the ECO.

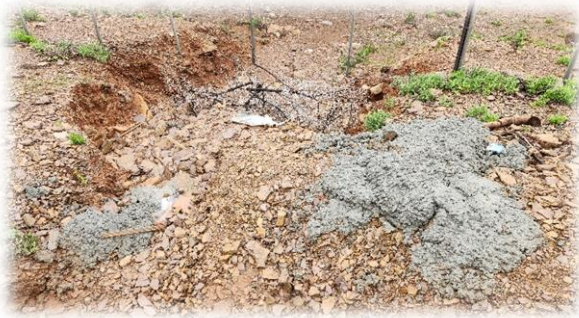
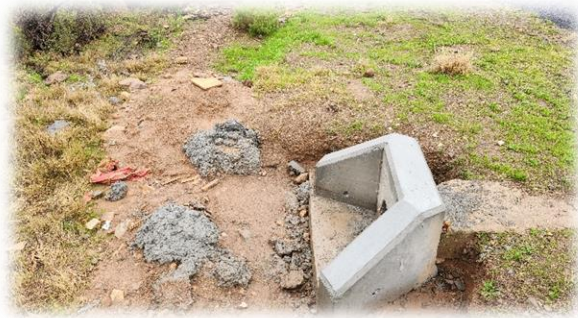
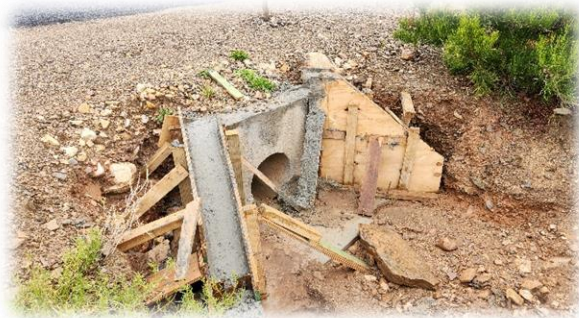
Large amounts of concrete remains were found at culverts along the site, especially the Prince Albert to Klaarstroom section. All culverts should please be properly cleaned. Proof of appropriate rubble disposal is required.

The amount of concrete remains at the culverts are a concern and must be cleaned as soon as possible.

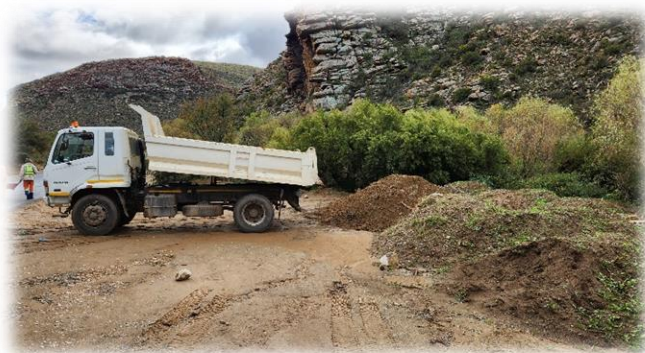
All material temporary stockpiled must be removed from the poort.

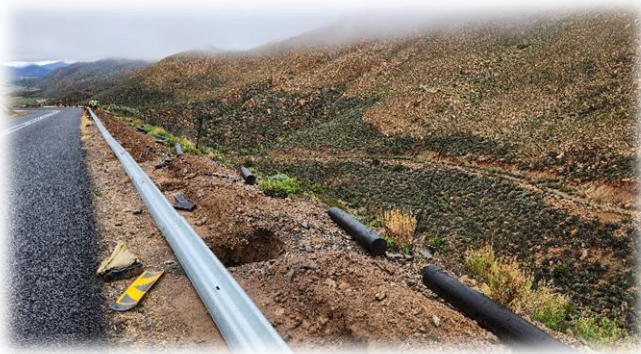
Minimal works took place during the audit. A small team was busy on the concrete side drains and at the guardrails.

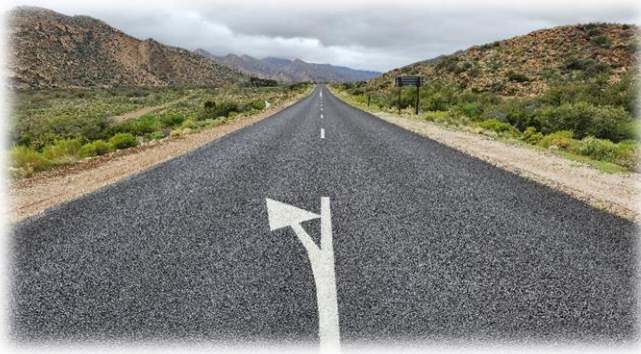
To date, the seal and line marking has been completed on the Prince Albert section of the project.
