**THE PERIODIC MAINTENANCE OF TRUNK ROAD 33/4 (DE RUST-KLAARSTROOM) AND TRUNK ROAD 34/2 (PRINCE ALBERT-KLAARSTROOM),  
WESTERN CAPE**

DEA&DP Ref: 14/12/16/3/3/1/2226 (EA)

**FORMAL ECO AUDIT REPORT**

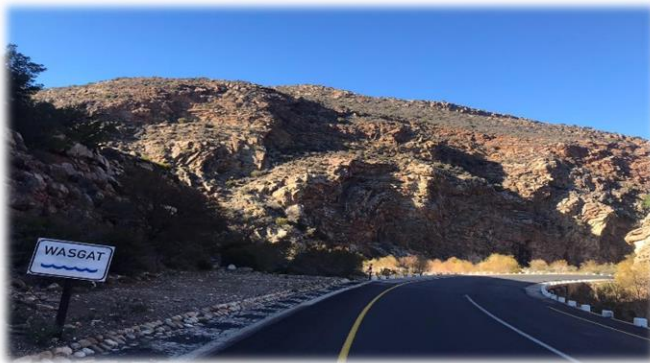
Excess seal stone were still found in the side drains within the poort. The contractor was advised to please remove the excess seal stone as soon as possible.

| | Finding | Close Out Recommendation |
|---|---|---|
| 1 | <b>Bitumen</b><br><br>Access seal stone still present in side drains and next to the road in the Poort | Remove all seal stone to be appropriately disposed. |

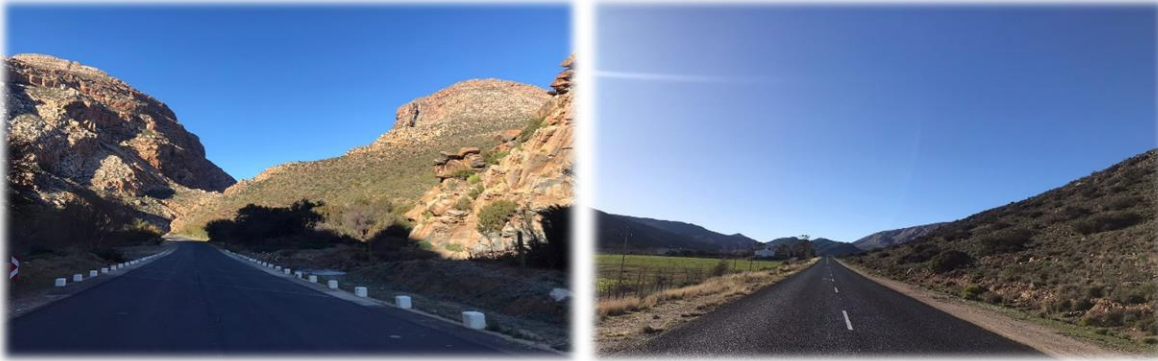
The road surface under traffic, must be clean from mud/sand at all times to prevent the material being a danger to traffic. The road was clean during the audit.

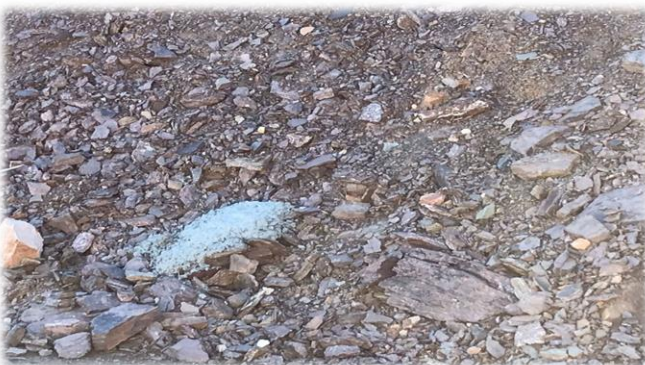
Concrete remains were noted on the rubble stockpile at the rest area on TR34/2, the contractor was advised to please remove the concrete remains from site.

| | Finding | Close Out Recommendation |
|---|---|---|
| 2 | <b>Concrete</b><br><br>Concrete remains were noted on rubble stockpile on TR34/2 | Please remove all concrete remains to be appropriately disposed. |

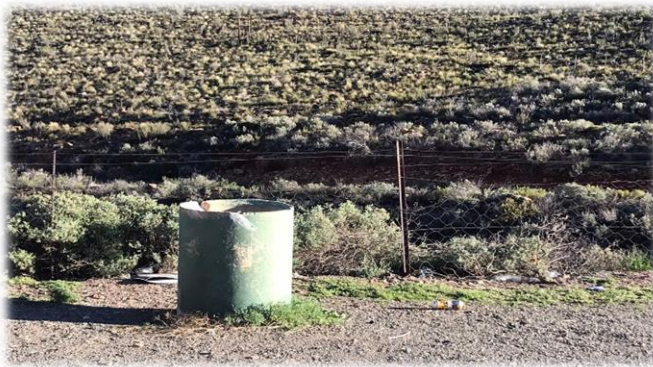
Litter was seen at the rest area bin on TR34/2, the contractor was advised to please ensure the litter is removed from site.

| | Finding | Close Out Recommendation |
|---|---|---|
| 3 | <b>Litter</b><br><br>Remove all litter at the rest area on TR34/2 | Please remove all litter at the rest area. |

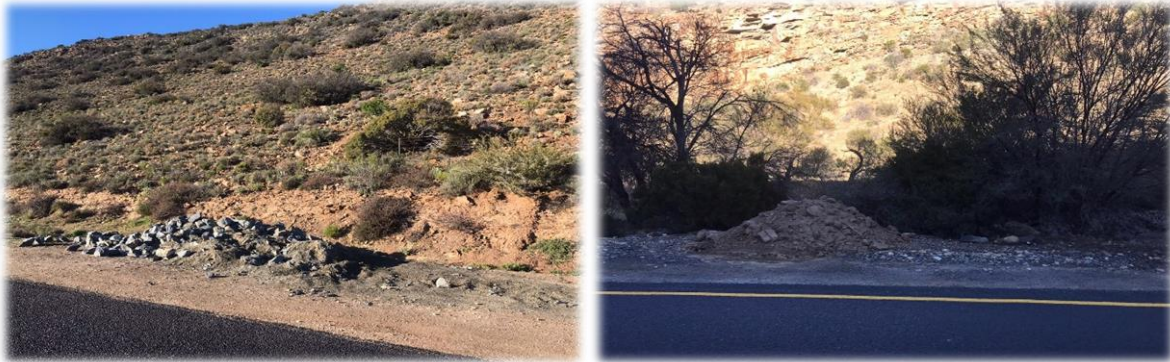
Rubble stockpiles were noted next to the road, the contractor is advised to please ensure that all rubble is stockpiled securely.

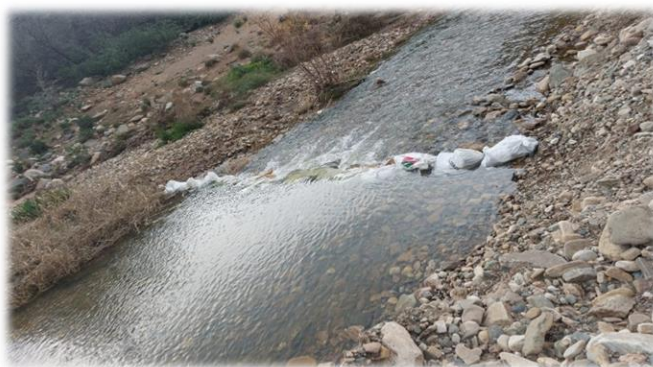
The contractor was advised to please create sediment traps within the watercourses where maintenance is proposed to limit the spread of sediment downstream due to maintenance works, thank you for that.

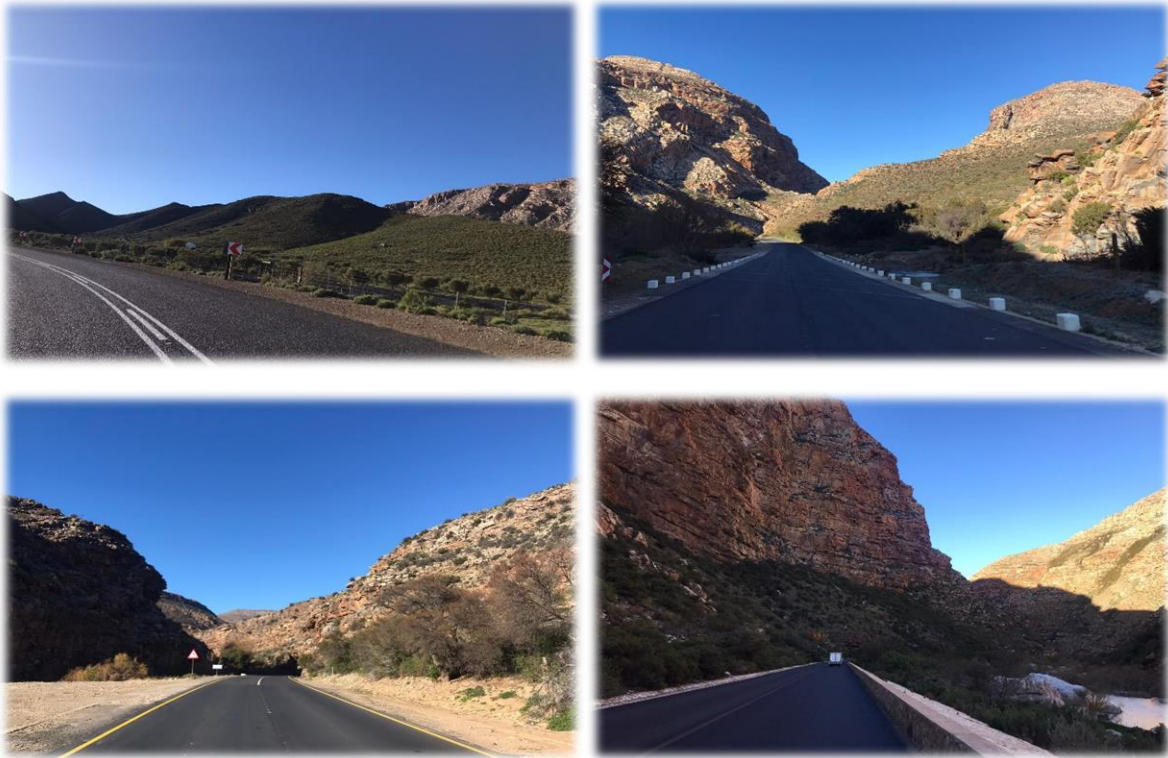
The works that took place during the audit was the joints within the Poort, and the guardrails on TR34/2.
