**THE PERIODIC MAINTENANCE OF TRUNK ROAD 33/4 (DE RUST-KLAARSTROOM) AND TRUNK ROAD 34/2 (PRINCE ALBERT-KLAARSTROOM),  
WESTERN CAPE**

DEA&DP Ref: 14/12/16/3/3/1/2226 (EA)

**FORMAL ECO AUDIT REPORT**

5 September 2023

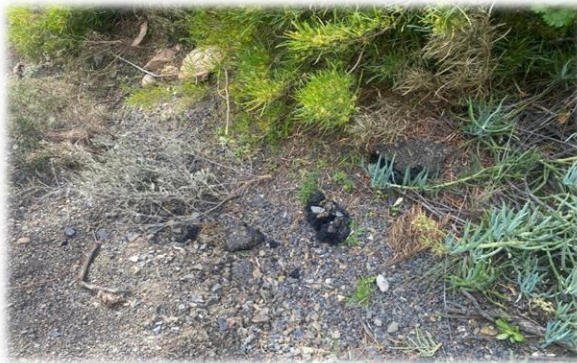
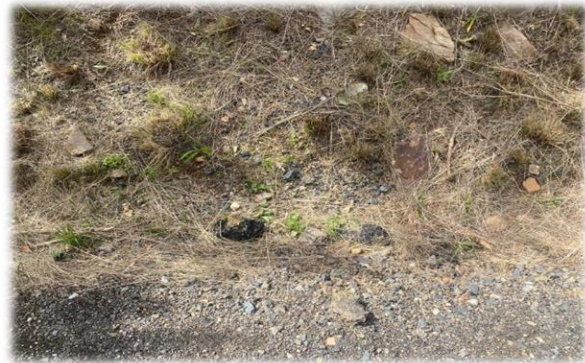
Bitumen remains were noted in the Pass between Km 11-13, the contractor was advised to please remove the bitumen remains next to the road.

| | Finding | Close Out Recommendation |
|---|---|---|
| 1 | <p><b>Bitumen</b></p> <p>Access seal stone still present next to the road in the Poort and on TR34/2</p> <p>Bitumen remains found within the Poort</p> | <p>Remove all seal stone to be appropriately disposed.</p> <p>Please remove all bitumen remains from site</p> |

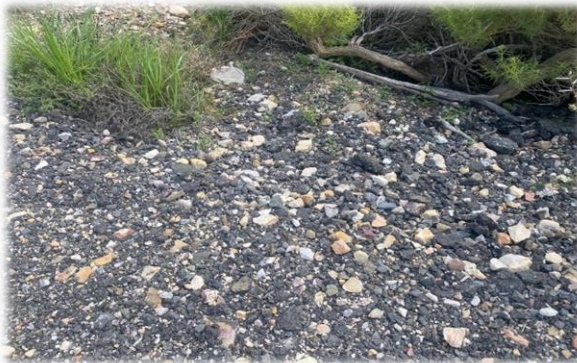
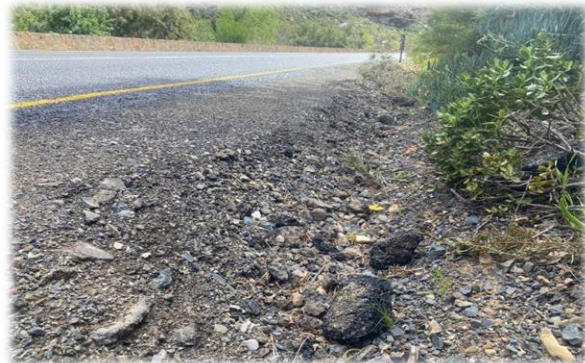
Bitumen millings were noted within the Pass, the contractor was advised to please remove the millings as soon as possible, to prevent them from going into the culverts when raining.

The contractor is requested to please confirm where bitumen remains are disposed of.

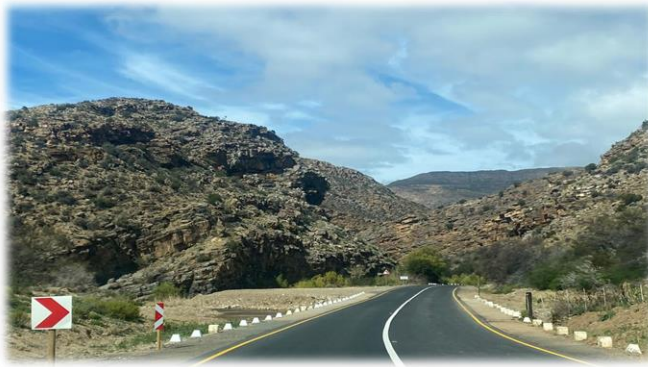
The road surface under traffic, must be clean from mud/sand at all times to prevent the material being a danger to traffic. The road was clean during the audit.

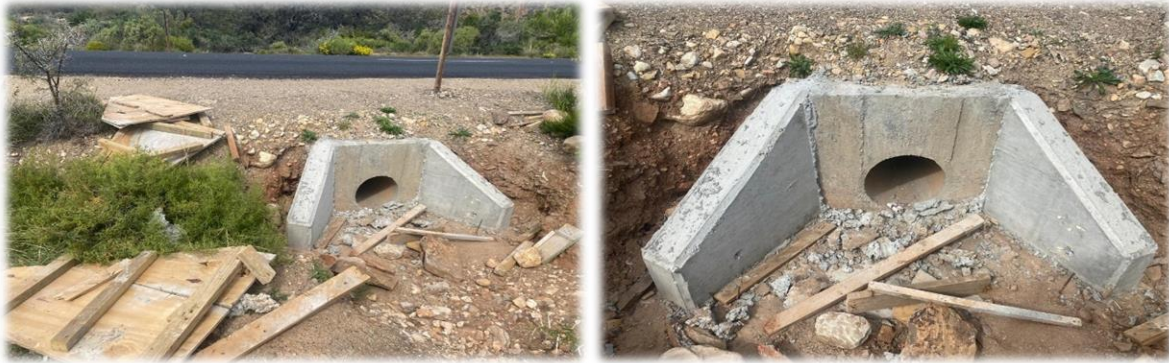
Concrete remains were noted within the culvert on the Prince Albert Road, the contractor was advised to please remove the concrete remains from site and dispose of it at a registered waste landfill site.

| | Finding | Close Out Recommendation |
|---|---|---|
| 2 | <p><b>Concrete</b></p> <p>Concrete remains were noted within the culverts on TR34/2</p> | <p>Please remove all concrete remains to be appropriately disposed.</p> |

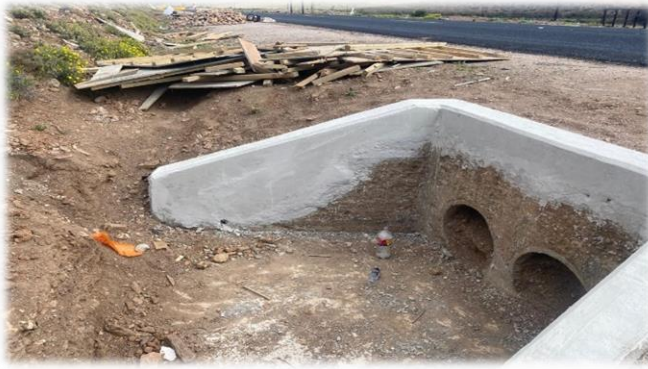
Some litter was noted within the culverts, the contractor was advised to please regularly remove litter from site.

| | Finding | Close Out Recommendation |
|---|---|---|
| 3 | <p><b>Litter</b></p> <p>Remove all litter at the culverts on TR34/2</p> | <p>Please remove all litter at the culverts.</p> |

Proof of litter disposal is required to be forwarded to the ECO.

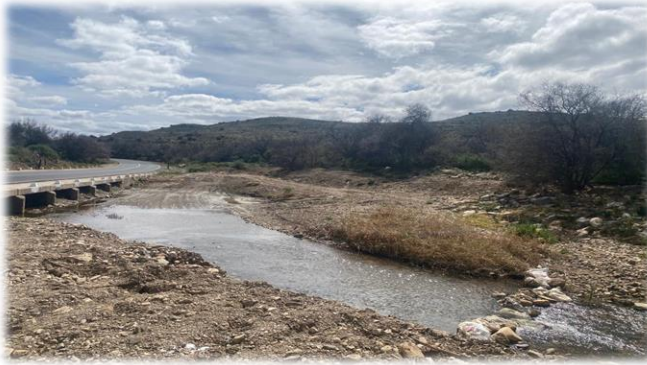
The contractor created sediment traps within the watercourses where maintenance is proposed to limit the spread of sediment downstream due to maintenance works, thank you for that.

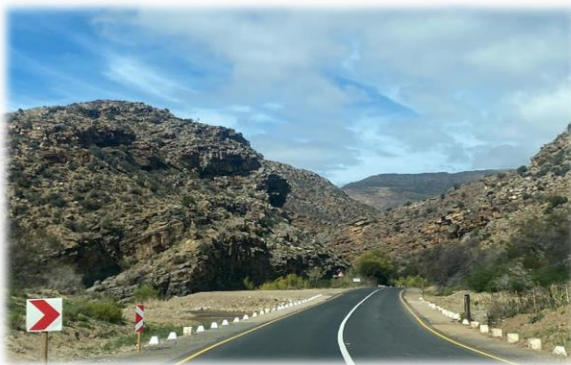
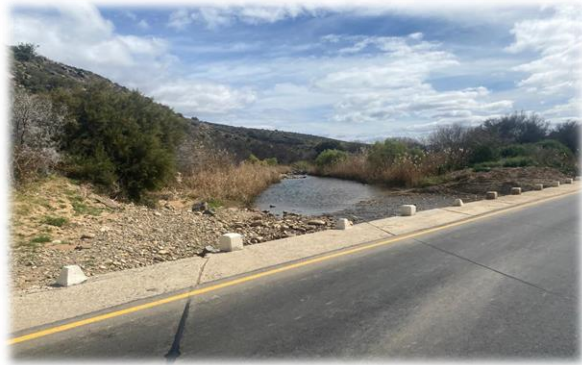
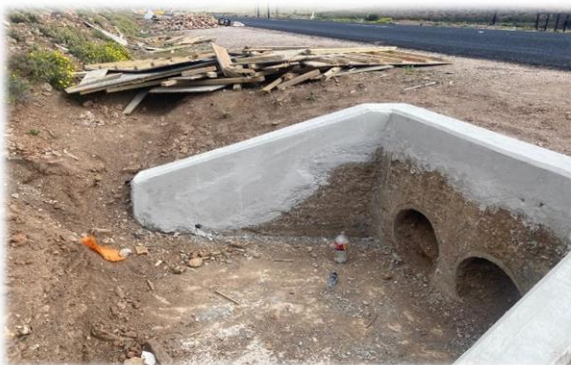
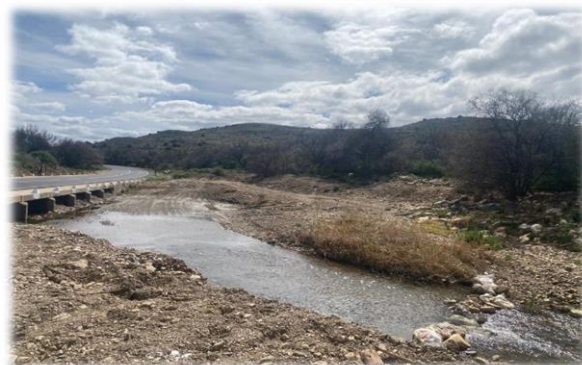
During the site visit the contractor was busy with the backfilling of the culverts on the Prince Albert road.
