**THE REHABILITATION AND UPGRADING OF TRUNK ROAD 28 SECTION 2  
(TR28/2)(R43) AND RELATED EXISTING DEGRADED STORMWATER  
INFRASTRUCTURE (CULVERTS), FROM KM23.83 TO KM43.88, BETWEEN  
STANFORD AND GANSBAAI, WESTERN CAPE**

DEA&DP Ref: 16/3/3/1/E2/37/1033/20

**FORMAL ECO AUDIT REPORT**

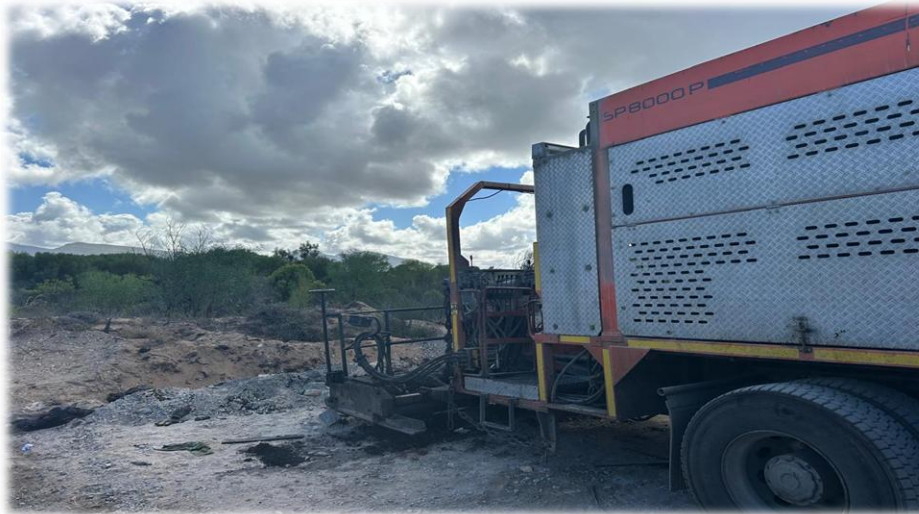
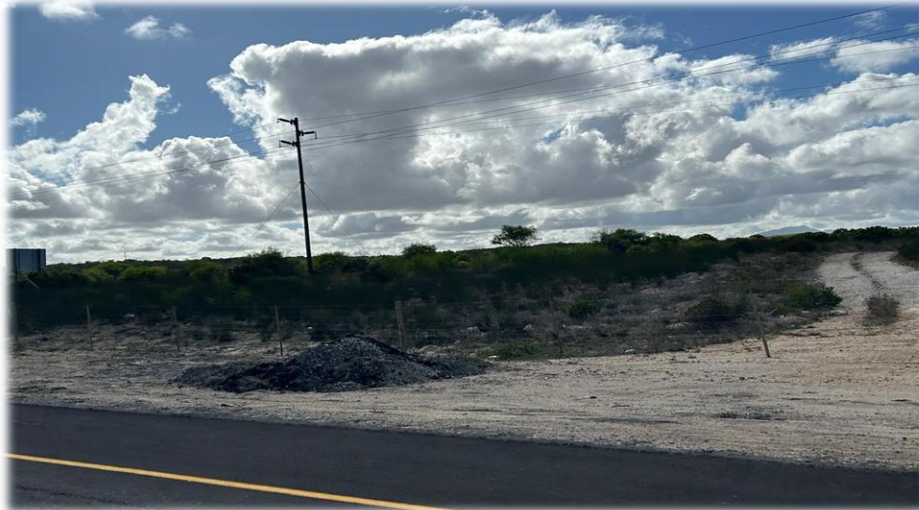
| <b>CONSTRUCTION PHASE EMPr</b> | | |
|---|---|---|
| <b>Oil and Chemicals</b> | <p>Two bulk fuel tankers were observed in the site camp, the tanks have an impermeable bunded area.</p> <p>No generators were seen on site during the audit.</p> <p>A spill kit was placed on site.</p> <p>The contractor should please ensure that the bitumen remains are removed from site and that the bitumen tanks are placed in a bunded area.</p> <p>Some remains were noted next to the road and the 2<sup>nd</sup> stockpile area and should please be disposed of.</p> | Partial Compliant |

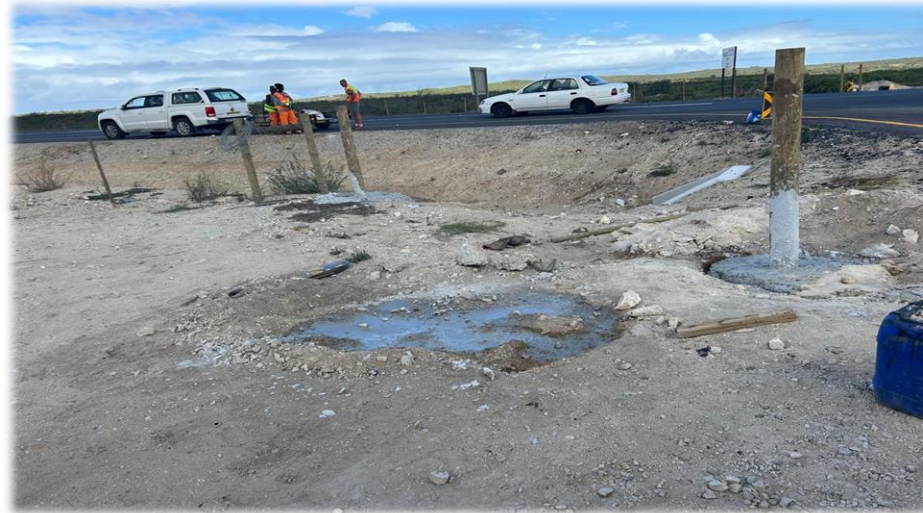
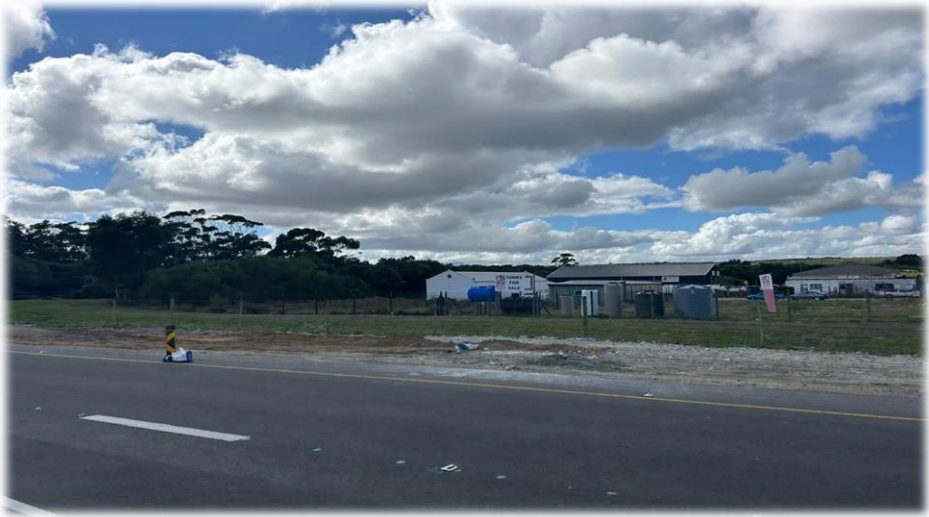
**Cement**

Batching remains were seen during the audit, the batching was done next to the road directly on the ground, the contractor is advised that no batching may be done directly on the ground and should use an impermeable area. The remains should please be removed.

**Partial Compliant**

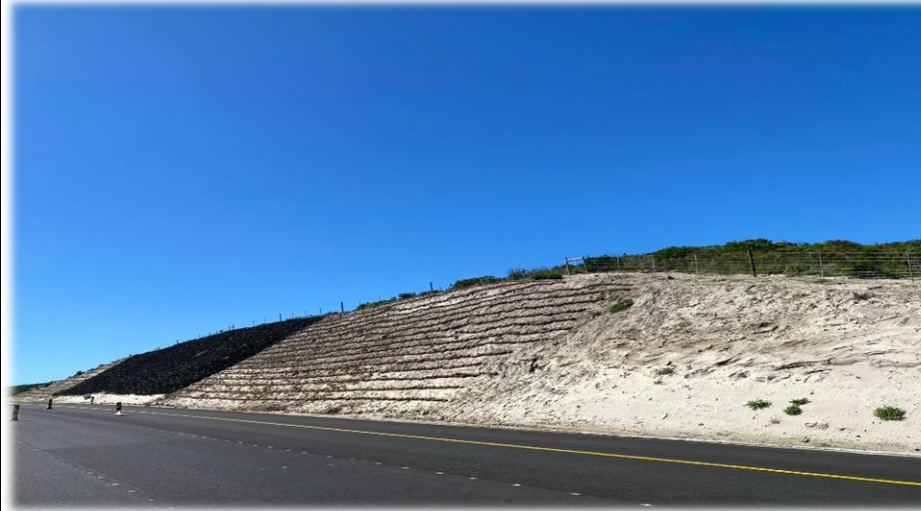
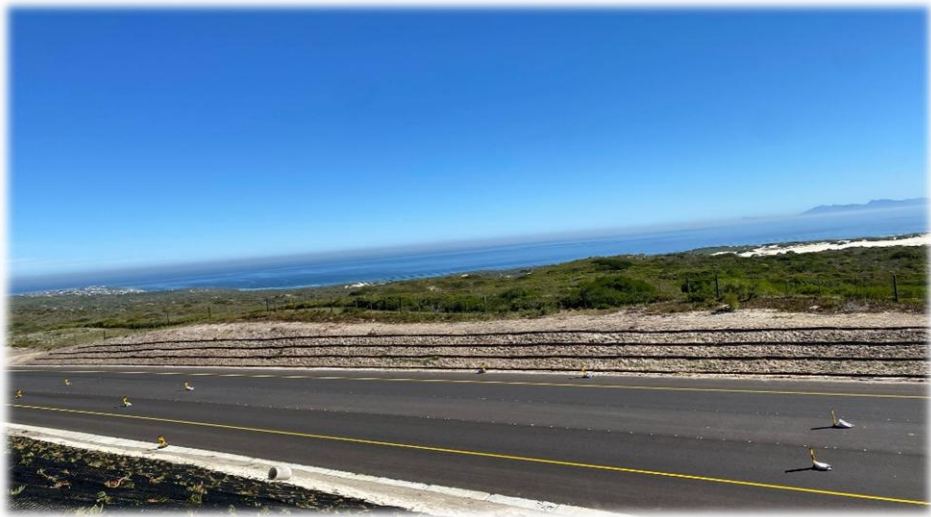
**Erosion and sedimentation**

No major erosion runnels or sedimentation was observed at any of the working areas.  
Erosion protection was installed on the steep slopes.

Compliant

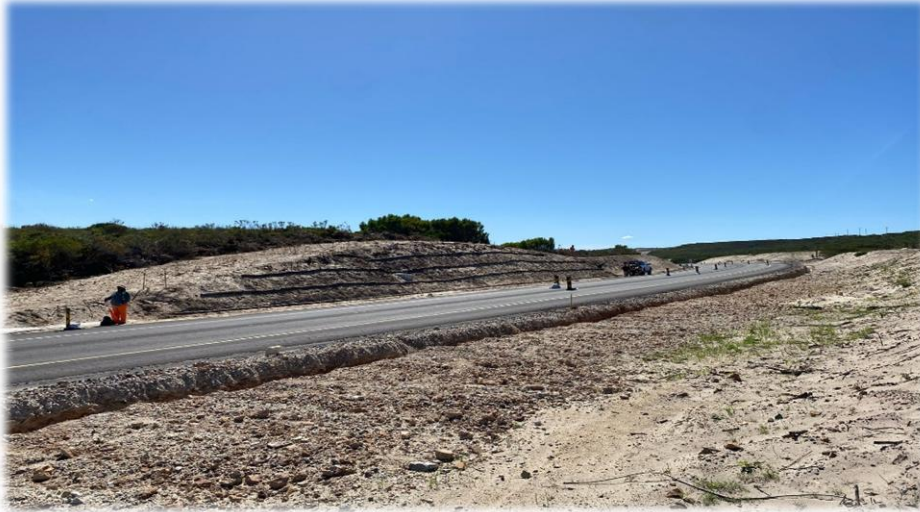
| <b>Rehabilitation process</b> | <p>Depending on the gradient of certain areas, horizontal stabilization by means of biodegradable sausages or soil savers will have to be considered. This will help with embankment stabilization and minimize and prevent erosion while the plants is stabilizing. This has been done already.</p> <p>Disturbed area needs to be rehabilitated by means of planting and hydro seeding these areas with the searched and rescued endemic plants and seeds. Please refer to the rehabilitation report attached.</p> | Premature |

| | Rehabilitation by means of planting should be undertaken in the beginning of the rainy season to ensure that the rehabilitated area receive enough water. Should rehabilitation be done in summer, the area will have to be watered at least once a week. | |

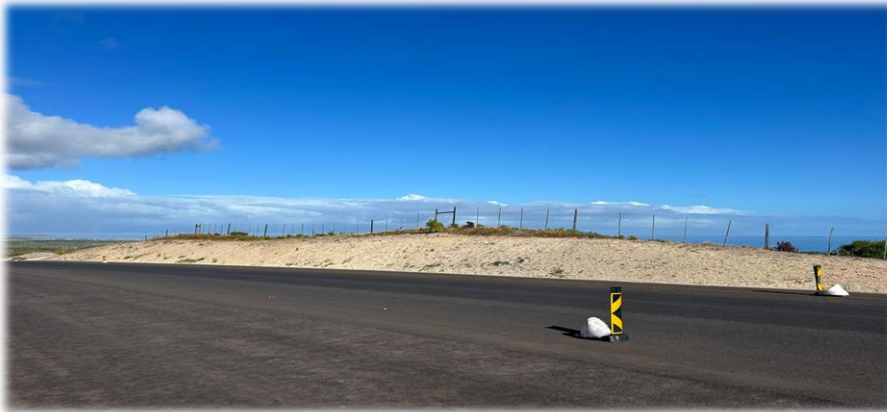
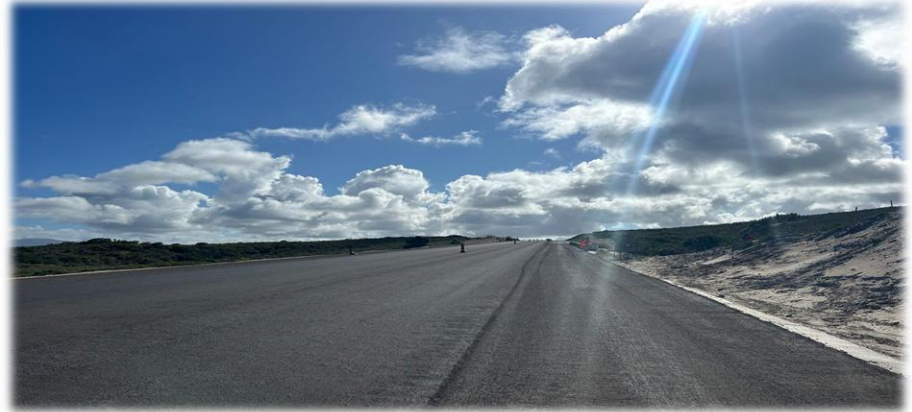
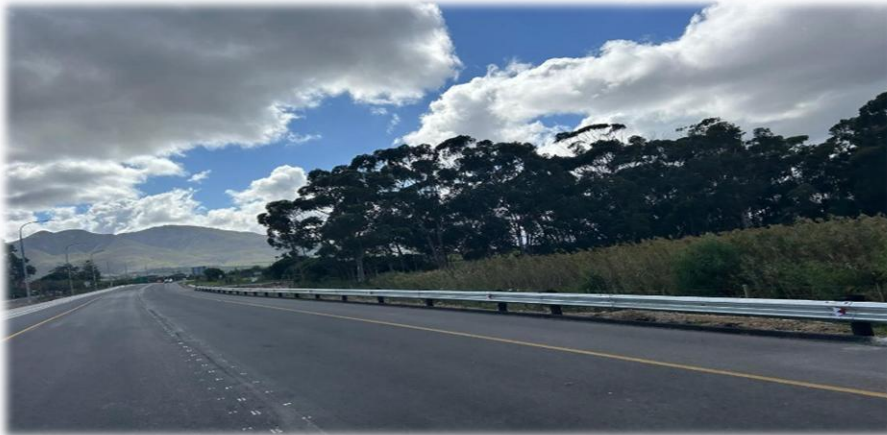
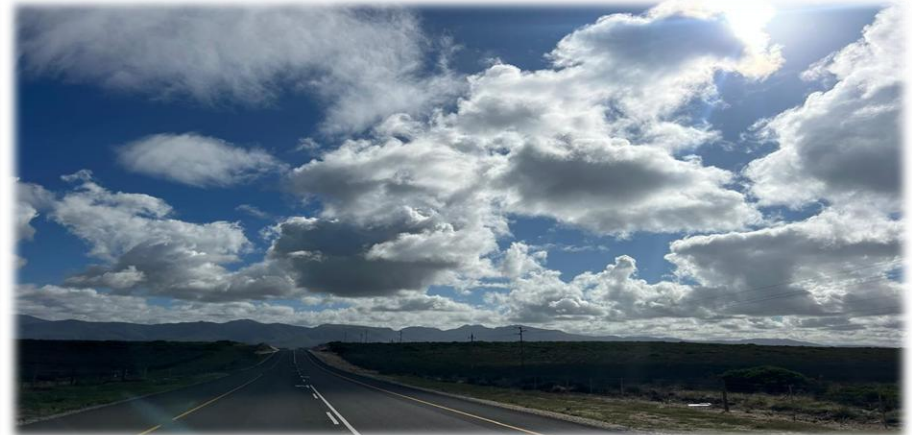
## PROGRESS

The contractor was almost completed with the road construction, the last few works are on going.
