**THE REHABILITATION AND UPGRADING OF TRUNK ROAD 28 SECTION 2  
(TR28/2)(R43) AND RELATED EXISTING DEGRADED STORMWATER  
INFRASTRUCTURE (CULVERTS), FROM KM23.83 TO KM43.88, BETWEEN  
STANFORD AND GANSBAAI, WESTERN CAPE**

DEA&DP Ref: 16/3/3/1/E2/37/1033/20

**FORMAL ECO AUDIT REPORT**

15 May 2025

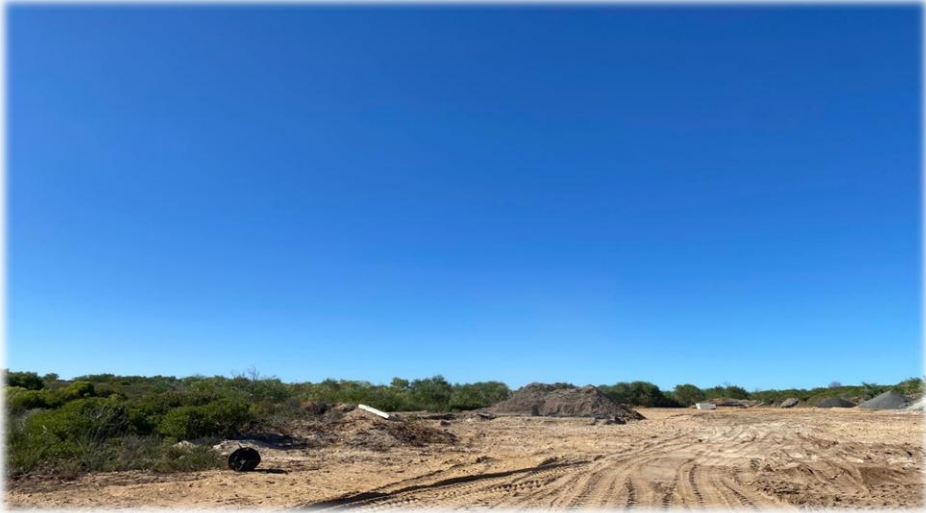
| <b>Stockpiles</b> | <p>Topsoil for the road is windrowed next to the road, and the topsoil for the access roads have been placed on the stockpile areas, the contractor is advised that the topsoil of each road to be placed back on the old road as soon as the new road is done.</p> <p>The topsoil stockpiles on the stockpile areas have been demarcated but needs to be reinstated and monitored. The topsoil should please be placed back on the old roads as rehabilitation.</p> | <b>Partial Compliant</b> |

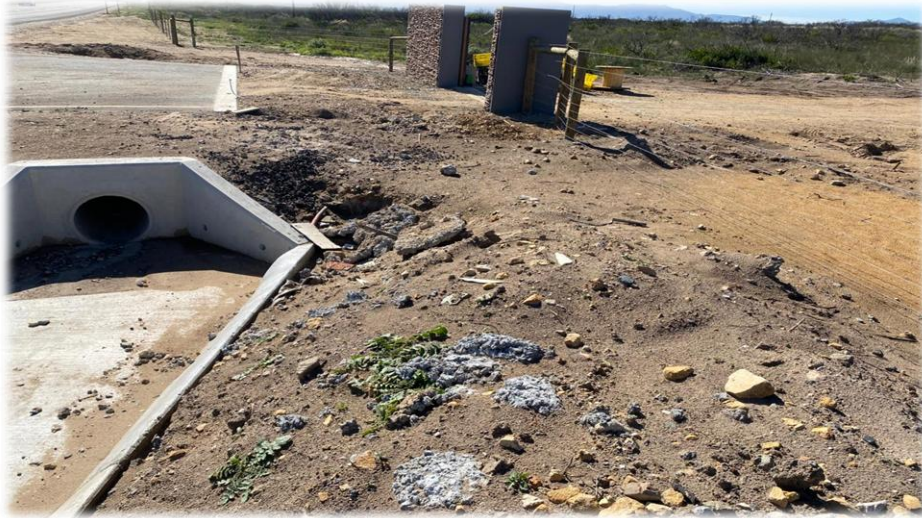
| Cement | <p>Batching was not active during the audit, but concrete remains were noted next to the road and should please be disposed of.</p> | Partial Compliant |

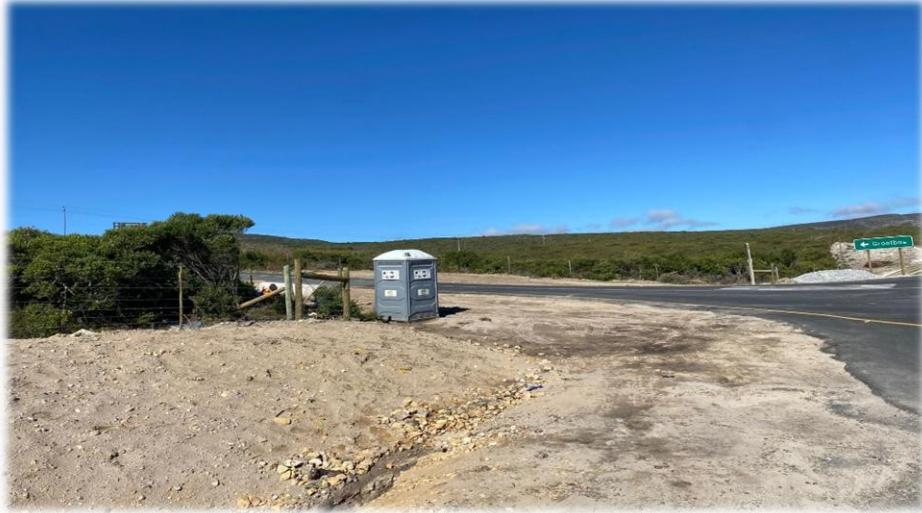
| <b>Toilets</b> | <p>Sufficient toilets were observed on site for the number of workers on site.</p> | Compliant |

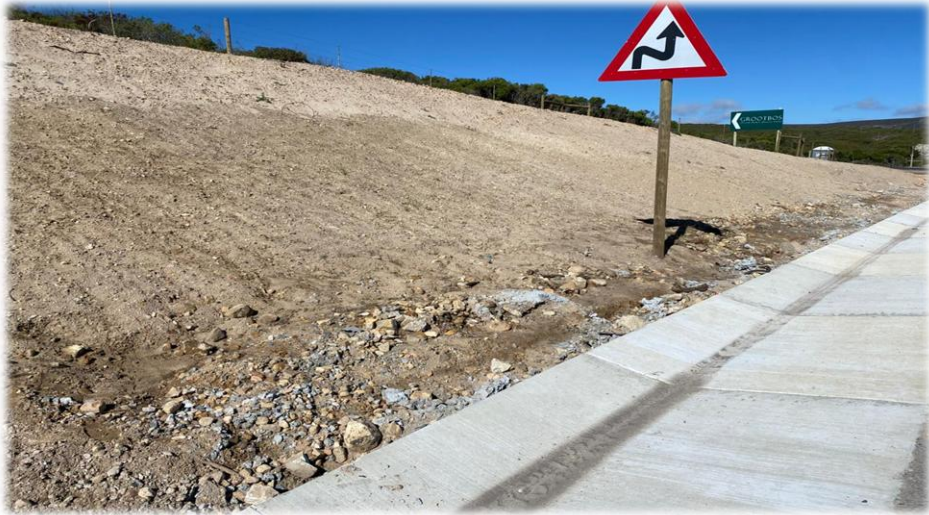
| <b>Erosion and sedimentation</b> | <p>Some erosion runnels or sedimentation was observed at any of the working areas.</p> <p>Erosion protection was installed on the steep slopes.</p> | Compliant |

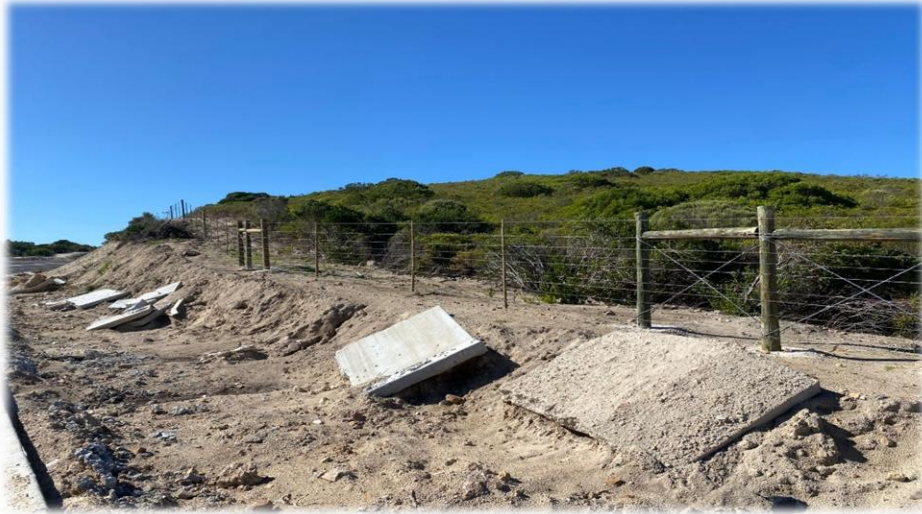
| <b>Visual Impact</b> | <p>The rubble and litter are removed from site every two weeks.</p> | <p>Compliant</p> |

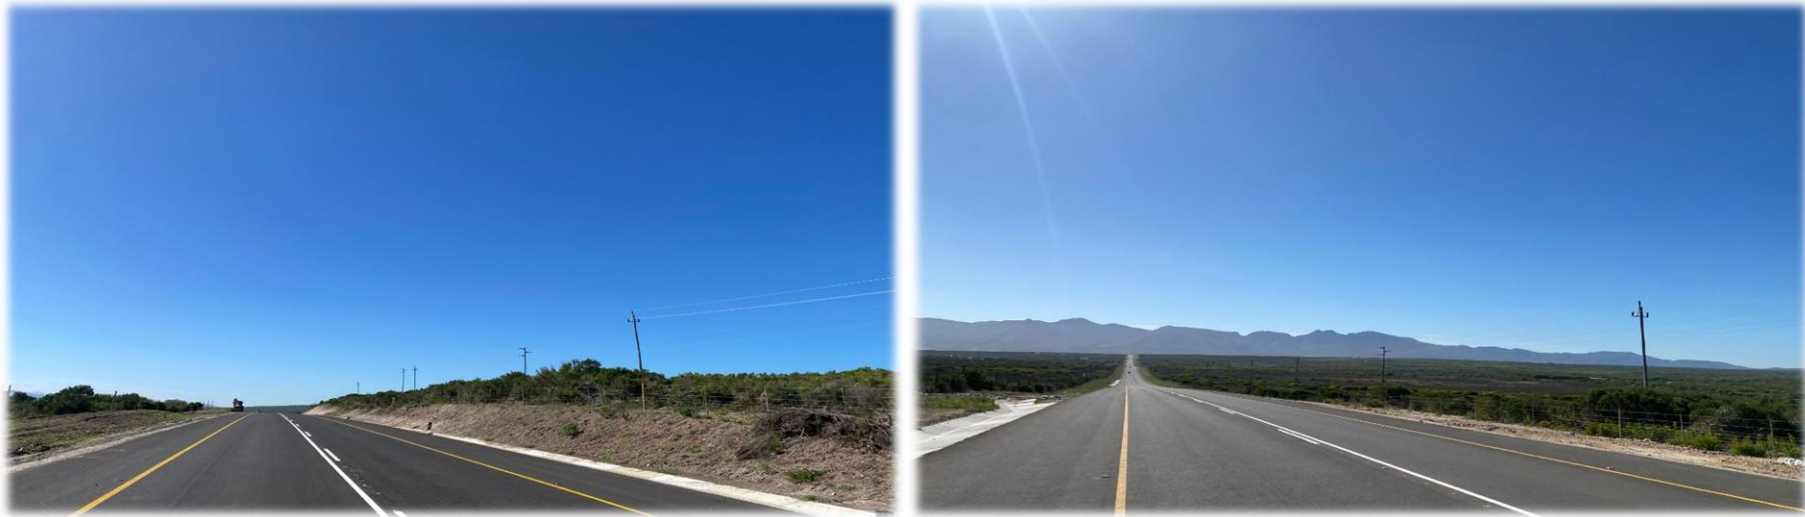
The contractor was almost completed with the road construction, the last few works are on going.
