## ENVIRONMENTAL MONITORING REPORT No. 10 FOR

*The Development of the Garden Walk on the Remainder of Portion 58  
of the Farm Hartenbosch 217, Hartenbos*

**November-December 2025**

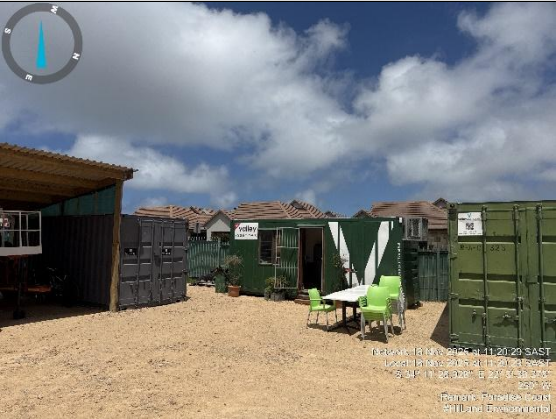
| EMPr Requirement | Level of Compliance | Comments / Findings | Photo's (if applicable) |
|---|---|---|---|
| The site camp area must be indicated and approved by the ECO. | DONE | <p>The site camp method statement (MBC) was approved by the ECO. The site camp is set up on RE/219 as per the method statement. Based on the survey data, the area in front of the site camp is also on RE/219, refer to non-compliance notification mentioned above.</p> <p>Civil and sub-contractor's site camp/material storage area is within the fenced off development footprint (parking area).</p> | <p><b>Sub-contractor's site camp</b></p> <p><b>MBC site camp</b></p> |

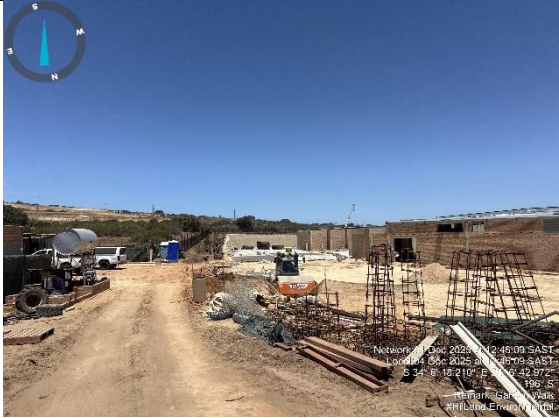
| <p>Storage sites for construction material and access must be approved by the ECO prior to commencing (and areas will require rehabilitation after use).</p> | <p>Compliant</p> | <p>All construction material is currently stored in the development site (fenced off area).</p> <p>Construction access is directly off the R102 to the construction site.</p> <p>Access point will shift to the access as indicated on the site plan at a later stage once the access has been constructed.</p> | <p>Construction materials stored on site</p> |

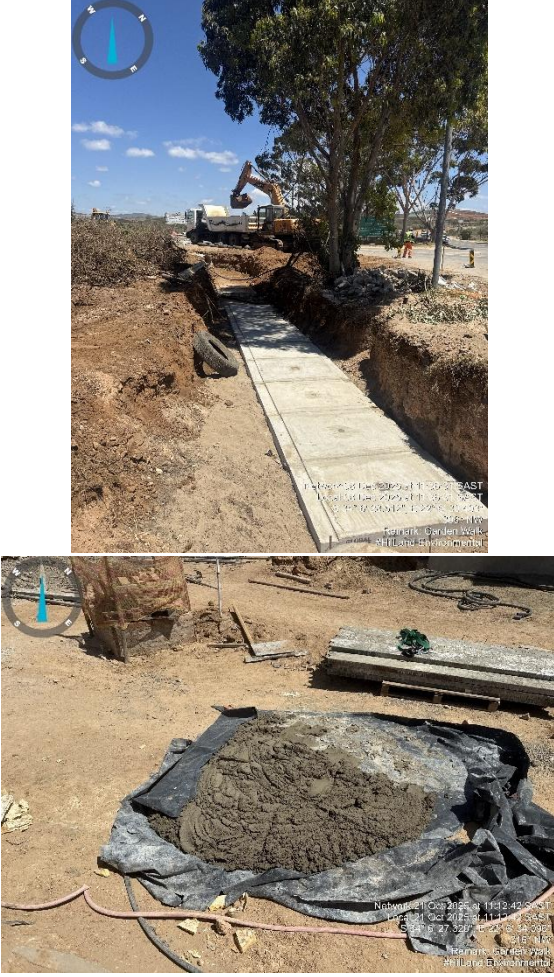
| <p>In the case of contaminated water run-off, silt can be stopped by means of sandbags and following the rain the contaminated area should be cleaned.</p> | <p>Ongoing</p> | <p>There is no contaminated run-off noted outside the demarcated site. Silt protection will need to be installed at the stormwater outlet, once completed.</p> <p>No contaminated runoff noted from the cement mixing areas (outside of the demarcated area).</p> | |

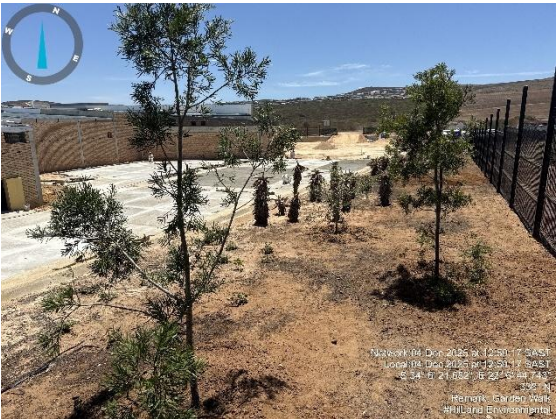
| <p>Topsoil must be stripped to stockpile from all construction areas before work commences in that specific area.</p> <p>All topsoil on the site will be stripped at least 200mm Deep, approx. 2500m<sup>3</sup> of topsoil will be retained on site for future use in the landscaping area.</p> | DONE | <p>Topsoil has been stripped. Only the required volume (approximately 2500m<sup>3</sup>) of topsoil for rehabilitation and landscaping has been stockpiled - off-site stockpile area Outeniquasbosch – within a development area. The excess has been removed from the site as agreed by the ECO.</p> <p>The topsoil stockpile will be moved to the nursery area next to Garden Walk centre and from there used directly to the landscaping and rehabilitation areas.</p> <p>The contractor must ensure that the topsoil stockpile is free from invasive alien plants (<i>Datura sp.</i>).</p> | |

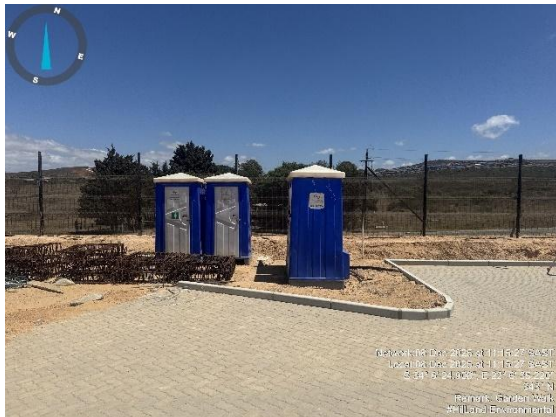
| Ablution facilities (chemical toilets) are to be provided at the campsite for use of the staff (one toilet per 15 people). | Compliant | Sufficient ablution facilities are provided on site, both for Jodan Construction and MBC. | |

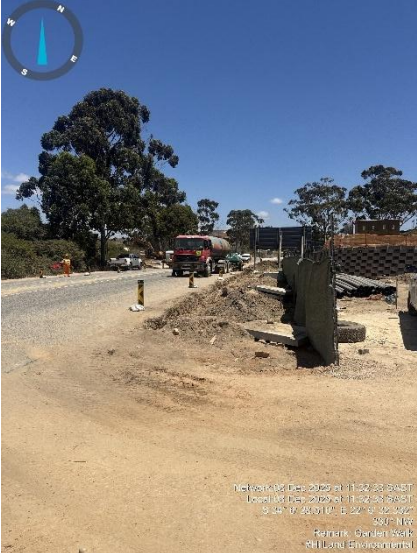
| Primary access has been approved from the MR344 (R102) at a point approximately 280m north-east of the intersection between the R102 (MR344) and DR6804. | Ongoing | Controlled construction access to the site is from the R102 and SANRAL piece (same location as the planned access). | |

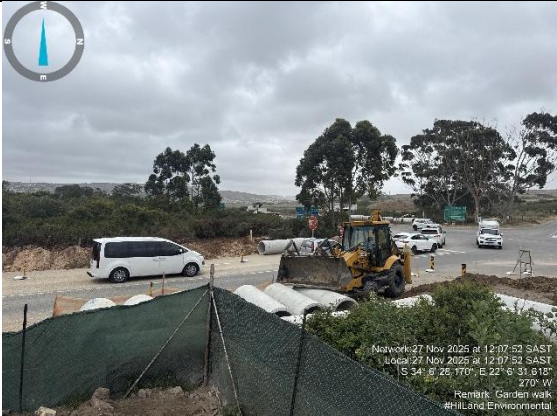
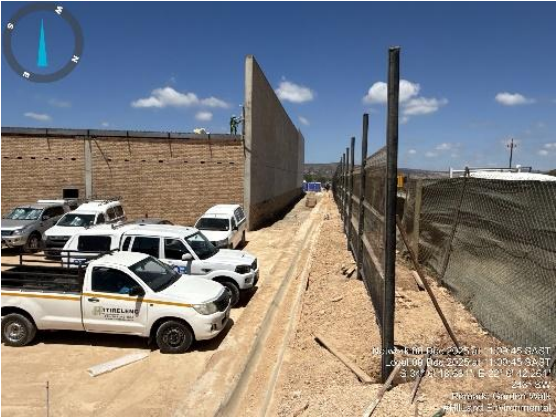
| <p>No-Go areas will be required to be demarcated by the contractor to ensure that they are visible at all times, to all personnel.</p> <p>The total footprint of a building zone / phase should be demarcated with 1.5 m (height) shade cloth for the entire period of the construction.</p> | <p>Compliant</p> | <p>The working area is demarcated with a 1.8m wire fence and shade netting.</p> | <div data-bbox="1406 193 1960 611"> </div> <p><b>Demarcation of the working zone with green shade netting</b><br/> <b>The construction work on the outside of the green netting fence entails the stormwater infrastructure and upgrades to the provincial roads.</b></p> <div data-bbox="1406 707 1960 1125"> </div> <p><b>Installation of the permanent clear-vu fence on the R102 section has started.</b></p> |

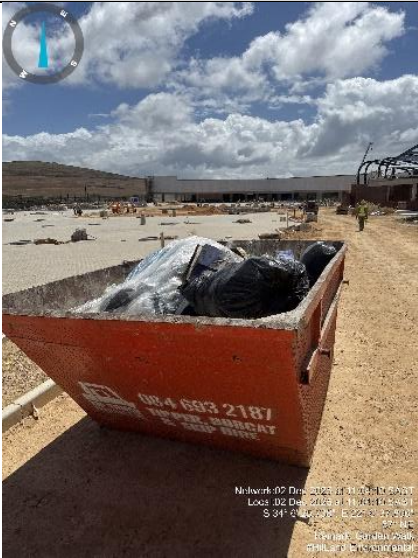
| It is <b>recommended</b> that an integrated waste management approach must be used that is based on waste minimisation and must include reduction, recycling, re-use and disposal where appropriate. | | | | |
| Recycling must be encouraged on-site and recycling bins must be provided and clearly marked. | Compliant / Ongoing | <p>Keeping general waste separate from construction rubble. Scrap metal is stockpiled separately in a skip for recycling.</p> <p>Construction rubble stockpiles must not have litter (papers and plastic) – ongoing.</p> <p>Subcontractors (shopfitters) are keeping recyclable material separate as noted by the ECO on site.</p> | | |

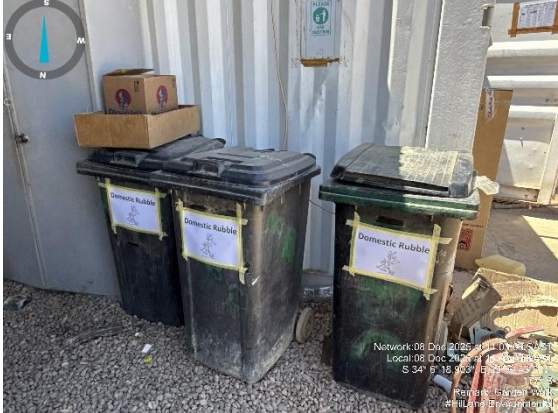
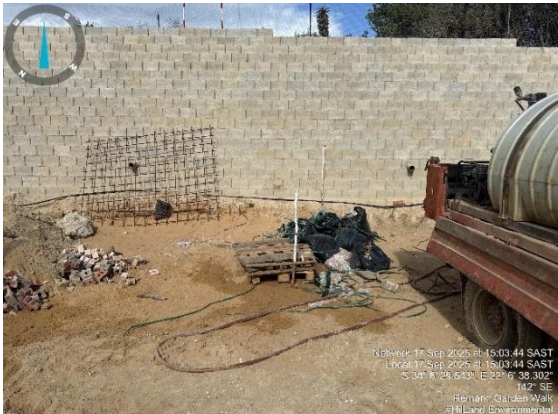
| <p>Litter to be removed from the site on a daily basis and kept in closable bins.</p> | <p>Compliant &amp; ongoing</p> | <p>Litter noted during ECO site inspection(s) have been reported to the contractor and are actioned accordingly – this will be ongoing.</p> <p>Regular litter picking is done.</p> | <p><b>waste bins/skips on site</b></p> <p><b>Litter picking is being done</b></p> |

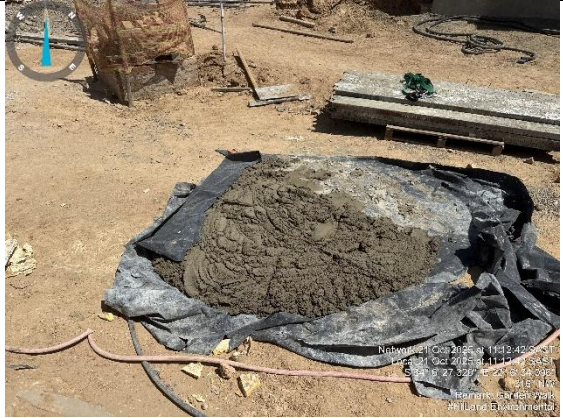
| No ready-mix trucks are permitted to rinse their tanks on site or along the access roads to and from the site. | Ongoing | No non-compliance noted during site inspections. | |

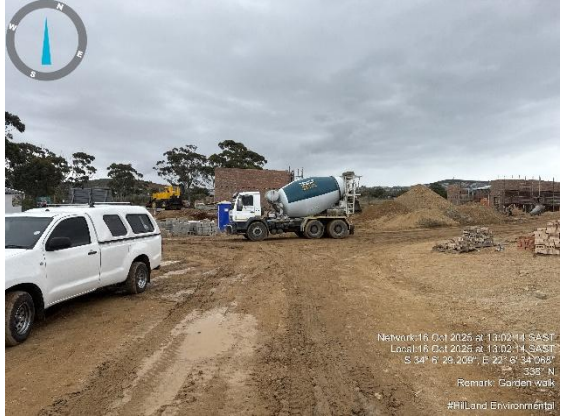
| <p>Bunding through the use of sandbag walls around any mixing areas is recommended.</p> <p>All concrete must be mixed on trays / on thick plastic and not on the soil.</p> | Ongoing | <p>Suitable bunding must always be in place to avoid contaminated water runoff.</p> <p>Ready-mix is used for the bulk concrete works.</p> | <p>Ready mix</p> |

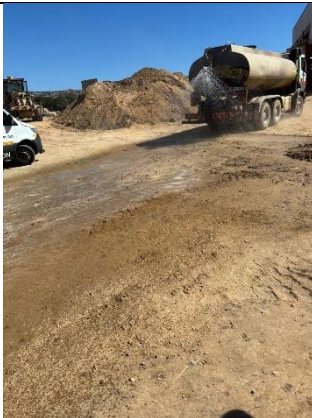
| Dust mitigation measures should be implemented as required. | Ongoing | <p>Dust nuisance complaint(s) are recorded in environmental file – <b>no new complaints received.</b></p> <p>Regular dust suppression is done – watering exposed areas and dust mitigation record sheet is kept in the environmental file.</p> <p>October/November has been exceptionally windy and dust mitigation was required almost daily. Record is kept by the contractor of dust suppression.</p> | <div>

</div> <p><b>Water truck on site</b></p> <div><p>ENVIRONMENTAL MANAGENT SYSTEM</p><p>DUST SUPPRESSION REGISTER</p><p>Completed by: <u>Andrew Rose</u> Date: <u>20-07-2025</u></p><p>Dust suppression must be done daily:</p><ol style="list-style-type: none"><li>1. Start of shift</li><li>2. Sudden change in weather conditions</li><li>3. During load and haul operations</li><li>4. Adhies as determined by Construction manager</li><li>5. At the end of shift</li></ol>

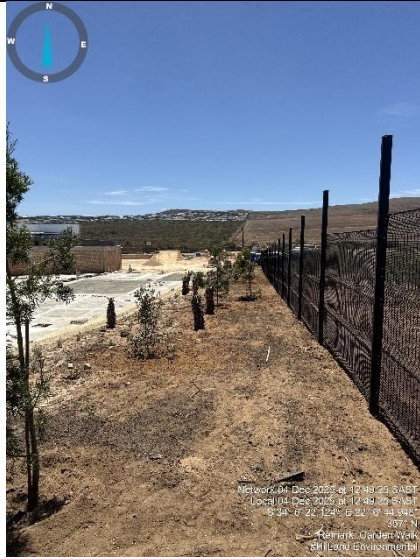
| Rehabilitation/vegetation management | | | |
|---|---|---|---|
| Any damage to private property or open space areas must be reinstated to the state it was before construction commenced and must be done to the satisfaction of the landowner and ECO. | Ongoing | Refer to the non-compliance letter / comment. Rehabilitation of the area above the retaining wall will in process – refer to the ECO rehabilitation monitoring report. | |

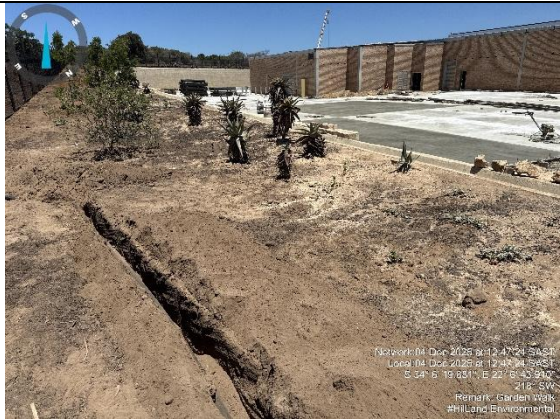
| Rehabilitation/vegetation management | | | |
|---|---|---|---|
| Reinstate the vegetation in accordance with the Landscape Master Plan. | Ongoing | <p>Rehabilitation / revegetation of the retaining wall / embankment has been done (phase 1) – refer to the ECO rehabilitation monitoring report.</p> <p>Landscape master plan was circulated to the ECO.</p> | |

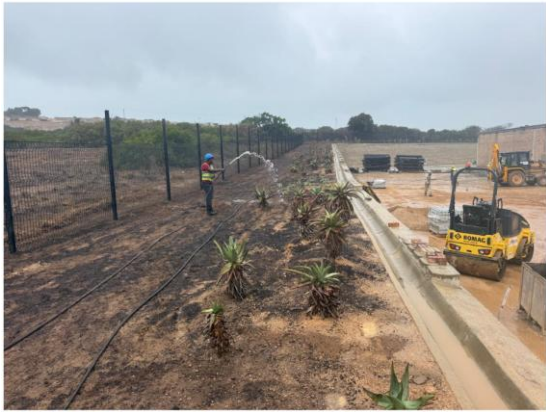
| <p>All landscaping areas to be planted and maintained.</p> | <p>Ongoing</p> | <p>Rehabilitation will be complete once construction is complete.</p> | |
