MOS25/1216/17  
25 June 2025

**RE: GARDEN WALK – ECO – NON-COMPLIANCE NOTIFICATION – REF 16/3/3/5/D6/18/0006/24**

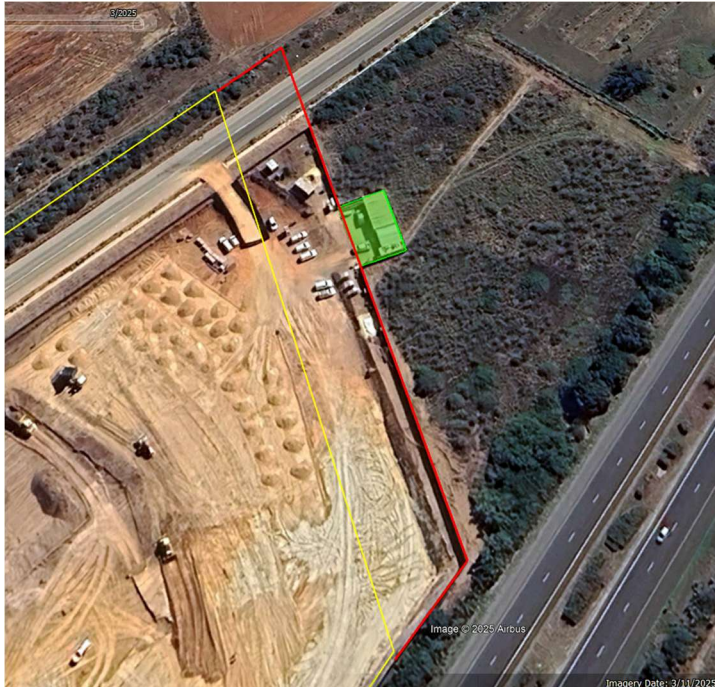
Based on the original pegging on site and shade net installation (Red line), the container office was erected by agreement on erf 219 as an area of less than 300m<sup>2</sup> within a previously disturbed area as per the method statement (see ECO report #2 – March 2025) – green square area 294m<sup>2</sup>.

Once the Google earth images were available and the ECO could import the cadastral boundary from the SG, it became clear that there was an error in relation to the cadastral boundary – either an error in the SG map layer, or a pegging error on site. See the difference between the Yellow cadastral line and the Red pegged line on site. ECO raised this concern with the applicant.

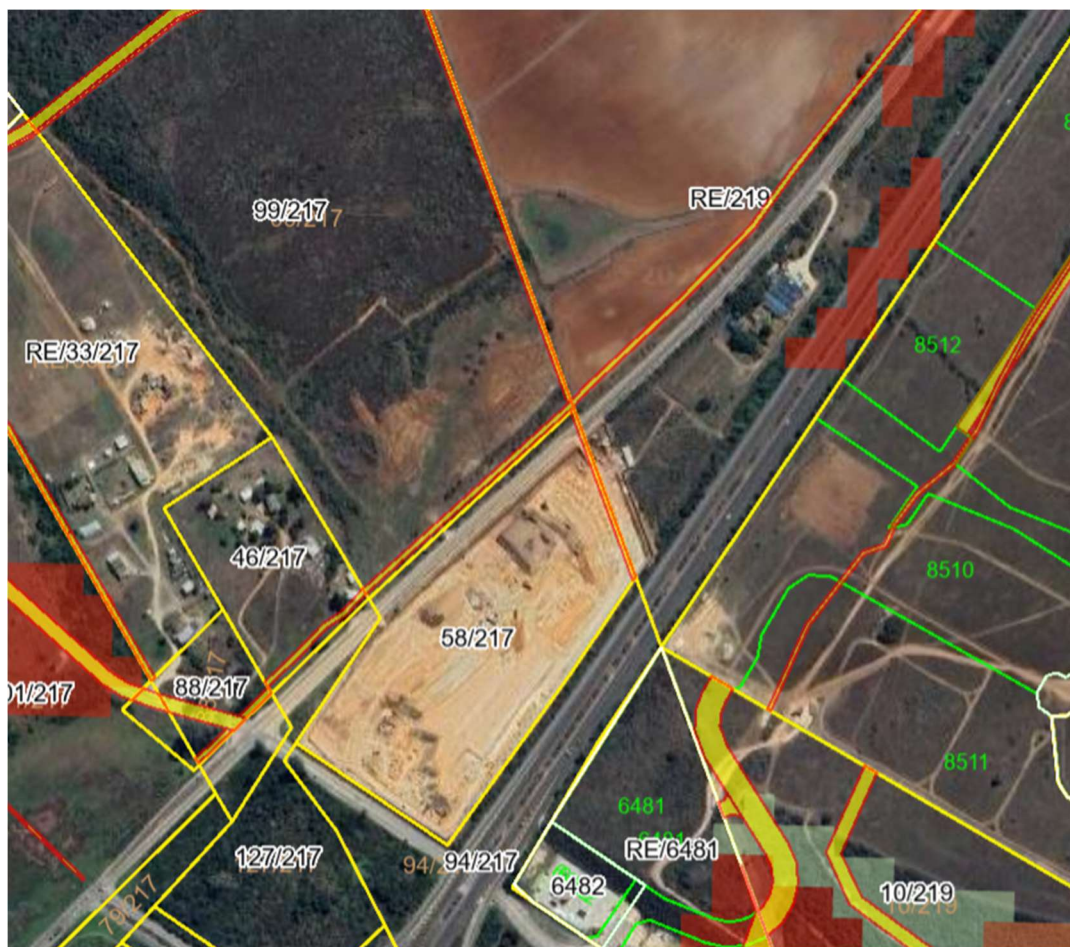
Remnant mapping – SANBI

- There has been earthworks and installation of the retaining wall within this area and there may be underground services in this zone.
- **Confirm with DEADP if rectification is required** for the clearance of vegetation on the farm 219 as the threshold of 300m<sup>2</sup> has been exceeded – as the area is currently mapped as Critically Endangered Mossel Bay Shale Fynbos – original extent. However, the remnant mapping, confirms that the area did not previously support this ecosystem as it had been previously transformed. ECO anticipates the following:

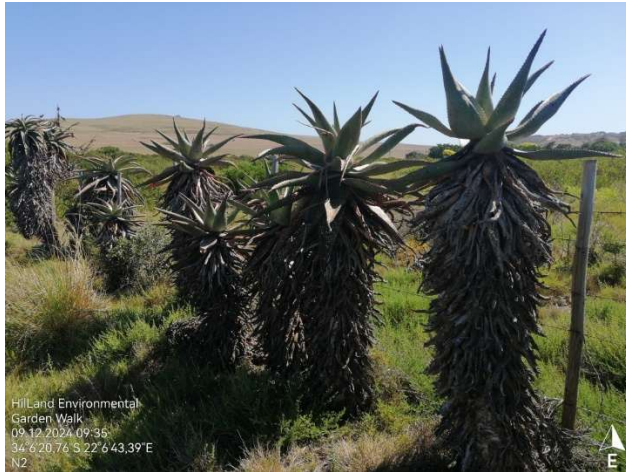
- The area cleared within the shade netting (including the 15m strip now on the neighbouring property) was cleared in accordance with the EMP, full plant rescue took place (in excess of 1000 Aloe were transplanted from the whole Garden Walk fenced area) within this zone and the topsoil was stockpiled as required in the EMP.

Large Aloe along the fence line that were rescued.
