## ***ENVIRONMENTAL MONITORING REPORT No.1***

**FOR THE REHABILITATION OF A PORTION OF THE REMAINDER OF FARM 219, MOSSEL BAY**

| <b>Report Period</b> | October 2025 to 4 December 2025 |

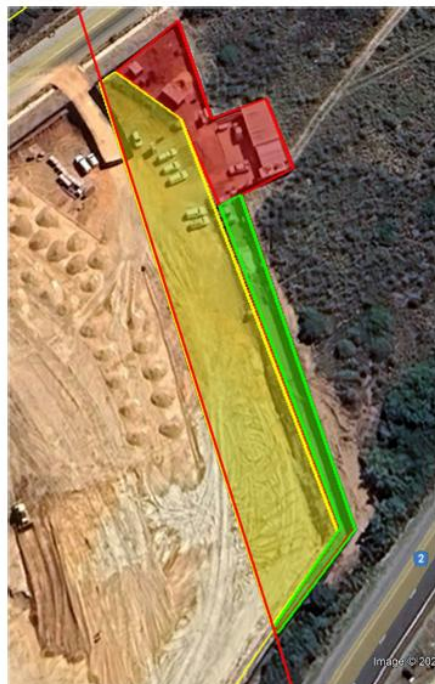
- Phase 1 (Green) 480m<sup>2</sup> to be undertaken immediately on approval of the rehabilitation plan
- Phase 2 (Red) 800m<sup>2</sup> to be undertaken in March 2026 as the construction phase reaches finality and the contractor can move their office off site.

*Affected area as included in the rehabilitation plan report (HillLand Environmental, 2025)*

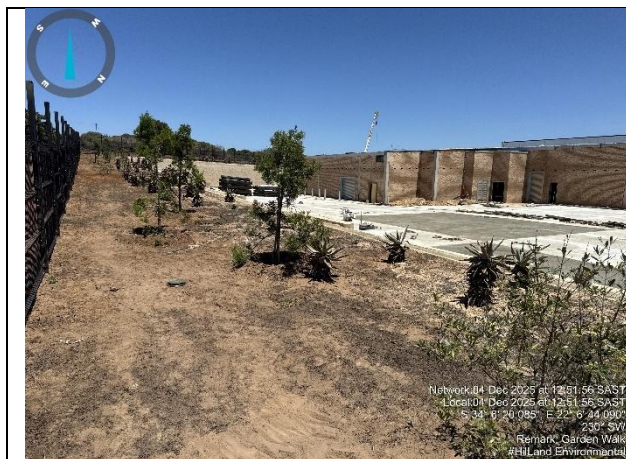
Showing phase 1 rehabilitation.

Implementation of **phase 1** commenced in October 2025 and is now completed (4 December 2025), refer to photographic record below.

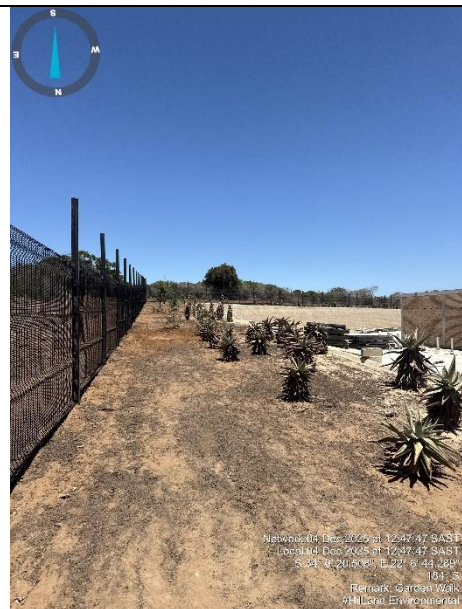
Protective fence has been installed.

No-go demarcation shade netting fence has been installed at the start of phase 1 (between phase 1 and phase 2) to prevent unauthorized access to the rehabilitation zone.

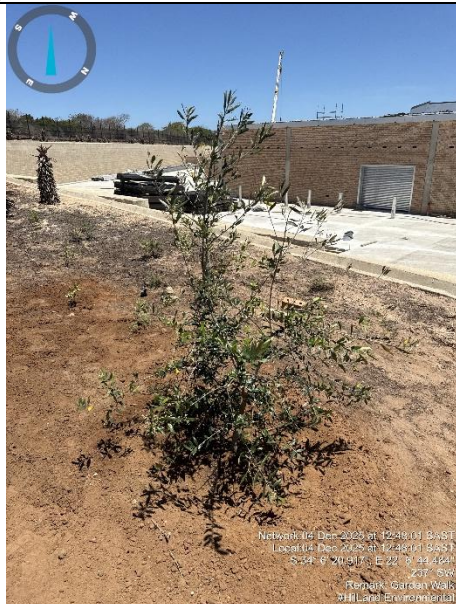
Cluster in phase 1.

- Plants were planted in clusters / bushclumps with open gaps. Rescued Aloes were planted in-between the clusters and all along the edge of the rehabilitation zone.

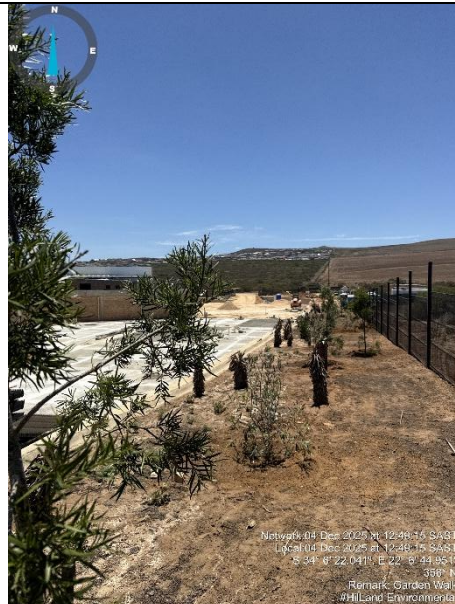
Cluster in phase 1.

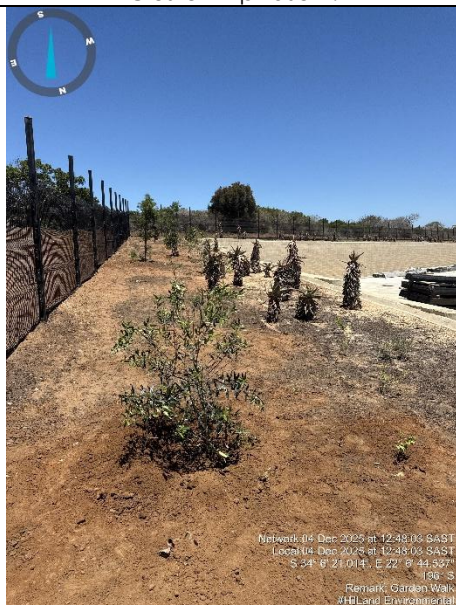
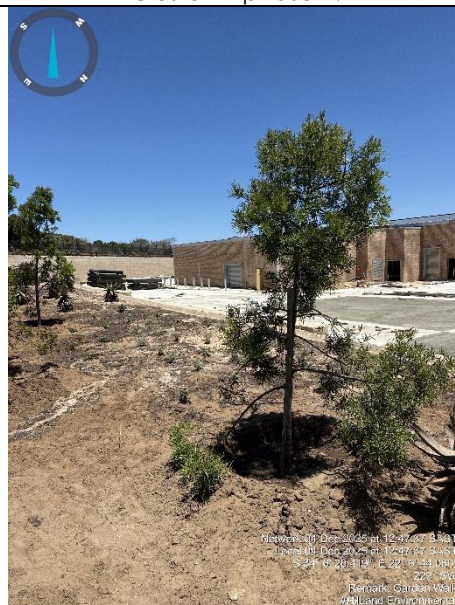
Showing one of the clusters in phase 1.

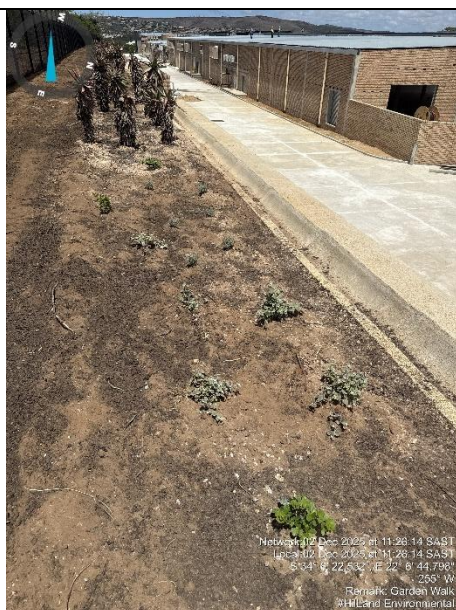
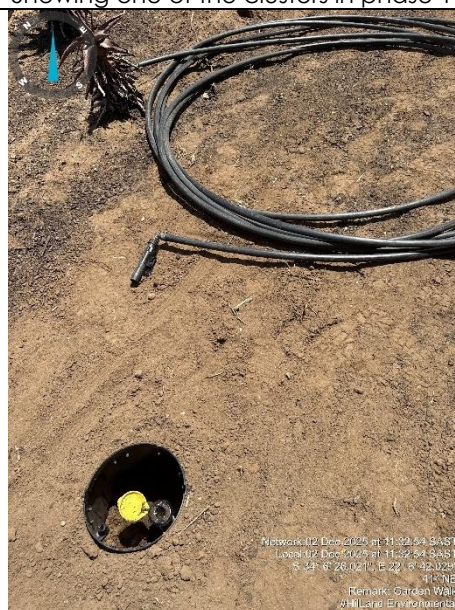
Irrigation has been installed and is functioning.

Plants to be watered intermittently.

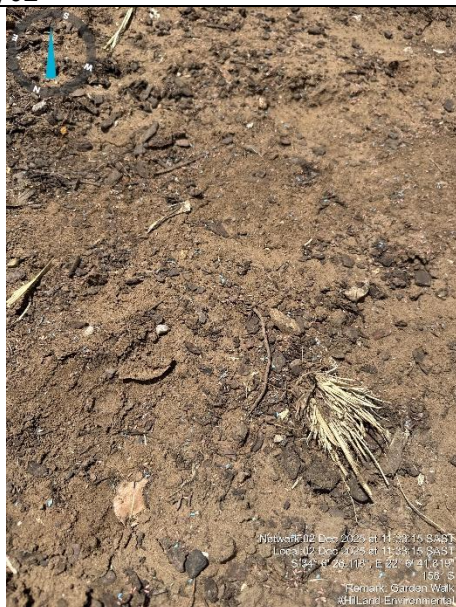
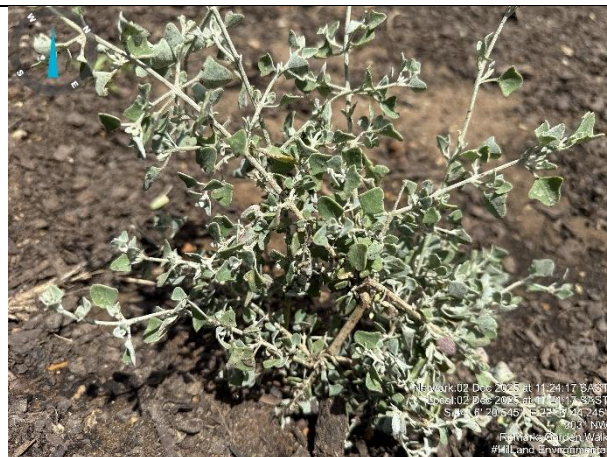
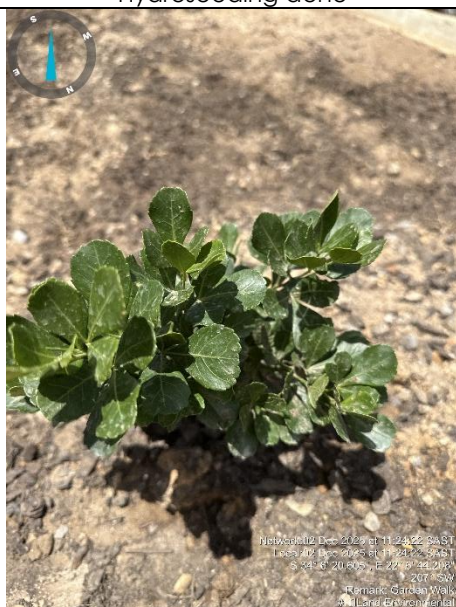
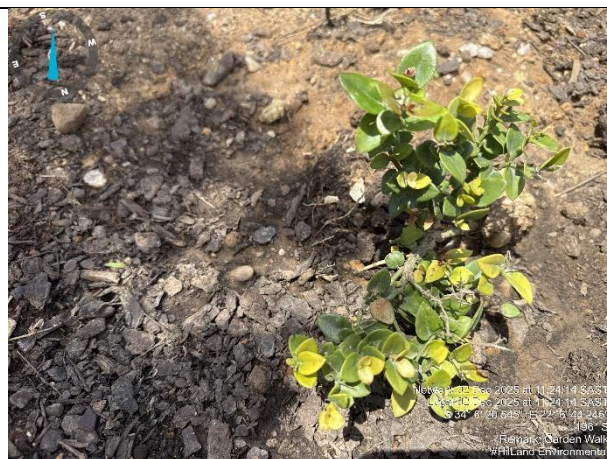
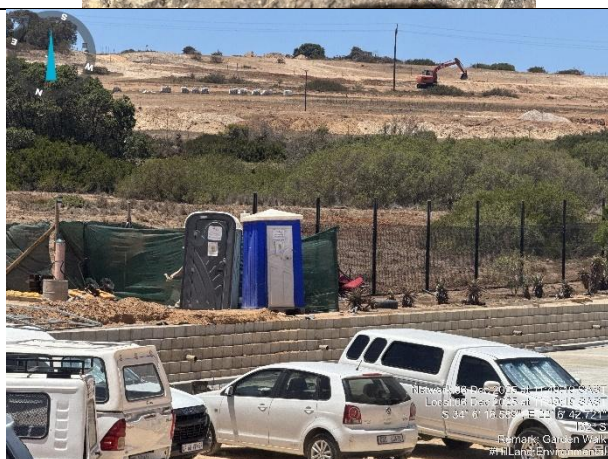
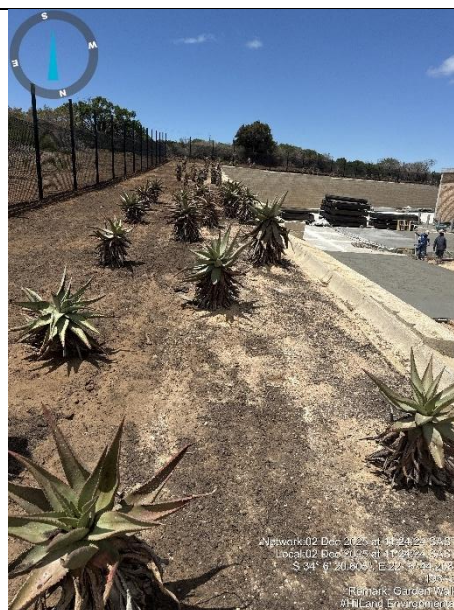
Implementation of phase 1 started in October 2025, installation of the protective fence, shaping and soil preparation. Phase 1 has been completed as of 4 December 2025. Additional much and brushwood can be added for wind erosion protection and to retain moisture.
