### ENVIRONMENTAL MONITORING REPORT NO.4 FOR Pinnacle Point WWTW Upgrade, Mossel Bay Municipality

**MOS24.1291.06**

**25 April and 9 May 2024**

## PINNACLE POINT WWTW UPGRADE ENVIRONMENTAL MONITORING REPORT NO 4

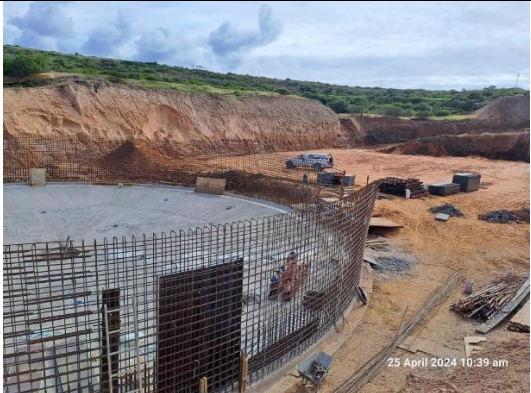
| <b>Item</b> | <b>Management / Mitigation Measure</b> | <b>Compliance/ Notes</b> | <b>Photographic record (where applicable)</b> |
|---|---|---|---|
| Site establishment | <ol style="list-style-type: none"> <li>1. The specific location for the construction site camp, storage of materials, ablution facilities, shall be identified in consultation with the ECO and must be clearly demarcated.</li> <li>2. Stockpiling of both natural and manufactured materials shall be restricted to the permanent and temporary stockpile areas identified by the Project Manager / Consulting Engineer and the ECO.</li> <li>3. Vegetation removal shall be kept to the minimum.</li> <li>4. Topsoil to be rescued and stockpiled for use during rehabilitation.</li> <li>5. No fauna or flora must be disturbed/damaged or removed outside the development footprint.</li> </ol> | <ol style="list-style-type: none"> <li>1. Site camp (including ablution facility) and construction material stockpile area are within the existing wastewater treatment works facility.</li> <li>2. The contractor is spoiling the subsoil material at an external site.<br/>The remaining soil is stockpiled on site.</li> <li>3. Vegetation clearing was limited to the development footprint - <b>DONE</b>.</li> <li>4. Topsoil is stockpiled within the existing WWTW facility.</li> <li>5. Disturbance is limited to the development footprint.</li> </ol> | <p>Construction and excavations are limited to demarcated development footprint (orange netting).</p> |

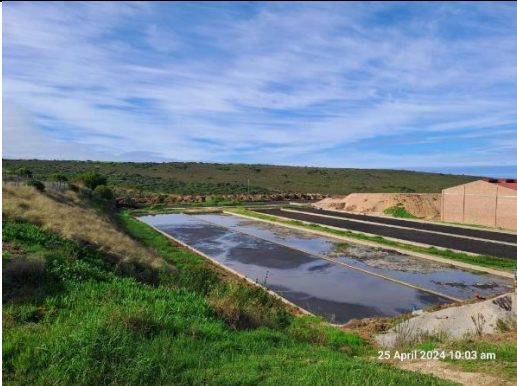
| | | | <p>25 April 2024 10:03 am</p> <p>Topsoil stockpile within the existing WWTW facility boundary</p> |

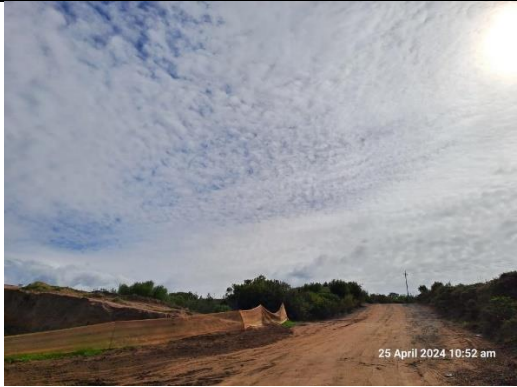
| Access and traffic control | Existing access track to be used | Existing access tracks are being used and maintained. | <p>25 April 2024 10:52 am</p> <p>Existing access track is utilized and maintained.</p> |

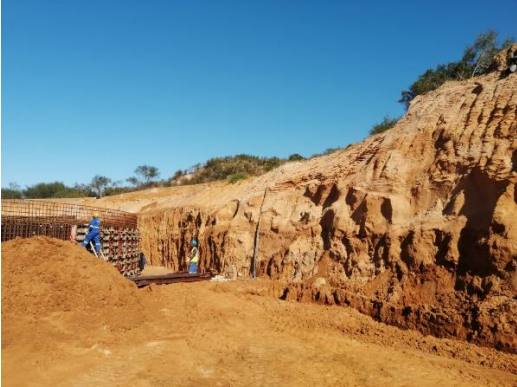
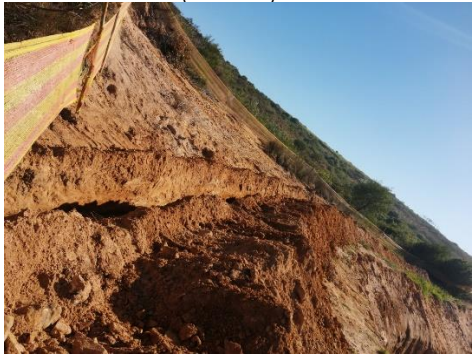
| Contaminated water control | No contaminated water from the construction site, shall be discharged into the environment. Any contaminated water shall be disposed of in an appropriate disposal facility. | <p>Not applicable to the current activity on site – bulk excavation of the reactors and foundation of the clarifier.</p> <p>A trench has been dug above the northwestern edge of the clarifier excavation to redirect stormwater into the natural vegetation and prevent it from entering the excavation. <b>Silt fences</b> are <b>still</b> required at the end of the stormwater trench.</p> | <p>No contaminated water entering the surrounding environment noted (09.05.24).</p> <p>Stormwater trench in place (09.05.2024)</p> |

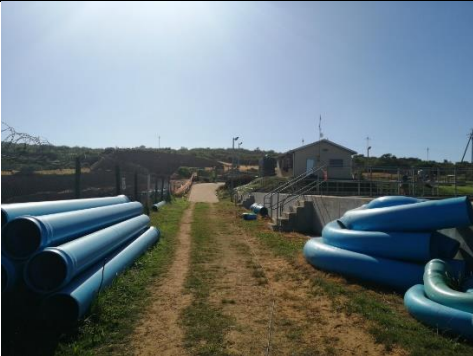
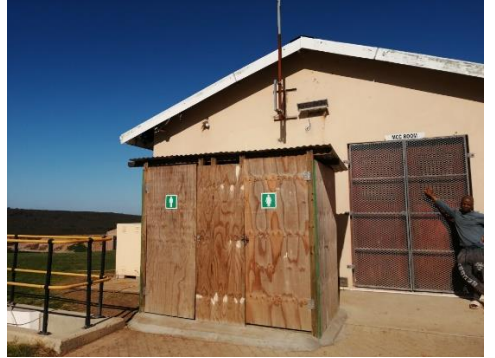
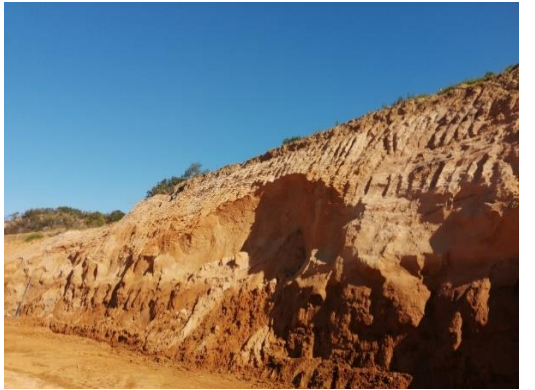
| Site and waste management | <ol style="list-style-type: none"> <li>1. Storage areas for potentially contaminating materials shall be roofed with impervious material (or double bagged in a skip until removed).</li> <li>2. Waste bins/skips must be used for all waste and litter. Waste bins must have lids to prevent content from blowing away or accumulating rainwater. Skips should be covered with netting.</li> <li>3. The burning of waste is forbidden.</li> <li>4. At least one chemical toilet must be made available on site for every 15 workers. All</li> </ol> | <ol style="list-style-type: none"> <li>1. Storage of hazardous material as per the contractor's method statement and within the existing site camp (if any)</li> <li>2. The waste storage area is fenced off and litter bins are available at the site camp.</li> <li>3. No burning or burying of waste noted or reported to the ECO.</li> <li>4. Portable- and permanent toilets area available on site.</li> </ol> <p><b>The top layer of material next to the excavation site consists of historic dumped</b></p> | |

| | workers will be required to use the chemical toilet(s). | <b>material (prior to the commencement of this project). The waste material layer is unpredictable due to its unknown composition and thus it poses an unknown risk (stability) and may collapse and expand beyond the development footprint.</b> | <p>Storage of material at the site camp (0.05.24).</p> <p>Waste storage area is fenced off.</p> <p>Toilet facilities on site (09.05.24)</p> <p>The slope was battered back to 34-40 degrees and stabilized. However, the top layer is made up of dumped/fill material and the risk it could potentially pose is unpredictable. (09.05.24).</p> |

The contractor is busy removing excess subsoil to a spoil site. Bulk excavation of the reactor unit is still in progress and construction of the clarifier is ongoing. The slope that was battered back has a top layer of waste material which could pose a risk (collapse and expansion beyond the approved development footprint) due to its unknown nature and stability. Water in the clarifier/ reactor excavation from natural seepage is being pumped out once a day.

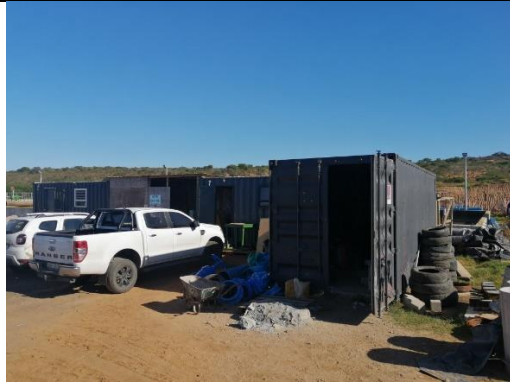
| Fire prevention and control | <ol style="list-style-type: none"> <li>Any welding or other sources of heating of materials shall be done in a controlled environment and under appropriate supervision</li> <li>Working fire extinguisher to be available on site.</li> <li>No smoking will be allowed on site, in particular in areas within or adjacent to natural vegetation, except in designated smoking points.</li> </ol> | <ol style="list-style-type: none"> <li>Not applicable to the current activity.</li> <li>As per the contractor's method statement.</li> <li>No smoking on site noted during ECO site inspection. Dedicated smoking area to be provided at the site camp.</li> </ol> | <p>Fire extinguishers at the site office (09.05.24)</p> |

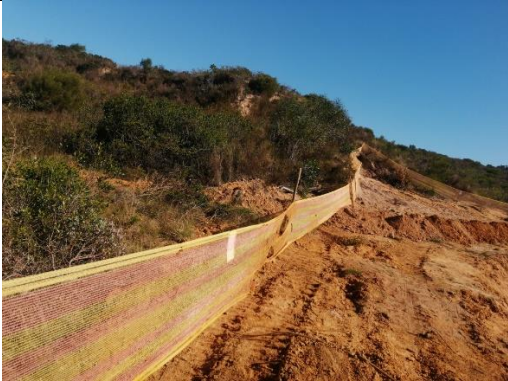
| <p>Natural vegetation and alien clearing</p> | <p>The surrounding area (fynbos) on the eastern side (east of the access road) and south-western side of the site and WWTW are highly sensitive and are to be regarded as No-Go areas.</p> <ol style="list-style-type: none"> <li>1. The development footprint must be pegged and demarcated in consultation with the ECO to avoid any disturbance of the sensitive vegetation areas.</li> <li>2. Topsoil rescued for use in the rehabilitation phase.</li> <li>3. Rehabilitate/revegetate all the disturbed surfaces after construction completed. Especially the newly created slopes directly behind the WWTW - erosion control measures will be required on the steep slopes, such as silt fences, logs or netting, to slow down runoff and potential erosion. Mulching and seeding with indigenous grass seed during rehabilitation phase.</li> <li>4. Engage in alien clearing.</li> </ol> | <p>Development footprint was pegged and vegetation within the development footprint was cleared. <b>Sensitive areas as identified in the EMP are avoided.</b></p> <p>Topsoil is stockpiled for rehabilitation phase.</p> <p>Invasive aliens within the development footprint were removed.</p> | <p>No-go demarcation in place.<br/>No disturbance of the natural vegetation noted (09.05.24).</p> |
