### ENVIRONMENTAL MONITORING REPORT NO.5 FOR Pinnacle Point WWTW Upgrade, Mossel Bay Municipality

**MOS24.1291.07**

**23 May and 7 June 2024**

**PINNACLE POINT WWTW UPGRADE  
ENVIRONMENTAL MONITORING REPORT NO 5**

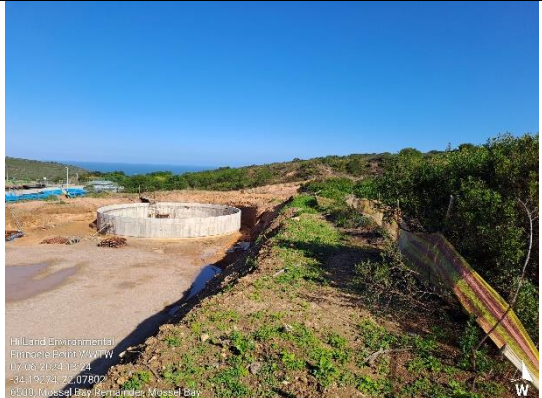
| Item | Management / Mitigation Measure | Compliance/ Notes | Photographic record (where applicable) |
|---|---|---|---|
| Site establishment | <ol style="list-style-type: none"> <li>1. The specific location for the construction site camp, storage of materials, ablution facilities, shall be identified in consultation with the ECO and must be clearly demarcated.</li> <li>2. Stockpiling of both natural and manufactured materials shall be restricted to the permanent and temporary stockpile areas identified by the Project Manager / Consulting Engineer and the ECO.</li> <li>3. Vegetation removal shall be kept to the minimum.</li> <li>4. Topsoil to be rescued and stockpiled for use during rehabilitation.</li> <li>5. No fauna or flora must be disturbed/damaged or removed outside the development footprint.</li> </ol> | <ol style="list-style-type: none"> <li>1. Site camp (including ablution facility) and construction material stockpile area are within the existing wastewater treatment works facility.</li> <li>2. The contractor is spoiling subsoil material at an external site.<br/>The remaining soil is stockpiled on site.</li> <li>3. Vegetation clearing was limited to the development footprint - <b>DONE</b>.</li> <li>4. Topsoil is stockpiled within the existing WWTW facility.</li> <li>5. Disturbance is limited to the development footprint – <b>The top layer of material next to the excavation site consists of historic dumped material (prior to the commencement of this project). The waste material layer is unpredictable due to its unknown composition and thus it poses an unknown risk (stability) and may collapse and expand beyond the development footprint.</b></li> </ol> | <p>Construction and excavations are limited to demarcated development footprint (orange netting).</p> |

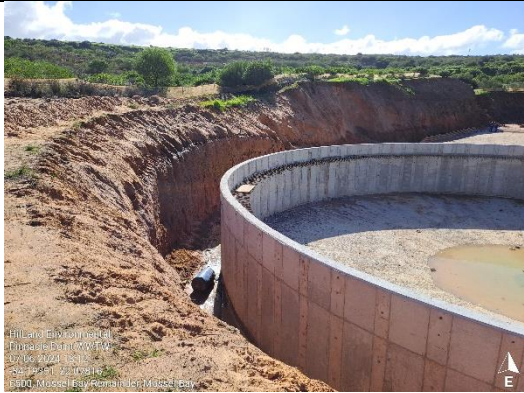
| | | | <p> <small> 111400 Environmental<br/> Drained Point WWTW<br/> 07/06/2024 13:12<br/> 36°19'58" S 22°07'17" E<br/> 1000, Mossel Bay Remains, Mossel Bay </small> </p> <p>Historic dumped material stability is undetermined.</p> |

## Conclusion

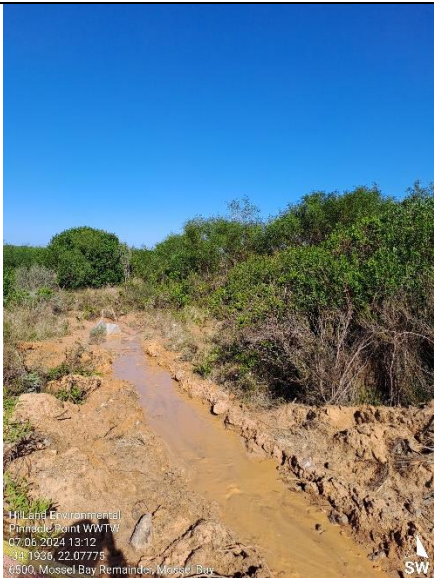
| Contaminated water control | <p>No contaminated water from the construction site, shall be discharged into the environment. Any contaminated water shall be disposed of in an appropriate disposal facility.</p> | <p>Not applicable to the current activity on site – bulk excavation of the reactors and foundation of the clarifier.</p> <p>Dewatering was required and was done to the satisfaction of the ECO. Water was released in the stormwater trench (with a silt fence).</p> <p>A stormwater diversion trench above the northwestern edge of the clarifier excavation is in place to prevent stormwater from entering the excavation. Silt fences are in place at the end of the stormwater trench. The trench held up well during the recent heavy rain storm.</p> | <p> <small> 111400 Environmental<br/> Drained Point WWTW<br/> 07/06/2024 13:12<br/> 36°19'58" S 22°07'17" E<br/> 1000, Mossel Bay Remains, Mossel Bay </small> </p> <p>No contaminated water entering the surrounding environment noted after the heavy rain in early June. This is the stormwater trench.</p> |

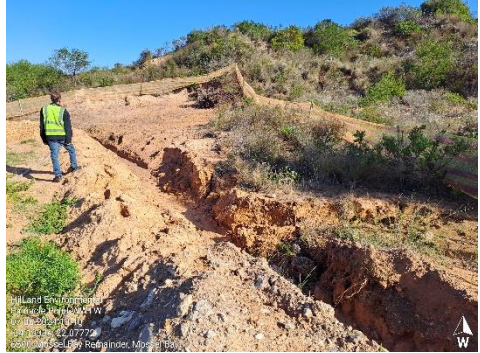
| | | | <p>Stormwater trench in place.</p> |

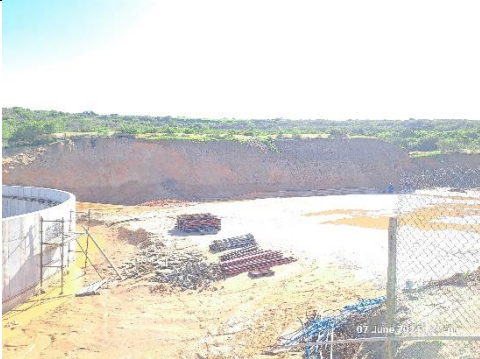
| Site and waste management | <ol style="list-style-type: none"> <li>1. Storage areas for potentially contaminating materials shall be roofed with impervious material (or double bagged in a skip until removed).</li> <li>2. Waste bins/skips must be used for all waste and litter. Waste bins must have lids to prevent content from blowing away or accumulating rainwater. Skips should be covered with netting.</li> <li>3. The burning of waste is forbidden.</li> <li>4. At least one chemical toilet must be made available on site for every 15 workers. All workers will be required to use the chemical toilet(s).</li> </ol> | <ol style="list-style-type: none"> <li>1. Storage of hazardous material as per the contractor's method statement and within the existing site camp (if any)</li> <li>2. The waste storage area is fenced off and litter bins are available at the site camp.</li> <li>3. No burning or burying of waste noted or reported to the ECO.</li> <li>4. Portable- and permanent toilets area available on site.</li> </ol> <p><b>The top layer of material next to the excavation site consists of historic dumped material (prior to the commencement of this project). The waste material layer is unpredictable due to its unknown composition and thus it poses an unknown risk (stability) and may collapse and expand beyond the development footprint.</b></p> | <p>Storage of material within the demarcated construction site.</p> |

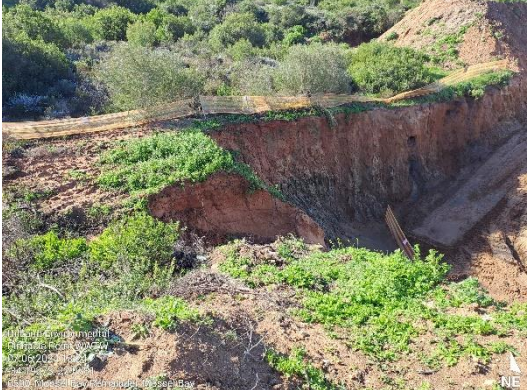
| | | | <p>The slope was battered back to 34-40 degrees and stabilized. However, the top layer is made up of historic dumped/fill material and the risk it could potentially pose is unpredictable – north western corner eroded during the recent heavy rain.</p> |

| <p><b>20</b> The physical alteration of the portion of the Remainder of Erf No. 15390, Mossel Bay, must be restricted to "the site" as depicted on the SDP in Annexure 2.</p> <p>20.1. No vegetation or land may be disturbed outside the perimeter of the site, unless such activities are authorised by the competent authority.</p> <p>20.2. Prior to the commencement of the physical implementation of any activities, the site must be clearly demarcated, preferably fenced-off.</p> | <p>Physical alteration (construction activity) is limited to the development footprint and is demarcated.</p> <p>The site is demarcated.</p> <p><b>The top layer of material next to the excavation site consists of historic dumped material (prior to the commencement of this project). The waste material layer is unpredictable due to its unknown composition and thus it poses an unknown risk (stability) and may collapse and expand beyond the development footprint.</b></p> <p><b>As reported previously (ECO report No.3) – "The engineers investigated the potential risk, and the proposal was to batter back the slope to 34-40 degrees – Done and ongoing monitoring during construction phase".</b></p> |

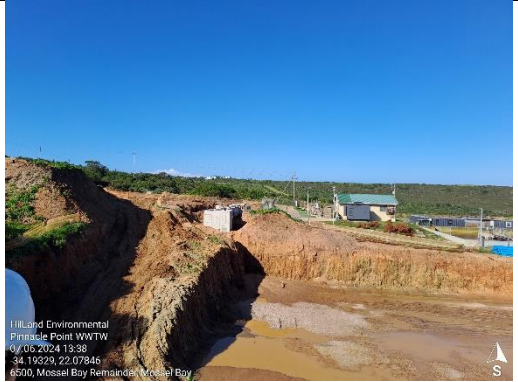
| Dust control | The contractor shall be responsible for the control of dust arising from the operations | <p><b>No dust issues noted or reported to the ECO.</b></p> <p>Dust management to be implemented as per the contractors method statement when necessary.</p> | <p> <small> Hilland Environmental<br/> Pinnacle Point WWTW<br/> 07/06/2024 13:38<br/> 34.19329, 22.07846<br/> 6500, Mossel Bay Remains, Mossel Bay </small> </p> <p>no dust mitigation required</p> |

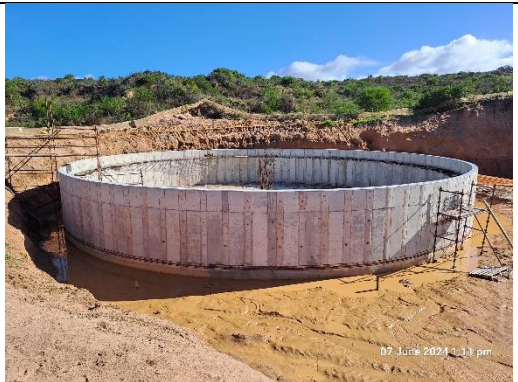
| Concrete management | <ol style="list-style-type: none"> <li>1. Ready-mix concrete should preferably be used.</li> <li>2. Cement and other potential environmental pollutants shall be stored in a dry lockable container.</li> <li>3. Mixing of mortar and concrete must take place on an impermeable substratum.</li> <li>4. Lined, concrete effluent catchpits must be created where on-site mixing takes place.</li> </ol> | No environmental issues noted in relation to the concrete walls for the clarifier. Stand mixer and ready mix are used. | <p>07 June 2024 1:13 pm</p> <p>No environmental issues related to concrete and cement noted.</p> |

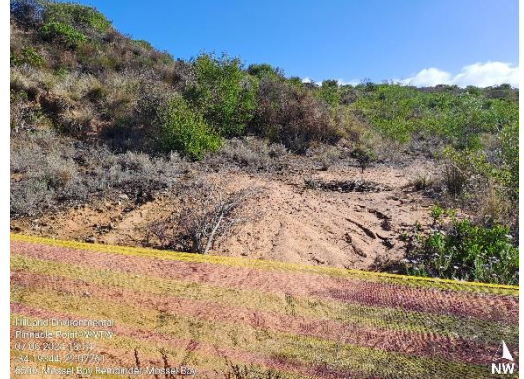
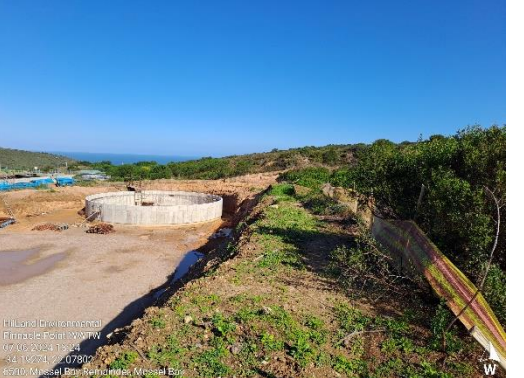
| <p>Natural vegetation and alien clearing</p> | <p>The surrounding area (fynbos) on the eastern side (east of the access road) and south-western side of the site and WWTW are highly sensitive and are to be regarded as No-Go areas.</p> <ol style="list-style-type: none"> <li>1. The development footprint must be pegged and demarcated in consultation with the ECO to avoid any disturbance of the sensitive vegetation areas.</li> <li>2. Topsoil rescued for use in the rehabilitation phase.</li> <li>3. Rehabilitate/revegetate all the disturbed surfaces after construction completed. Especially the newly created slopes directly behind the WWTW - erosion control measures will be required on the steep slopes, such as silt fences, logs or netting, to slow down runoff and potential erosion. Mulching and seeding with indigenous grass seed during rehabilitation phase.</li> <li>4. Engage in alien clearing.</li> </ol> | <p>Development footprint was pegged and vegetation within the development footprint was cleared. <b>Sensitive areas as identified in the EMPr are avoided.</b></p> <p>Topsoil is stockpiled for rehabilitation phase.</p> <p>Invasive aliens within the development footprint were removed.</p> | <p>Surface water from <b>outside</b> the demarcated construction site resulted in silt wash – not related to the construction activity.</p> <p>No-go demarcation in place.<br/>No disturbance of the natural vegetation noted.</p> |
