### ENVIRONMENTAL MONITORING REPORT NO.6 FOR Pinnacle Point WWTW Upgrade, Mossel Bay Municipality

**MOS24.1291.08**

**18 June and 03 July 2024**

**PINNACLE POINT WWTW UPGRADE  
ENVIRONMENTAL MONITORING REPORT NO 6**

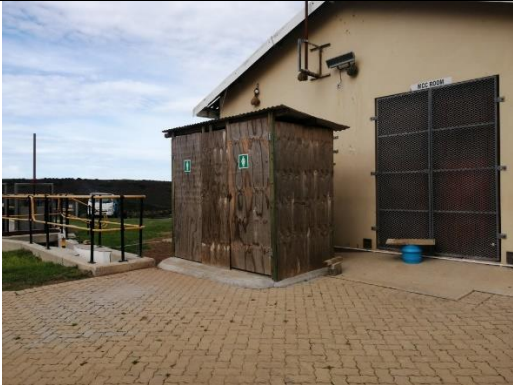
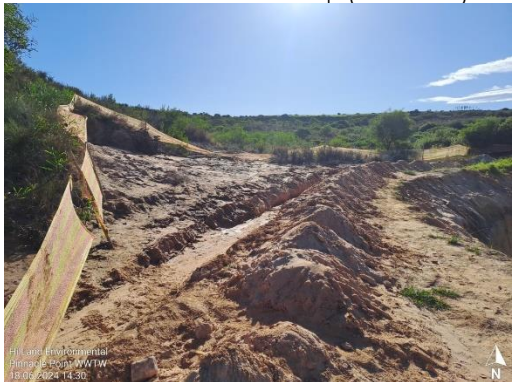
| Item | Management / Mitigation Measure | Compliance/ Notes | Photographic record (where applicable) |
|---|---|---|---|
| Site establishment | <ol style="list-style-type: none"> <li>1. The specific location for the construction site camp, storage of materials, ablution facilities, shall be identified in consultation with the ECO and must be clearly demarcated.</li> <li>2. Stockpiling of both natural and manufactured materials shall be restricted to the permanent and temporary stockpile areas identified by the Project Manager / Consulting Engineer and the ECO.</li> <li>3. Vegetation removal shall be kept to the minimum.</li> <li>4. Topsoil to be rescued and stockpiled for use during rehabilitation.</li> <li>5. No fauna or flora must be disturbed/damaged or removed outside the development footprint.</li> </ol> | <ol style="list-style-type: none"> <li>1. Site camp (including ablution facility) and construction material stockpile area are within the existing wastewater treatment works facility.</li> <li>2. The contractor is spoiling subsoil material at an external site.<br/>The remaining soil is stockpiled on site.</li> <li>3. Vegetation clearing was limited to the development footprint - <b>DONE</b>.</li> <li>4. Topsoil is stockpiled within the existing WWTW facility.</li> <li>5. Disturbance is limited to the development footprint – <b>The top layer of material next to the excavation site consists of historic dumped material (prior to the commencement of this project). The waste material layer is unpredictable due to its unknown composition and thus it poses an unknown risk (stability) and may collapse and expand beyond the development footprint.</b></li> </ol> | <p>Ablution facilities in the site camp (03.07.2024)</p> <p>Construction and excavations are limited to demarcated development footprint (orange netting).</p> |

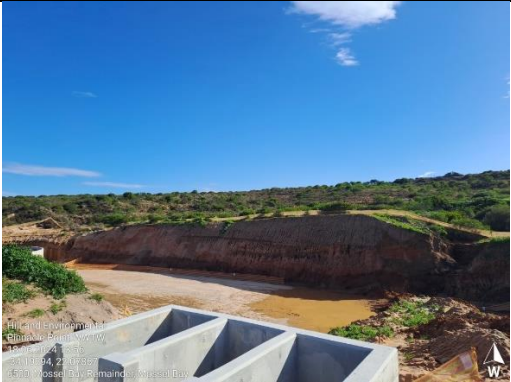
| | | | <p>Historic dumped material stability is undetermined.</p> |

Bulk excavation of the reactor unit is complete. The excavation and installation of the subsoil drainage pipes for the reactor started during this reporting period and construction of the clarifier is ongoing. The slope that was battered back has a top layer of waste material which could pose a risk (collapse and expansion beyond the approved development footprint) due

to its unknown nature and stability, this is still a concern. A section of the northwestern wall is slowly caving in – contractor and engineers to constantly monitor the slope and report any failures to the ECO immediately. Water in the clarifier/ reactor excavation from natural seepage and rainfall is being pumped out once a day, or as necessary, through a silt fence. Ongoing ECO monitoring is to be done.

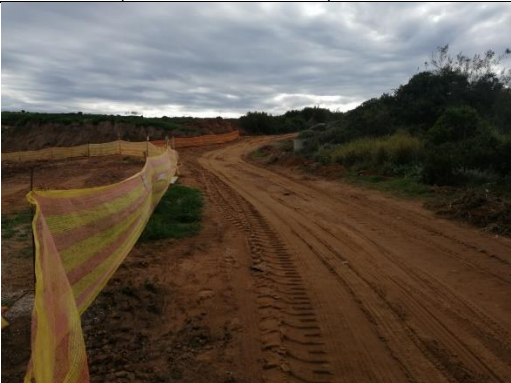
| Access and traffic control | Existing access track to be used | Existing access tracks are being used and maintained. | <p>(03.07.2024)</p> |

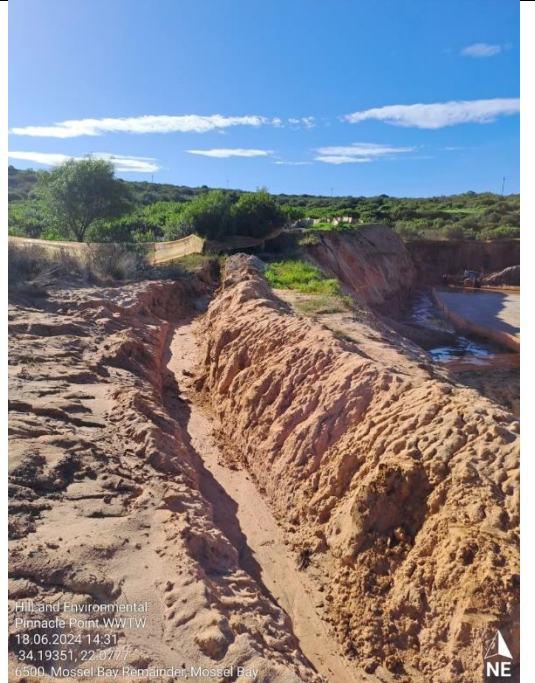
| | | <p>stormwater trench and must be monitored and cleared, by hand, to ensure effectiveness. The trench held up well during the recent heavy rainstorm as confirmed by the contractor and engineer.</p> | <p>Hill and Environmental<br/>Pinnacle Point WWTW<br/>18.06.2024 14:31<br/>-34.19351, 22.07802<br/>16500 Mossel Bay Remander, Mossel Bay</p> <p>Stormwater trench in place.</p> |

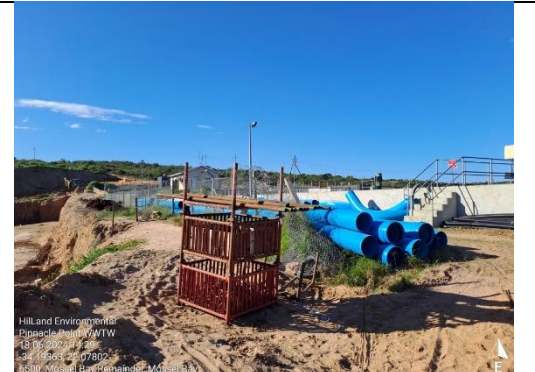
| Site and waste management | <ol style="list-style-type: none"> <li>1. Storage areas for potentially contaminating materials shall be roofed with impervious material (or double bagged in a skip until removed).</li> <li>2. Waste bins/skips must be used for all waste and litter. Waste bins must have lids to prevent content from blowing away or accumulating rainwater. Skips should be covered with netting.</li> <li>3. The burning of waste is forbidden.</li> <li>4. At least one chemical toilet must be made available on site for every 15 workers. All workers will be required to use the chemical toilet(s).</li> </ol> | <ol style="list-style-type: none"> <li>1. Storage of hazardous material as per the contractor's method statement and within the existing site camp (if any)</li> <li>2. The waste storage area is fenced off and litter bins are available at the site camp.</li> <li>3. No burning or burying of waste noted or reported to the ECO.</li> <li>4. Portable- and permanent toilets area available on site.</li> </ol> <p><b>The top layer of material next to the excavation site consists of historic dumped material (prior to the commencement of this project). The waste material layer is unpredictable due to its unknown composition and thus it poses an unknown</b></p> | <p>Hill and Environmental<br/>Pinnacle Point WWTW<br/>18.06.2024 14:31<br/>-34.19351, 22.07802<br/>16500 Mossel Bay Remander, Mossel Bay</p> <p>Storage of material within the demarcated construction site.</p> |

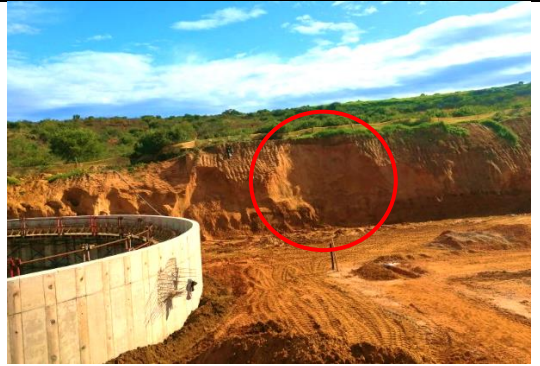
| | | <b>risk (stability) and may collapse and expand beyond the development footprint.</b> | <p>The slope was battered back to 34-40 degrees and stabilized. However, the top layer is made up of historic dumped/fill material and the risk it could potentially pose is unpredictable – an area along the northwestern wall close to the clarifier is slowly but continuously caving in as seen by the red circle (03.07.2024).</p> |

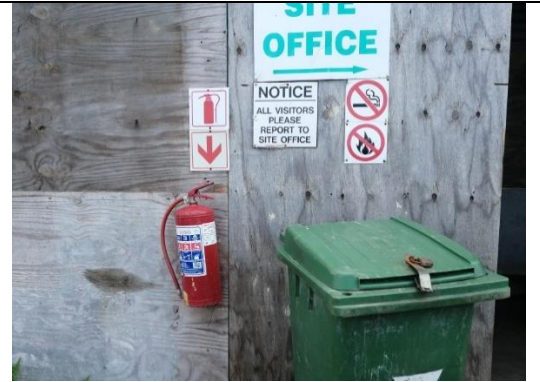
| Fire prevention and control | <ol style="list-style-type: none"> <li>Any welding or other sources of heating of materials shall be done in a controlled environment and under appropriate supervision</li> <li>Working fire extinguisher to be available on site.</li> <li>No smoking will be allowed on site, in particular in areas within or adjacent to natural vegetation, except in designated smoking points.</li> </ol> | <ol style="list-style-type: none"> <li>Not applicable to the current activity.</li> <li>As per the contractor's method statement.</li> <li>No smoking on site noted during ECO site inspection. Dedicated smoking area to be provided at the site camp.</li> </ol> | <p>Fire extinguisher in site camp (03.07.2024).</p> |

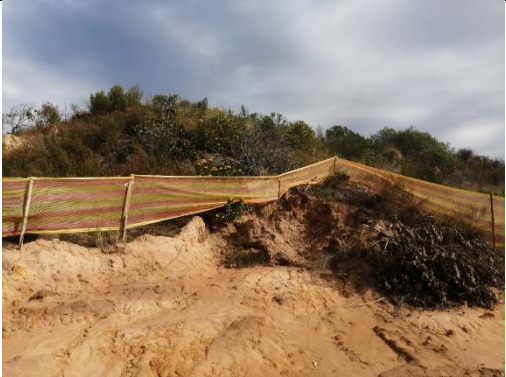
| Natural vegetation and alien clearing | <p>The surrounding area (fynbos) on the eastern side (east of the access road) and south-western side of the site and WWTW are highly sensitive and are to be regarded as No-Go areas.</p> <ol style="list-style-type: none"> <li>1. The development footprint must be pegged and demarcated in consultation with the ECO to avoid any disturbance of the sensitive vegetation areas.</li> <li>2. Topsoil rescued for use in the rehabilitation phase.</li> <li>3. Rehabilitate/revegetate all the disturbed surfaces after construction completed. Especially the newly created slopes directly behind the WWTW - erosion control measures will be required on the steep slopes, such as silt fences, logs or</li> </ol> | <p>Development footprint was pegged and vegetation within the development footprint was cleared. <b>Sensitive areas as identified in the EMPr (outside the development footprint) are avoided.</b></p> <p>Topsoil is stockpiled for rehabilitation phase.</p> <p>Invasive aliens within the development footprint were removed. The (at least) 5m wide strip around the site is still to be cleared – ECO to guide to ensure compliance with NEMA and NEM:BA.</p> | <p>The development footprint is demarcated with orange netting fence (03.07.2024).</p> |

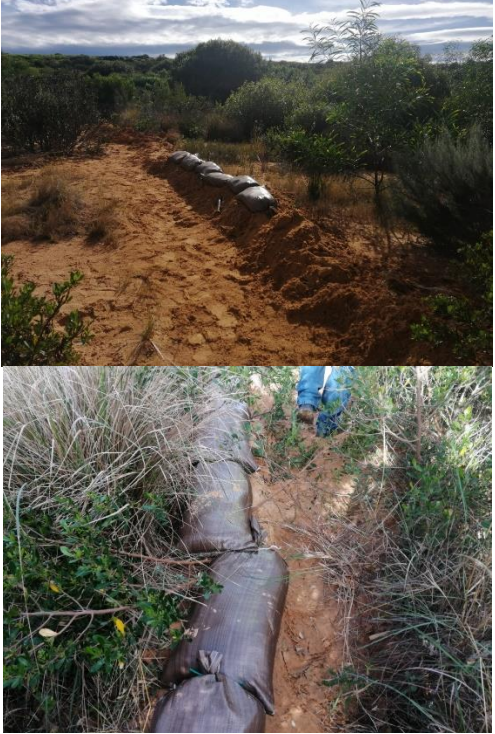
| | <p>netting, to slow down runoff and potential erosion. Mulching and seeding with indigenous grass seed during rehabilitation phase.</p> <p>4. Engage in alien clearing (at least 5m around the site).</p> | | <p>Sandbag berms have been created behind the WWTW to divert the water away from the excavations and into the natural vegetation (03.07.2024).</p> |

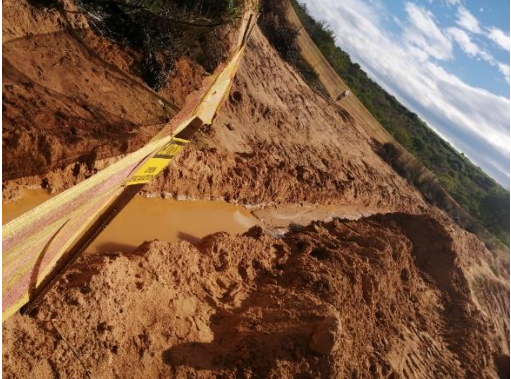
| | | | <p>Stormwater diversion trench directing stormwater away from the clarifier excavation and into the natural vegetation. Silt fence is in place to prevent silt from washing into the vegetation.</p> |
