## ENVIRONMENTAL MONITORING REPORT NO. 59

KRAAIBOSCH PARK

| <b>Report Period</b> | August 2025 |

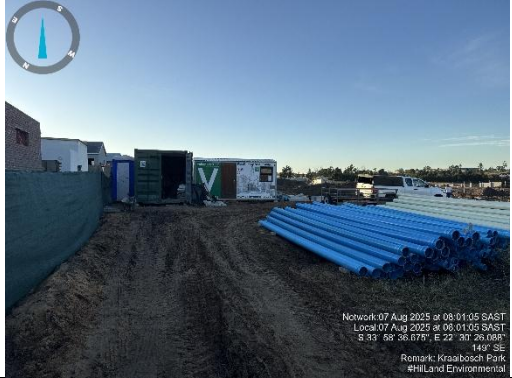
| Construction Site Camp | | | | |
|---|---|---|---|---|
| The area of the site camp must be approved by the ECO. | Yes | | | <p>Construction site camp is set up within the development zone on an Erf.<br/>Building contractor:</p> <p>Network: 07 Aug 2025 at 08:01:05 SAST<br/>Local: 07 Aug 2025 at 08:01:05 SAST<br/>S: 33° 08' 36.670" E: 22° 39' 26.180"<br/>149° SE<br/>Remark: Kraaibosch Park<br/>#HLLand Environmental</p> |

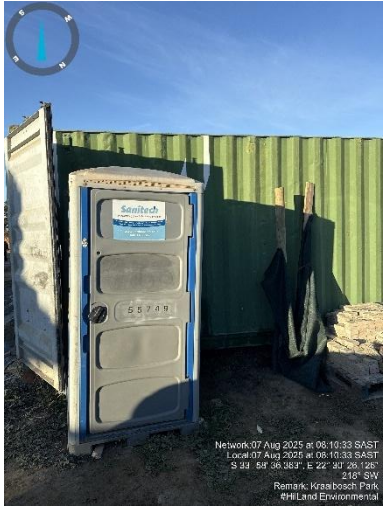
| Construction Site Camp | | | | |
|---|---|---|---|---|
| Ablution facilities are to be provided prior to commencement of activities. | Yes | | | <p>Ablution facilities are available on site.</p> <p>Network: 07 Aug 2025 at 08:10:33 SAST<br/>Local: 07 Aug 2025 at 08:10:33 SAST<br/>S: 33° 08' 36.670" E: 22° 39' 26.180"<br/>149° SE<br/>Remark: Kraaibosch Park<br/>#HLLand Environmental</p> |

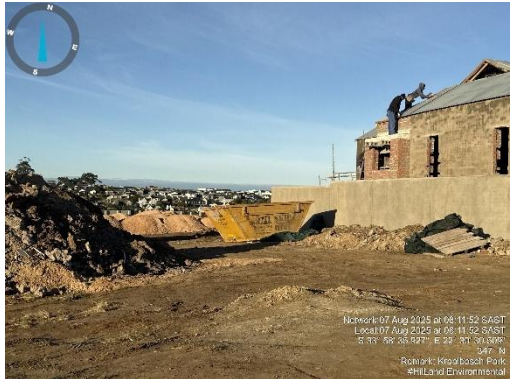
| Construction Site Camp | | | | |
|---|---|---|---|---|
| A dedicated area must be created in the site camp for refuse and waste management. | Yes | | | <p>There are skip throughout the construction phase (building contractor) – the skips must be covered to prevent wind-blown litter issues.</p> <p>Network: 07 Aug 2025 at 08:11:52 SAST<br/>Local: 07 Aug 2025 at 08:11:52 SAST<br/>S: 33° 08' 36.670" E: 22° 39' 26.180"<br/>149° SE<br/>Remark: Kraaibosch Park<br/>#HLLand Environmental</p> |

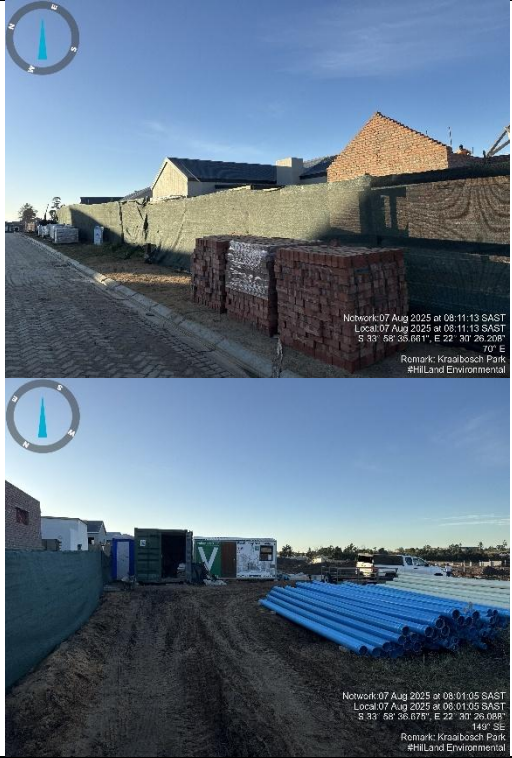
| Construction Site Camp | | | | |
|---|---|---|---|---|
| No storage of construction materials within the no-go areas. | Yes | | | <p>Construction materials are stored in the development zone (civil and building contractor).</p> |

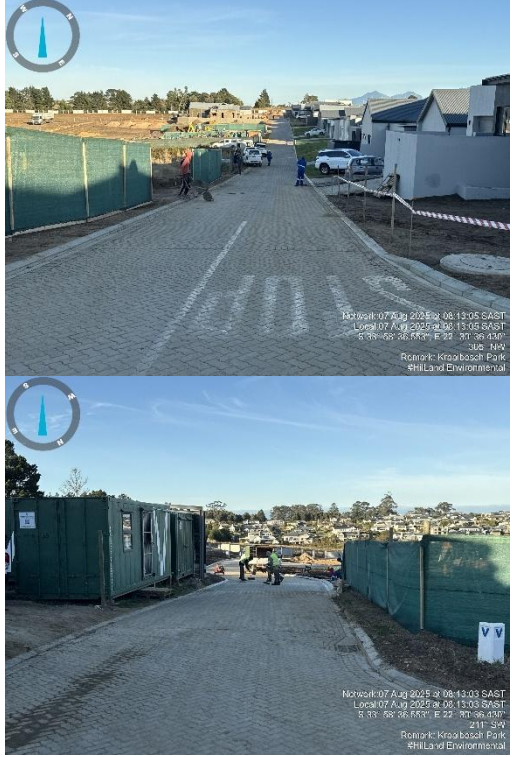
| | | | | <p>North: 07 Aug 2025 at 08:11:13 SAST<br/>Local: 07 Aug 2025 at 08:11:13 SAST<br/>S 33° 58' 36.681" E 22° 30' 26.206"<br/>70° E<br/>Remark: Kraaihoek Park<br/>#HLLand Environmental</p> <p>North: 07 Aug 2025 at 08:01:05 SAST<br/>Local: 07 Aug 2025 at 08:01:05 SAST<br/>S 33° 58' 36.670" E 22° 30' 26.064"<br/>140° SE<br/>Remark: Kraaihoek Park<br/>#HLLand Environmental</p> |
|---|---|---|---|---|
| <p>Construction vehicles must be restricted to the designated roads only.</p> <p>Roads to be cleaned where necessary.</p> | Yes | | | <p>Existing road in the development are used.</p> <p>Roads are cleaned regularly (civil contractor and building contractor). Stormwater inlets must be kept clean – do not sweep or wash the mud into the stormwater network.</p> <p>Providence road must be kept clean.</p> <p>North: 07 Aug 2025 at 08:15:05 SAST<br/>Local: 07 Aug 2025 at 08:15:05 SAST<br/>S 33° 58' 36.681" E 22° 30' 26.436"<br/>306° N/A<br/>Remark: Kraaihoek Park<br/>#HLLand Environmental</p> <p>North: 07 Aug 2025 at 08:13:03 SAST<br/>Local: 07 Aug 2025 at 08:13:03 SAST<br/>S 33° 58' 36.681" E 22° 30' 26.436"<br/>211° SW<br/>Remark: Kraaihoek Park<br/>#HLLand Environmental</p> <p>Road being cleaned</p> |

| | | | | <p>House construction mainly uses ready mix.</p> <p>Currently no house building near the wetland/buffer.<br/>No cement water noted in wetland.</p> |
|---|---|---|---|---|
| Water spraying and/or wood chips need to be used in areas where dust is generated. | Ongoing | | | Dust suppression must continue to be implemented. Dust remains an ongoing problem. The contractor is continually sweeping the roads and spraying water on bare areas. |

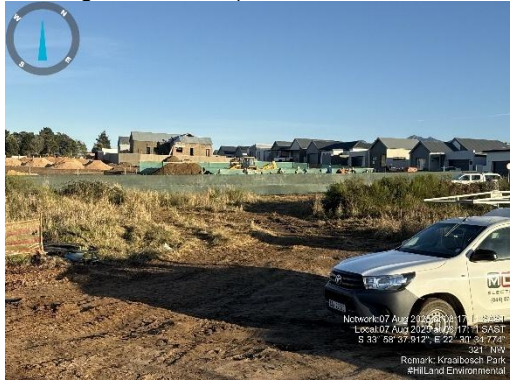
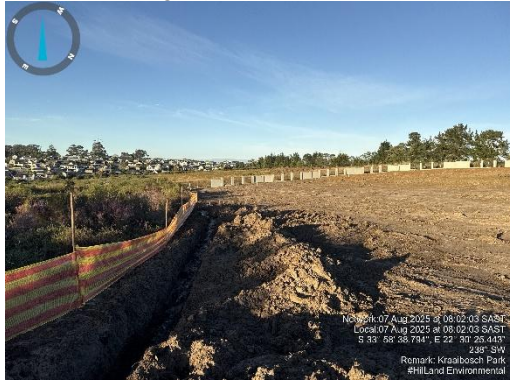
| is immediately stopped in the immediate vicinity of the site and the ECO is to be contacted to inform HWC. | | | | |
|---|---|---|---|---|
| All people on site must be made aware of the boundaries within which work may be done (working zones) and which areas are No-Go areas.<br><br>Only approved activities may be undertaken in no-go areas (ECO approved method statement) | Yes | | | As discussed during the environmental induction with the civil contractor. Communicated to the main building contractor.<br><br>No-Go demarcation of the eastern and western wetland buffer area is in place. As there is no need to move in this area, all construction activity must be restricted to the working zone.<br><br>House contractor is normally confined to the erf (green shade netting demarcation).<br><br>Green shade netting in place for house construction area<br><br>Western wetland demarcation |

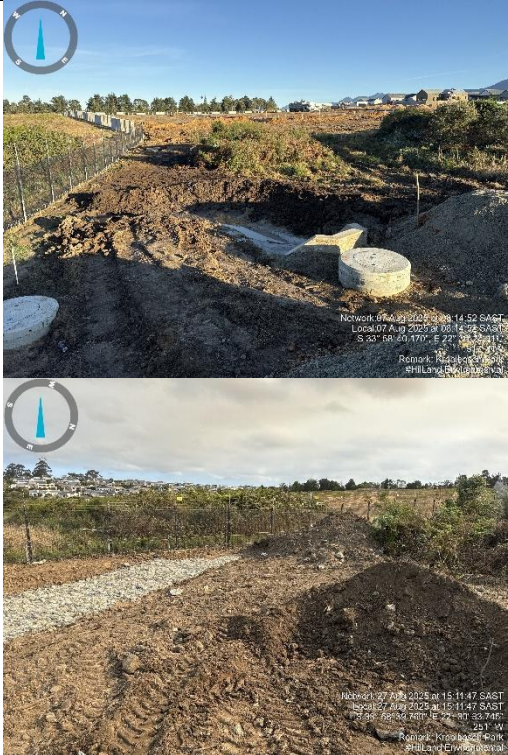
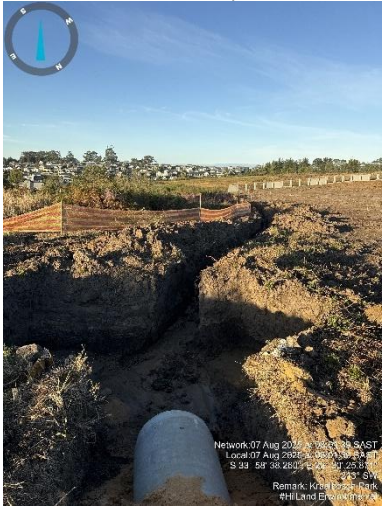
| | | | | <div><p>Phase 4A – stormwater outlet (reno mattress dissipator installed)</p><p>Stormwater pipeline in Phase 4B – outlet channel still to be constructed</p></div> |

| Silt fences, sandbags or berms must be used to limit runoff during construction. No contaminated water to enter the no-go areas. | Yes | | | Phase 4A – stormwater outlet is functional – reno-mattress dissipator installed<br><br>Phase 4B - silt fences must be installed and maintained |

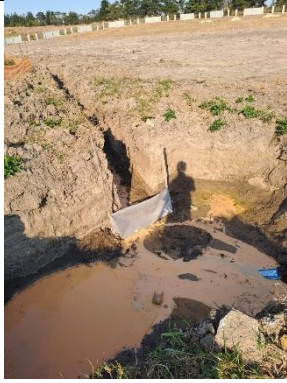
| | | | | <p>The silt fences will remain in place until all building construction is complete.</p> |

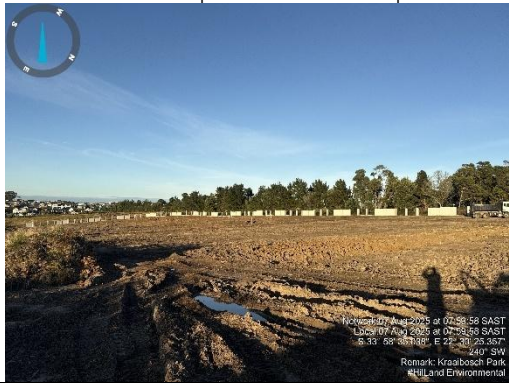
| | | | | <p>The silt fences will remain in place until all building construction is complete.</p> |
|---|---|---|---|---|
| Vegetation must only be cleared in the immediate working area for any activity. | Yes | | | <p>The entire phase 4A and 4B have been cleared for civil services installation and platforms for the top structures.</p> <p>WGS84: 29.5959 S 30.5959 E 07:59:59 SAST<br/> UTM: 30 QJ 2959 S 3059 E 07:59:59 SAST<br/> 6 33 59 2959 S 3059 E 07:59:59 SAST<br/> 2959 S 3059 E 07:59:59 SAST<br/> Remark: Kraaibosch Park<br/> 2014 Land Environmental</p> |

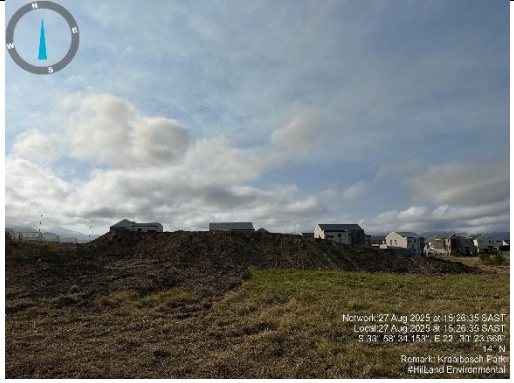
| | | | | <p>Topsoil stockpile</p> |

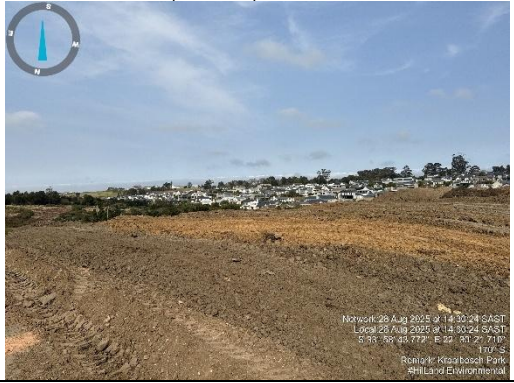
| | | | | <p>Topsoil stockpile</p> |
|---|---|---|---|---|
| Surplus subsoil that is required for cut and fill operations may be stockpiled in an area approved by the ECO. All earthwork material that is not going to be used must be removed immediately from the site. | Yes | | | Ongoing during civil construction phase.<br>Surplus subsoil is stockpiled in phase 5.<br> |

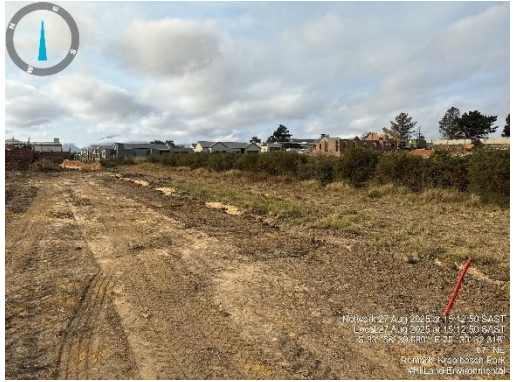
| | | | | <p>Topsoil stockpile</p> |
|---|---|---|---|---|
| The working zone must be demarcated, and all activities must be restricted to the demarcated working zone. | Yes | No | | Civil construction phase – eastern and western wetland and buffer area (no-go area) has been demarcated with orange netting. This will need to be maintained and kept in place during the housing construction phase as well.<br><br> <p>The short section of the eastern wetland still to be installed.</p> |

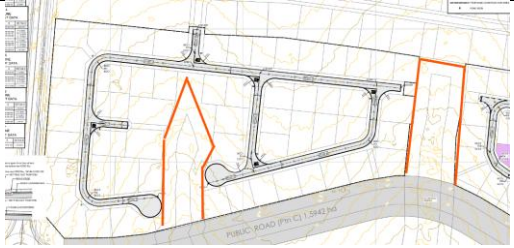
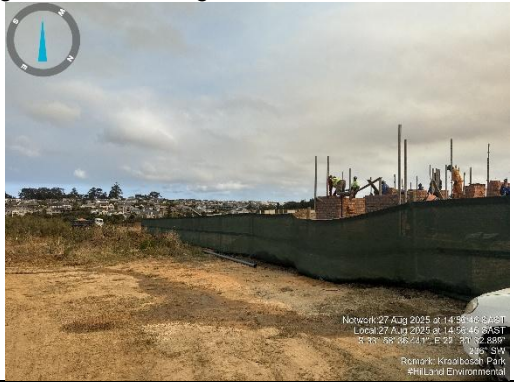
| | | | | <p>Housing construction – individual houses are demarcated with green shade netting.</p> |

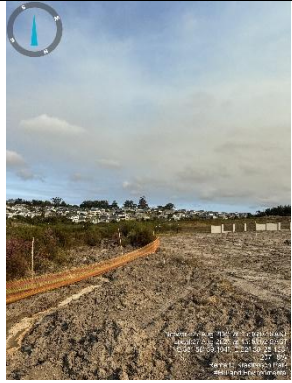
| | | | | <p>Eastern wetland demarcated.</p> |

| | | | | <p>House construction mainly uses ready mix.</p> <p>Currently no house building near the wetland/buffer.<br/>No cement water noted in wetland.</p> |
|---|---|---|---|---|
| <p>Buffers are No-Go areas.</p> <p>Buffers must be clearly demarcated.</p> | Yes | NO | | <p>No-Go demarcation of the eastern and western wetland buffer area is in place and must be maintained. Small section on the western edge of the eastern wetland to be demarcated.</p> |

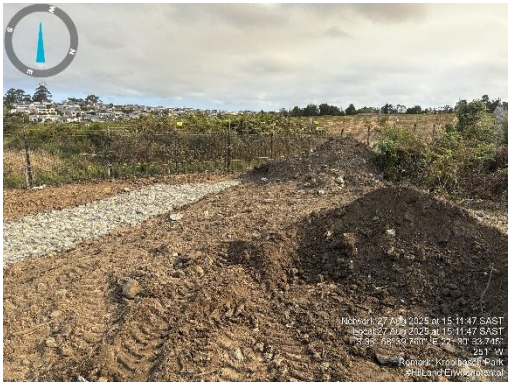
| | | | | <p>Eastern wetland demarcated.</p> |
|---|---|---|---|---|
| Excavated soil from trenched to be stockpiled along the outer edge of the trench furthest away from wetland. Trenches to be reshaped to original contours and vegetated/seeded. | Yes | No | | <p>Sewer line (phase 4A) was installed, and trench was backfilled. <b>Still to be shaped to the original contour and seeded.</b></p> <p>Stormwater outlets are in the buffer area as per the stormwater management plan.</p> |
