**ENVIRONMENTAL MONITORING REPORT NO. 64**

**KRAAIBOSCH PARK**

| <b>Report Period</b> | March 2026 |

HillLand Environmental, the appointed Environmental Control Officer (ECO) compiled this report as the environmental monitoring report (**No. 64**). This report monitors compliance against the approved Environmental Management Plan (Ref.: GEO25.981.100 – dated April 2025) and constitutes the **64<sup>th</sup>** Environmental Monitoring Report and covers inspections done during **March 2026** for the construction activities at Kraaibosch Park.

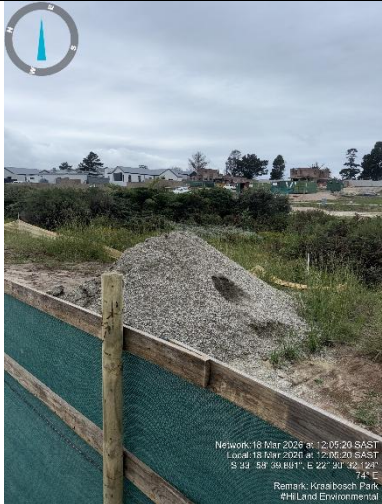
| | | | | <p>Phase 4B – temporary storage of the erf platform material in the buffer area must be removed and the area must be rehabilitated.</p> |

| Construction work needs to be limited to normal working hours. | Ongoing | | | Ongoing during both civil and house building phase. Developer to notify residents if/when civil or building contractor is intending to work on Saturdays. |
|---|---|---|---|---|
| No materials may be stockpiled within the <b>buffer area</b> . | Yes | No | | <br><br>Phase 4B – temporary storage of the erf platform material in the buffer area must be removed and the area must be rehabilitated – based on a site inspection on 10 April 2026, the material has been removed, and the area must be fully rehabilitated – topsoil must be replaced and indigenous grass seed spread. |

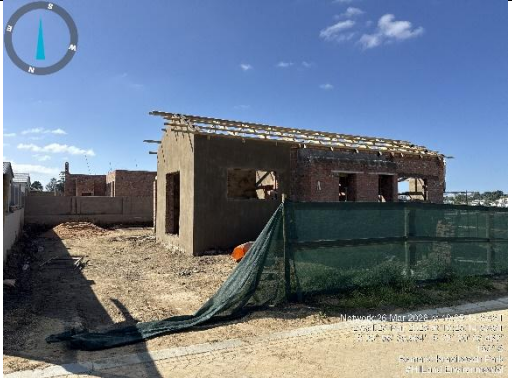
| | | | | <p>Green shade netting in place for house construction area</p> |

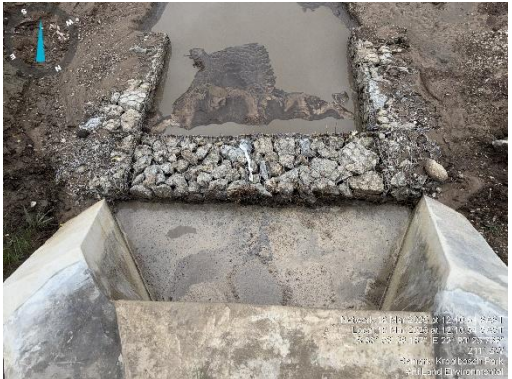
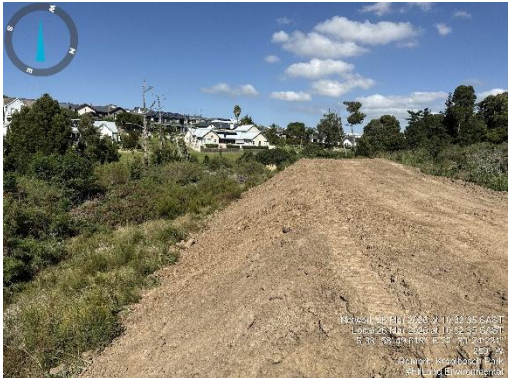
| | | | | <p>Green shade netting in place for house construction area</p> |
|---|---|---|---|---|
| Only the approved stormwater management plan may be implemented. | Yes | | | <p>Stormwater outlets will tie into the stormwater system. Note that the structures in the wetland will not be constructed at this stage, only stormwater outlets within the buffer area with energy dissipators (reno-matgrass).</p> <p>Phase 4B – stormwater outlet erosion protection is required until the reno-matgrasses have been installed.</p> <p>Preparation for the swale as per the stormwater management plan</p> |

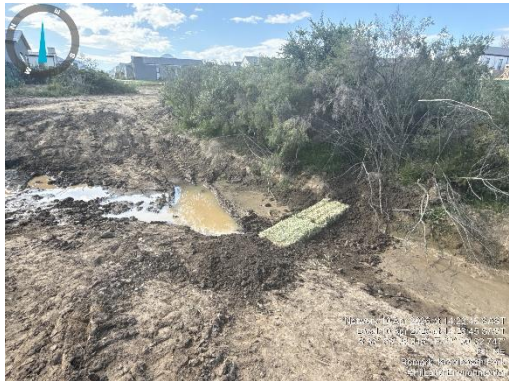
| | | | | |
|---|---|---|---|---|
| Silt fences, sandbags or berms must be used to limit runoff during construction. No contaminated water to enter the no-go areas. | Yes | | | <p>Phase 4A and Phase 4B stormwater outlets are functional – reno-mattress dissipator installed. The ECO requested additional silt protection (hay-bales) to be installed at the stormwater outlet area to further prevent potential contaminated soil/silt entering the wetland – done as noted on 18 March and 10 April 2026.</p> <p><i>The silt fences will remain in place until all building construction is complete.</i></p> |

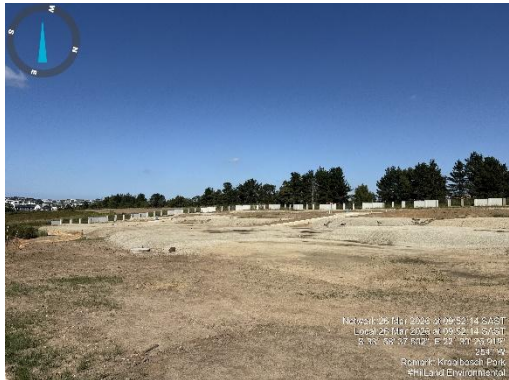
| | | | | |
|---|---|---|---|---|
| Vegetation must only be cleared in the immediate working area for any activity. | Yes | | | <p>The phase 4A and 4B development area have been cleared for civil services installation and platforms for the top structures.</p> |

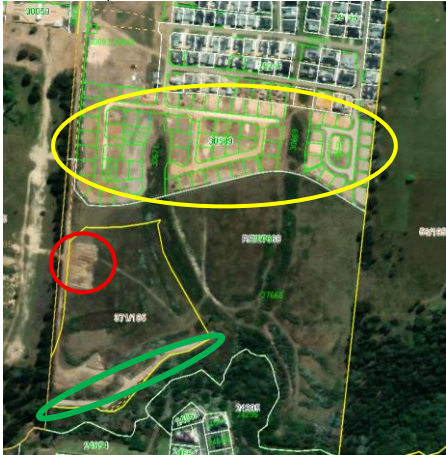
| | | | | <p>Vegetation clearing was done as part of the preparation for the swale as per the stormwater management plan.</p> <p>Cape Farm Mapper (2026) – phase 4 is indicated in yellow, note the wetlands remain unaffected, temporary stockpile area for the swale indicated in red in "future phase" and swale preparation area indicated in green</p> |

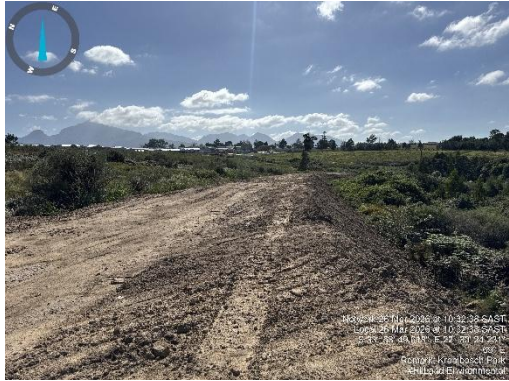
| | | | | <p>Vegetation clearing was done as part of the preparation for the swale as per the stormwater management plan.</p> <p>Cape Farm Mapper (2026) – phase 4 is indicated in yellow, note the wetlands remain unaffected, temporary stockpile area for the swale indicated in red in "future phase" and swale preparation area indicated in green</p> |
|---|---|---|---|---|
| The landscape swales need to be shaped to their final shape immediately before the soil becomes hard. | ongoing | | | <b>Ongoing</b> – combination between the house building contractor and the civil contractor. Shaping in process as resources are available. <p>Swale created with rescued topsoil.</p> |

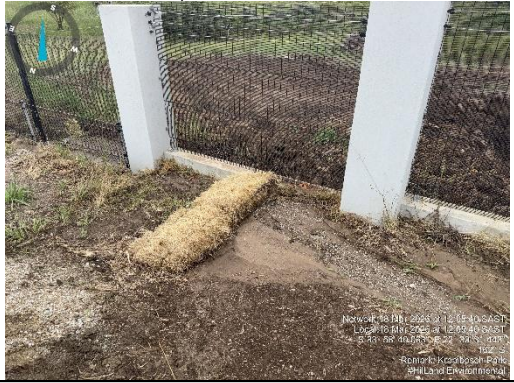
| | | | | <p>Vegetation clearing was done as part of the preparation for the swale as per the stormwater management plan.</p> <p>Cape Farm Mapper (2026) – phase 4 is indicated in yellow, note the wetlands remain unaffected, temporary stockpile area for the swale indicated in red in "future phase" and swale preparation area indicated in green</p> |
|---|---|---|---|---|
| Silt fencing needs to be installed as indicated by the ECO. | Yes | | | Phase 4A and Phase 4B stormwater outlets are functional – reno-mattress dissipator installed. The ECO requested additional silt protection (hay-bales) to be installed at the stormwater outlet area to further prevent potential |

| | | | | contaminated soil/silt entering the wetland – done as noted on 18 March and 10 April 2026. |

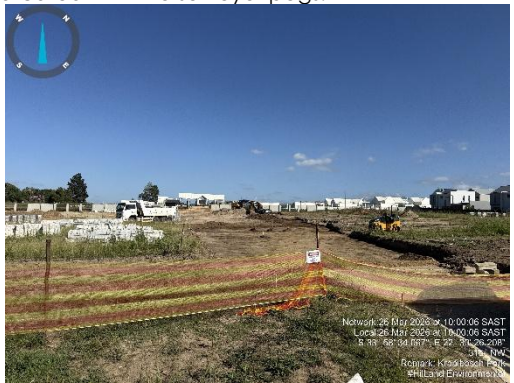
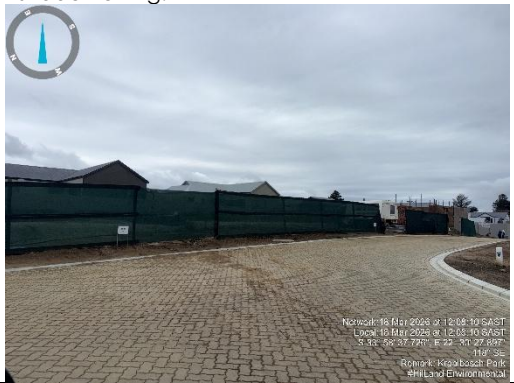
| | | | | contaminated soil/silt entering the wetland – done as noted on 18 March and 10 April 2026. |
|---|---|---|---|---|
| The <b>working zone</b> must be demarcated, and all activities must be restricted to the demarcated working zone. | Yes | | | <p>Frail care site - working zone (civil construction phase) is demarcated with the surveyor pegs.</p> <p>Housing construction "building sites" are demarcated with green shade netting.</p> |

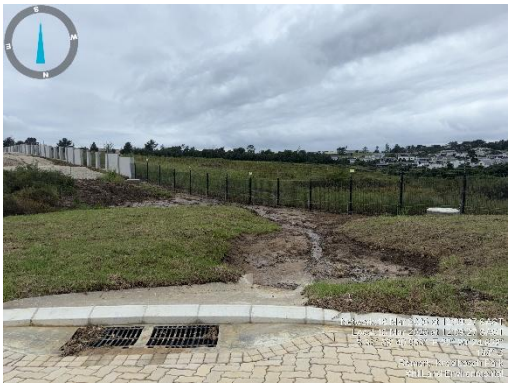
| reshaped to original contours and vegetated/seeded. | | | | Stormwater outlets are in the buffer area as per the stormwater management plan. |
|---|---|---|---|---|
| Vegetation must only be cleared in the immediate working area for any activity. | Yes | | | Wetland buffer area clearing for the stormwater outlets were done immediately before clearing started.<br><br>The development footprint (sewer, stormwater, water, roads and housing platforms) has been pegged, and vegetation clearing was limited to the pegged area.<br><br>The sewer line and stormwater dissipator (phase 4) have been installed and rehabilitation of phase 4B is in process.<br><br> |
