**THE UPGRADE OF PROTEA AND MAINTENANCE TO WAARBURGH ROAD NEAR  
JOOSTENBERG VLAKTE, WESTERN CAPE**

Contract No: C1049.03

**FORMAL ECO AUDIT REPORT**

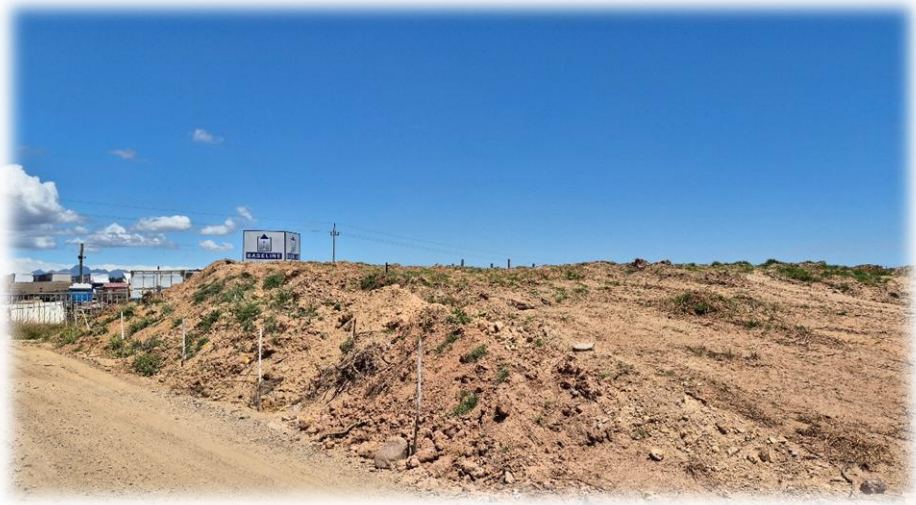
| <b>Topsoil management</b> | <p>Topsoil has been stripped at a few locations along the site and currently stockpiled at Stockpile Area 1 and 2. Where possible topsoil has been windrowed, but due to limited space on site stockpiling is preferred.</p> <p>The contractor was advised to please reduce the height of the topsoil stockpile as it is currently higher than 2m and to remove any material on top of topsoil which is not plant material.</p> | Partial-Complaint |

| | <p>It is important to keep record of where topsoil from different sections is stockpiled to ensure the correct topsoil is returned to the same area.</p> | |

| | Finding | Close Out Recommendation |
|---|---|---|
| 1. | <b>Topsoil management</b><br><br>Topsoil stockpile higher than 2m. | The contractor was advised to please reduce the height of the topsoil stockpile as it is currently higher than 2m and remove any material on top of topsoil which is not plant material. |

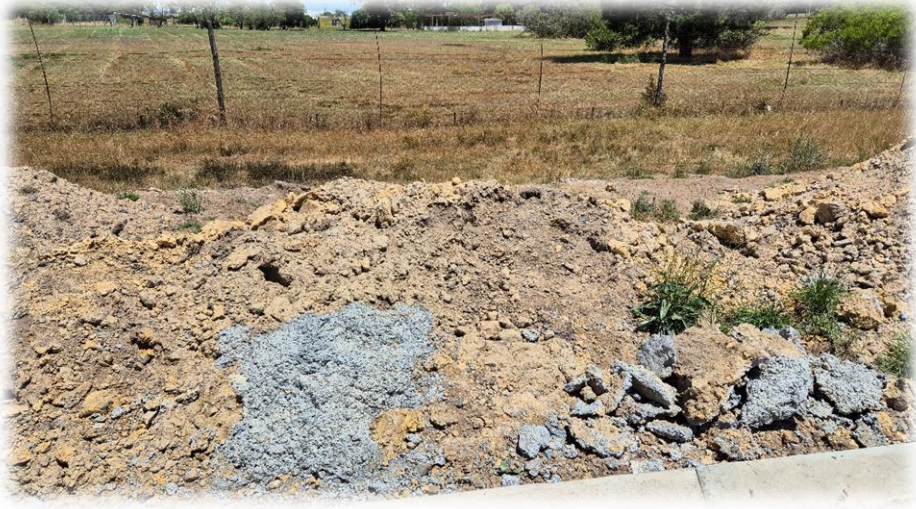
| <b>Cement</b> | <p>No batching or pouring of concrete was noted during the audit.</p> <p>No concrete spills took place to date on site, apart from the small concrete remains during the pouring of concrete which must be picked up on the day the concrete was poured.</p> <p>The contractor is please requested to remove all concrete remains from next to the side drains. The rubble may be stockpiled at an approved stockpile area prior to appropriate disposal.</p> | Partial-Complaint |

| | Finding | Close Out Recommendation |
|---|---|---|
| 2. | <b>Cement</b><br><br>Concrete remains found next to the concrete lined side drains. | The contractor is requested to remove all concrete remains from next to the side drains. The rubble may be stockpiled at an approved stockpile area prior to appropriate disposal from site. |

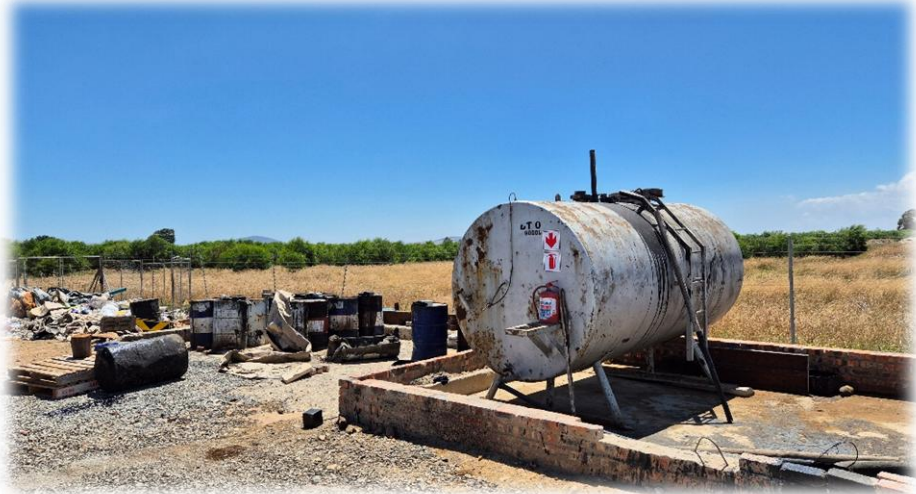
| <p><b>Dangerous and Toxic Materials</b></p> | <p>Oils and chemicals are stored at the site camp area in appropriate containers. No large fuel storage takes place on site.</p> <p>A bunded area with 110% storage capacity has been constructed for the bitumen tanker.</p> <p>The contractor confirmed the empty tanks are temporally stored on site and will be used at another site.</p> | <p>Compliant</p> |

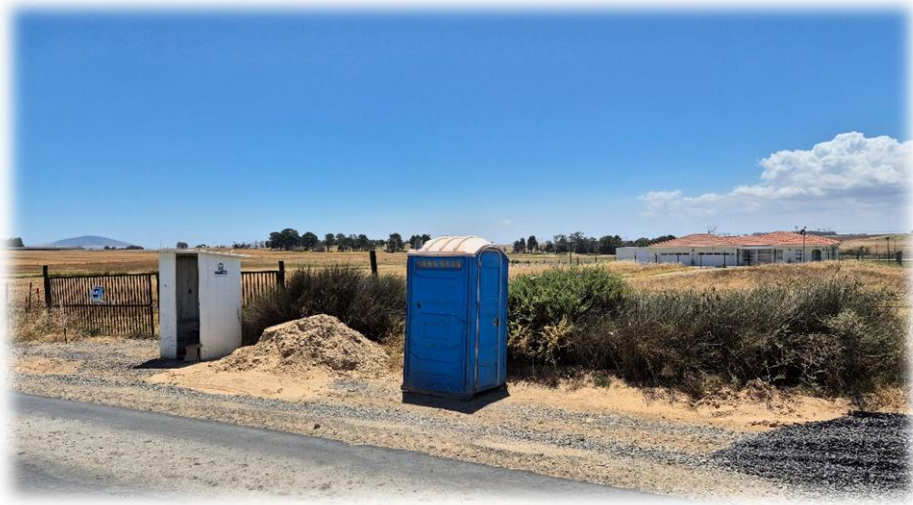
| <b>Toilets and ablution facilities</b> | <p>A few mobile toilets were noted on site.</p> | Compliant |

| | <p><u>The contractor will be responsible for providing all sanitary arrangements for his and the sub-contractors team. A minimum of one chemical toilet shall be provided per 15 persons.</u></p> <p><u>Toilets provided by the contractor must be easily accessible and a maximum of 150m from the works area to ensure they are utilised.</u></p> | |

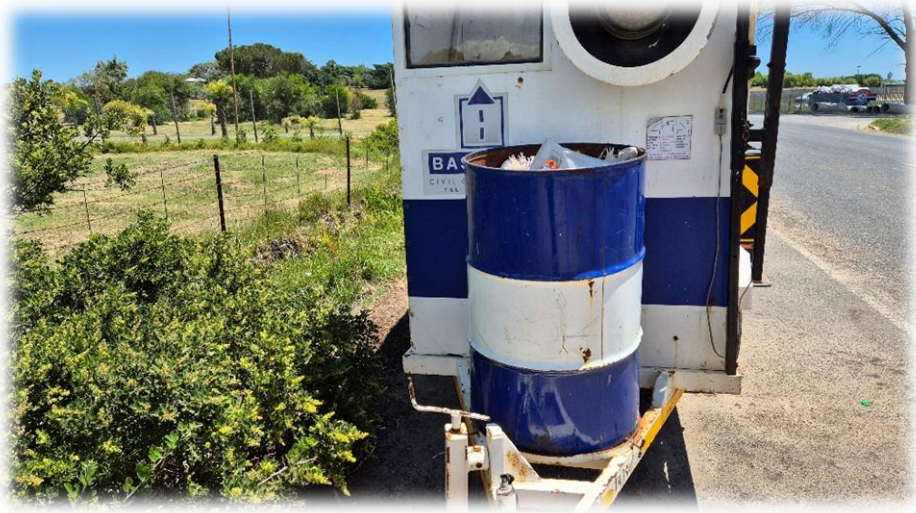
| <p><b>Waste management</b></p> <p>Please refer to the waste minimization plan as part of the EMP.</p> | <p>Litter and rubble disposal receipts are required to be forwarded to the ER and ECO for record keeping.</p> <p>No receipts were received to date.</p> <p><u>Should rubble not be proposed to be disposed at a registered landfill site (for example a farmer wants the rubble), authorisation is required from Western Cape Government: Environmental Affairs and Development Planning: Waste Department</u></p> <p>Bins were placed at the closures.</p> | <p>Partial compliant</p> |

| | Finding | Close Out Recommendation |
|---|---|---|
| 3. | <b>Waste management</b><br><br>Litter and rubble disposal receipts are required to be forwarded to the ER and ECO for record keeping. | No receipts were received to date. Please forward disposal receipts for record purposes. |

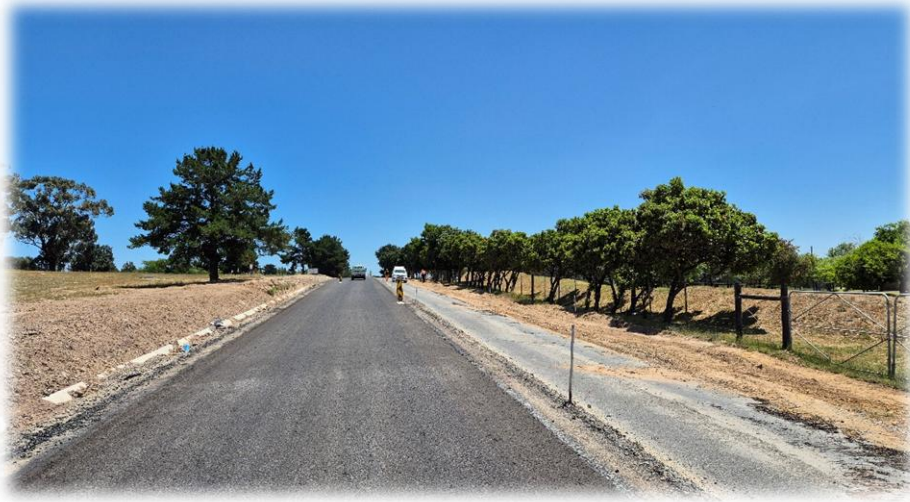
Traffic has been placed on the sections which were recently surfaced.

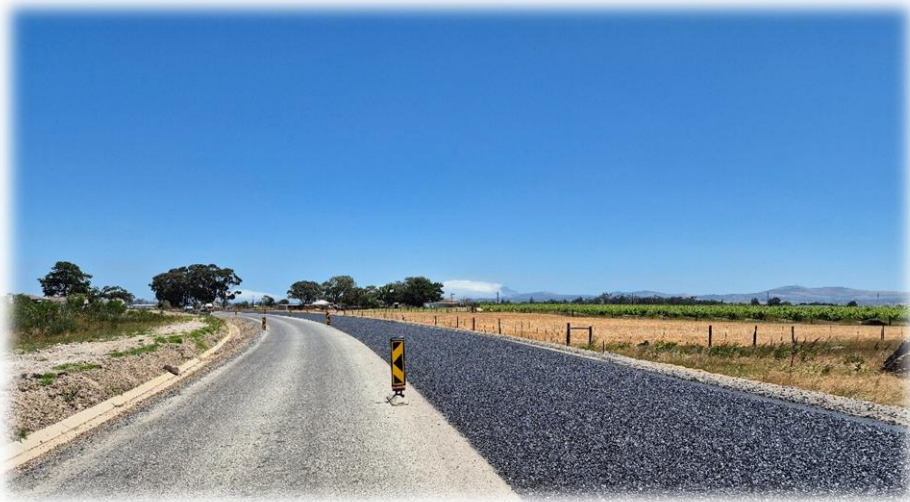
New sections have been surfaced after the previous audit.

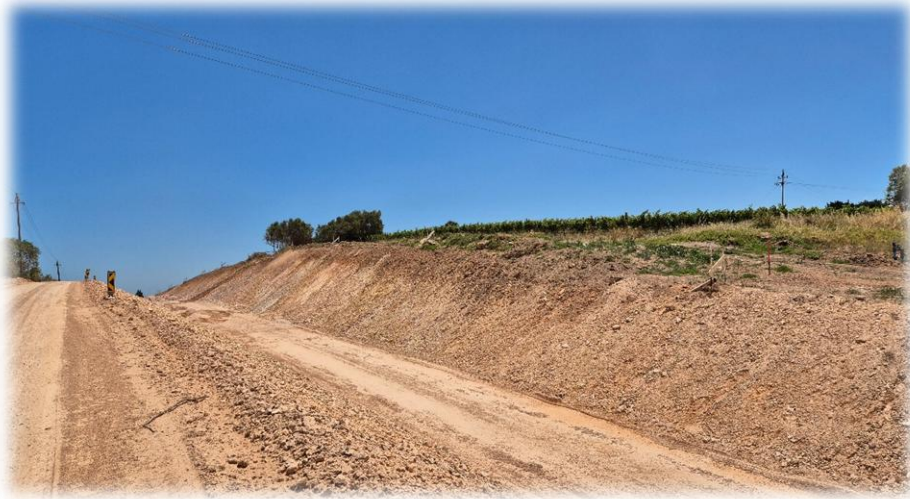
The cutting on Protea Road commenced and progressed well.
