## THE CONSTRUCTION OF RESERVOIR FOR MOSSEL BAY AREA ON THE FARM VAALE VALLEY 219, MOSSEL BAY ENVIRONMENTAL MONITORING REPORT NO. 1

**THE CONSTRUCTION OF RESERVOIR FOR MOSSEL BAY AREA ON THE FARM VAALE  
 VALLEY 219, MOSSEL BAY**

ENVIRONMENTAL MONITORING REPORT NO. 1 –FEBRUARY 2021

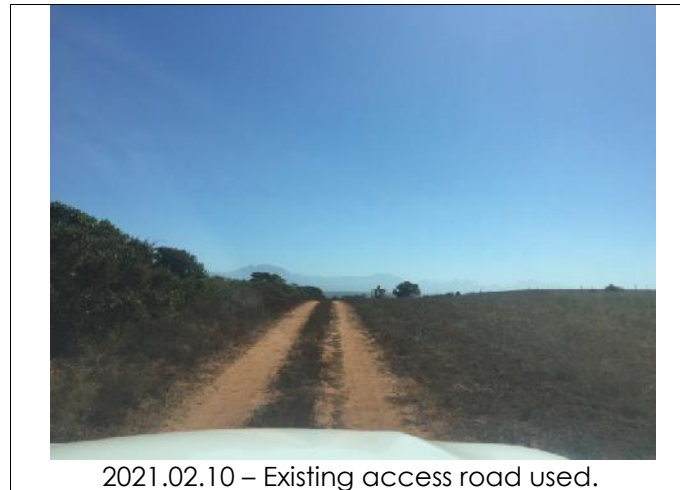
The existing road leading to site was upgraded to provide better access for construction vehicles. Please be reminded that driving off the designated access roads is not permitted. Access to site is being controlled by the contractor to prevent any unauthorised access to the site – there is a guard at the farm gate.

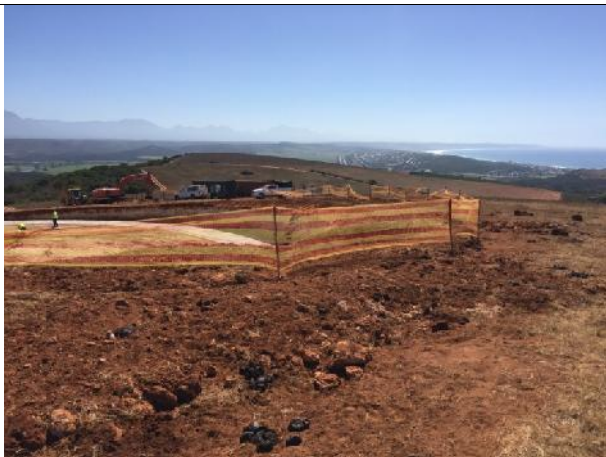
No-Go demarcation is in place. It was noted that the current orange netting at the top excavation area is not sturdy enough to prevent the cattle from pushing it over. It was suggested that a stronger, more stable fence be installed to prevent the cattle from entering the excavation/construction area. The ECO monitors maintenance and adherence to the demarcation during site inspections.

2021.02.10 – The No-Go demarcation at the top of the excavation area on the Southern edge of the reservoir.

The ECO is satisfied that the contractor is aware of the environmental requirements. The contractor should ensure that the construction site (excavation area) is demarcated appropriately to prevent the farm animals from entering the site. Regular litter picking is recommended. The Palaeontologist confirmed that there were no fossil materials found during his site inspection and that no further palaeontologist site inspections are required.

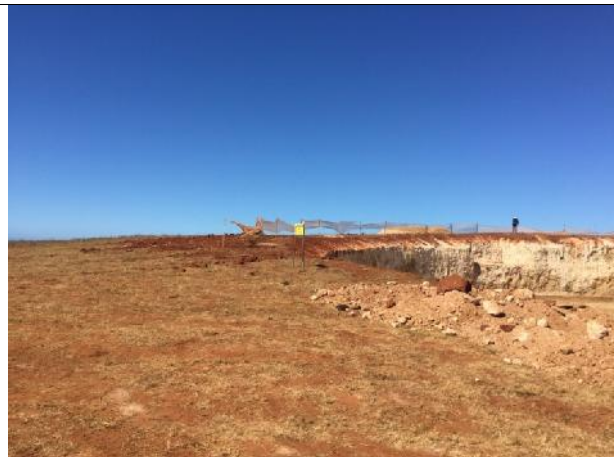
2021.02.10 – The orange netting is only installed on the southern edge, where the deepest excavated area is.

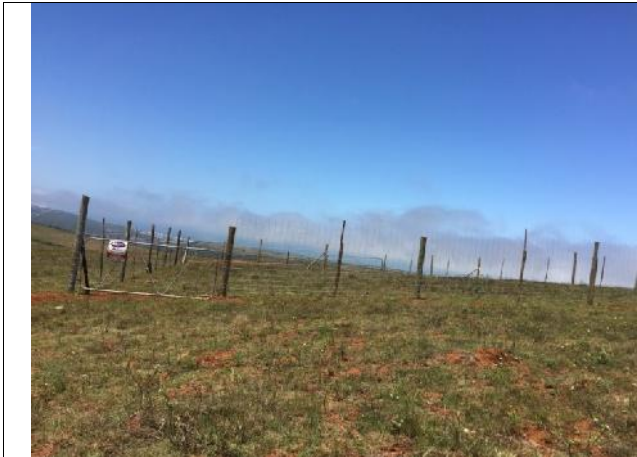
The site camp is fenced off correctly and set up in an area that is not within or adjacent a sensitive natural area.

2021.01.14 – Site camp

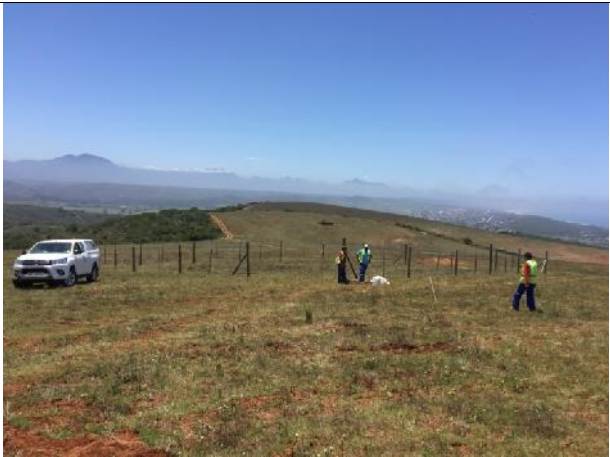
2021.01.14 – Site camp

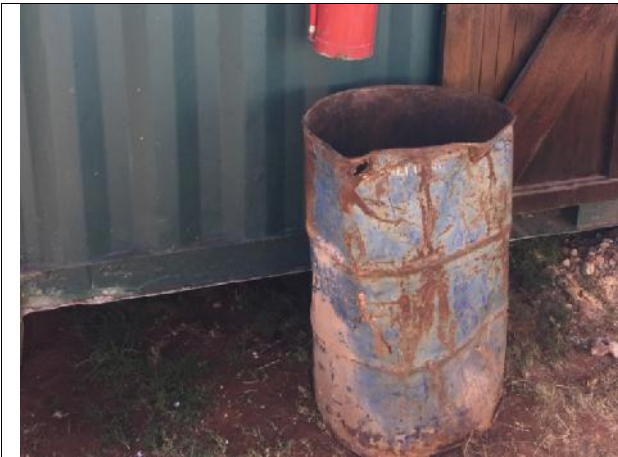
Adequate litter bins are provided at the site camp and littering issues should be covered in regular “toolbox” talks with all staff members. Portable toilet facilities are available on site for male and female construction workers.

2021.02.10 – A litter bin is located in the site camp

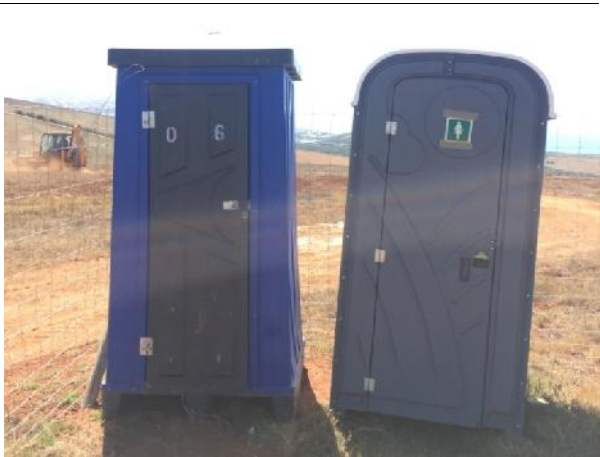
2021.02.10 – On-site ablution facilities

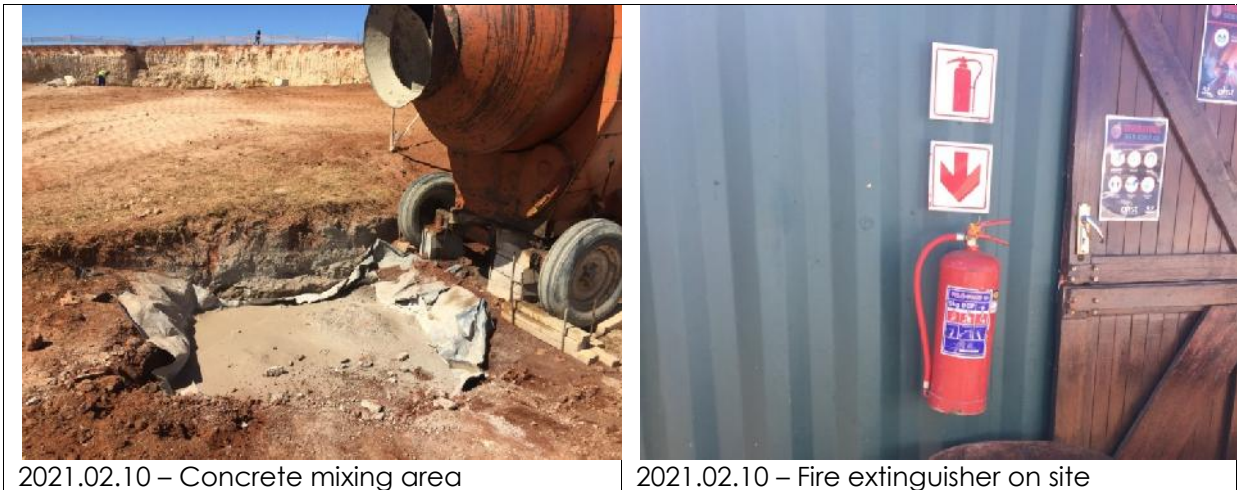
A bunded concrete mixing area, which is lined with a non-permeable layer, was created for small patchwork. The contractor should ensure that the contaminated runoff water is always contained and disposed of at an authorised disposal facility. Major works will be done with Ready-mix concrete – please note that the Ready-mix trucks are not allowed to rinse out anywhere on site.

2021.02.10 – Concrete mixing area

2021.02.10 – Fire extinguisher on site
