## THE CONSTRUCTION OF RESERVOIR FOR MOSSEL BAY AREA ON THE FARM VAALE VALLEY 219, MOSSEL BAY ENVIRONMENTAL MONITORING REPORT NO. 3

**THE CONSTRUCTION OF RESERVOIR FOR MOSSEL BAY AREA ON THE FARM VAALE  
VALLEY 219, MOSSEL BAY**

ENVIRONMENTAL MONITORING REPORT NO. 3 – 23 APRIL 2021

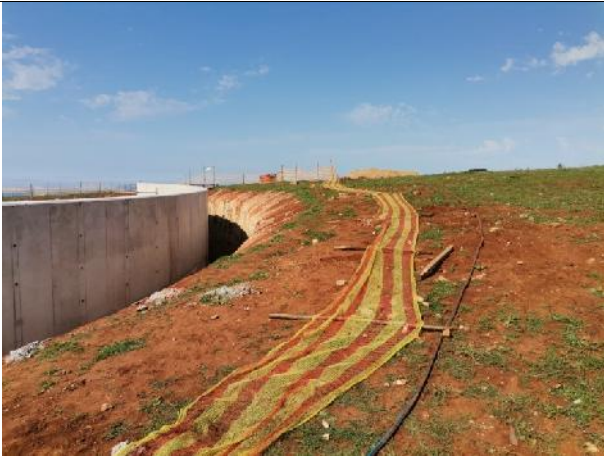
No-Go demarcation is in place. It was noted that the current orange netting at the top excavation area is not sturdy enough to prevent the cattle from pushing it over. It was discussed during the previous site meeting that a stronger, more stable fence be installed to prevent the cattle from entering the excavation/construction area.

2021.04.21 – The No-Go demarcation around the excavation area is removed during the day. The fence MUST be in place during inactive construction periods.

The contractor should ensure that the construction site (excavation area) is demarcated appropriately to prevent the farm animals from entering the site. Regular litter picking must be continued. A small soil berm (or suitable alternative) must be created to prevent any run-off cement contaminated water from flowing into the agricultural fields.

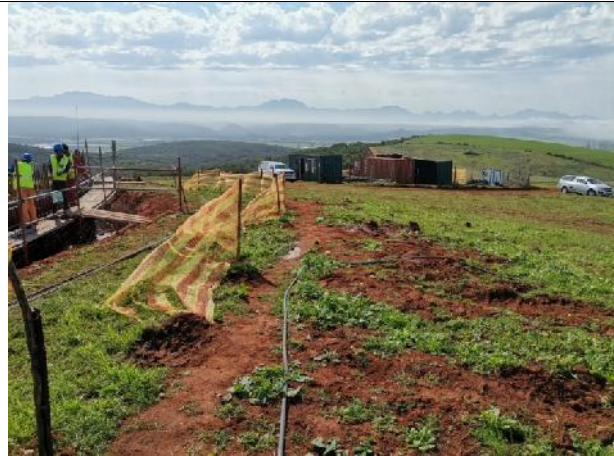
2021.04.21 – The orange netting is only installed on the southern edge.

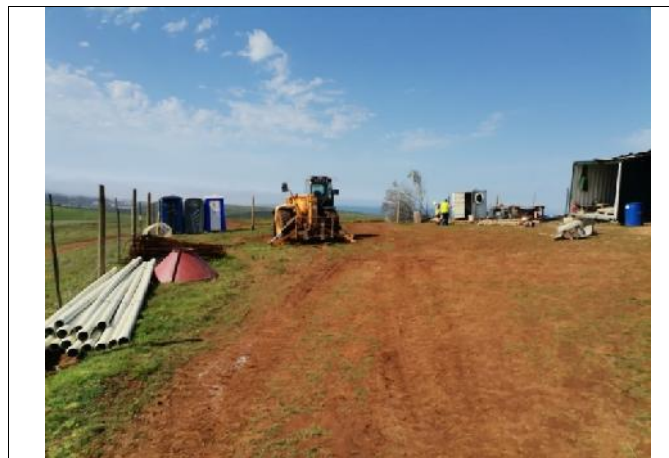
The site camp is fenced off correctly and set up in an area that is not within or adjacent a sensitive natural area.

2021.04.21 – Site camp is kept neat and tidy

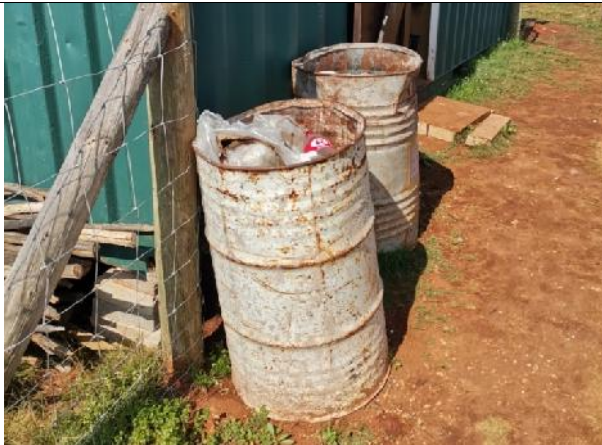
Adequate litter bins are provided at the site camp and littering issues should be covered in regular “toolbox” talks with all staff members. The concerns regarding the scattered cigarette butts and litter have been addressed in the Environmental Induction and there were no litter or cigarette butts noted during this inspection. It is still suggested that the contractor create separate suitable containers for cigarette butts or a designated smoking area with suitable bins.

| <p>2021.04.21 – The litter bins are located at the site office.</p> | <p>2021.04.21 – On-site ablution facilities.</p> |

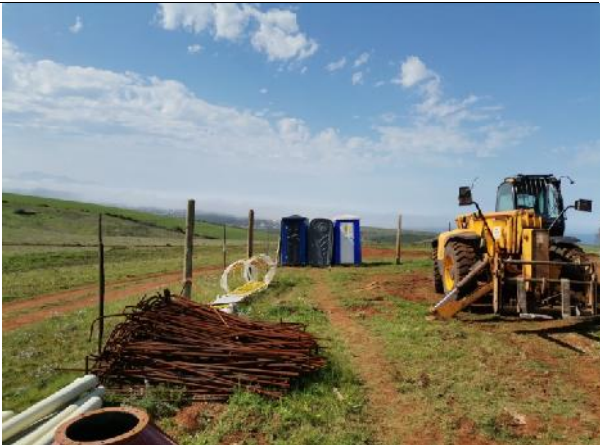
Portable toilet facilities are available on site for male and female construction workers.

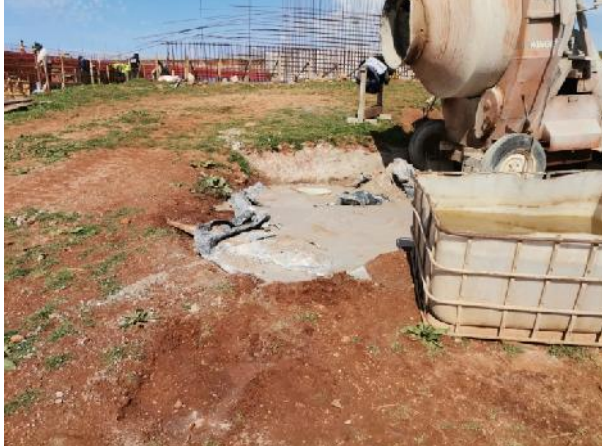
A bunded concrete mixing area, which is lined with a non-permeable layer, was created for small patchwork. The contractor should ensure that the contaminated runoff water is always contained and disposed of at an authorised disposal facility. Major works will be done with Ready-mix concrete – **please note that the Ready-mix trucks are not allowed to rinse out anywhere on site.**

| <p>2021.04.21 – The concrete mixing area is contained.</p> | <p>2021.04.21 – The cement run-off water must be contained by a creating a small berm below the opening.</p> |

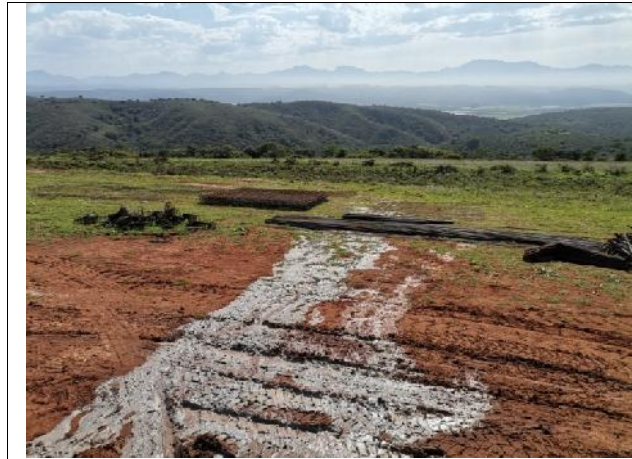
2021.04.21 – The cement run-off water MUST be prevented from flowing into the agricultural fields and natural vegetated area.

**A small bunding wall (with sandbags or soil) must be created to prevent the cement contaminated run-off water from flowing into the agricultural field. The contaminated area must be rehabilitated – please note that all construction rubble must be disposed of at an authorised disposal site, no burring of waste is allowed.**
