## THE CONSTRUCTION OF RESERVOIR FOR MOSSEL BAY AREA ON THE FARM VAALE VALLEY 219, MOSSEL BAY ENVIRONMENTAL MONITORING REPORT NO. 4

**MOS21/472/29**

ENVIRONMENTAL MONITORING REPORT NO. 4 – 20 MAY 2021

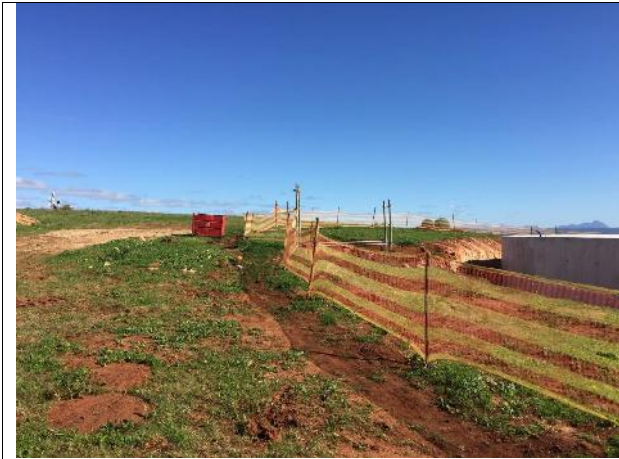
2021.05.12 – The demarcation around the excavation area is in place. The fence **MUST** be in place during inactive construction periods.

No-Go demarcation is in place. It was noted that the current orange netting at the top excavation area is not sturdy enough to prevent the cattle from pushing it over. It was discussed during a site meeting that a stronger, more stable fence be installed to prevent the cattle from entering the excavation/construction area. The ECO monitors maintenance and adherence to the demarcation during site inspections.

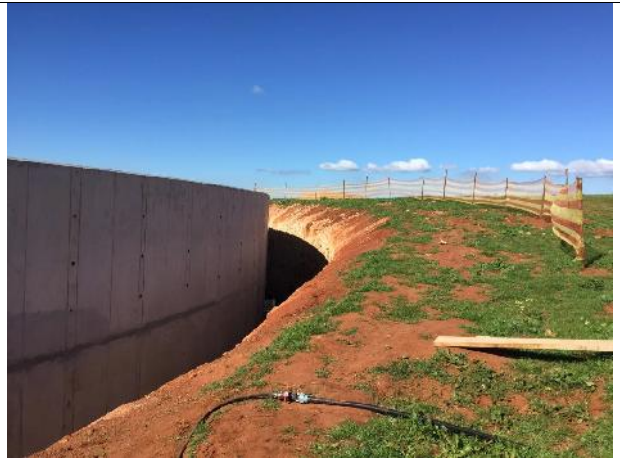
2021.05.12 – The orange netting is only installed on the southern edge; cattle can still enter the construction site where there is deep excavation.

The contractor should ensure that the construction site (excavation area) is demarcated appropriately to prevent the farm animals from entering the site. Regular litter picking is done, and the site was neat and tidy during ECO inspection.

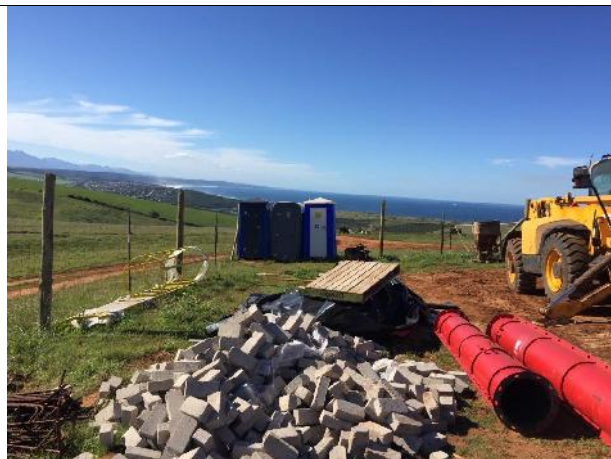
2021.05.12 – Site camp is kept neat and tidy.

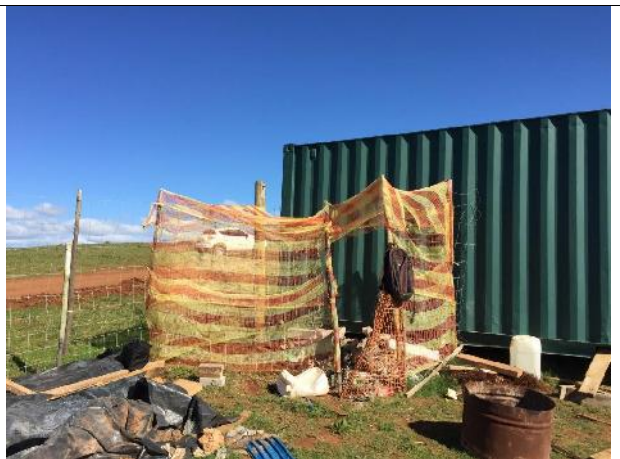
2021.05.12 – Enclosed litter disposal area is available in the site camp.

Adequate litter bins are provided at the site camp and littering issues should be covered in regular “toolbox” talks with all staff members. The contractor is now doing daily litter picking to keep the site neat and tidy.

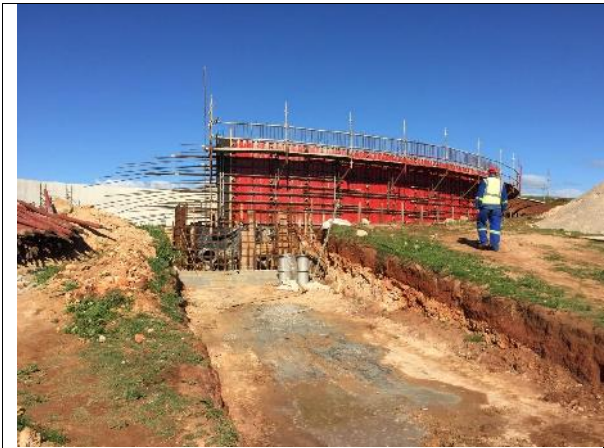
2021.05.12 – cement run-off water catch pit.

**The issue regarding cement contaminated run-off water was addressed and is now resolved. All contaminated soil was removed and a cement run-off water catch pit was created.**

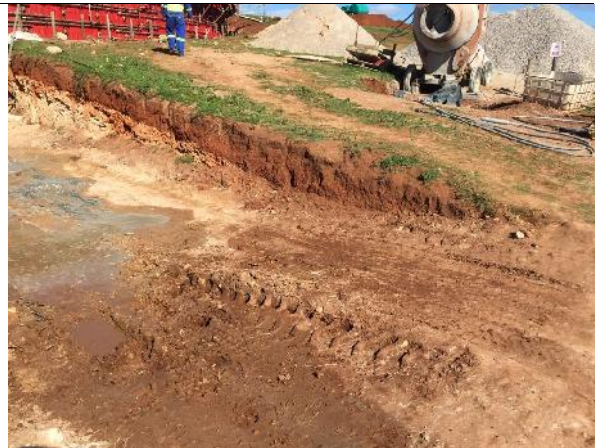
2021.05.12 – cement run-off water catch pit.

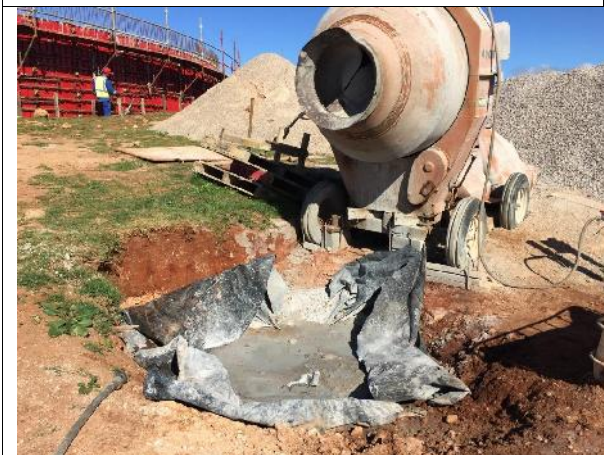
2021.05.12 – The concrete mixing area is contained.

A bunded concrete mixing area, which is lined with a non-permeable layer, was created for small patchwork. The contractor should ensure that the contaminated runoff water is always contained and disposed of at an authorised disposal facility.

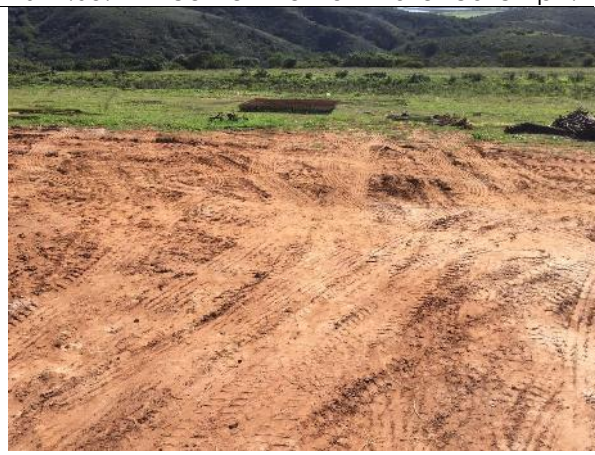
2021.05.12 – Cement run-off water was removed.
