## THE CONSTRUCTION OF RESERVOIR AND ASSOCIATED INFRASTRUCTURE FOR MOSSEL BAY AREA ON THE FARM VAALE VALLEY 219, MOSSEL BAY

### FINAL ENVIRONMENTAL MONITORING REPORT

**TDR69/2020/2021 (RESERVOIR) & TDR70/2020/2021 (PUMP STATION)**

COMPLETION ENVIRONMENTAL REPORT – JUNE 2022

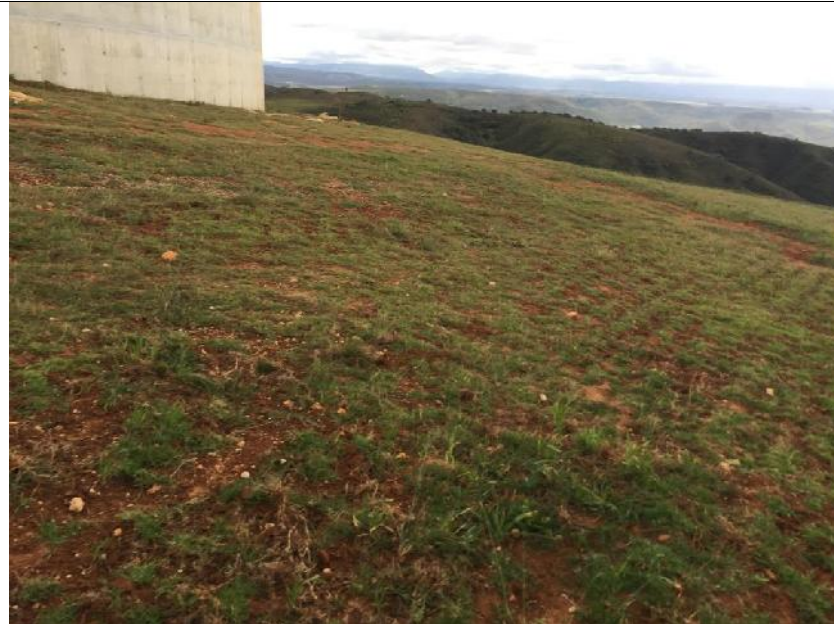
Compacted soil was loosened, and grass is growing

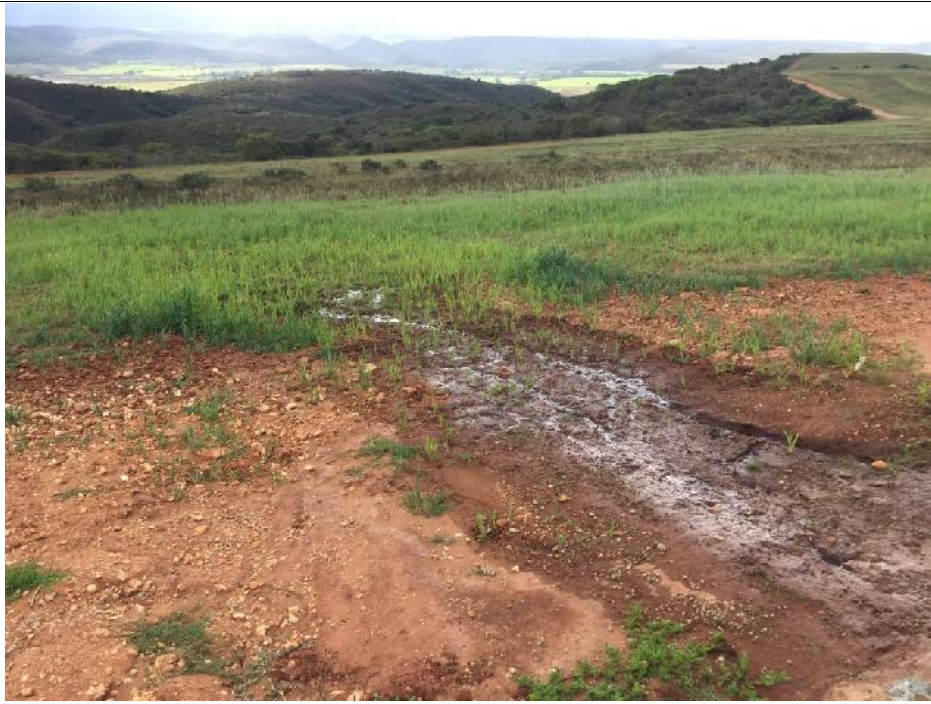
A series of small soil berms is required below the outlet structure to prevent soil erosion.

Additional erosion protection below the outlet structure is required – a small series of small soil berms seeded with the indigenous grass seed mixture described above.

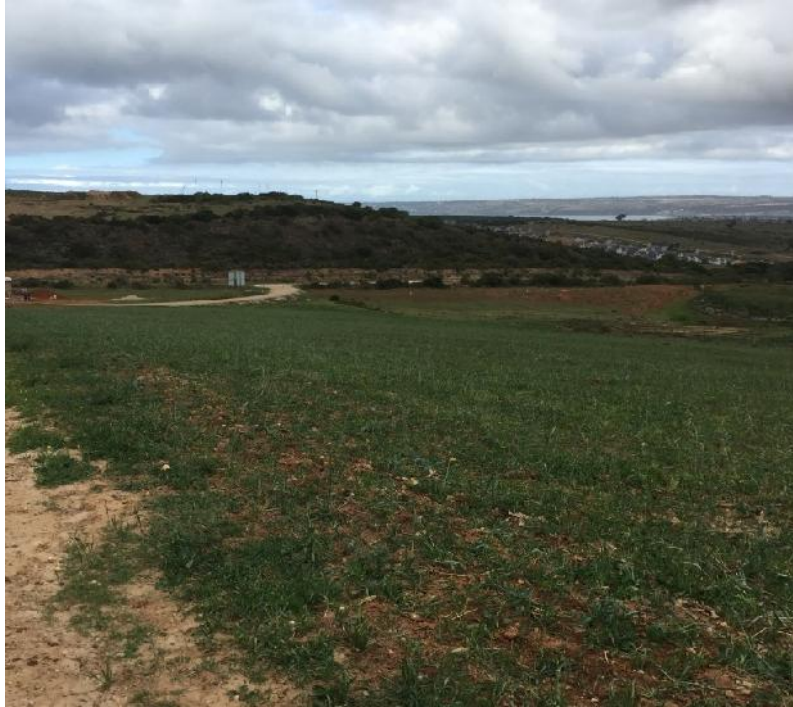
The rising main pipeline (disturbance area) has recovered to the satisfaction of the ECO.

Rising main pipeline is rehabilitated to the satisfaction of the ECO
