### THE CONSTRUCTION OF GRAVITY FEED PIPELINES ON THE FARM VAALE VALLEY 219, MOSSEL BAY

### ENVIRONMENTAL MONITORING REPORT FOR SEPTEMBER 2024

This report monitors compliance against the Environmental Management Plan (Ref: MOS23/472/02 – dated 20 July 2023) and it constitutes the sixth Environmental Monitoring Report for the project (TDR14/2023/2024) which covers all work undertaken as part of the construction of the new gravity feed pipeline(s) on the Farm Vaale Valley No. 219, Mossel Bay Municipality.

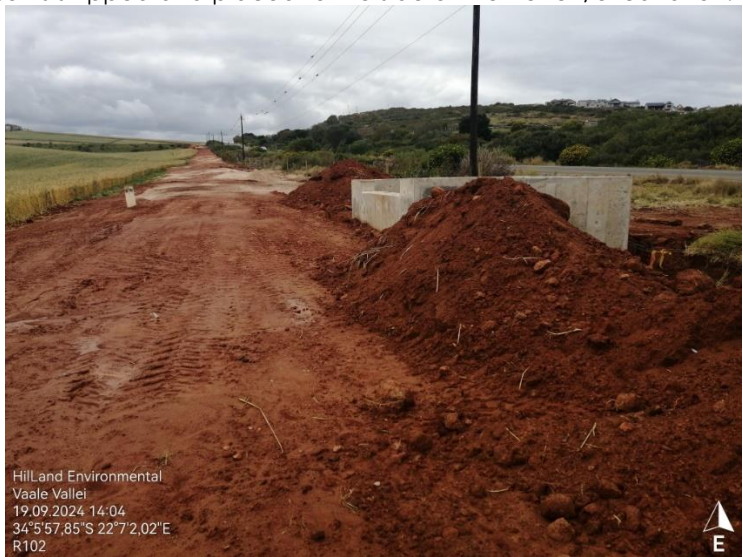
| Section | | Yes | No | Not yet necessary | Comments and Photos (if applicable) |
|---|---|---|---|---|---|
| 6.1.3 | Topsoil must be stripped from all construction areas <b><u>before work commences in that specific area</u></b> and stockpiled at an area approved by the ECO. | Yes | | | Topsoil is stripped and placed to the side of the trench/excavation.<br> <p>HillLand Environmental<br/>Vaale Valley<br/>19.09.2024 14:04<br/>34°5'57,85"S 22°7'2,02"E<br/>R102</p> |

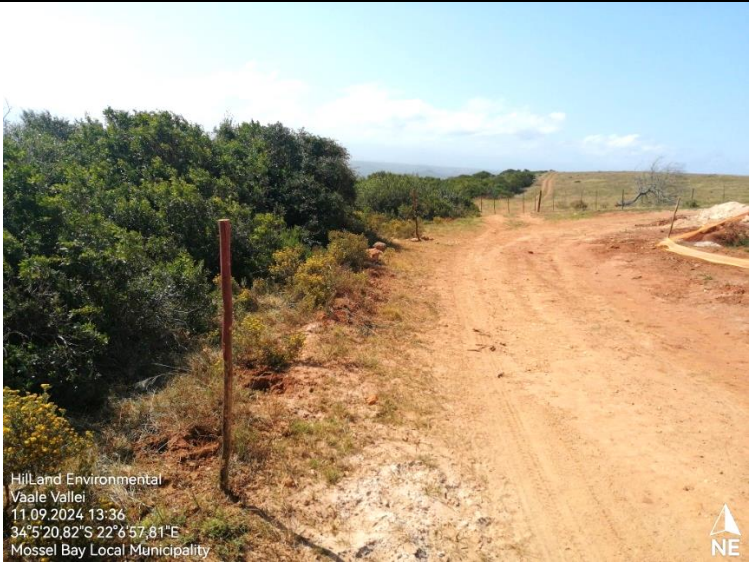
| 6.2.1 | The construction area must be demarcated, any encroachment | <b>Yes</b> | | | The construction area and the No-Go vegetation areas are demarcated. |

| | into agricultural or sensitive vegetation areas is prohibited. | | | | <p>HillLand Environmental<br/>Vaale Vallei<br/>11.09.2024 13:36<br/>34°5'20,82"S 22°6'57,81"E<br/>Mossel Bay Local Municipality</p> <p>NE</p> |

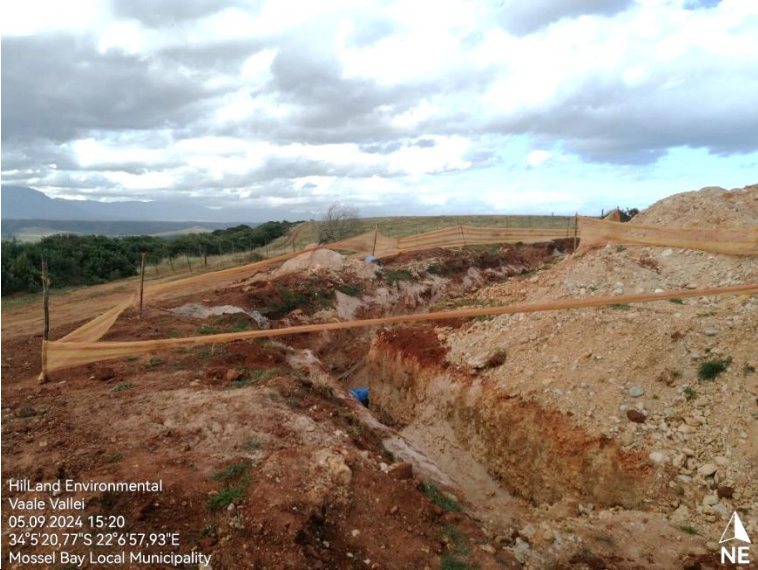
| | All topsoil must be stripped from the area required and stockpiled in the site camp for later use in rehabilitation. | Yes | | | <p>Trenches - Topsoil has been stripped and stockpiled along the side of the trench.<br/>No environmental issues noted.</p> <p>HillLand Environmental<br/>Vaale Vallei<br/>05.09.2024 15:20<br/>34°5'20,77"S 22°6'57,93"E<br/>Mossel Bay Local Municipality</p> <p>NE</p> |

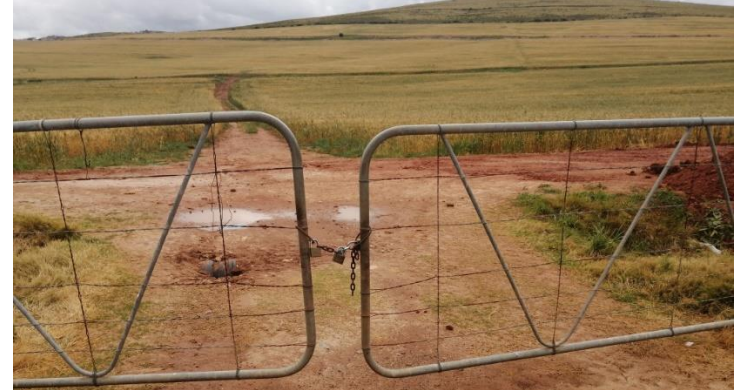
| 6.2.3 | <b><u>Access to the Site</u></b><br>No unauthorized access to the site permitted – gate to be kept closed at all times. | <b>Yes</b> | | | Farm gate is kept locked and closed. All visitors are required to sign in at the site office.<br><br><small>HillLand Environmental<br/>Vaale Valley<br/>19.09.2024 14:03<br/>34°58.29'S 22°7'1.97"E<br/>R102</small><br> |

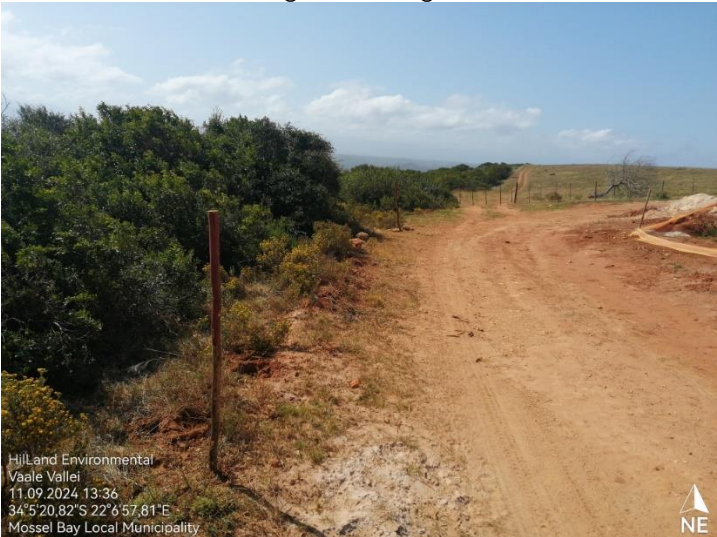
| | Construction vehicles to use existing access routes or if not available can only use one route per site to minimize the potential environmental impact. These access routes must be confirmed prior to construction with the appointed ECO. | <b>Yes</b> | | | Construction vehicles are using the existing farm tracks.<br> |

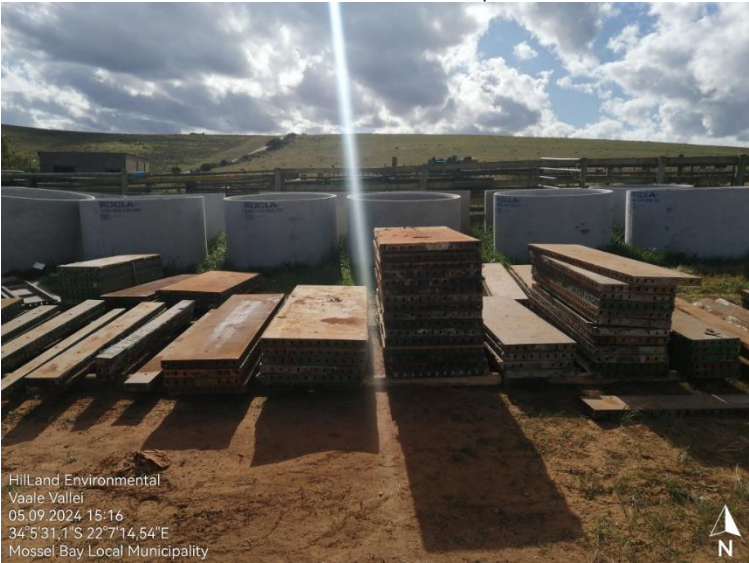
| | <p>Storage sites for construction material and access must be approved by the ECO prior to commencing (and areas will require rehabilitation after use).</p> | <p>Yes</p> | | <p>Construction material is stored in the site camp.</p> <p>HillLand Environmental<br/>Vaale Valley<br/>05.09.2024 15:16<br/>34°5'31.1"S 22°7'14.54"E<br/>Mossel Bay Local Municipality</p> |

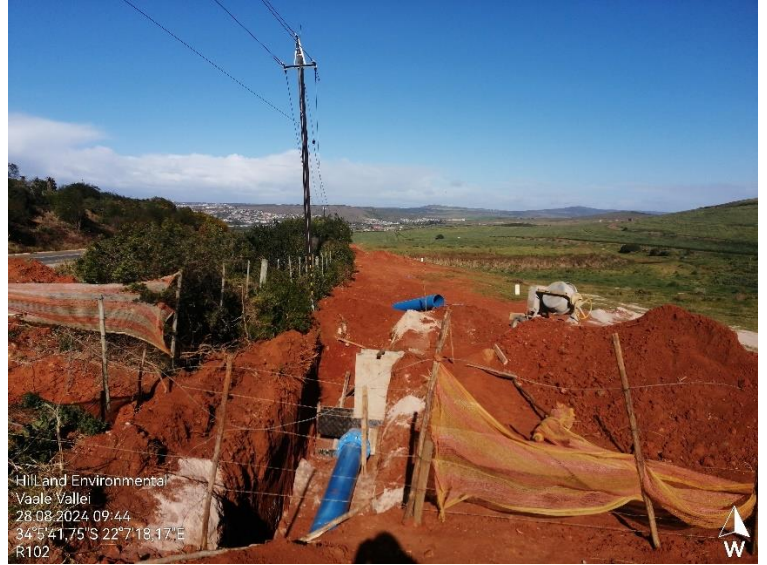
| | Methods of demarcation will be agreed with the ECO and can include danger tape, rope, fencing, shade cloth, wire fencing etc. | Yes | | | <p>The site and open trenches/excavations are being demarcated with droppers and orange netting.</p> <p>Hilland Environmental<br/>Vaale Valley<br/>28-08-2024 09:44<br/>34°54'1.75"S 22°7'18.17"E<br/>R102</p> |

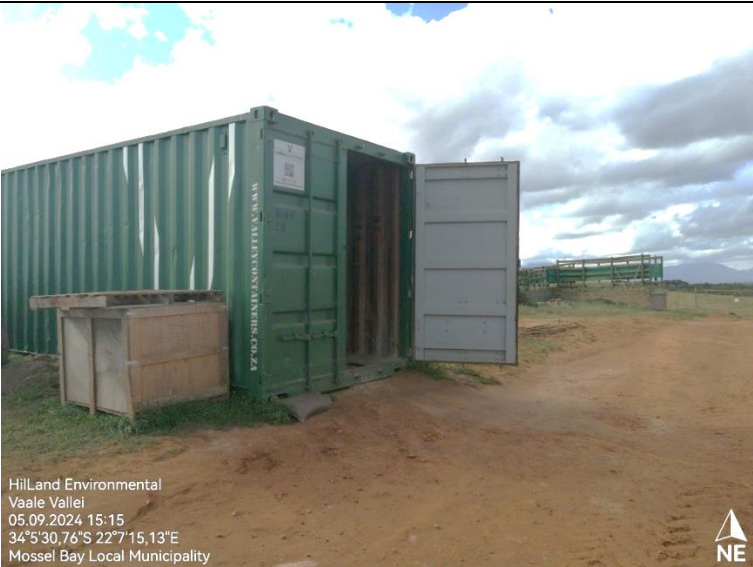
| 6.2.7 | <p><b><u>Construction site camp</u></b></p> <p>The contractors' site camp is to be set up in the area indicated and approved by the ECO for this purpose.</p> | Yes | | | As per the approved method statement. |

| | | | | | <p>HillLand Environmental<br/>Vaale Valley<br/>05.09.2024 15:15<br/>34°5'30,76"S 22°7'15,13"E<br/>Mossel Bay Local Municipality</p> <p>NE</p> |

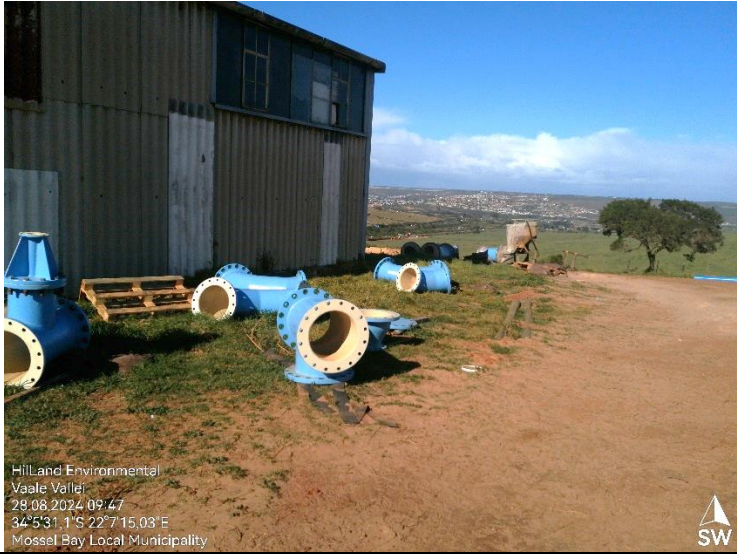
| | The contractors' site camp, offices and storage facilities shall not be located within or adjacent to an environmentally sensitive area. | Yes | | | <p>As per the approved method statement, next to the existing farm shed/store.</p> <p>HillLand Environmental<br/>Vaale Valley<br/>28.08.2024 09:47<br/>34°5'31,1"S 22°7'15,03"E<br/>Mossel Bay Local Municipality</p> <p>SW</p> |

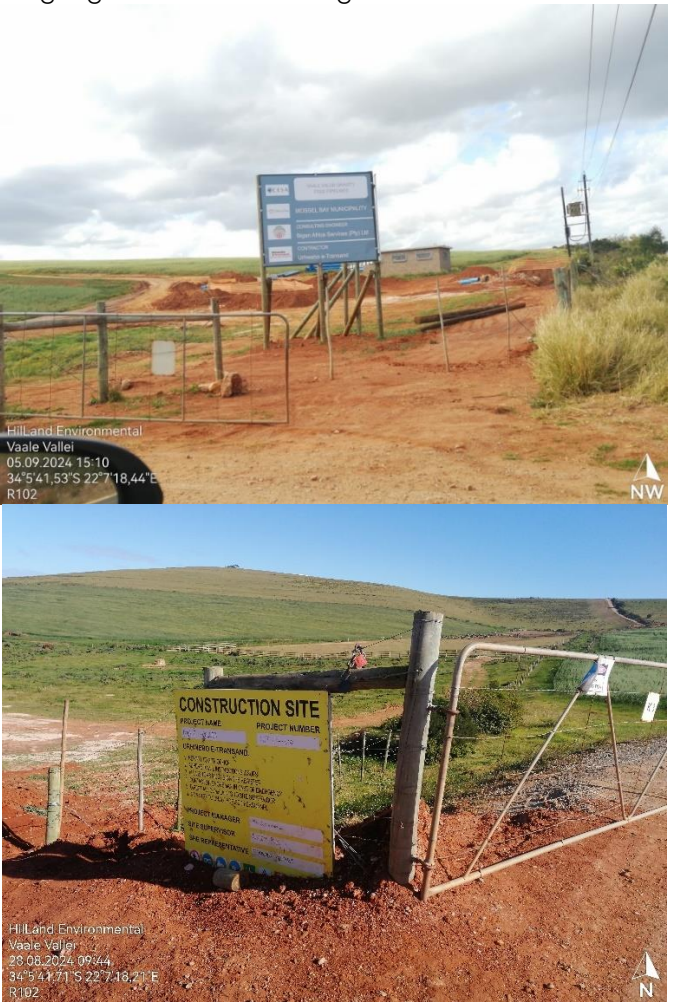
| | Adequate signage must be erected at the main entrance to the construction site to ensure that safety regulations are adhered to. | <b>Yes</b> | | | <p>As per the approved method statement – no environmental issues to report.</p> <p>Sufficient signage is at the entrance gate to the site.</p> |

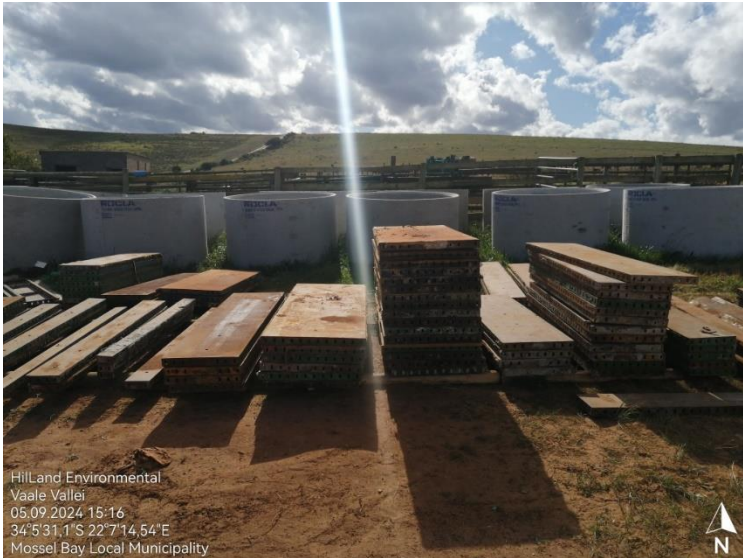
| 6.2.8 | <p><b><u>Storage of construction material</u></b><br/>All stockpile sites to be approved by the ECO <b>prior</b> to the commencement of stockpiling.</p> | Yes | | | <p>As per the approved method statement, stockpiling within the site camp.</p> <p>HilLand Environmental<br/>Vaale Valley<br/>05.09.2024 15:16<br/>34°5'31.1"S 22°7'14.54"E<br/>Mossel Bay Local Municipality</p> |

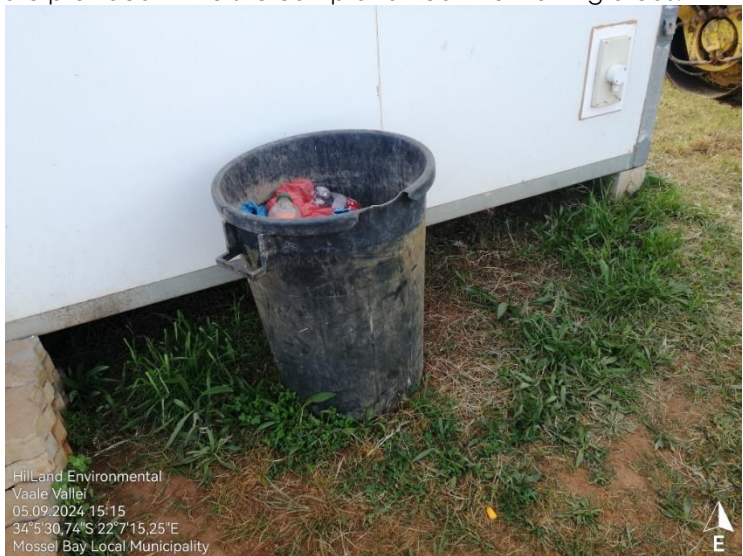
| | The contractor shall ensure that the site is maintained in a <b>neat and tidy</b> condition and kept <b>free of litter (including the adjacent open space area)</b> . At all places of work, the contractor shall provide <b>litter bins, containers and refuse collection facilities</b> for later disposal. Litter to be removed from the site on a <b>daily</b> basis. Rubbish bins must be provided on-site and regularly cleaned / emptied. | <b>Yes</b> | | | <p>Bins are provided in the site camp and near the working areas.</p> <p>HillLand Environmental<br/>Vaalre Vlei<br/>05.09.2024 15:15<br/>34°5'30,74"S 22°7'15,25"E<br/>Mossel Bay Local Municipality</p> |

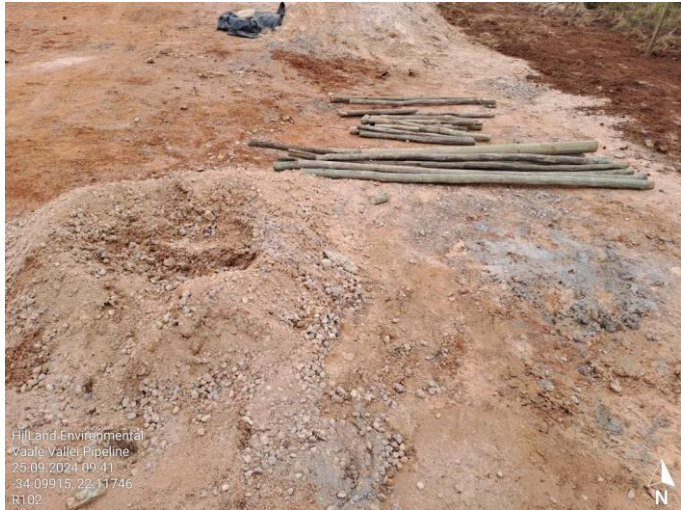
| | <b>Any concrete batching plant areas</b> are to be approved by the ECO prior to utilisation and must be equipped with suitable settling ponds and | | <b>No</b> | | Cement mixing areas directly on the topsoil must be cleaned and rehabilitated (remove and dispose contaminated topsoil and replace topsoil). |

| | trapping mechanisms to ensure that contaminated water does not leave the restricted area ( <b>Bunding</b> through the use of sandbag walls around any mixing areas is recommended). | | | | Cement mixing must be done on a non-permeable surface and must be suitable banded.<br> |

| | <b>Contaminated soil</b> from such bunds to be disposed of at the municipal waste disposal site | <b>Yes</b> | | | Cement mixing issue was reported to the contractor and the contaminated soil will be removed. |

Contaminated soil as a result of cement mixing directly on the soil must be removed and disposed of at an authorised disposal site and the areas must be rehabilitated. No other environmental issues were noted/recorded during this reporting period.

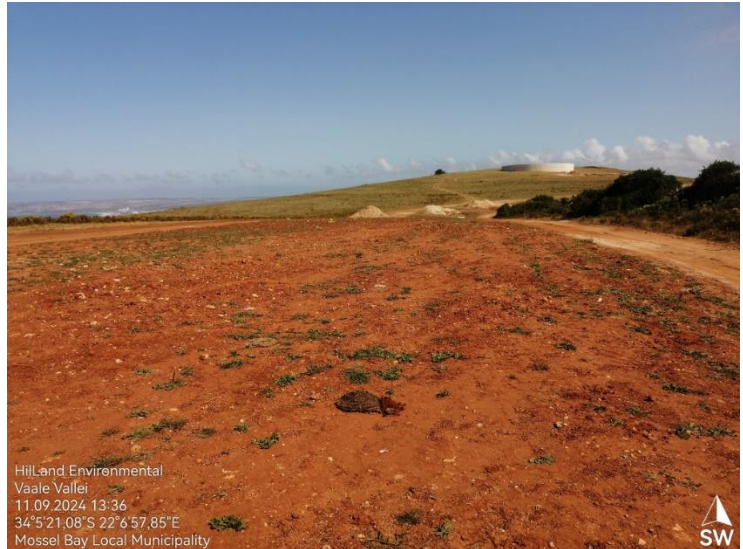
| | Compacted topsoil must be raked loose. | <b>Yes</b> | | | Sections of the pipeline route that are complete have been covered in topsoil and raked loose.<br> |
