## ANNEXURE A – SITE PHOTOGRAPHS

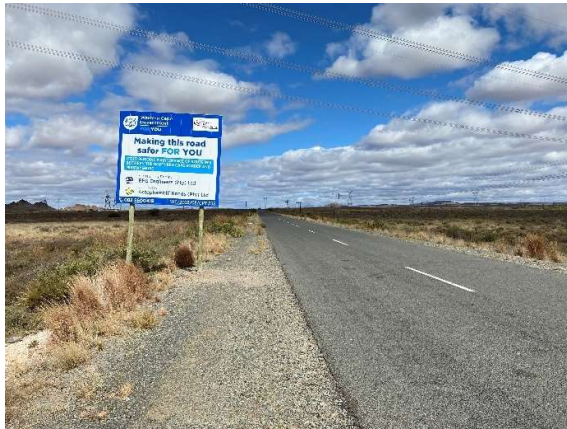
Construction information notice board placed at approximately Km 43.5 on TR 16/8.

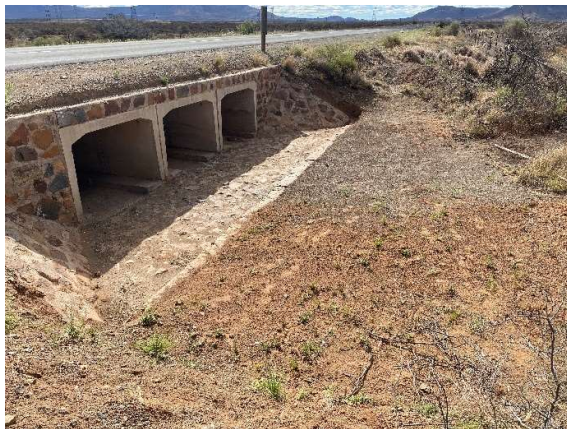
Culvert upgrading includes repaired concrete structures, stone-pitching, erosion control, and vegetation clearing.

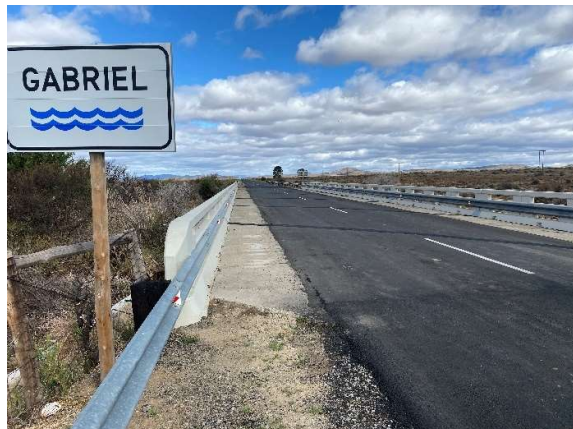
Newly installed guardrails at B4611 on TR16/8 at Km 46.11 (Gabriel Stream).

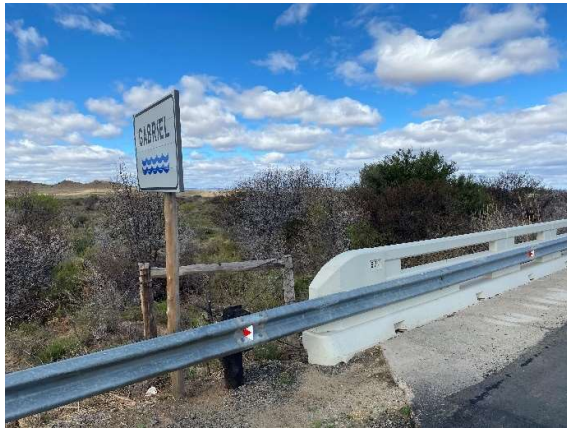
Condition of Gabriel River with newly installed guardrailings.

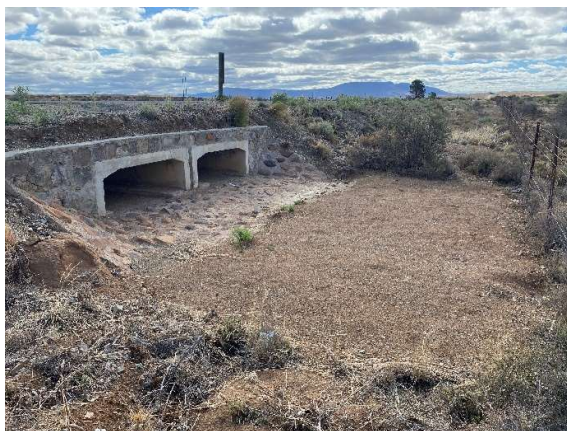
Km 46.75 on TR 16/8 with repaired concrete and stone-pitching, daylighting and vegetation clearance.

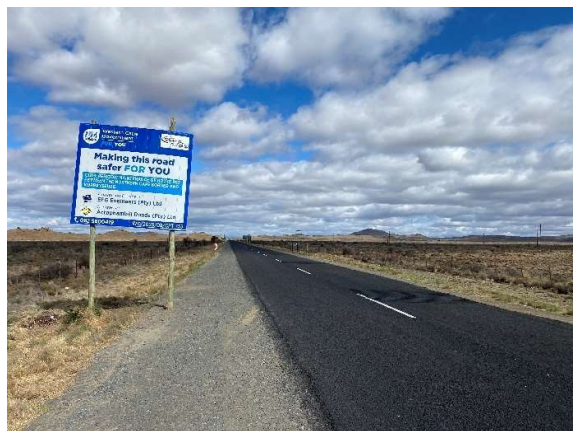
Construction information notice board placed at approximately Km 0.25 on TR 16/9.

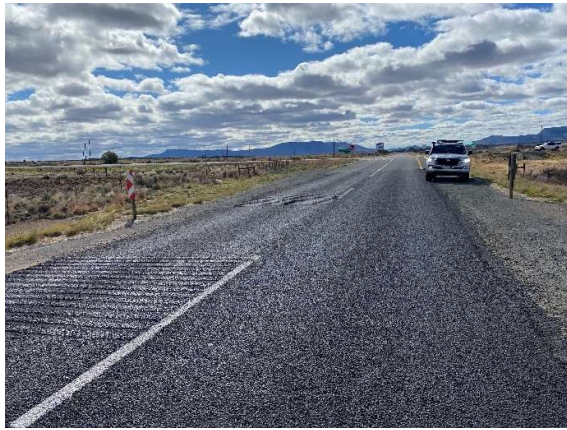
From approximately Km 0.25 on TR 16/9 showing the new road surface towards the northwest.

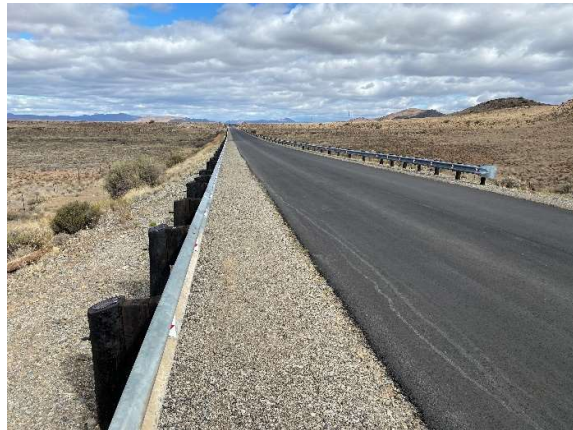
Newly installed guardrails along the TR 16/9 as seen towards the southeast.

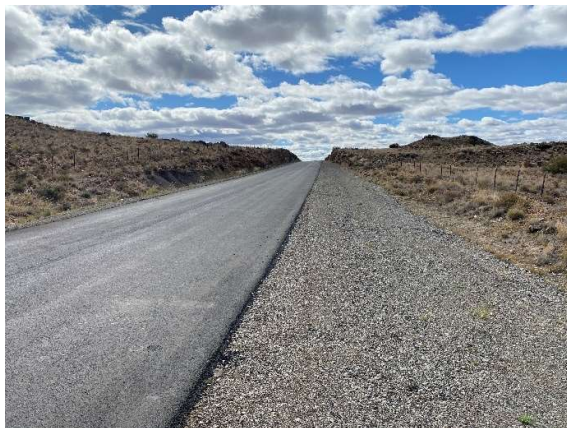
Condition of the road reserve along the TR 16/9 as seen towards the northwest.

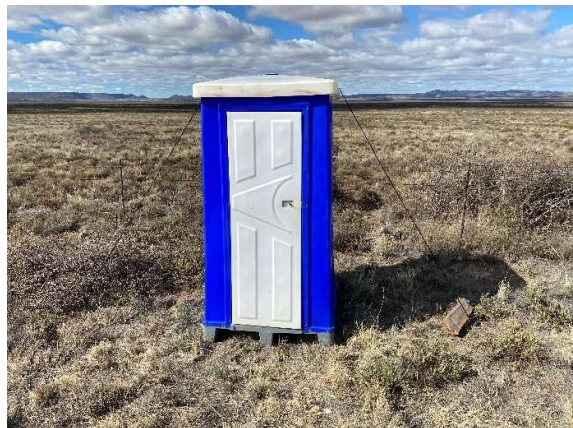
Secured chemical toilet in place on-site within the road reserve.

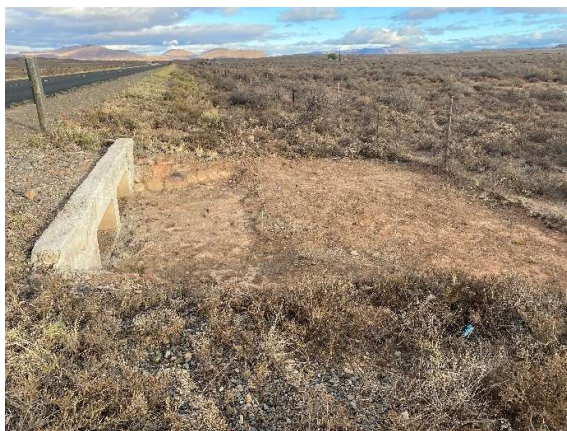
Culverts upgraded with new concrete structures, daylighting, and clearing of vegetation.

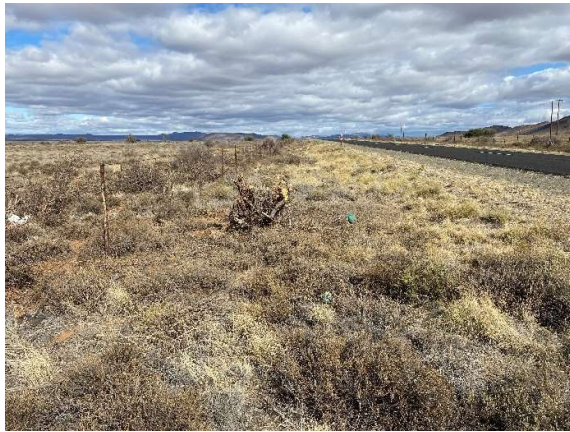
Condition of the road reserve along the route. Larger trees have been trimmed or removed.

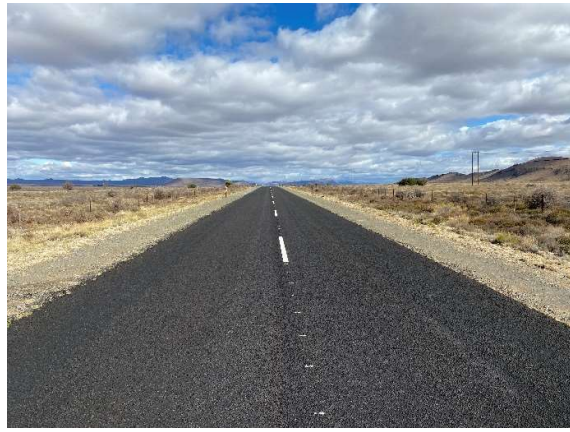
Condition of the road surface and the road reserve along the TR 16/9 as seen towards the southeast.

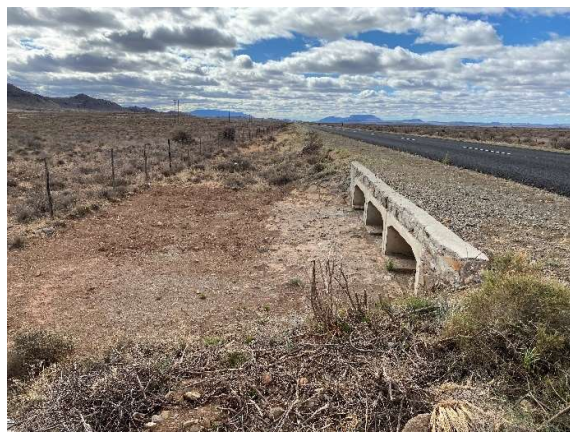
Culvert upgraded with repaired concrete and new stone-pitching, daylighting and vegetation clearance.

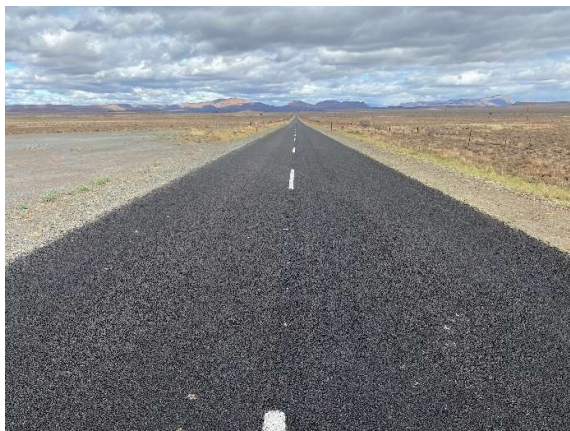
Condition of the new road surface and the cleared road reserve adjacent to stockpile area 2.

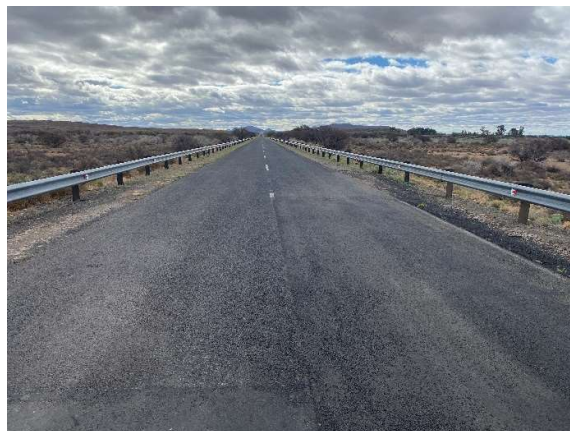
Condition of the new road surface and newly installed guardrails at Km17.36 along the TR 16/9.

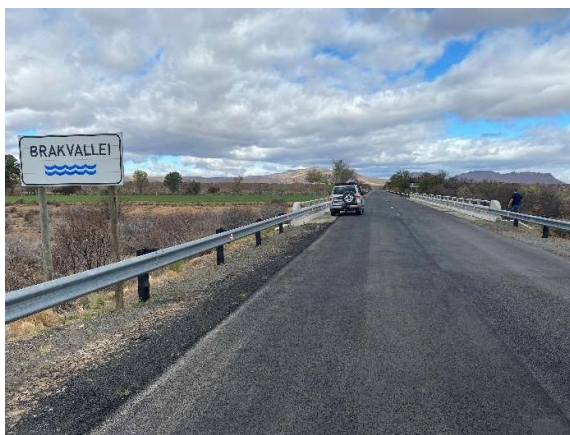
Condition of the new road surface and newly installed guardrails at Brakvallei River Bridge at Km 17.45.

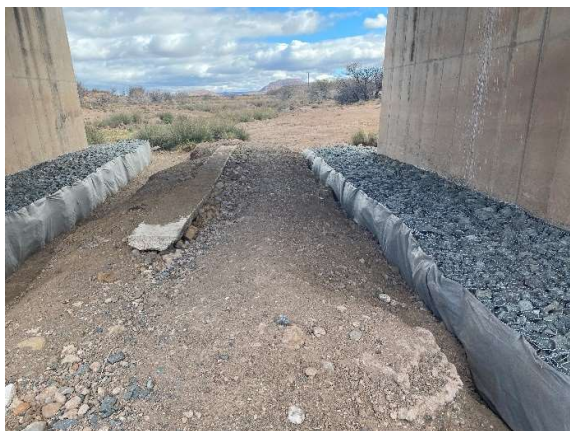
Below the Brakvallei River Bridge as seen towards the south.

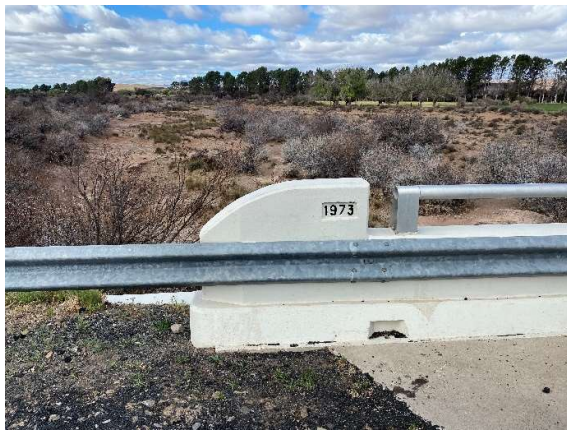
Numbering of the Brakvallei River bridge displays along the new precast concrete handrails.

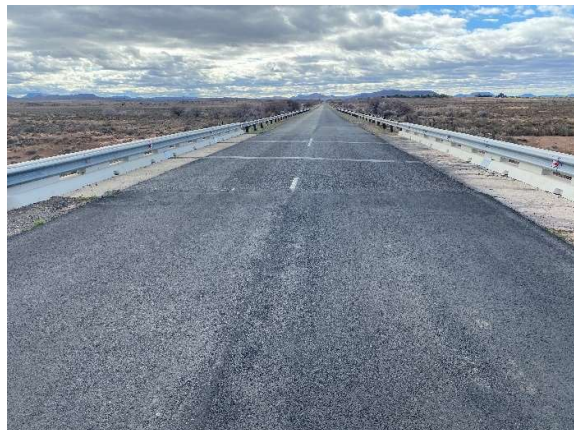
Condition of the completed Brakvallei River bridge road surface as seen towards the northwest.

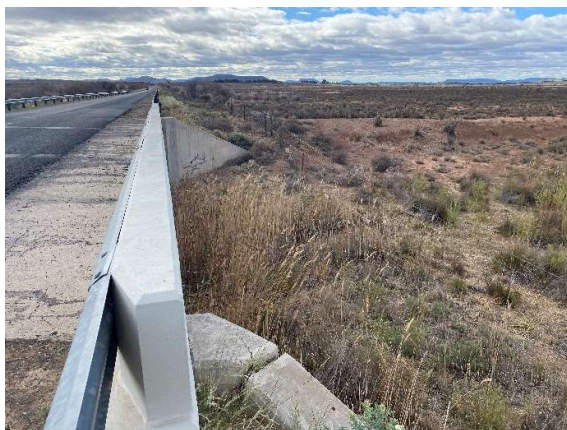
Upstream condition of the Brakvallei River bridge.

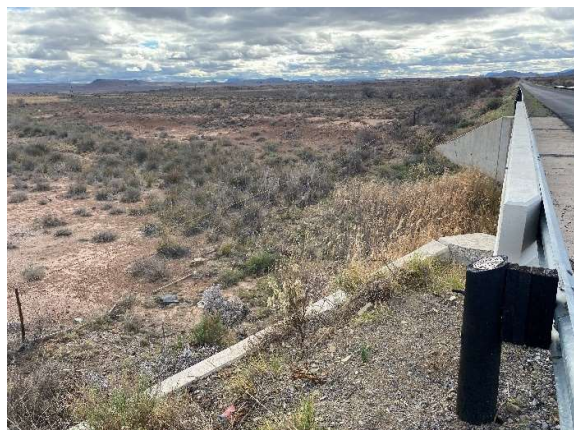
Downstream condition of the Brakvallei River bridge..

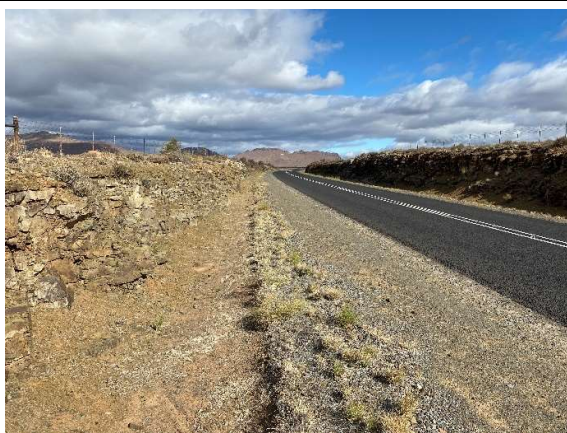
Cleared road reserve with stormwater drainage channels created at the road reserve shoulder along the TR 16/9.

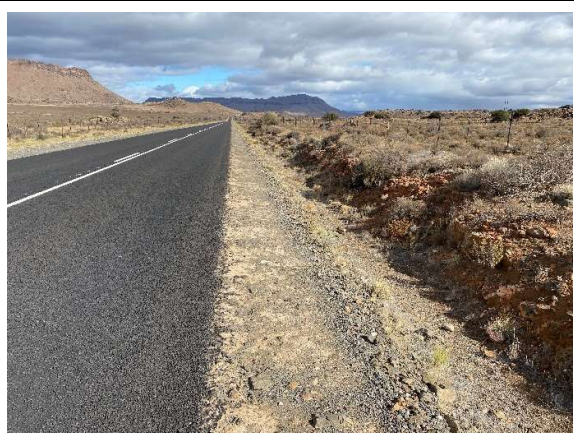
Cleared road reserve with stormwater drainage channels created at the road reserve shoulder along the TR 16/9.

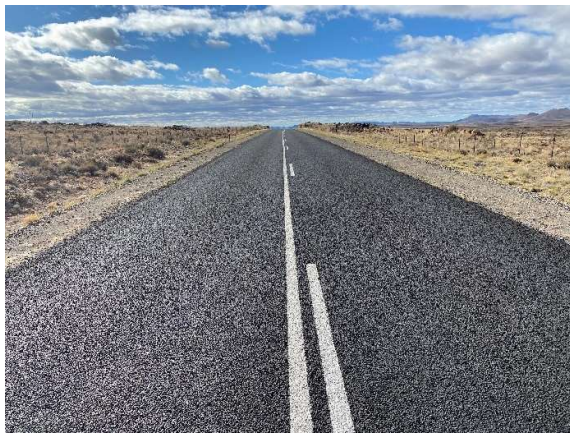
Condition of the new road surface and cleared road reserve along the TR 16/9.

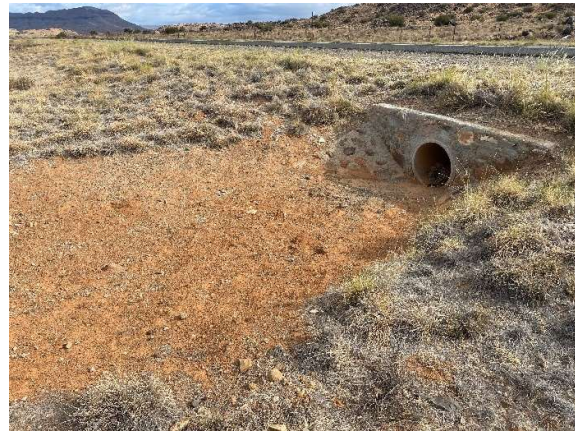
Culverts upgraded with new concrete repairs, daylighting, and clearing of vegetation.

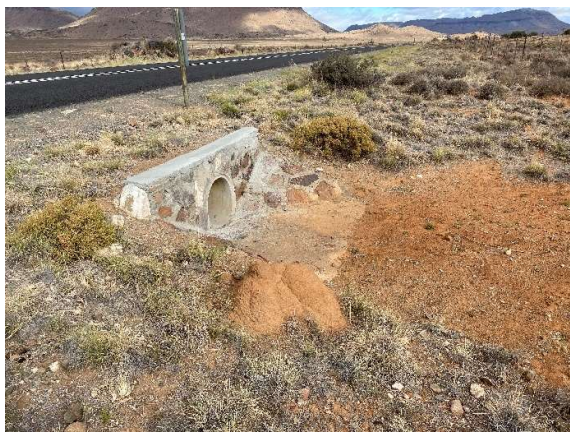
Culverts upgraded with new concrete repairs, daylighting, stone-pitching and clearing of vegetation.

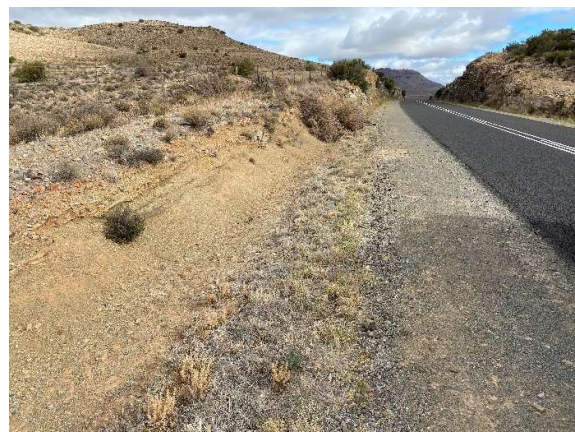
Stormwater drainage channel along the TR 16/9 at Km 24.9 of the road reserve along the route.

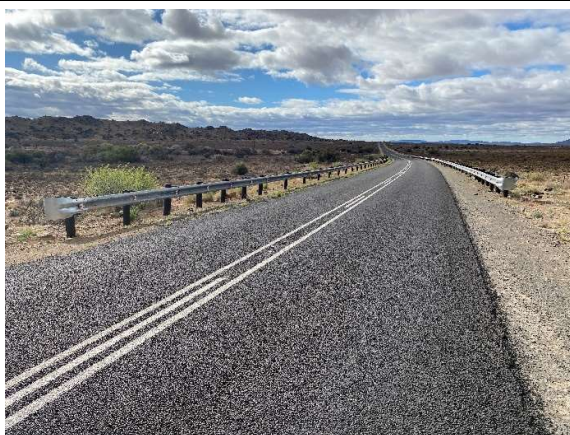
Condition of the new road surface and guardrails along the TR 16/9 at Km 25.2.

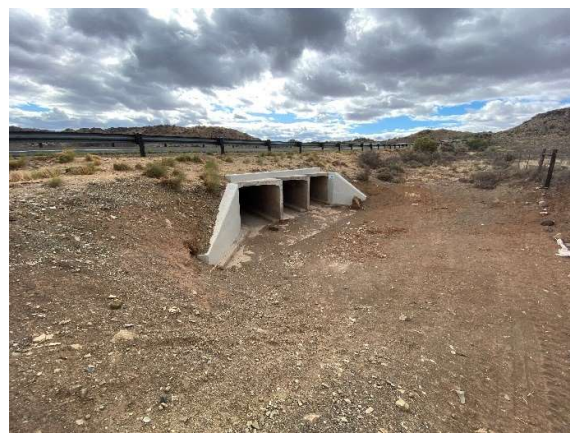
Upgraded box culvert with new concrete structures, erosion control, daylighting and clearing of vegetation.

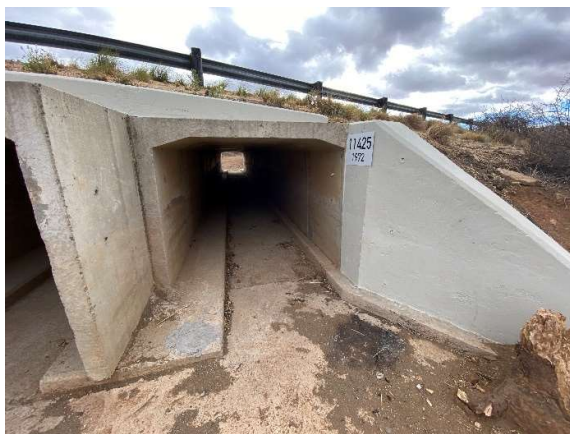
Culvert upgraded with concrete repairs apron slabs and cut off walls at culverts on inlet and crack repairs.

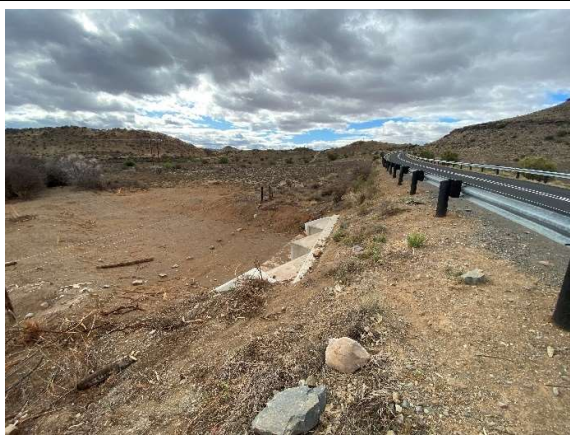
Downstream of box culvert with new concrete structures, erosion control, daylighting and clearing of vegetation.

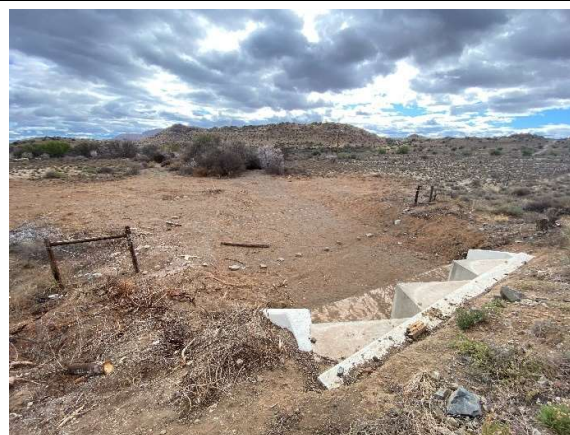
Downstream of box culvert shows daylighting required given the topography to prevent damming of water.

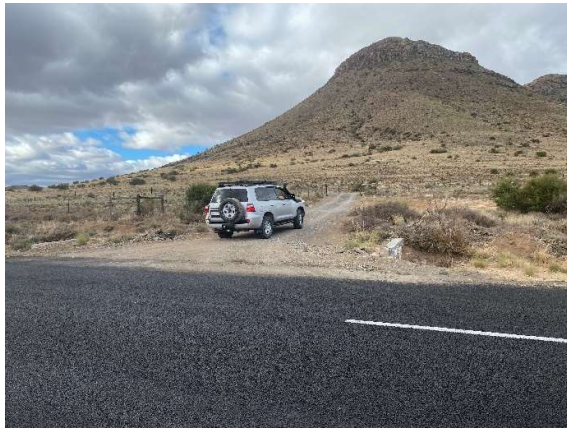
The entrance to the northern section of the gravel bypass road at km 26.56 along the TR16/9.

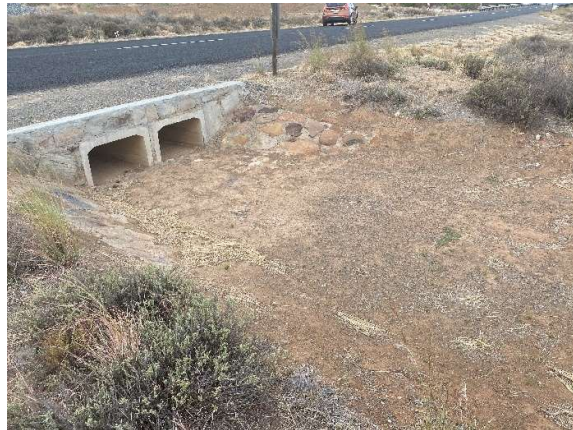
Culvert upgraded adjacent to the northern bypass road with repaired concrete structures and daylighting.

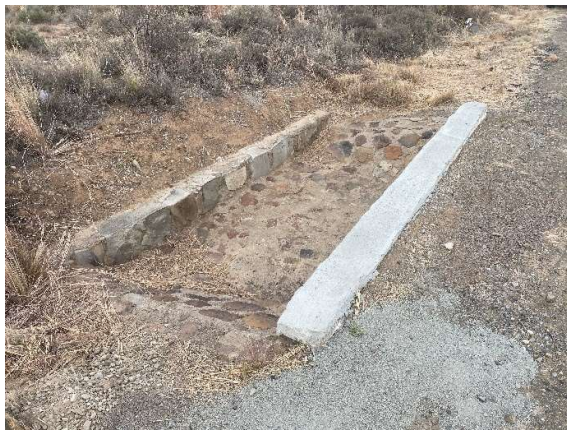
Culvert upgraded adjacent to the northern bypass road with repaired concrete and stone-pitching maintained.

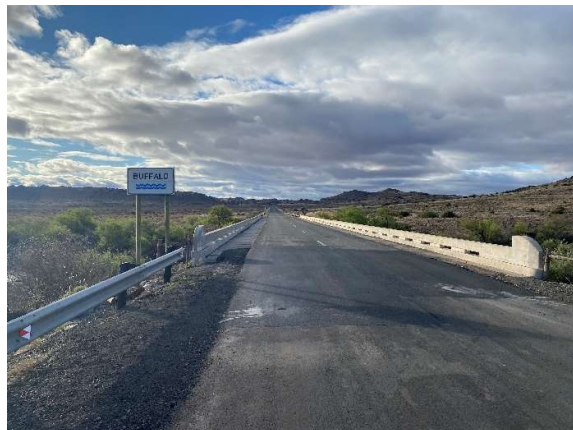
Current condition of the Buffalo River bridge at Km 26.94 along the TR16/9.

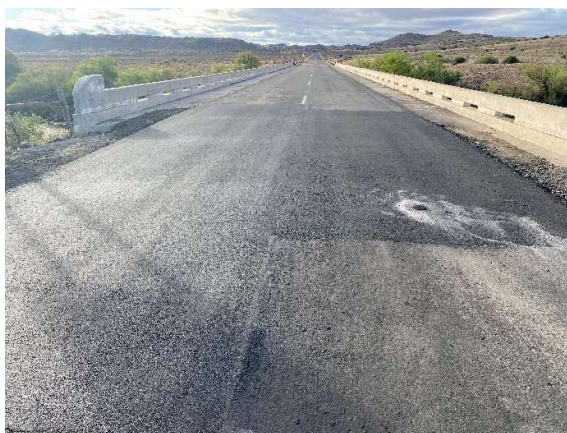
Current condition of the Buffalo River bridge at Km 26.94 along the TR16/9.

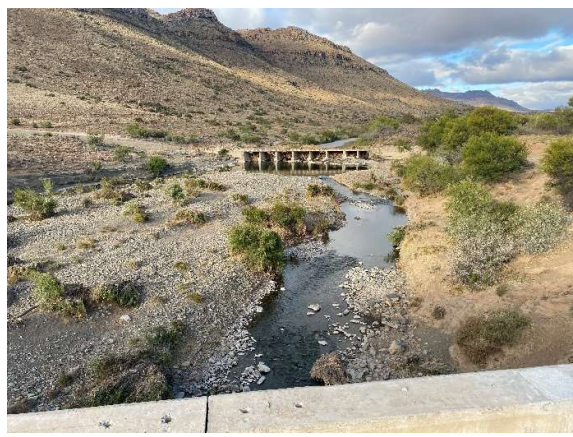
The old bridge upstream of the Buffalo River bridge as seen from the deck of the bridge towards the northeast.

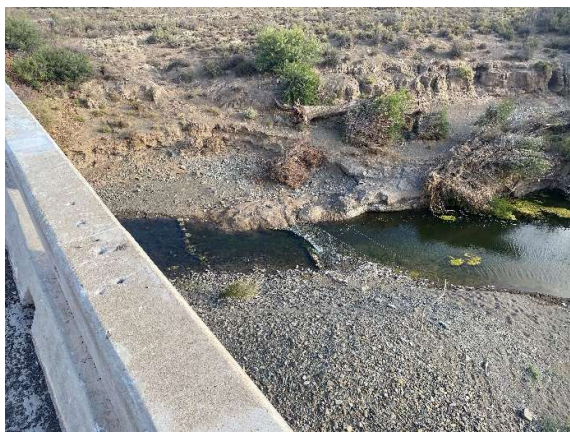
Downstream of the Buffalo River bridge as seen from the deck of the bridge.

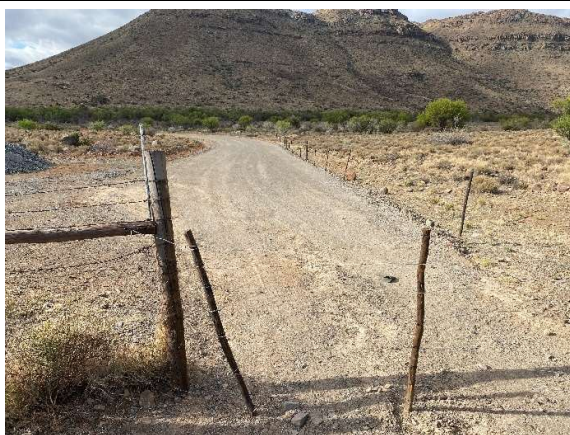
The southern offramp and entrance to the gravel bypass road which is to lead across Buffalo River.

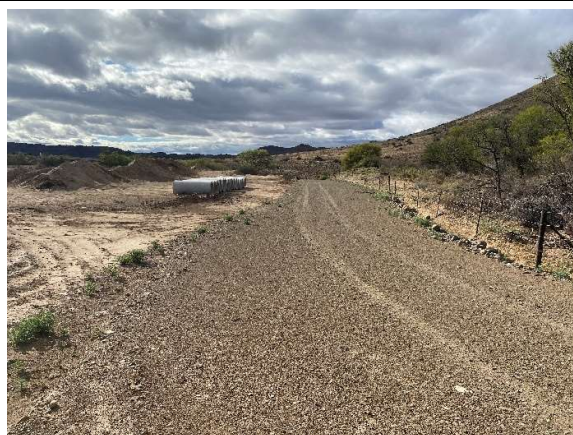
The southern gravel bypass road which is to lead across Buffalo River.

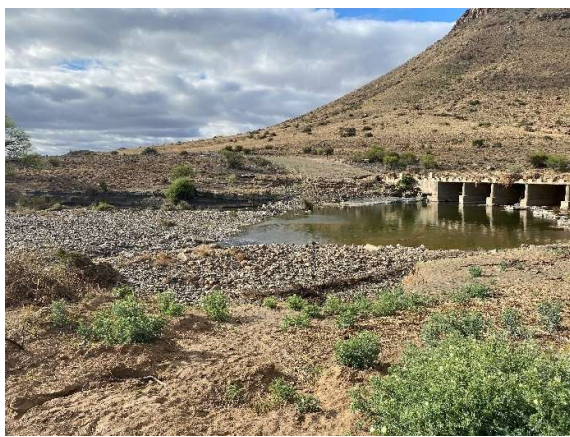
The location in the Buffalo River where the bypass will soon be constructed.

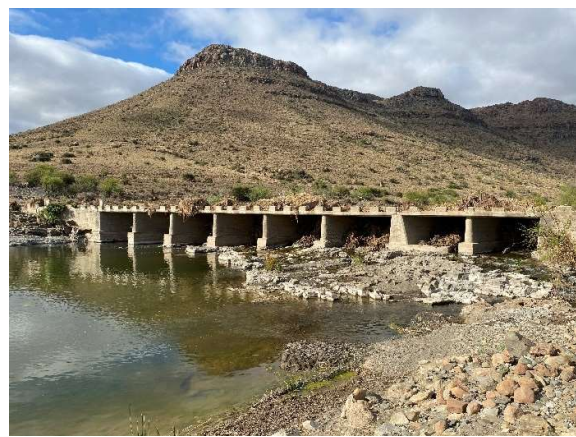
The old bridge which has been determined not safe for temporary traffic accommodation.

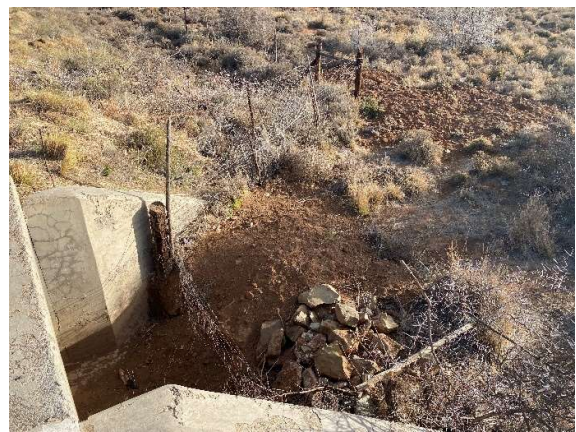
Culverts upgraded with concrete repairs, erosion control, and clearing of vegetation.

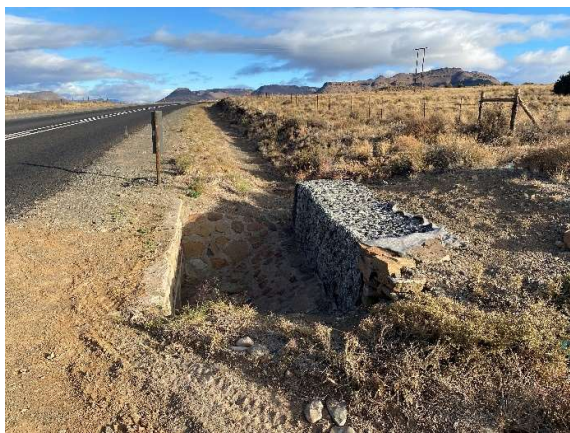
Box culvert to dissipate stormwater energy and channel towards existing culvert at km 27.29 along the TR16/9.

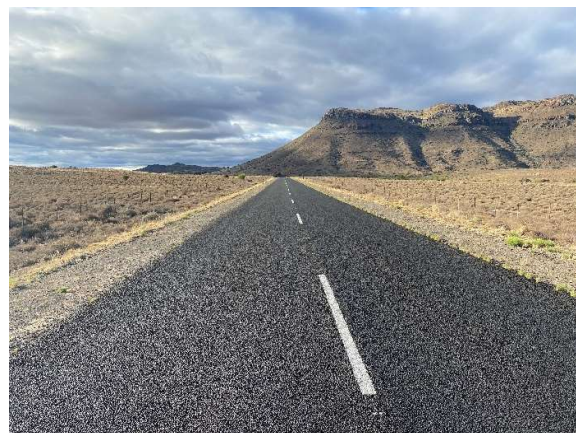
Condition of the new road surface and cleared road reserve at km 28.20 along the TR16/9.

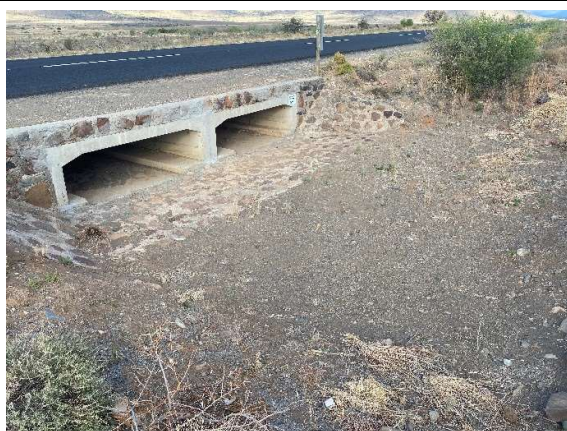
Culvert upgraded along the TR16/9 with repaired concrete and stone-pitching maintained.

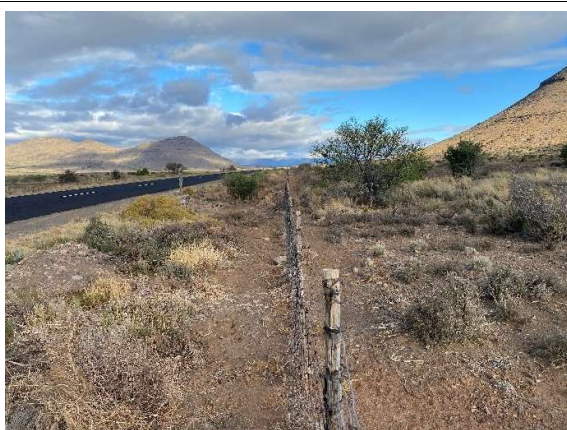
Cleared vegetation along the road reserve fence as firebreak condition along the route.

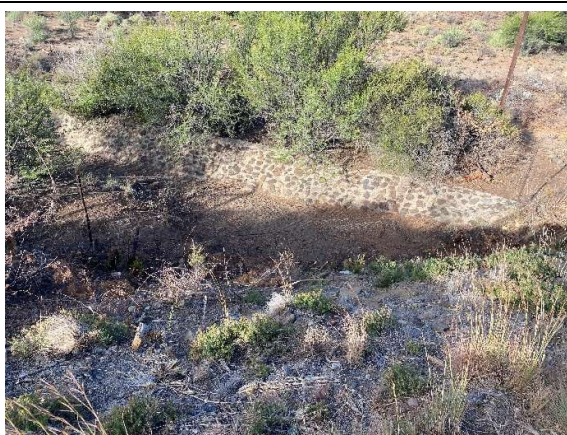
A stone-pitched side drains channel leading to a farm capturing the water from the road reserve.

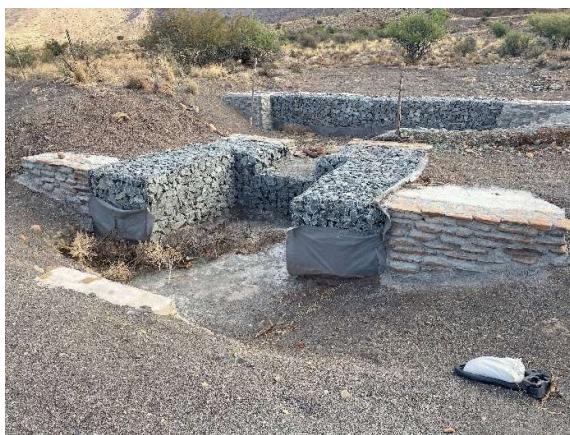
Newly installed gabion baskets for sediment within the road reserve at approximately Km 34.6 on TR 16/9.

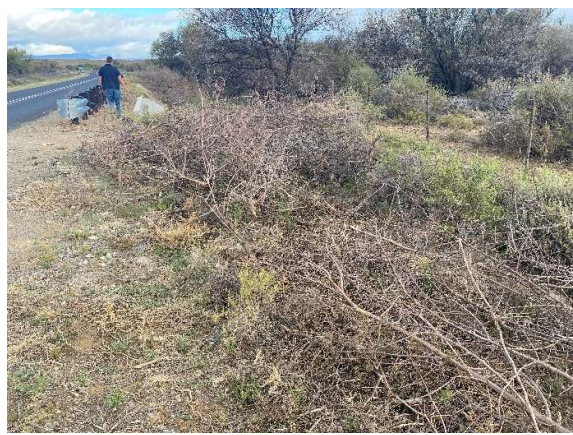
Cleared vegetation debris to be removed at upgraded culvert at Km38 on TR 16/9.

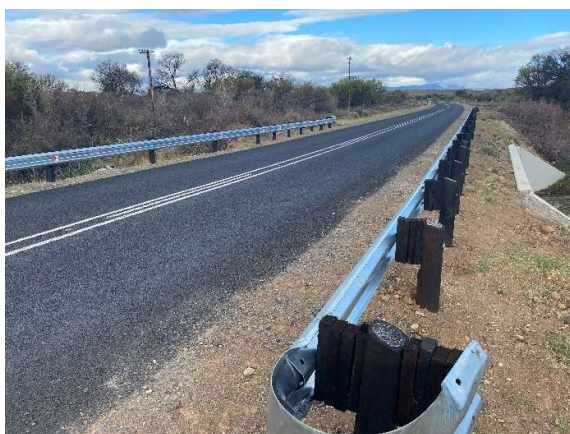
Newly installed guardrails at upgraded culvert at Km38 on TR 16/9.

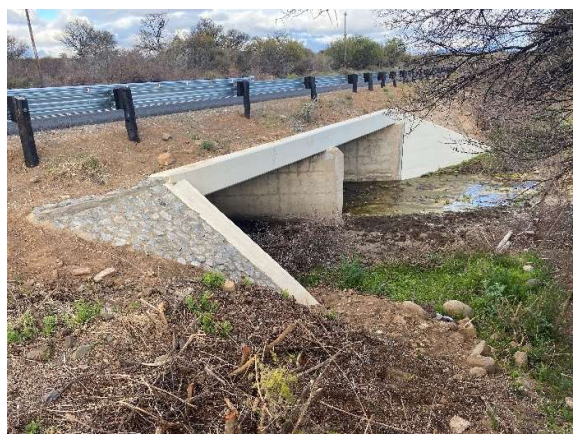
Upgraded culvert at Km38 on TR 16/9 with new concrete structures, erosion control, and clearing of vegetation.

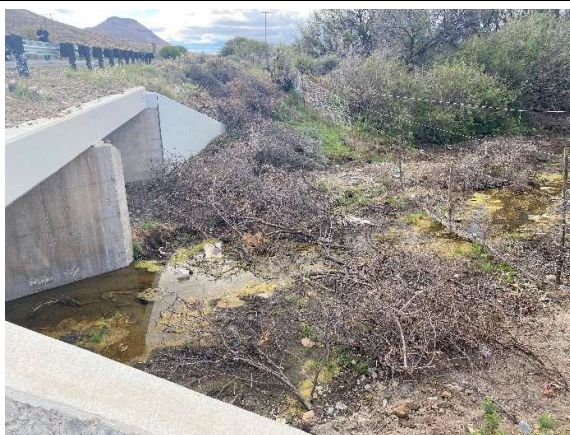
Upgraded culvert at km38 on TR 16/9 where some cleared vegetation debris still noticable.

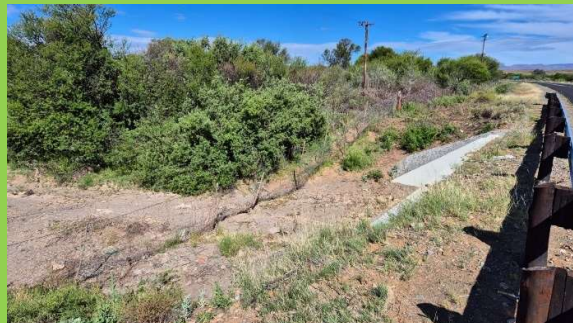
The ECO provided photographic proof on the 26th of November that the vegetation debris at the culvert (km38 on TR 16/9) has been removed.

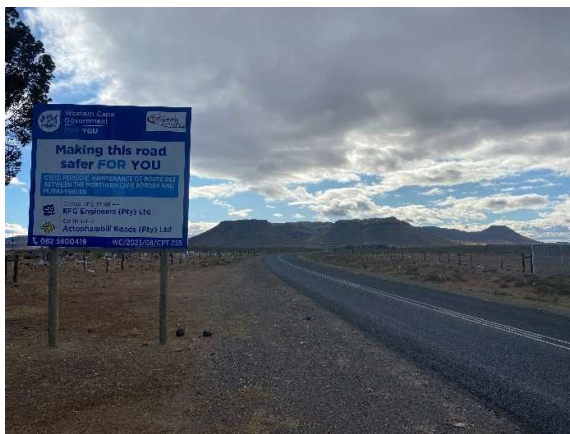
Construction information notice board placed at approximately Km 41.3 on TR 16/9.

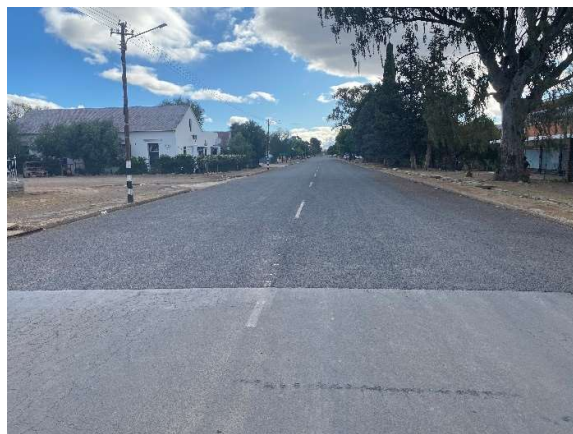
Contract end at Km 42 within the town of Murraysburg. Road surface redone, and surface work is now complete.
