# THE PROPOSED DEVELOPMENT OF A PRIMARY DWELLING AND ASSOCIATED STRUCTURES AND INFRASTRUCTURE ON ERF 4716, GROOT BRAK RIVER.

EXTERNAL ENVIRONMENTAL AUDIT REPORT IN TERMS OF REGULATION 34 OF THE NEMA EIA REGULATIONS, 2014 (AS AMENDED).

DEA&DP EIA REF. NO. 16/3/3/1/D6/17/0020/22  
NEAS REF. NO. WCP/EIA/0001142/2022

15 May 2025

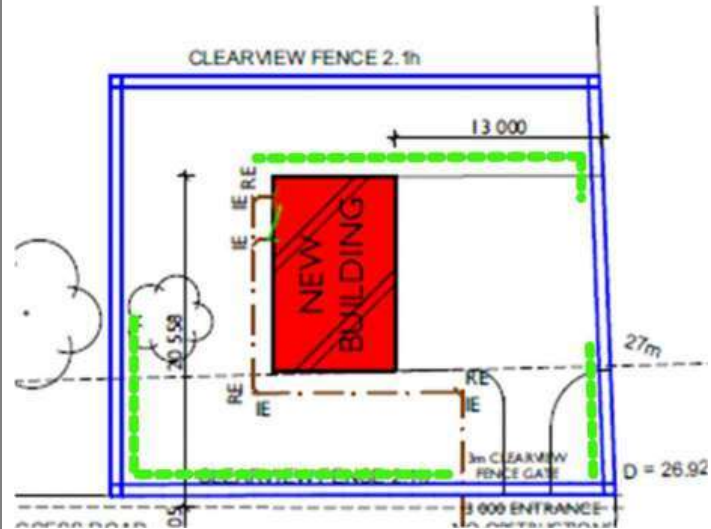
| 17.2 | Tree planting should be incorporated as proposed. The preference is for Milkwood trees, or similar lower growing trees so as not to | Indigenous vegetation has ensured successful screening as well as planted milkwood trees along the western property boundary. |

create a strong vertical element in contrast to the predominantly horizontal lines created by the dune and the ocean horizon line.
