### ENVIRONMENTAL MONITORING REPORT #1

*Erf 4716, Grootbrak, Willie Nel*

**MOS23.1136.25**

**May 2023**

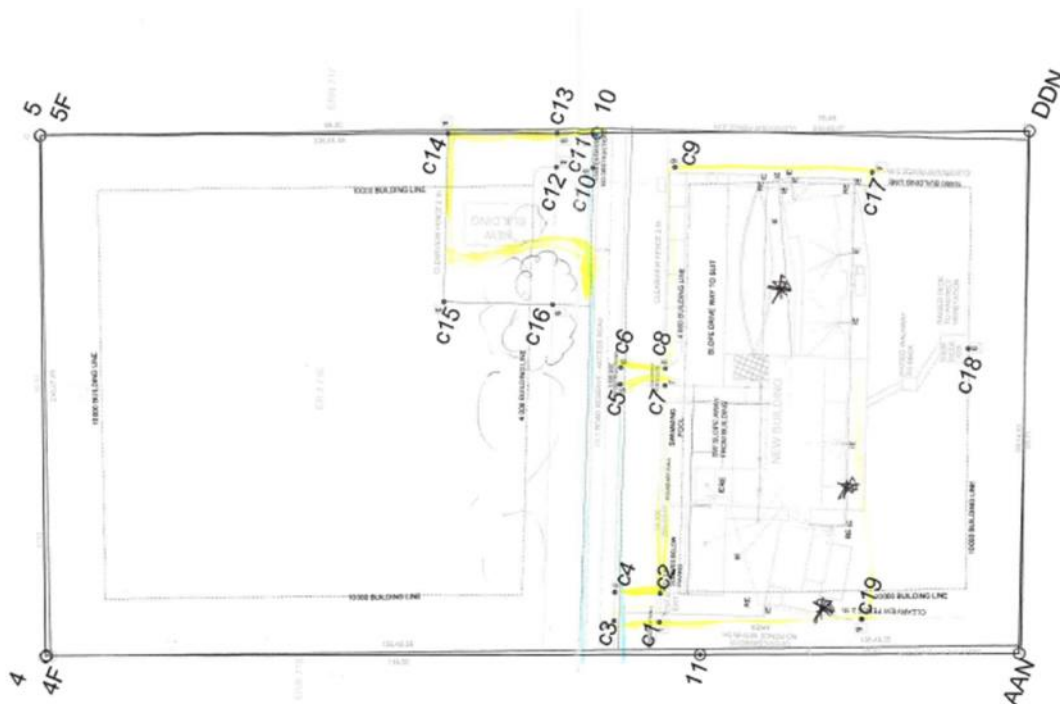
The surveyor installed the required pegs to demarcate the building footprint (see attached map). This footprint was marked off with twine and danger tape and served as the initial no-go demarcation (24<sup>th</sup> April 2023).
