### ENVIRONMENTAL MONITORING REPORT # 11

#### *Erf 4716, GROOT BRAKRIVIER*

**May 2024**

**ERF 4716, GROOTBRAK, WILLIE NEL  
ENVIRONMENTAL MONITORING REPORT NO 11  
Report period: May 2024**

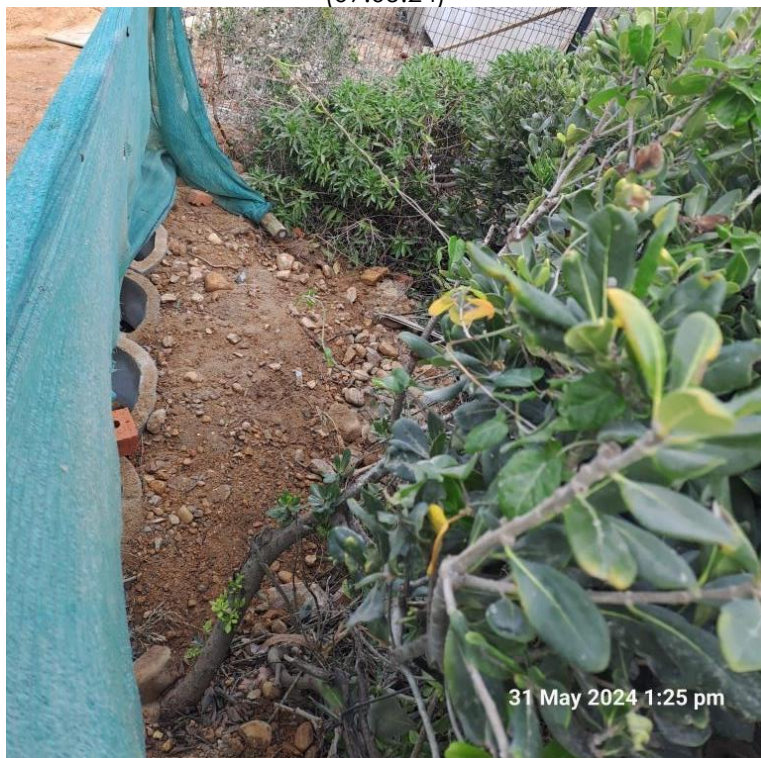
(09.05.24)

Building rubble in the "no-go" area has been removed.

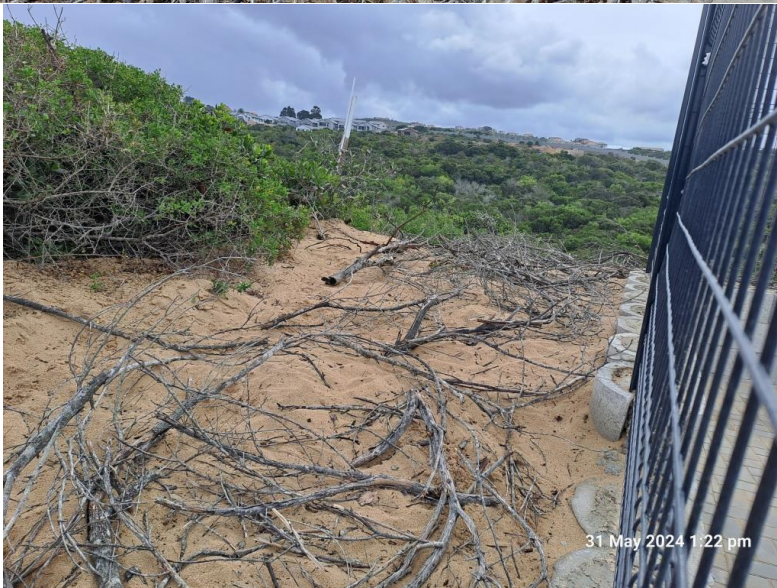
The bare areas around the garage site have been brush packed to protect the exposed areas from erosion and promote revegetation.
