**PERIODIC MAINTENANCE OF TR 83/1, KM 25.78 TO  
KM 34.00 AND KM 48.50 TO KM 58.00, TR 83/2 FROM  
KM 0 TO KM 11,16 AND KM 15.25 TO KM 23.01, MR  
365 FROM KM 0 TO KM 14.12, AND TR 31/5 FROM  
KM 0.42 TO KM 0.90, BETWEEN RIVERSDALE TO  
LADISMITH, WESTERN CAPE.**

**FINAL CLOSURE EXTERNAL ENVIRONMENTAL AUDIT  
REPORT IN TERMS OF REGULATION 34 OF THE NEMA  
EIA REGULATIONS, 2014 (AS AMENDED).**

DEA&DP Ref: 16/3/3/1/D5/16/0005/22

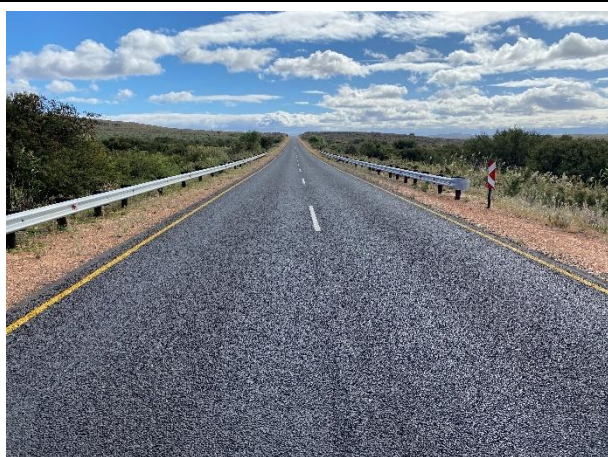
Newly surfaced and installed guardrails at culvert 10875 off TR 83/1.

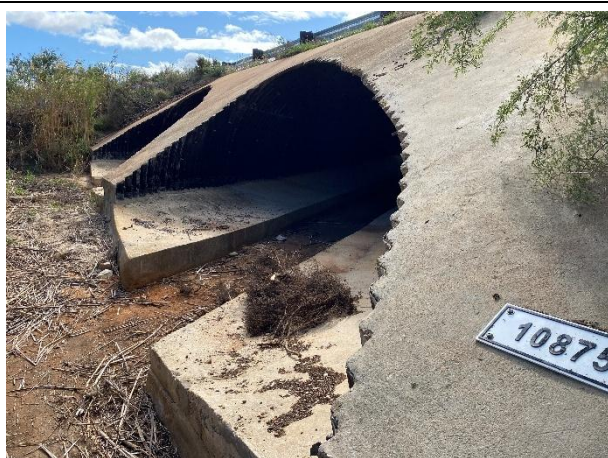
Trimming and removal of dense vegetation at the inlet and outlet and removal of silt deposits inside the barrel.

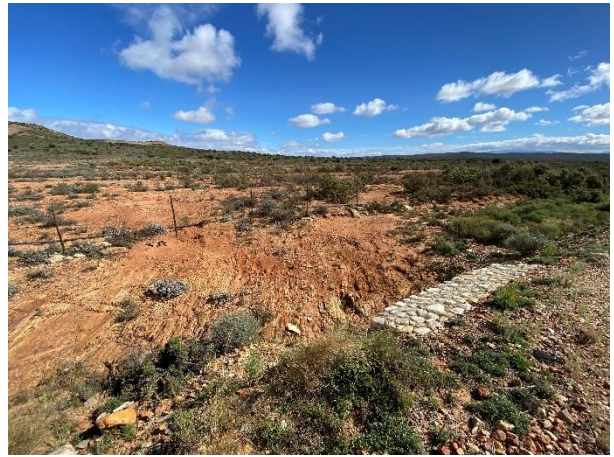
Removal and trimming of dense vegetation at the inlet and outlet.

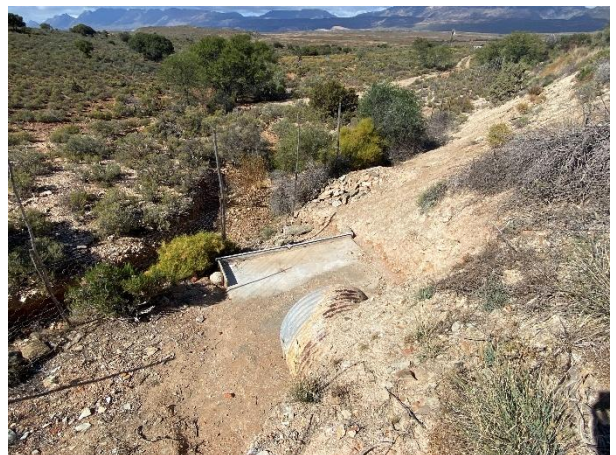
Condition of the vegetation surrounding Culvert 10692 at km 30.63

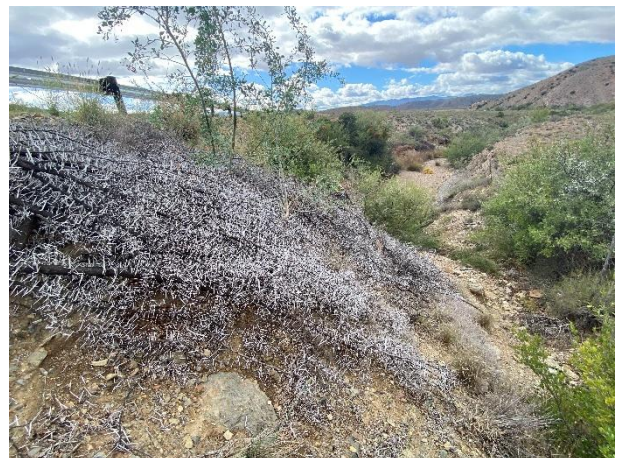
Condition of the vegetation surrounding the culvert.

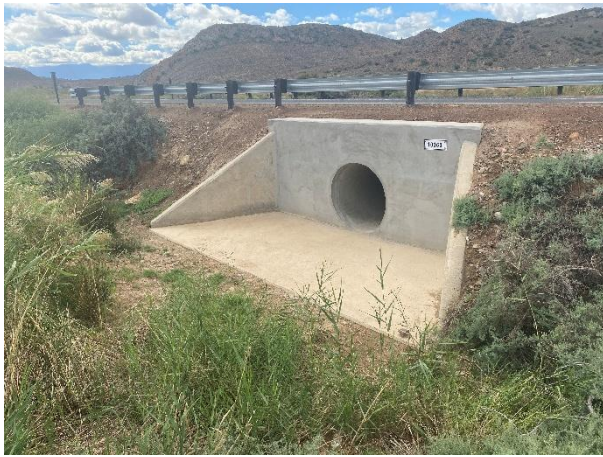
The construction of a new headwall, apron slab and wingwalls at the outlet.

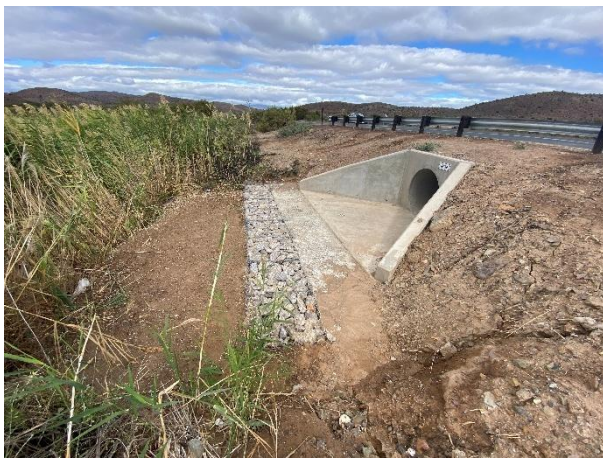
New gabion mattresses installed at the outlet.

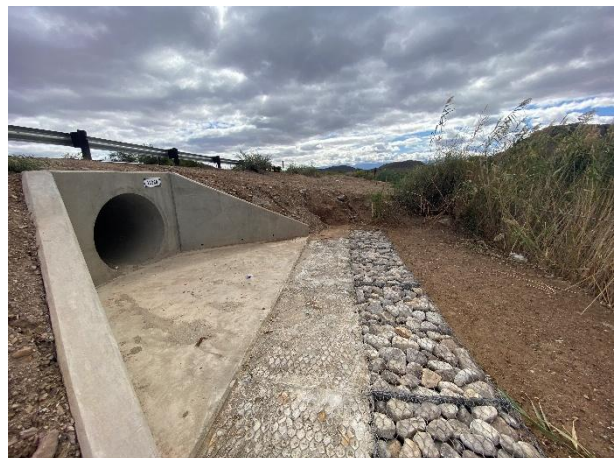
Culvert 10867: TR 83/1 at km 52.61 (an existing single cell consisting of an Armco drainage culvert that is 3.2m wide x 2.1m high structure in very poor condition).

- There is significant chemical attack and corrosion evident in the walls and roof of the Armco structure.
- Repairing of culvert by placing a new prefabricated concrete pipe within the existing culvert and the remaining space to be filled with self-compacting concrete.
- The construction of a new headwall, apron slab and wingwalls are to be constructed at the outlet and new gabion mattresses are to be installed to prevent further scouring and erosion.

New prefabricated concrete pipe within the existing culvert.

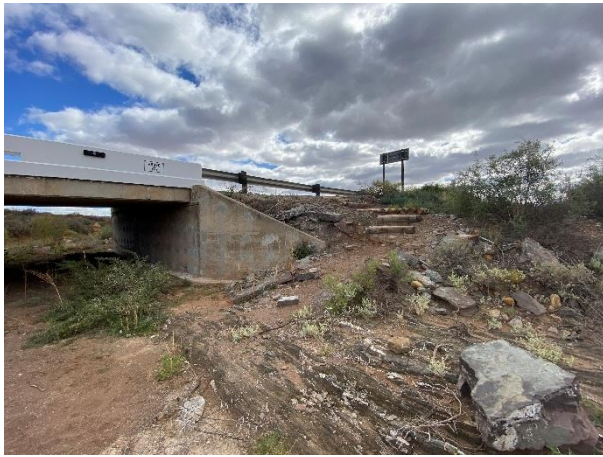
Condition of the vegetation surrounding the bridge. Some fencing is seen on the ground which has been replaced.

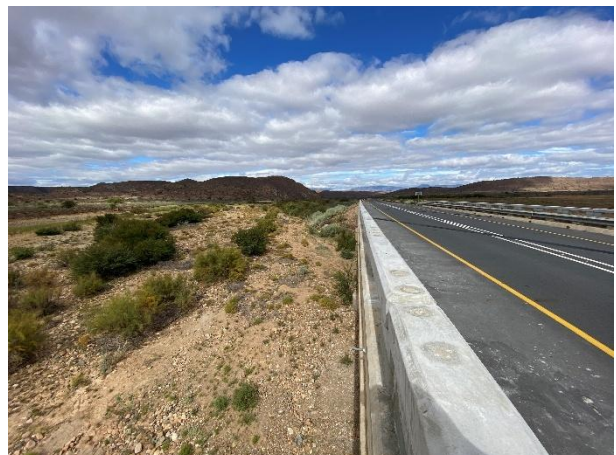
Condition of the vegetation surrounding the bridge.

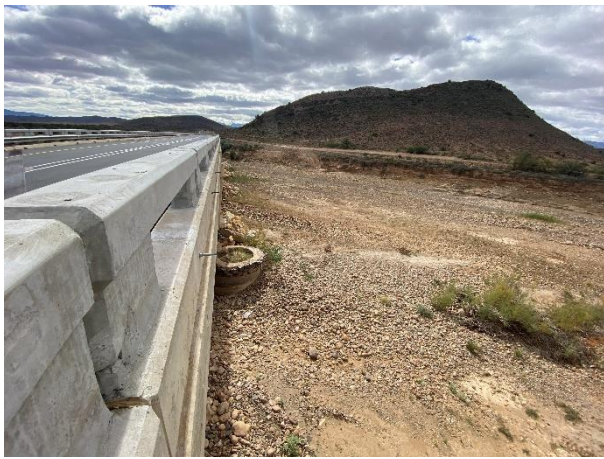
Condition of the vegetation surrounding the bridge.

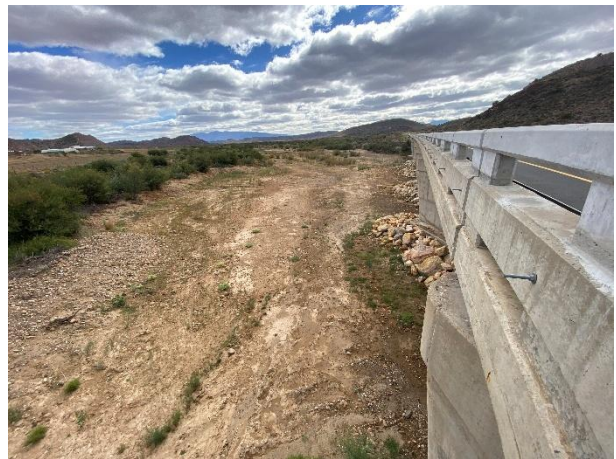
Condition of the vegetation surrounding the bridge.

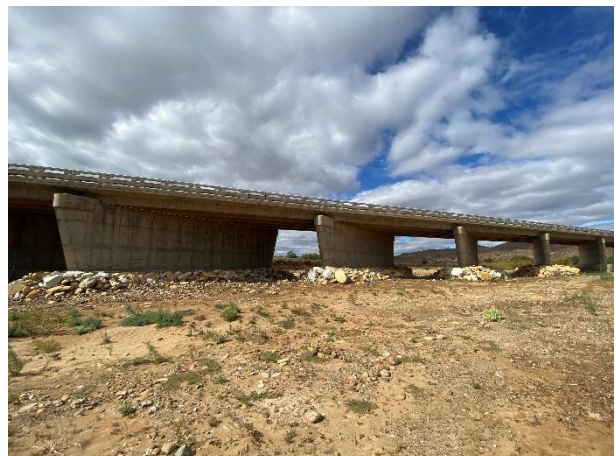
Condition of Bridge 5007.

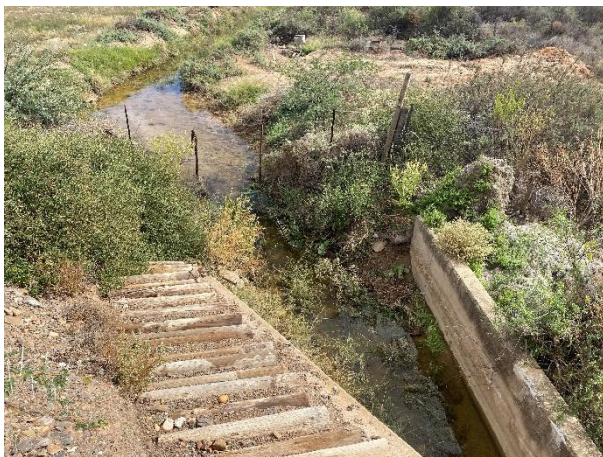
Timber-reinforced embankment slope.

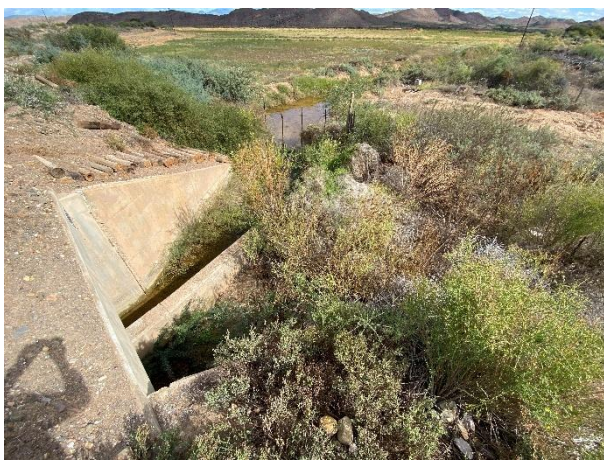
Condition of the vegetation surrounding the culvert.  
Fencing in place.

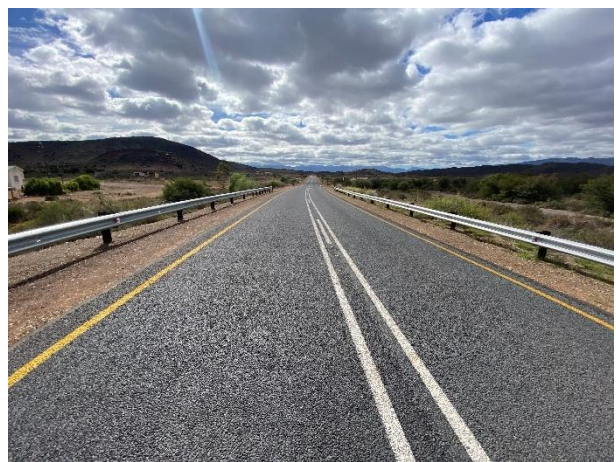
Condition of the newly installed guardrails and road surface at Culvert 10867.

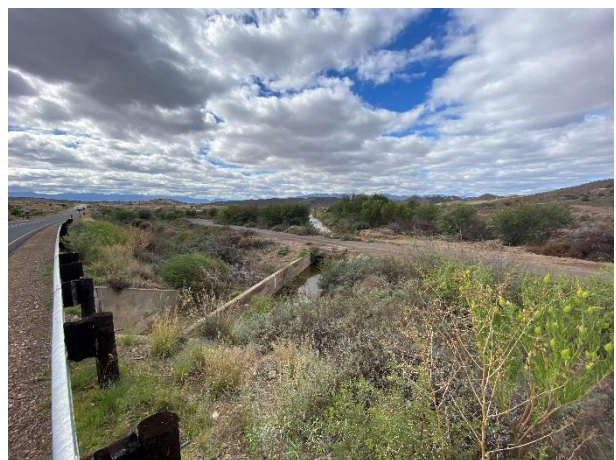
Condition of the vegetation surrounding the culvert.

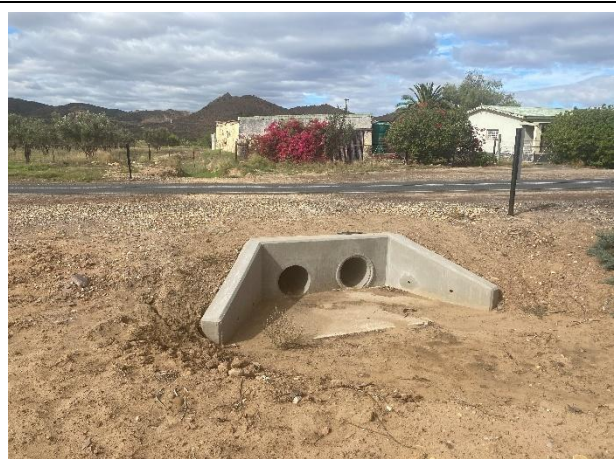
Small stormwater system adjacent to bridge 4837.

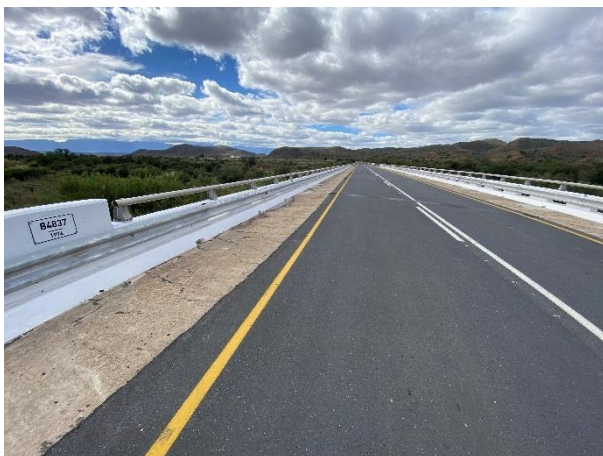
Condition of the newly installed guardrails and road surface at bridge 4837.

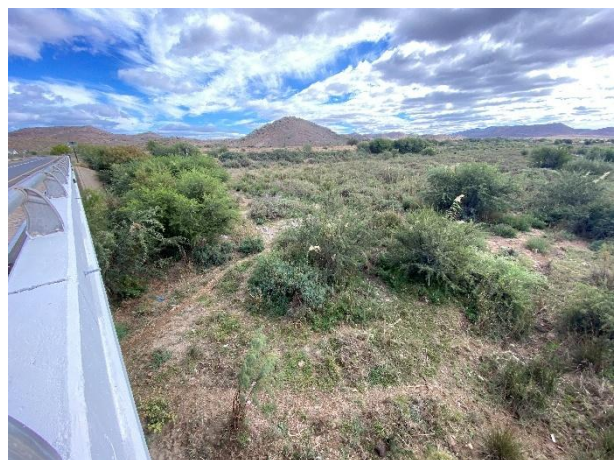
Condition of the vegetation surrounding the bridge.

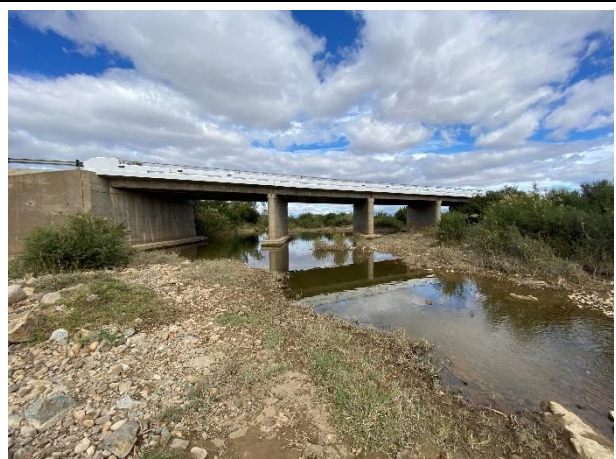
Condition of Bridge 4837.

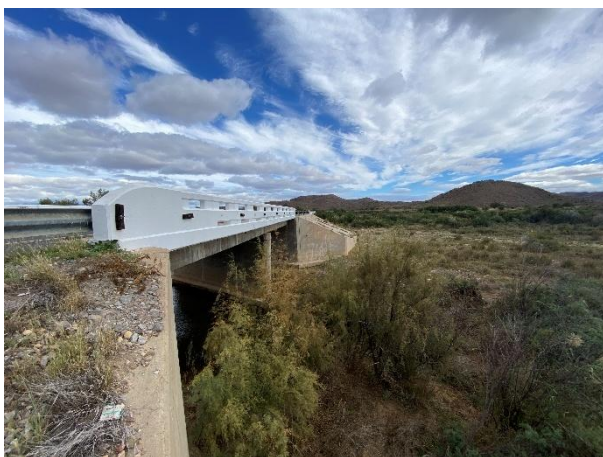
Condition of Bridge 4838.

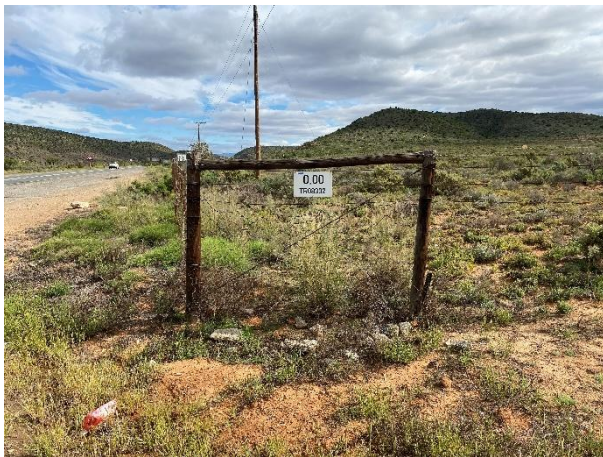
## Bridge 5359: TR 83/2 at km 6.73

Condition of the road reserve at TR 83/2.

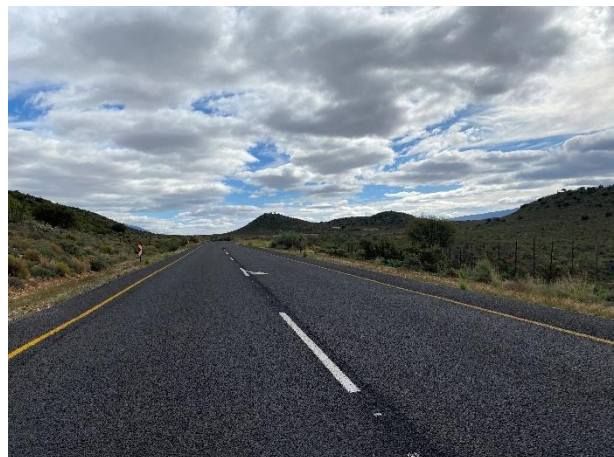
Condition of the road reserve at TR 83/2.

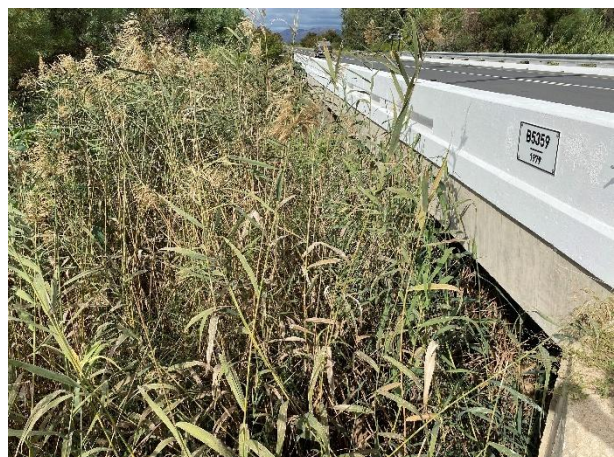
Overgrown vegetation due to the recent rainfall.

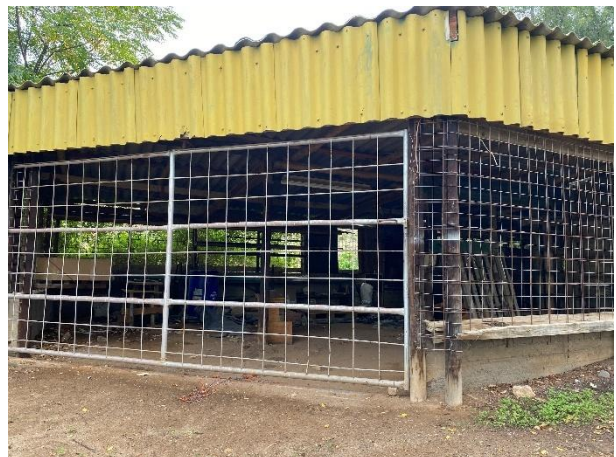
Previous site camp storage facility.

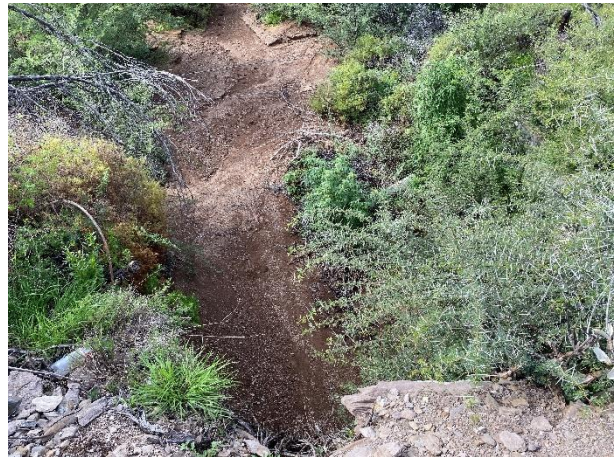
Condition of the vegetation surrounding the bridge.

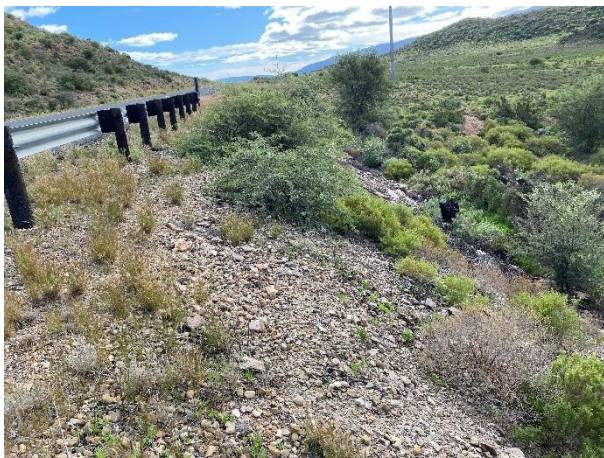
Regraded banks of the bridge.

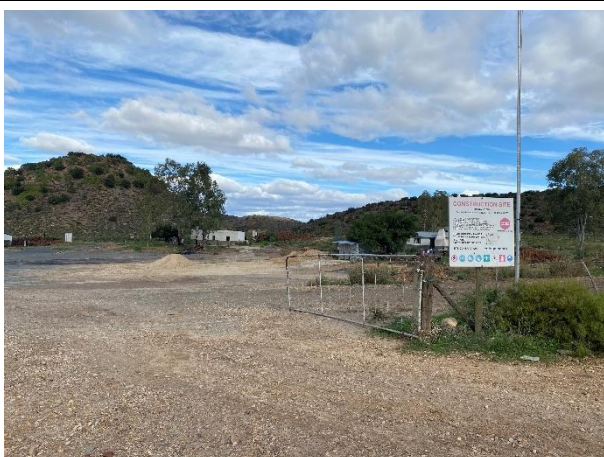
Entrance of the construction camp.

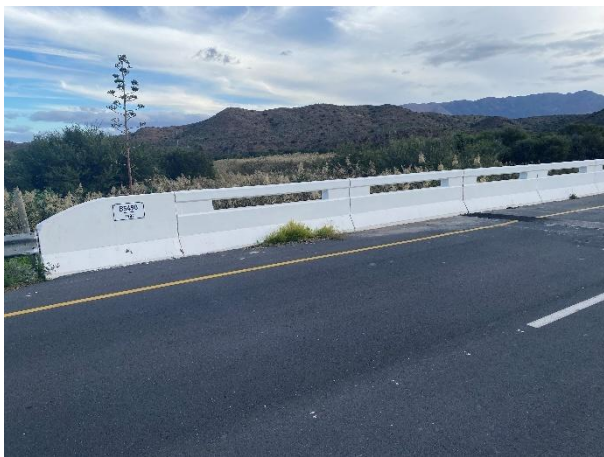
Replaced expansion movement joints.

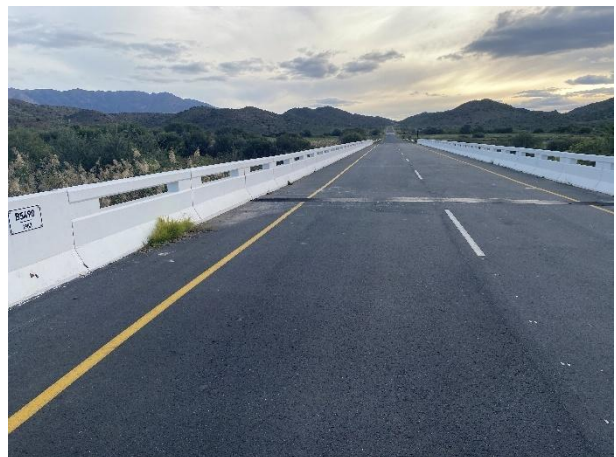
Replaced expansion movement joints.

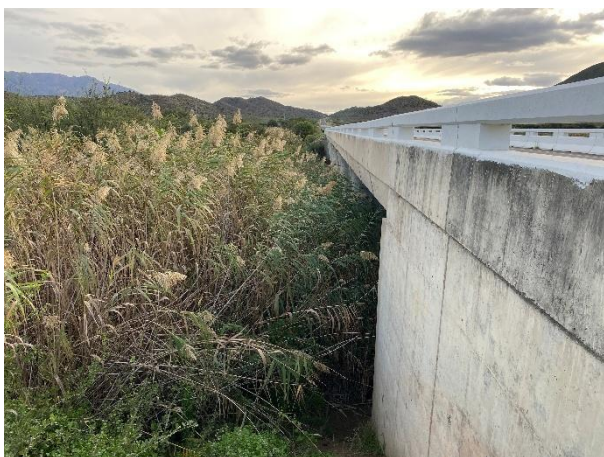
Overgrown vegetation due to the recent rainfall.

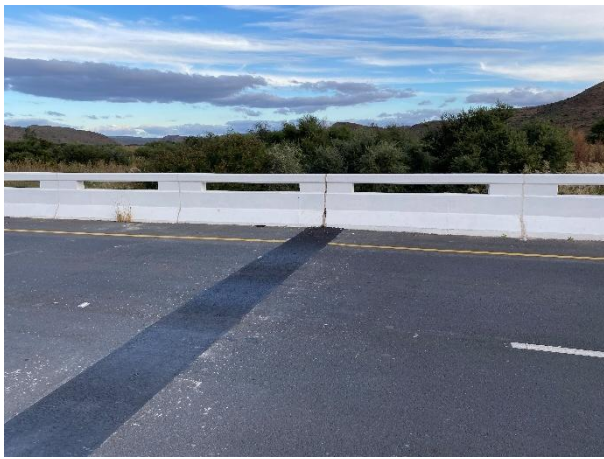
Replaced expansion movement joints.

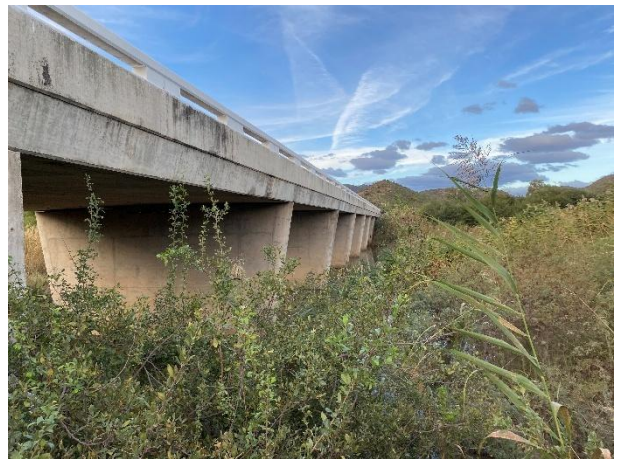
Condition of the vegetation surrounding the bridge.

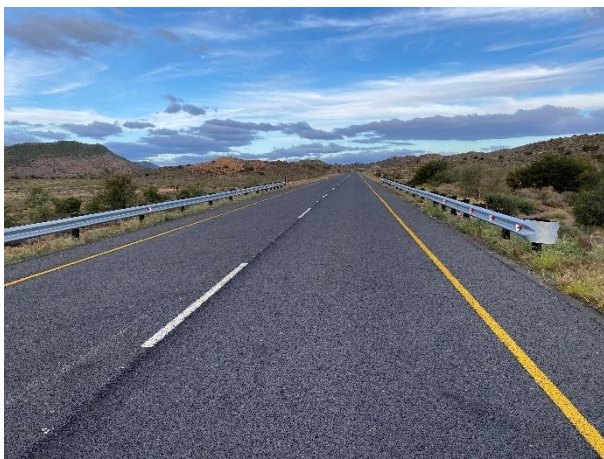
### Culvert 10976: TR83/2 at km 19.93

Condition of the newly installed guardrails and road surface at culvert 10976.

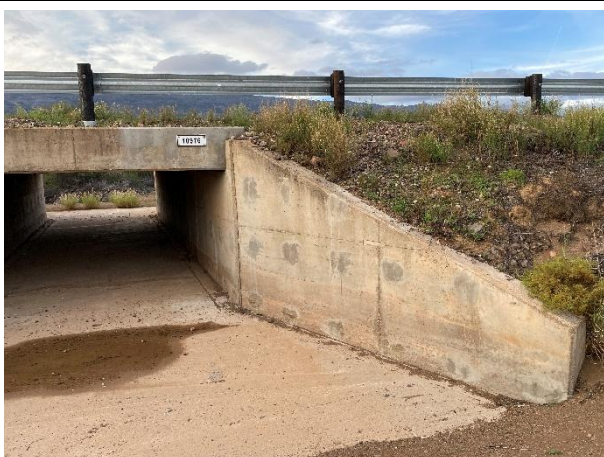
Repairs of vertical and horizontal cracks.

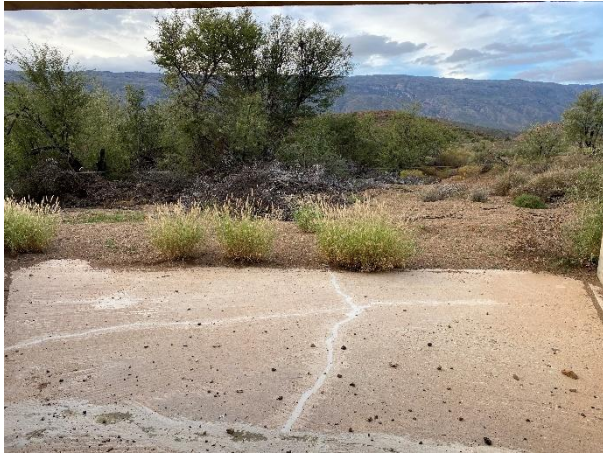
Removal of vegetation overgrowth and silt deposits.

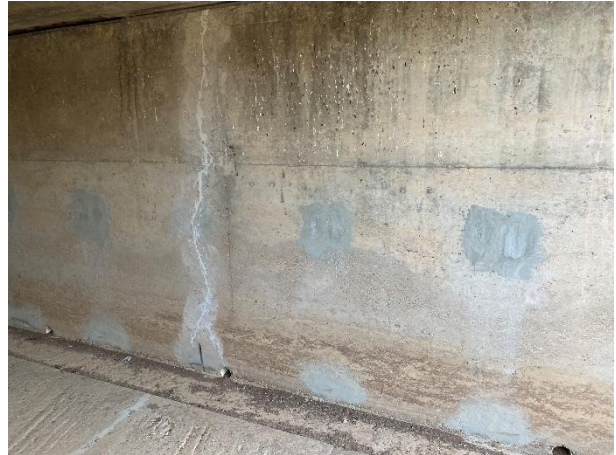
Repairs of vertical and horizontal cracks.

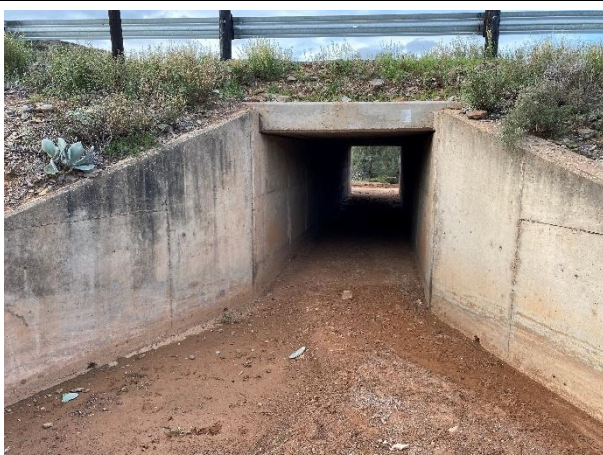
Removal of vegetation overgrowth and silt deposits.

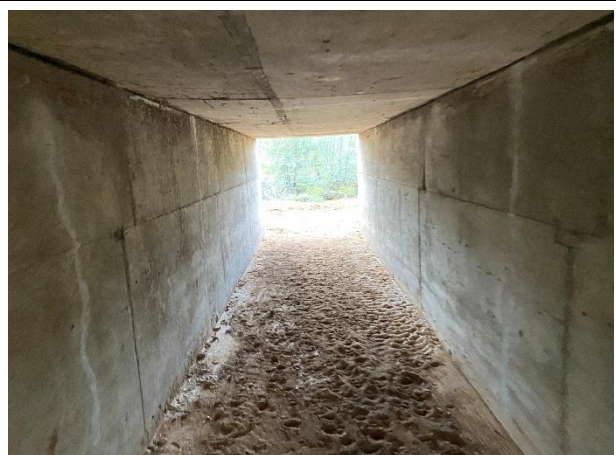
Removal of vegetation overgrowth and silt deposits.

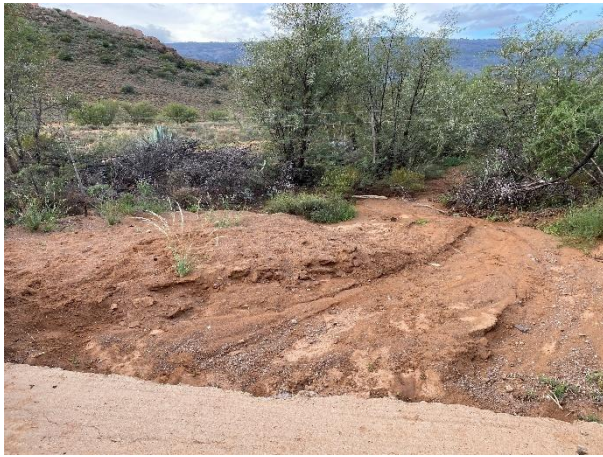
Removal of vegetation overgrowth and silt deposits.

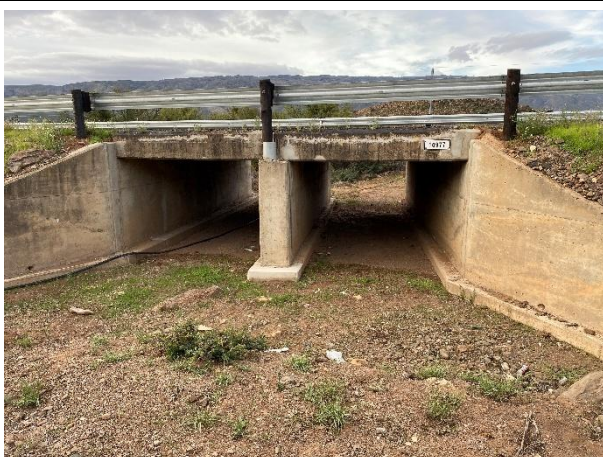
Removal of vegetation overgrowth and silt deposits.

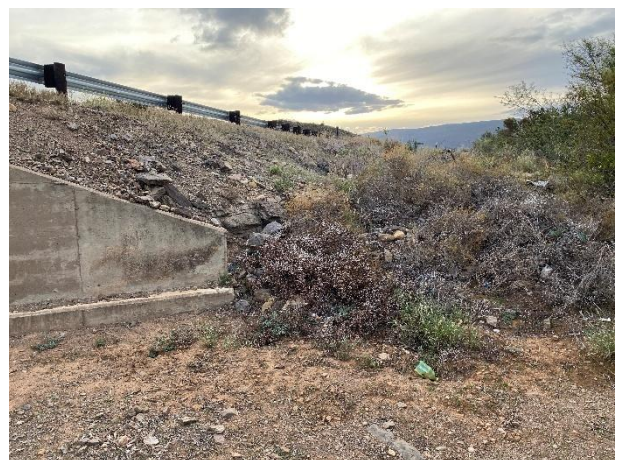
Backfill of the eastern and western cell.

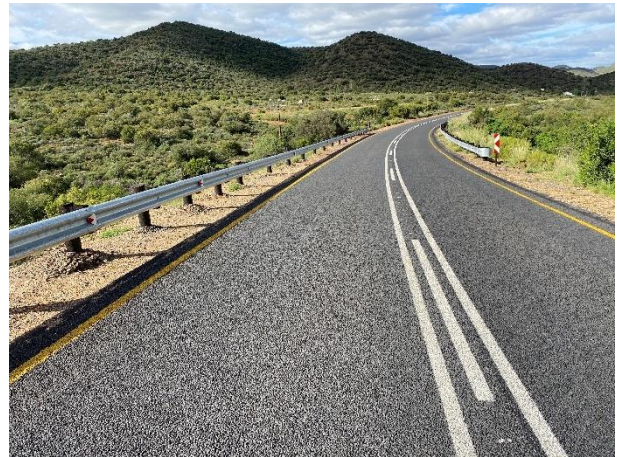
Condition of the newly installed guardrails and road surface.

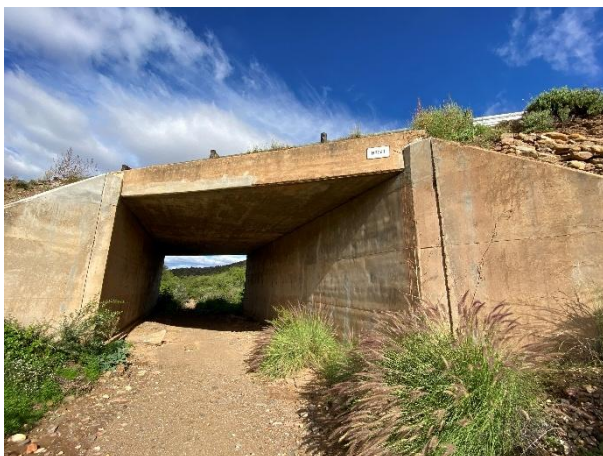
Condition of bridge 9061.

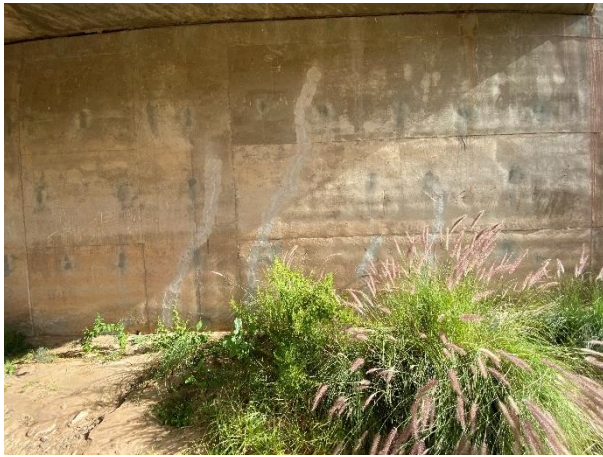
Repairs of vertical and horizontal cracks.

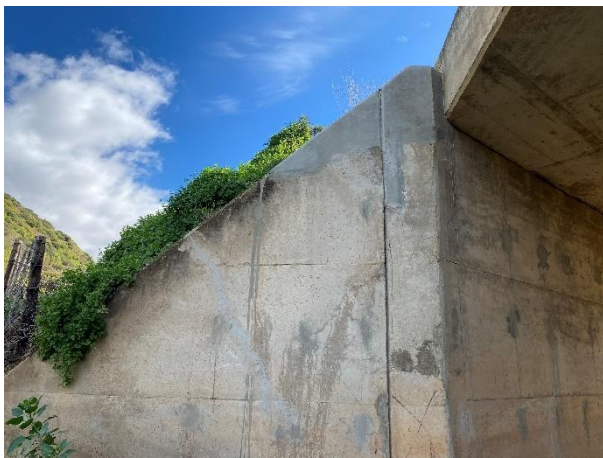
Concrete spalling repaired with an epoxy repair mortar.

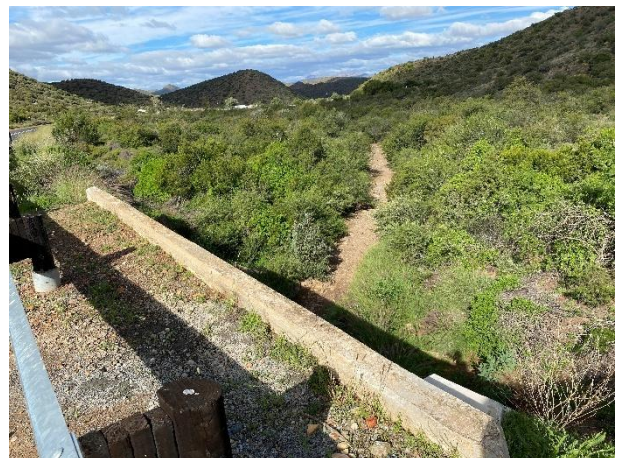
Condition of the vegetation surrounding the bridge.

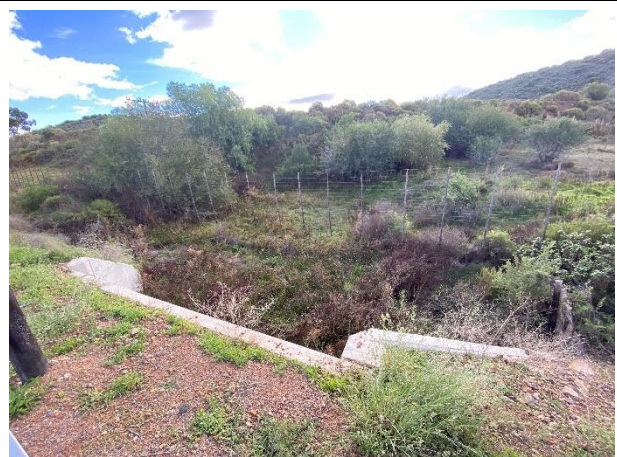
Condition of the vegetation surrounding the culvert.

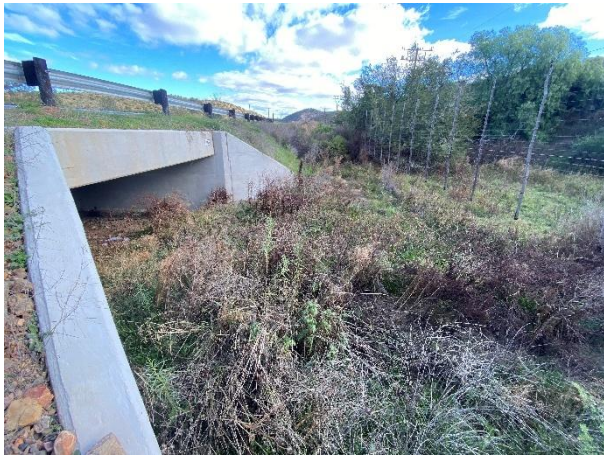
Overgrown vegetation due to the recent rainfall.

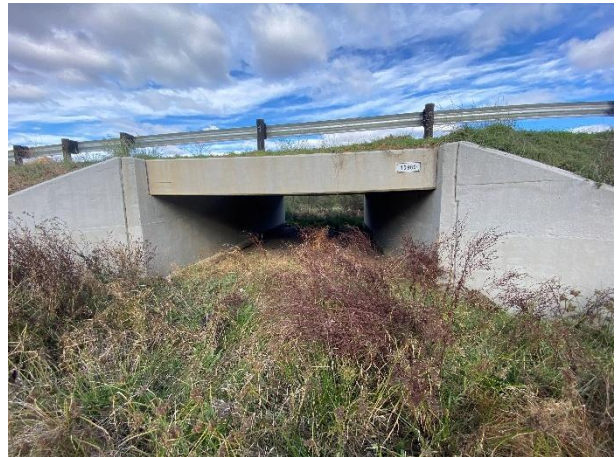
Overgrown vegetation due to the recent rainfall.

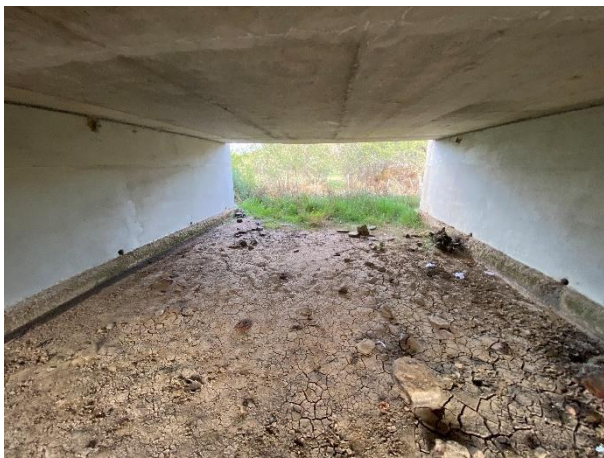
Removal of vegetation overgrowth and silt deposits.

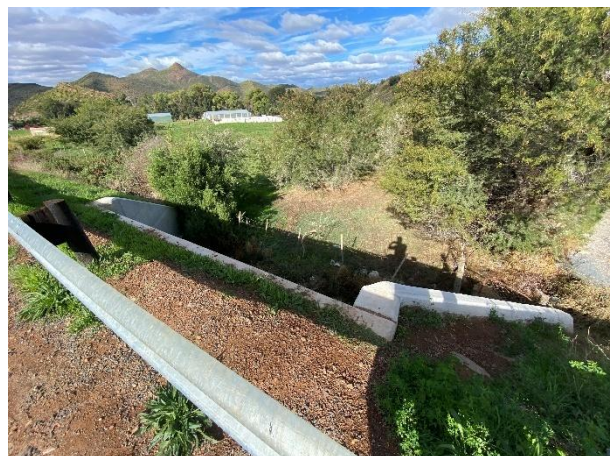
Condition of the vegetation surrounding the culvert. Fencing in place.

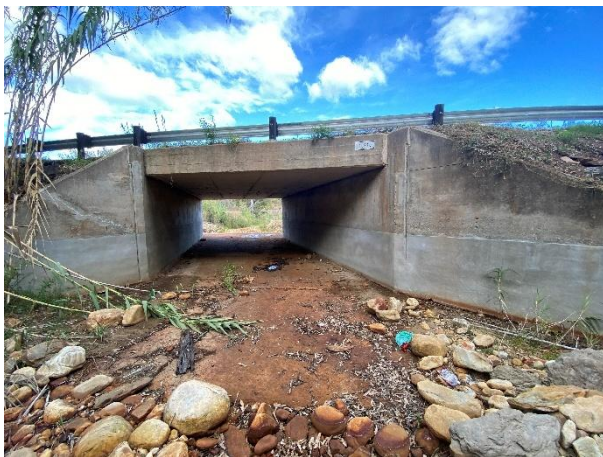
Removal of vegetation overgrowth and silt deposits.

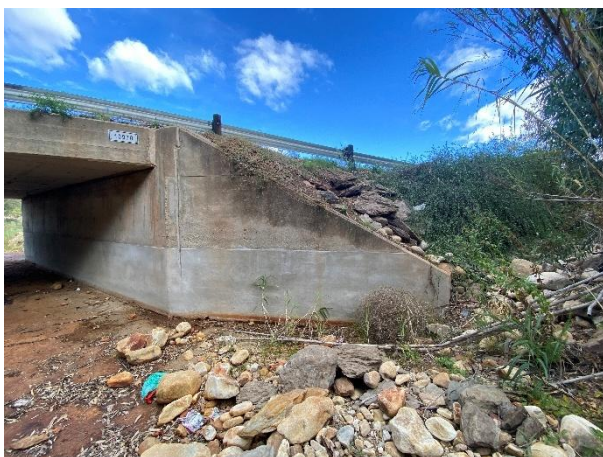
Repaired vertical and horizontal cracks in the abutment, piers, and wingwalls.

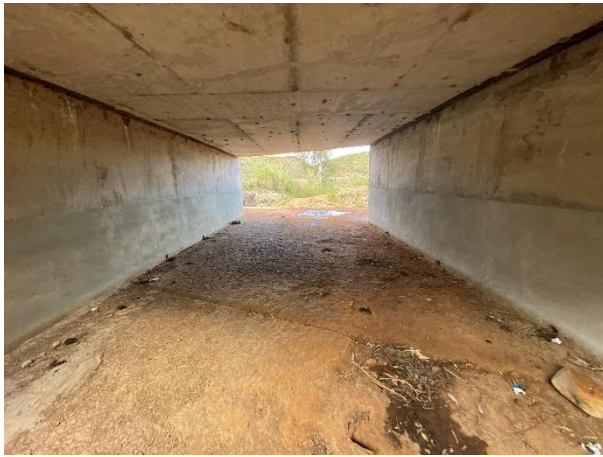
Removal of vegetation overgrowth and silt deposits.

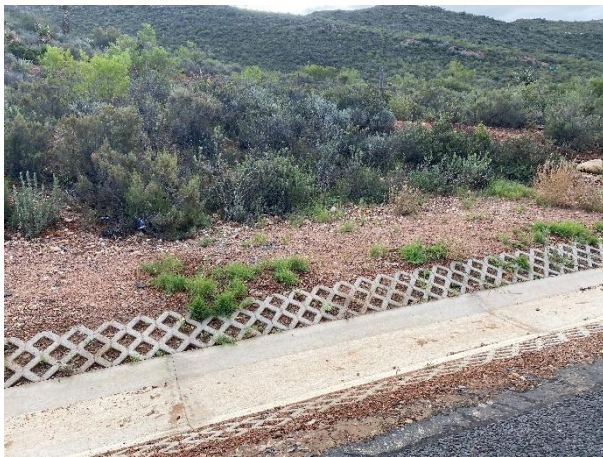
Upgraded side drains off MR 365.

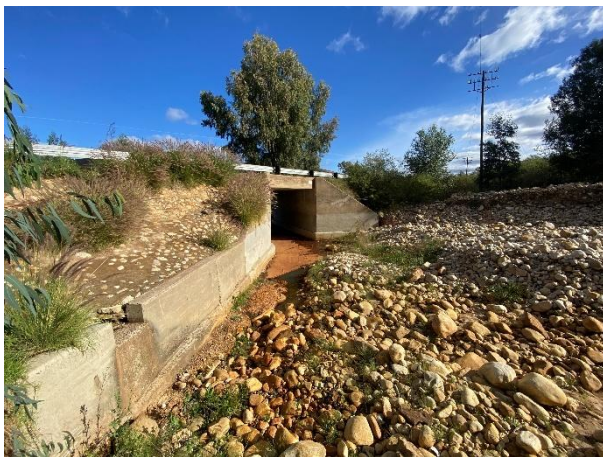
Condition of Culvert 10971.

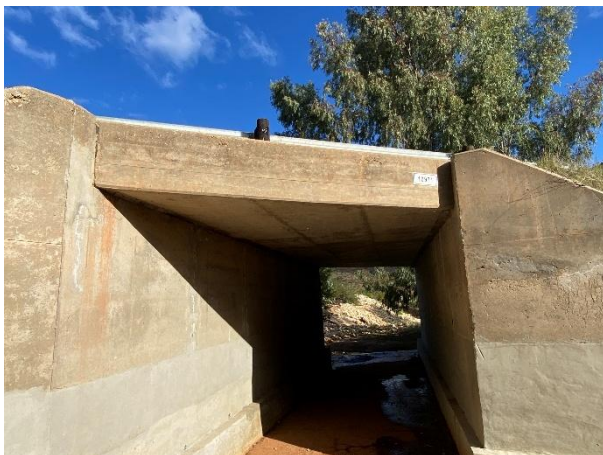
Replacement of the missing culvert number.

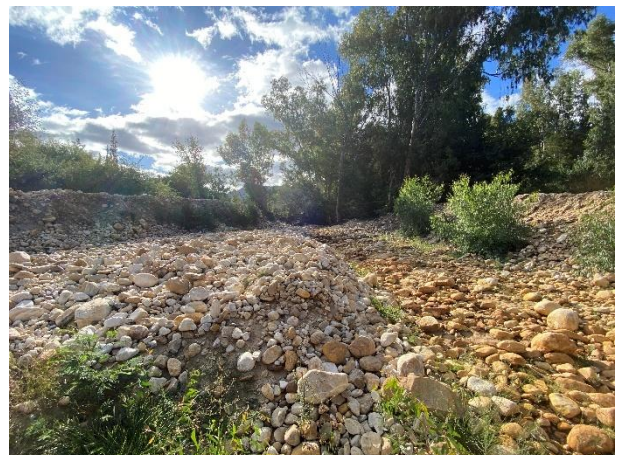
Condition of the vegetation surrounding the culvert.

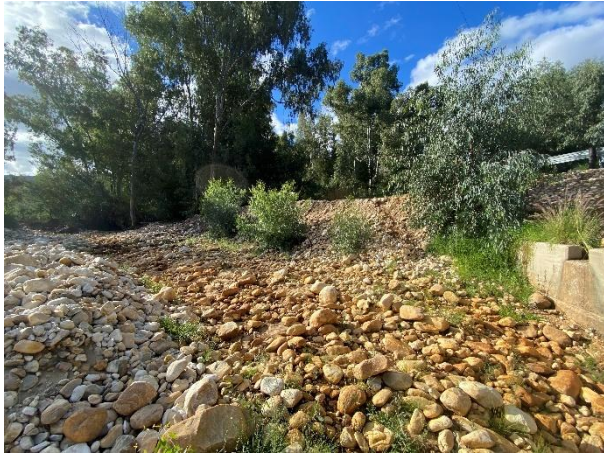
Condition of the vegetation surrounding the culvert.

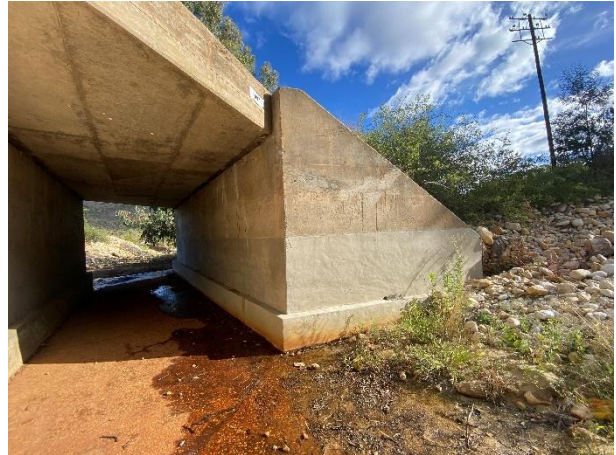
Removal of debris from the waterway.

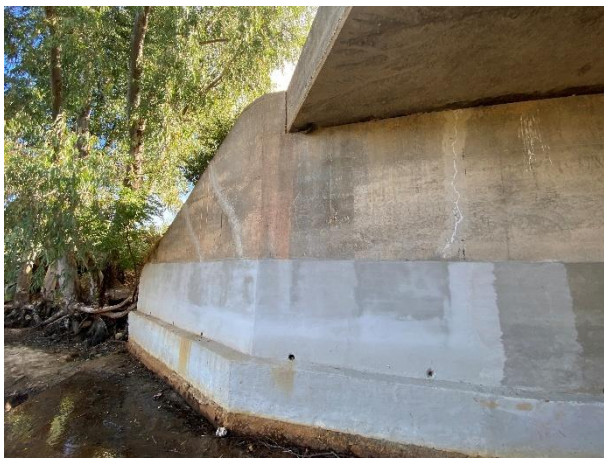
Repaired vertical and horizontal cracks along with concrete spalling in the abutment, piers, and wingwalls.

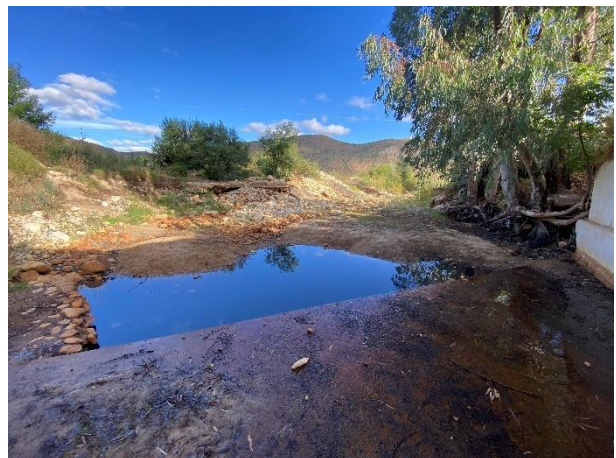
Condition of the vegetation surrounding the culvert.

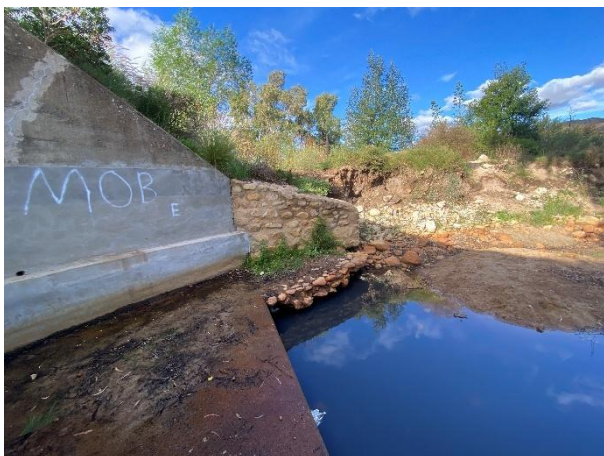
Condition of the vegetation surrounding the culvert.

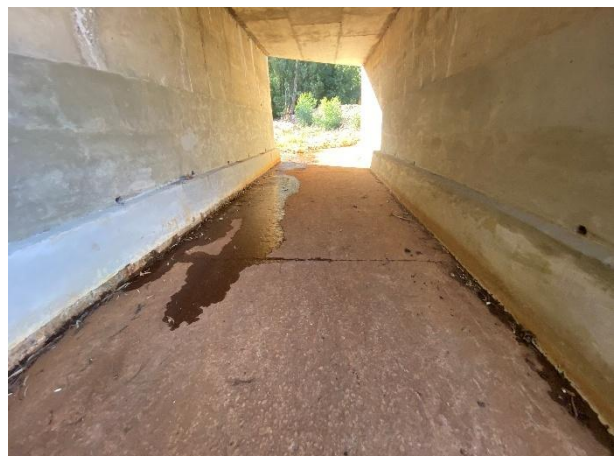
Removal of debris from the waterway.

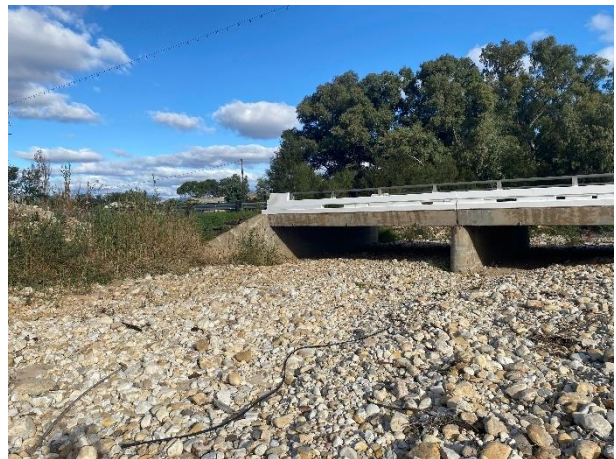
Condition of the vegetation surrounding the culvert.

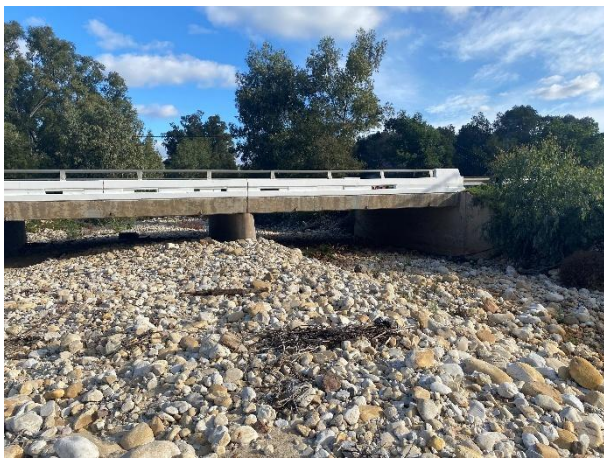
Condition of the vegetation surrounding the culvert.

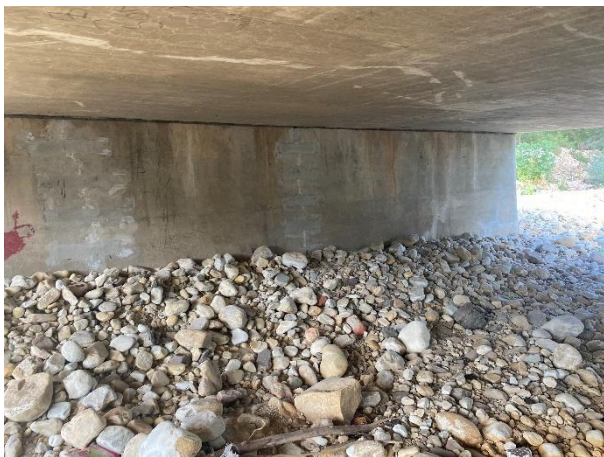
Removal of debris from the waterway.

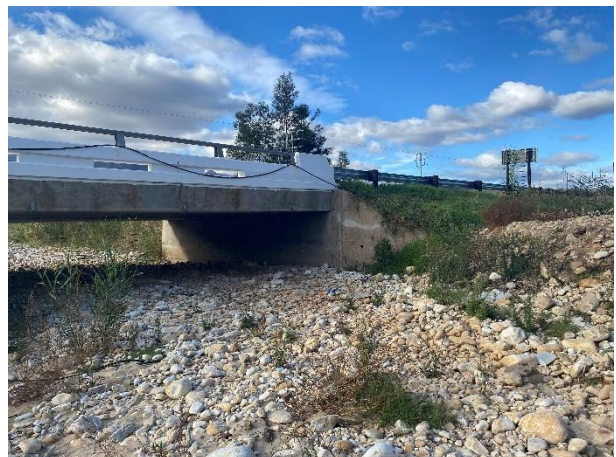
Condition of bridge 4515.

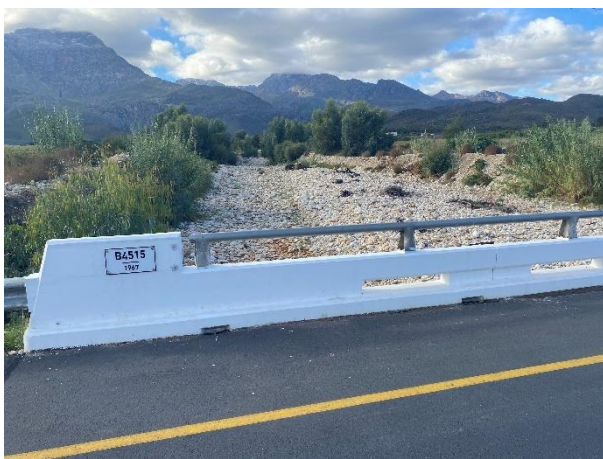
Condition of bridge 4515.

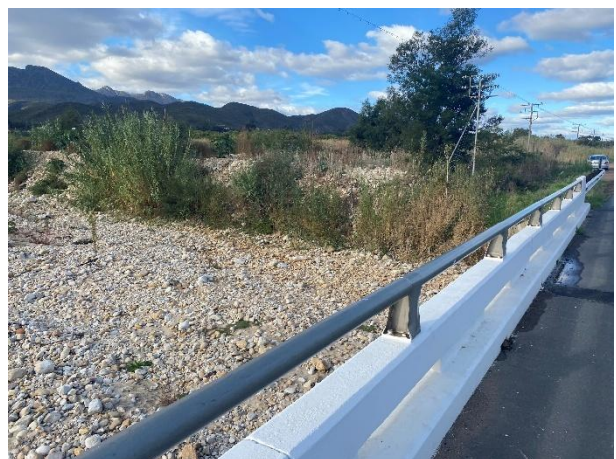
Condition of the vegetation surrounding the culvert.

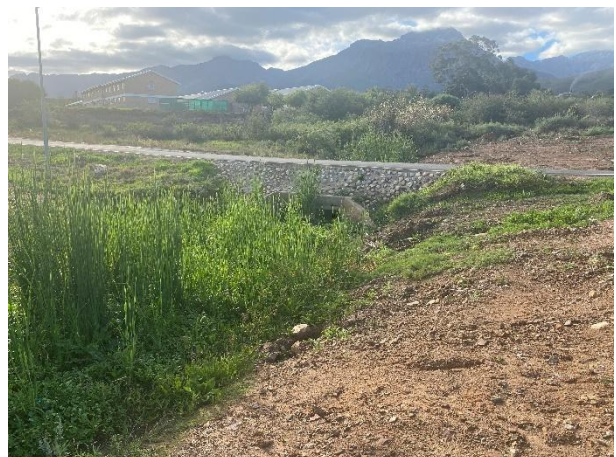
Overgrown vegetation due to the recent rainfall.

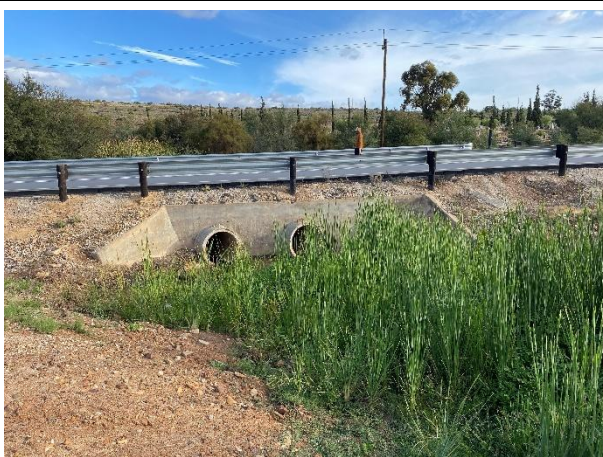
Overgrown vegetation due to the recent rainfall.

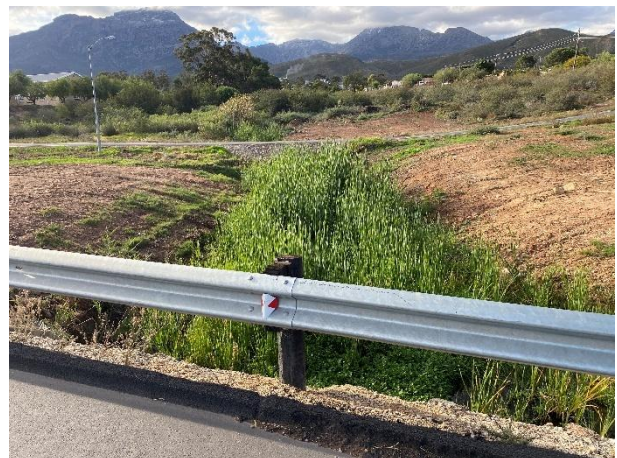
Overgrown vegetation due to the recent rainfall.
