## APPENDIX A – SITE PHOTOGRAPHS

Culvert 10875: TR 83/1 at km 26.24

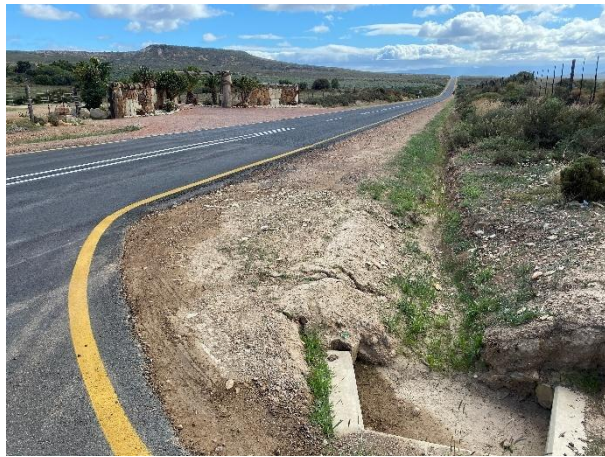
Condition of the road reserve at TR 83/1 km 25.78.

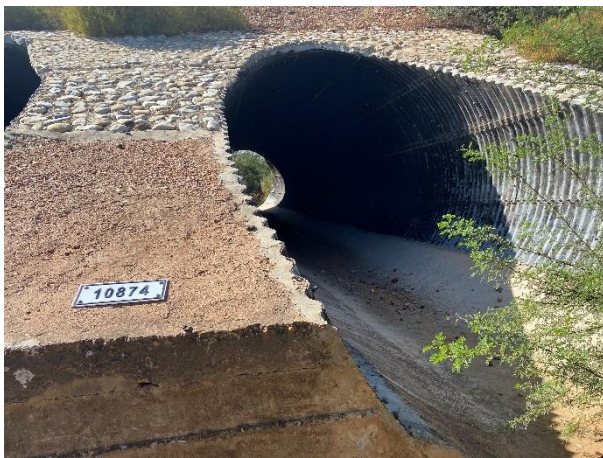
Removal of silt deposits inside the barrel and carting thereof to spoil.

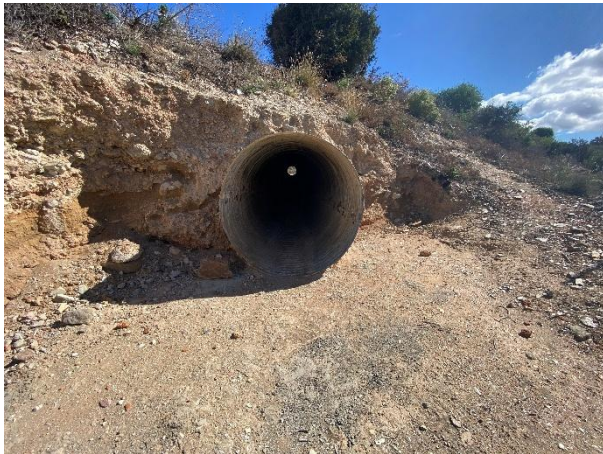
Clearance of accumulation of debris and silt deposits within the barrel.

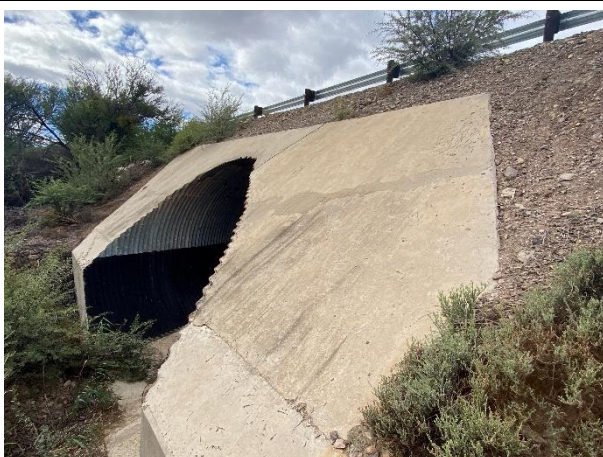
Clearance of dense vegetation and debris from the culvert.

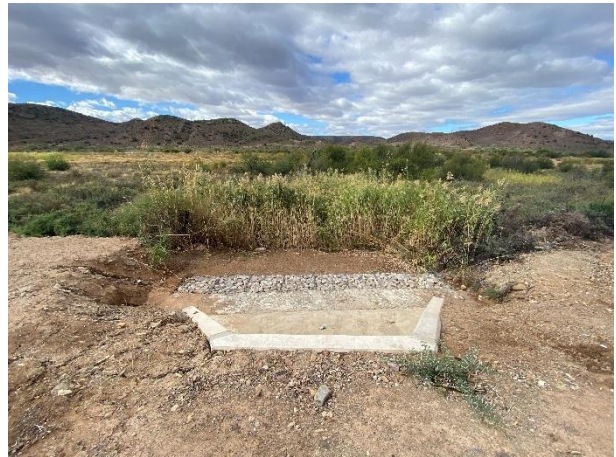
New gabion mattresses installed at the outlet.

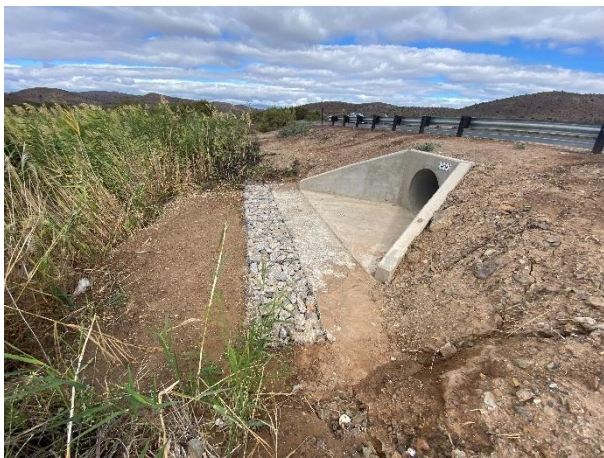
New gabion mattresses installed at the outlet.

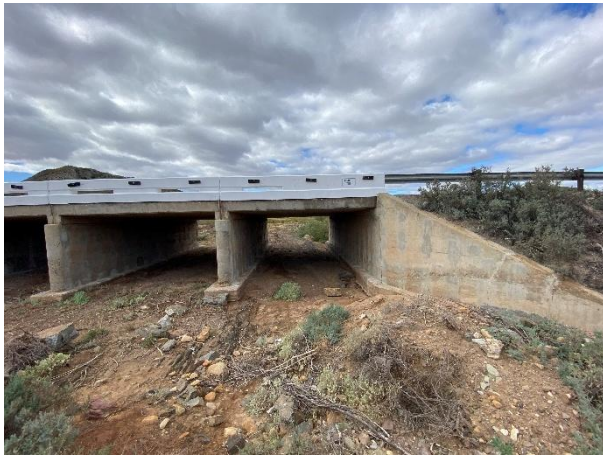
Repairing of cracks on the wingwalls and headwalls.

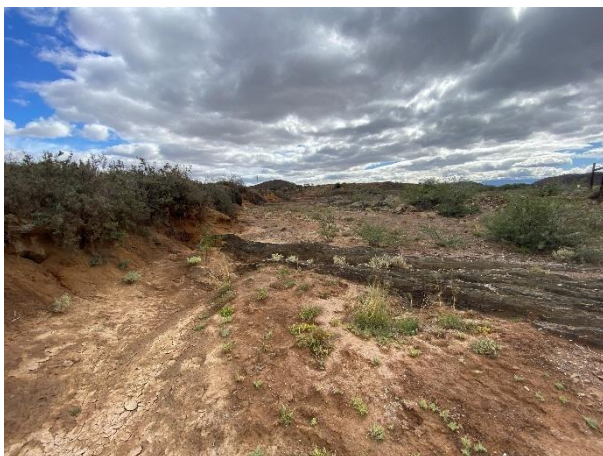
Removal of vegetation overgrowth and silt deposits surrounding Bridge 5090.

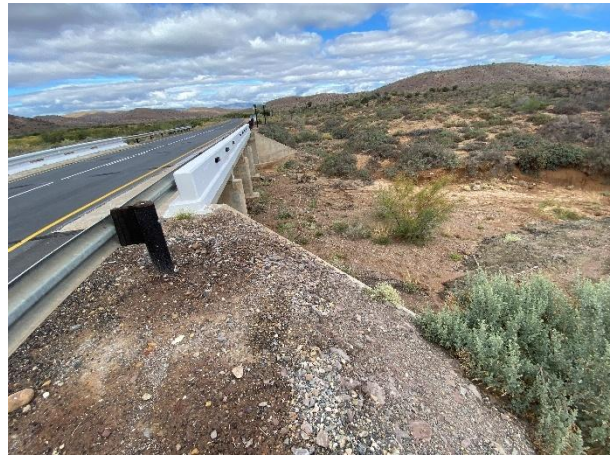
Condition of Bridge 5090.

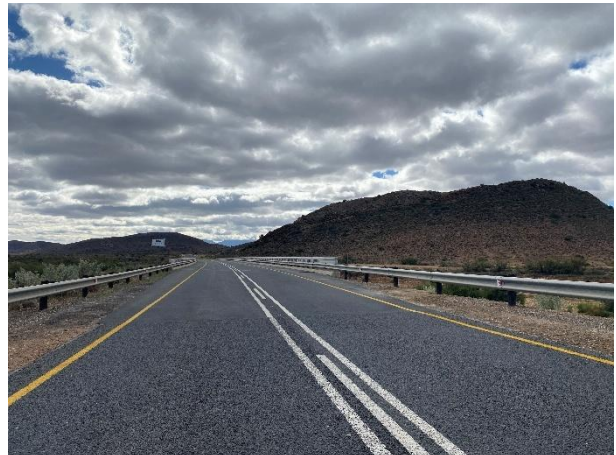
Condition of the newly installed guardrails and road surface at Bridge 5007.

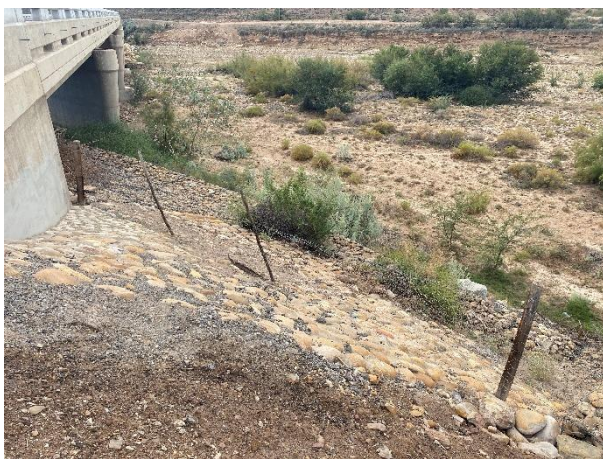
Condition of the vegetation surrounding the bridge. Fencing in place.

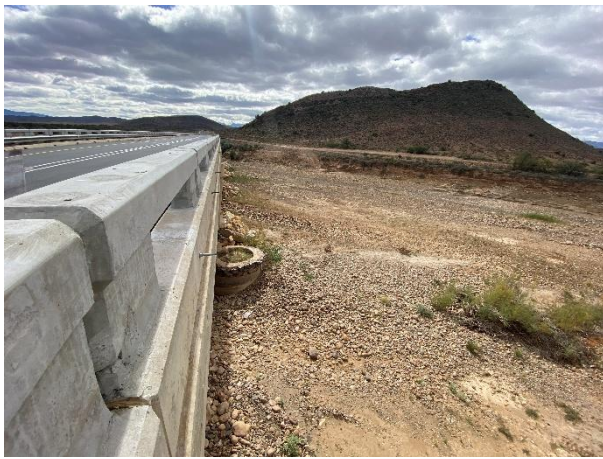
Condition of the vegetation surrounding the bridge.

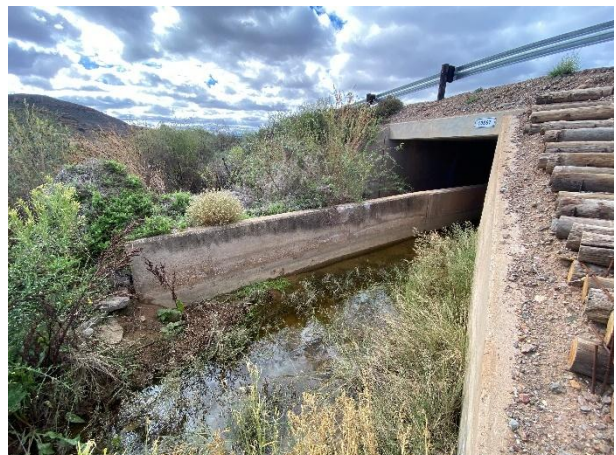
Concrete culvert outlet with vegetated channel and timber-reinforced embankment slope.

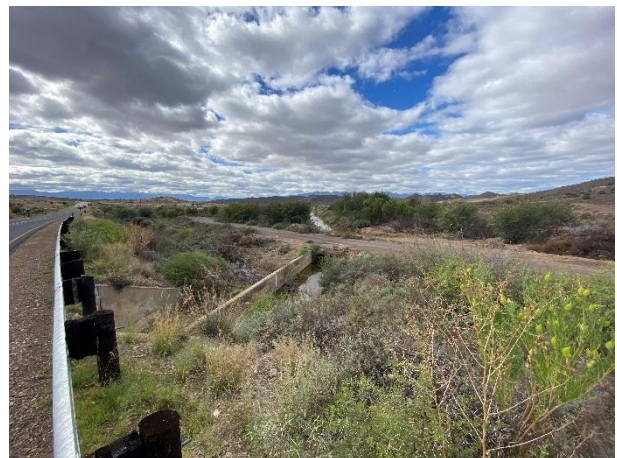
Condition of the vegetation surrounding the culvert.

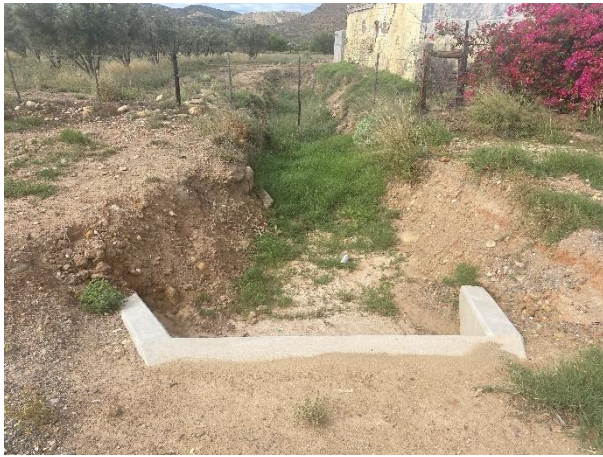
Inlet of the small stormwater system adjacent to bridge 4837.

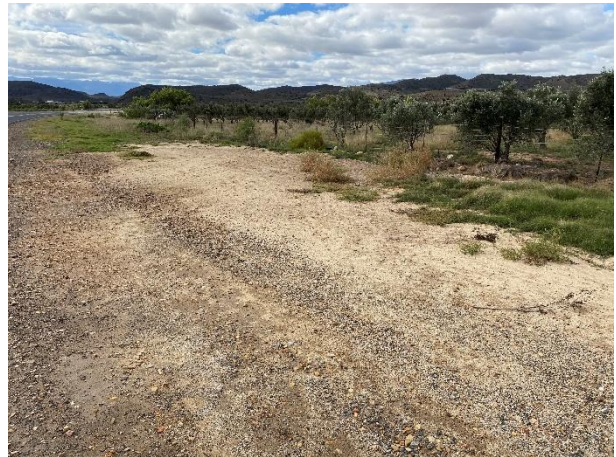
Condition of the vegetation surrounding the small culvert.

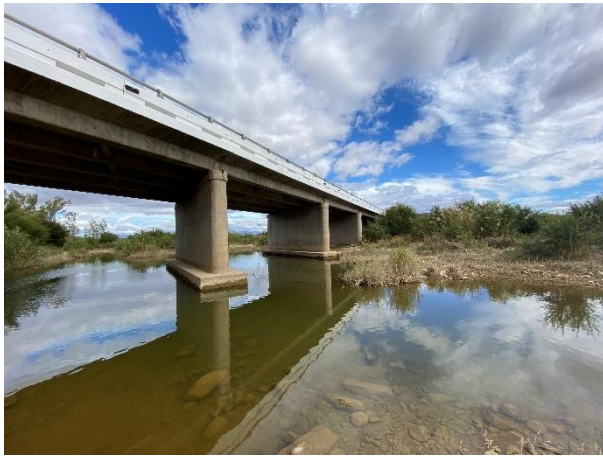
Condition of Bridge 4837.

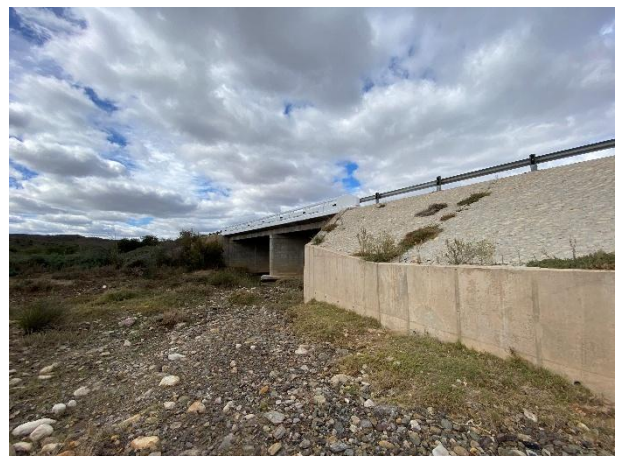
Backfilling and dump rock riprap around the piers and abutments.

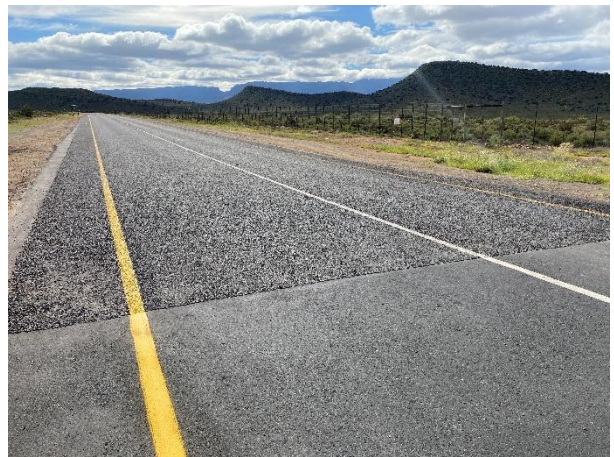
Condition of the road reserve and surface of TR 83/2.

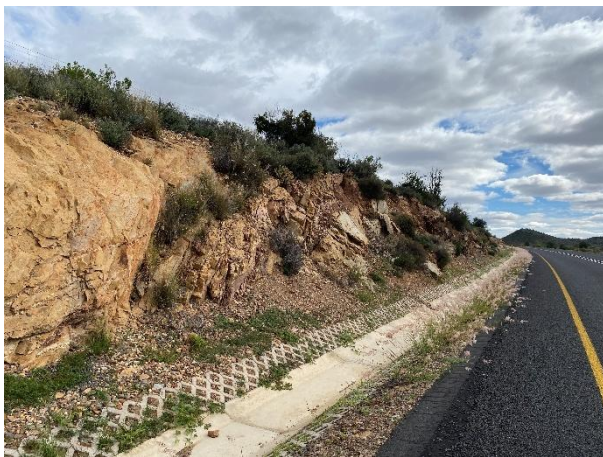
Upgraded side drains off TR 83/2.

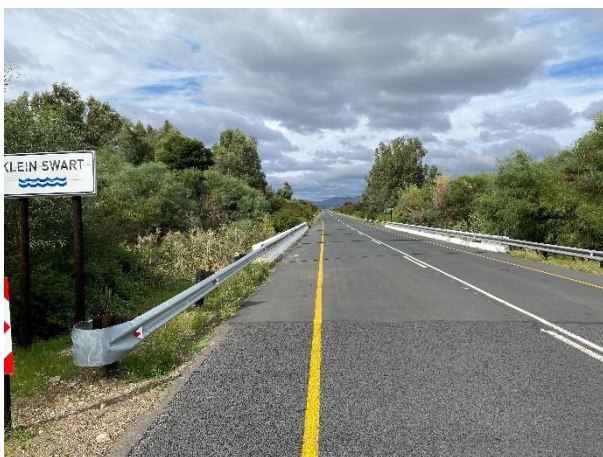
Condition of the newly installed guardrails and road surface at bridge 5359.

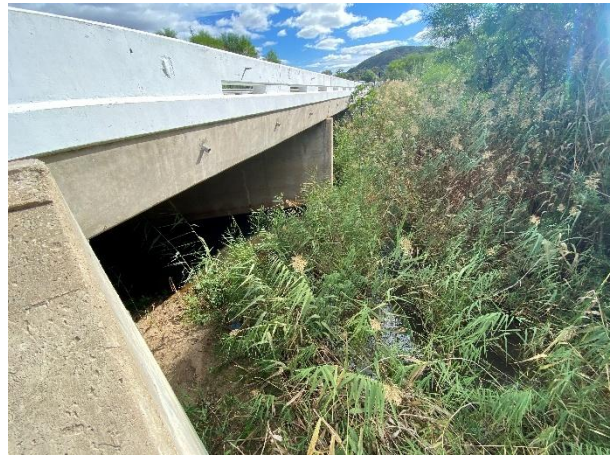
Condition of the vegetation surrounding the bridge.

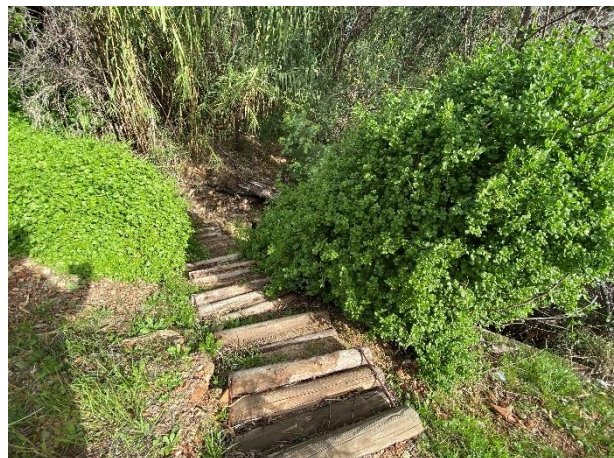
Timber-reinforced embankment slope.

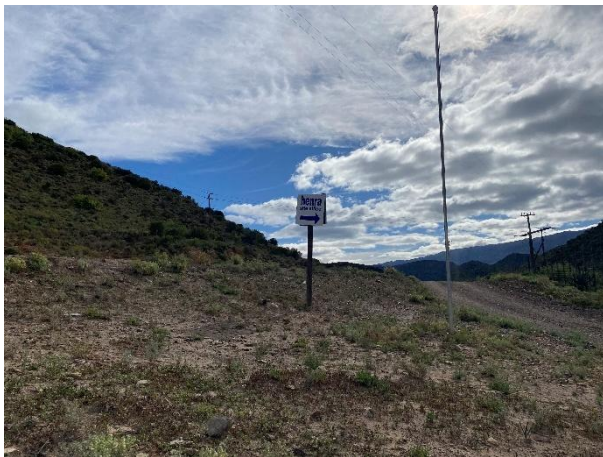
Previous site camp notice board.

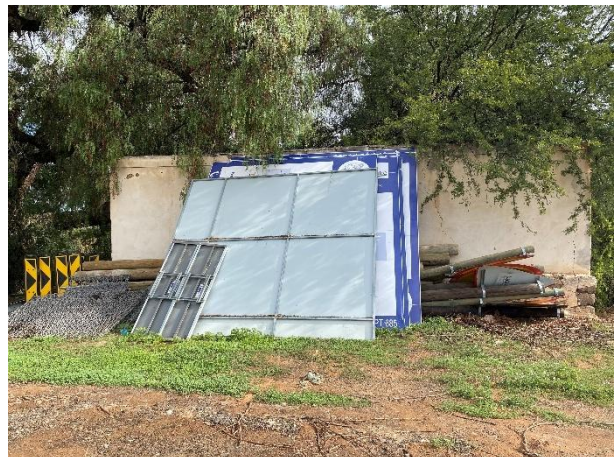
Contractor's notice boards remain stored at the site camp.

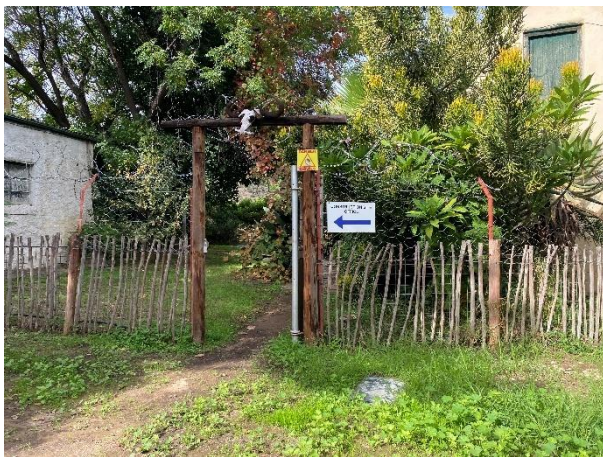
Previous site camp notice board.

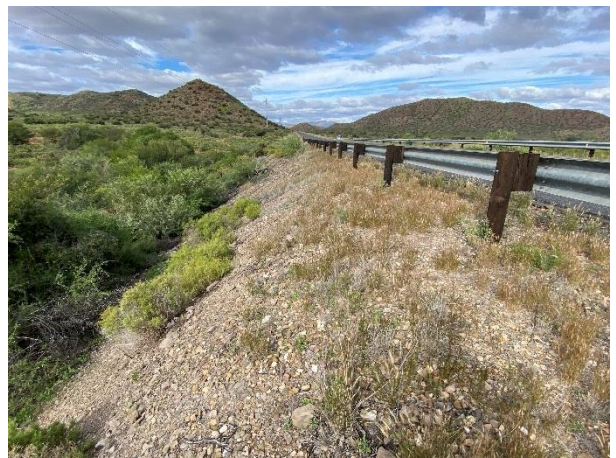
Regraded banks of the bridge.

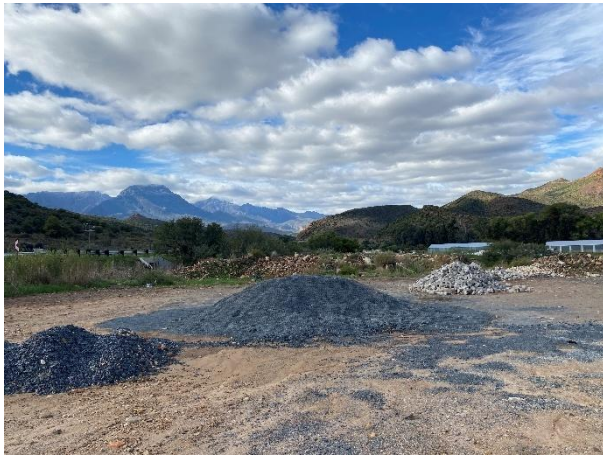
Condition of the construction camp with remained material stockpiles.

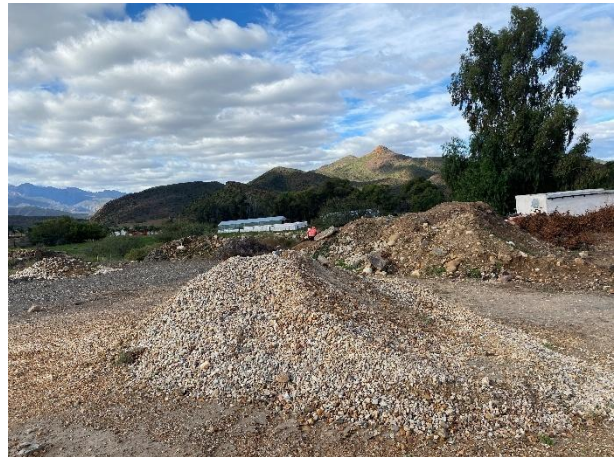
Remaining material stockpiles at the construction camp.

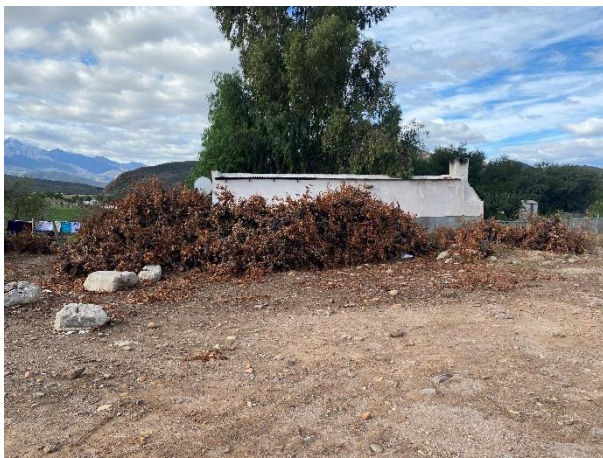
Vegetation debris located at the construction camp.

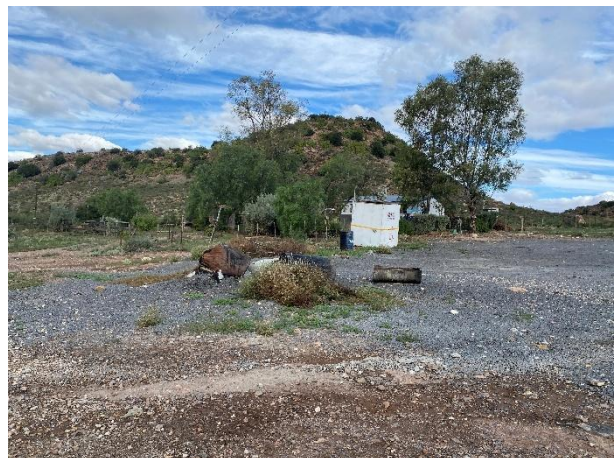
Vegetation debris located at the construction camp.

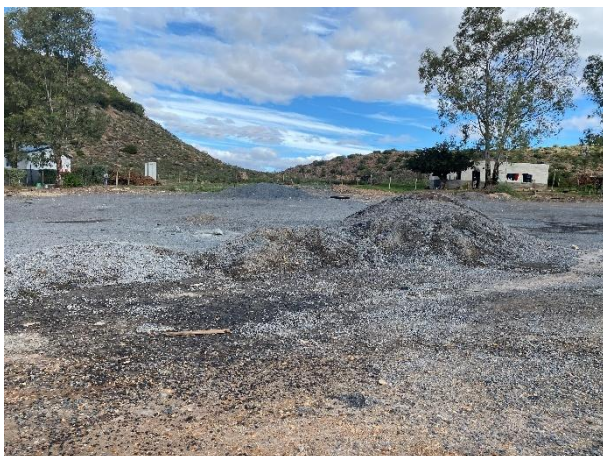
Remaining material stockpiles at the construction camp.

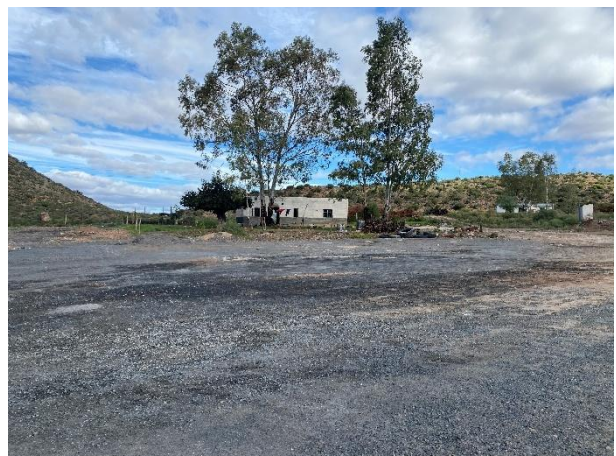
Oil and fuel residues remained at the construction camp.

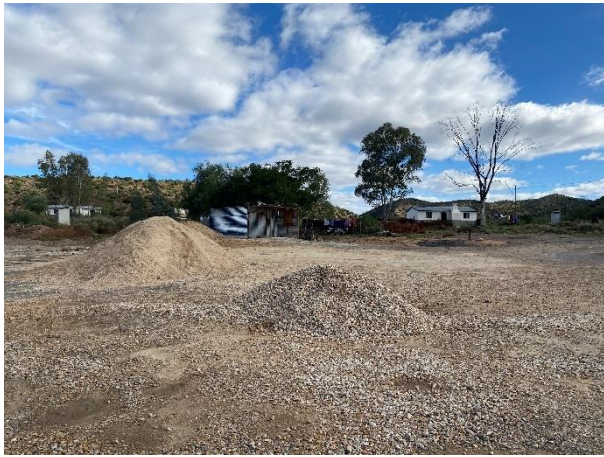
Remaining material stockpiles at the construction camp.

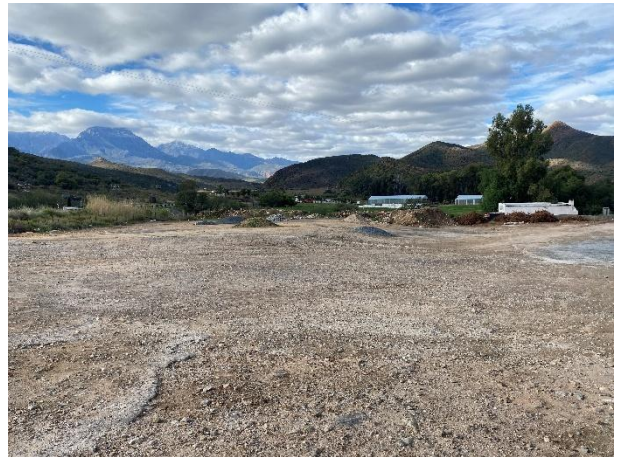
Remaining material stockpiles at the construction camp.

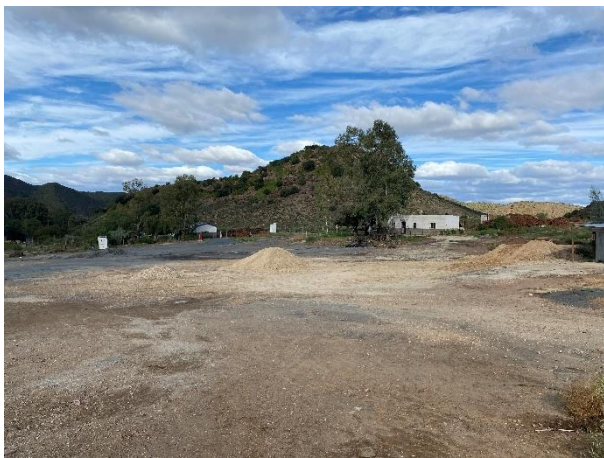
Remaining material stockpiles at the construction camp.

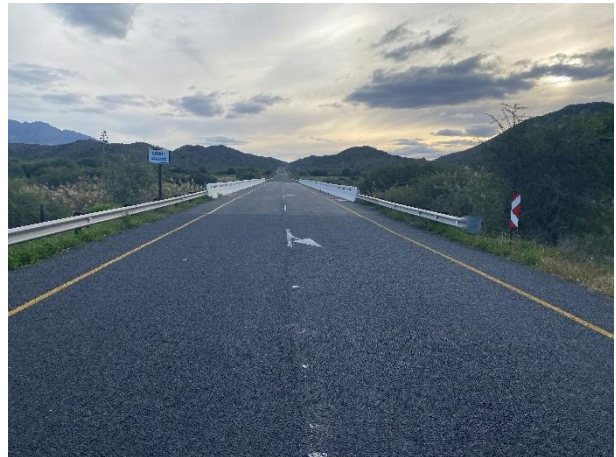
Condition of the newly installed guardrails and road surface at bridge 5490.

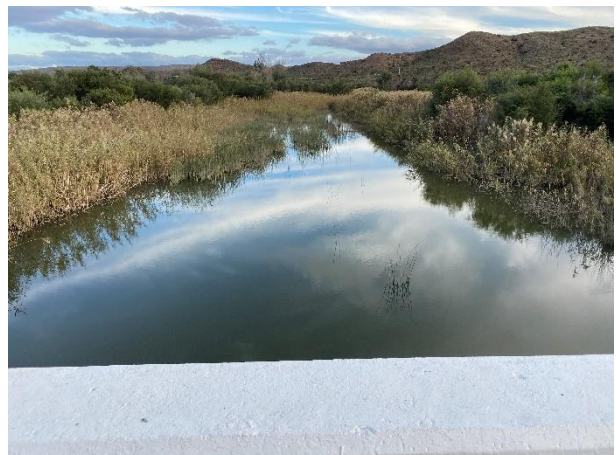
Condition of the vegetation surrounding the bridge.

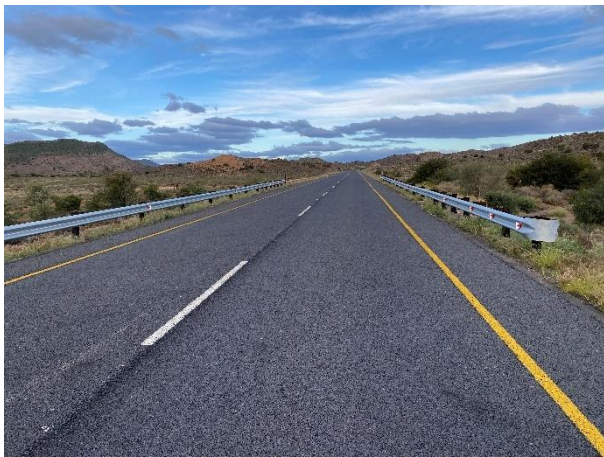
### Culvert 10976: TR83/2 at km 19.93

Condition of the newly installed guardrails and road surface at culvert 10976.

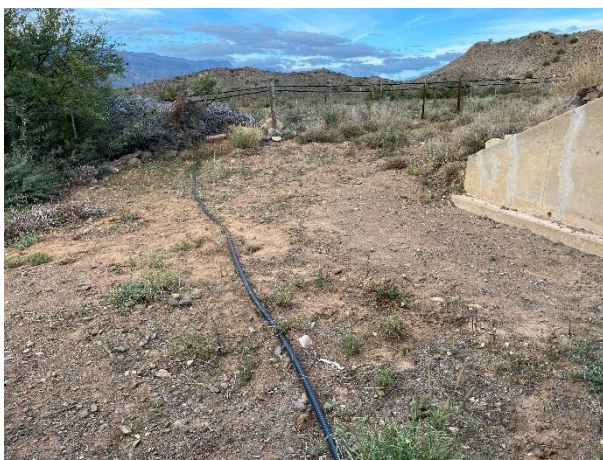
Condition of the vegetation surrounding the culvert.

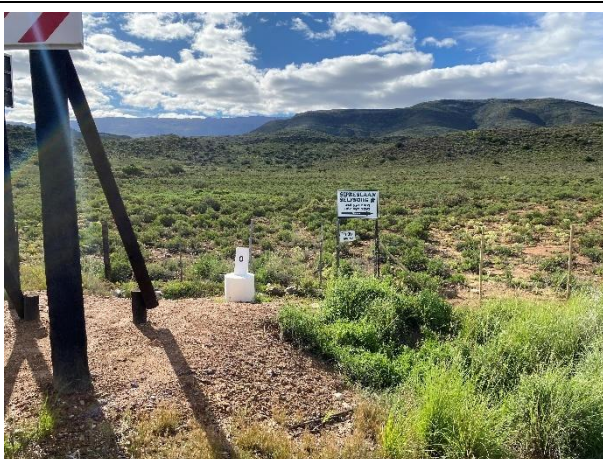
### Bridge 9061: MR 365 at km 3.30

Condition of the road reserve at MR 365.

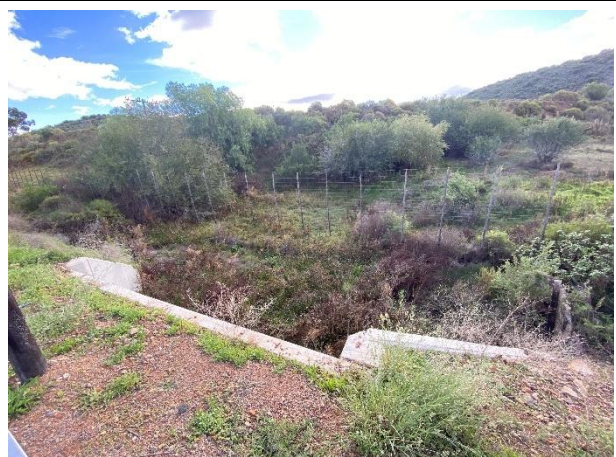
Condition of the vegetation surrounding the culvert.

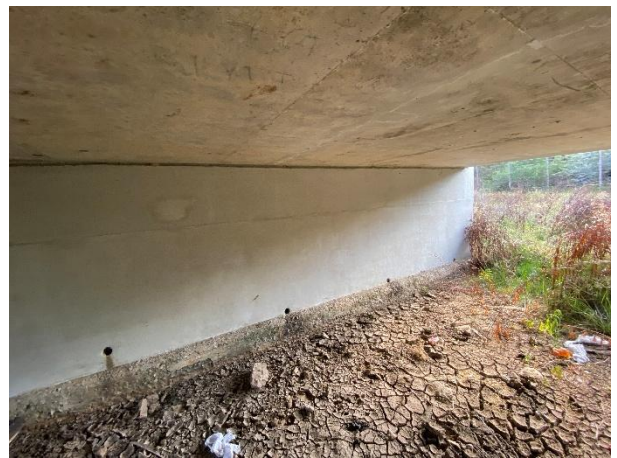
Concrete spalling and cracks repaired with an epoxy repair mortar.

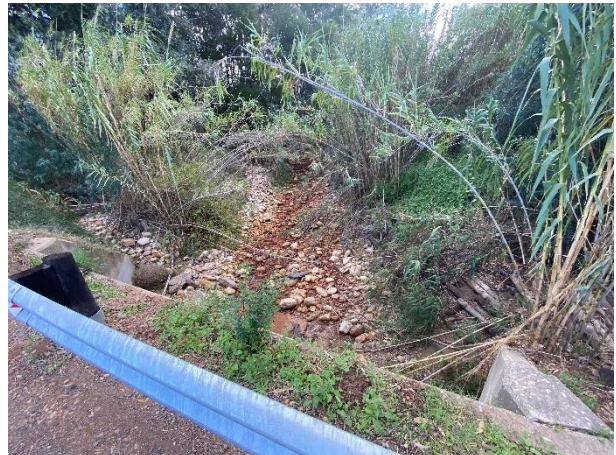
Condition of the vegetation surrounding the culvert.

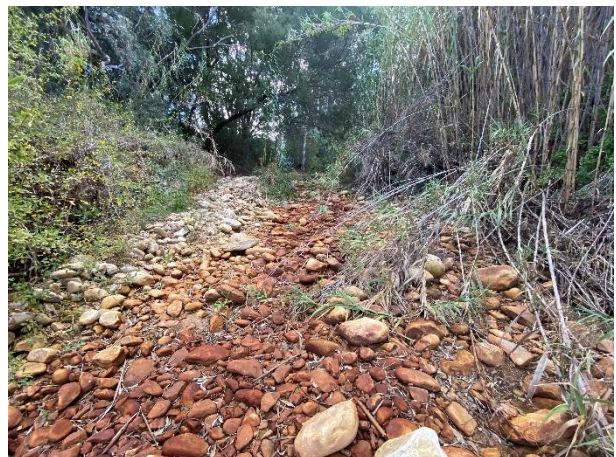
Removal of vegetation overgrowth and silt deposits.

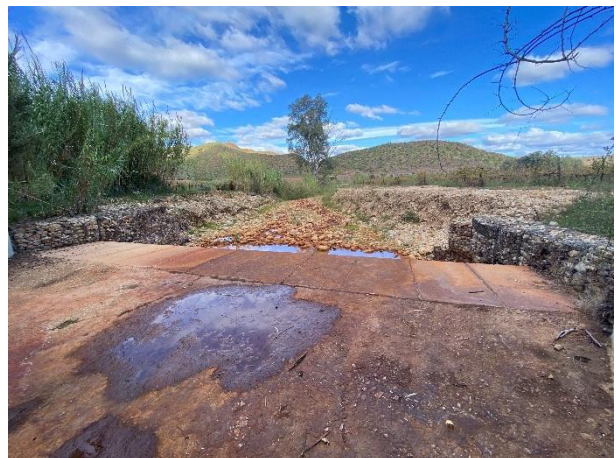
Removal of vegetation at wingwalls and the installation of gabion boxes.

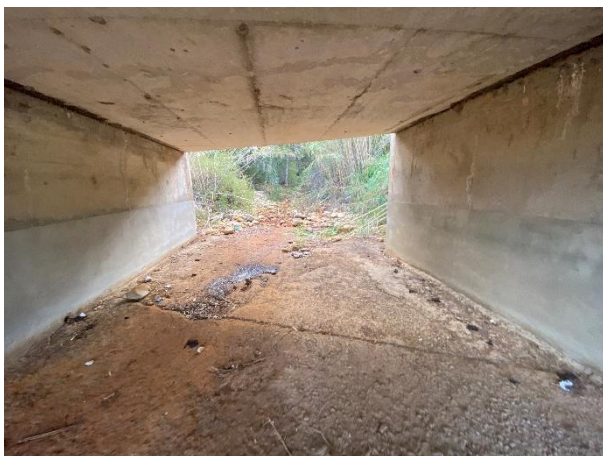
Removal of vegetation overgrowth and silt deposits.

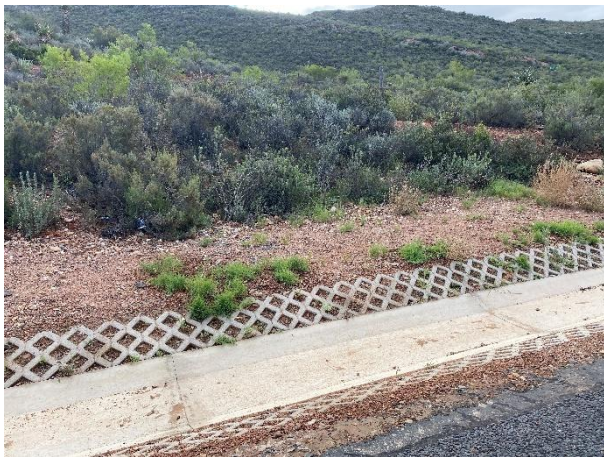
Culvert 10971: MR 365 at km 8.33

Upgraded side drains off MR 365.

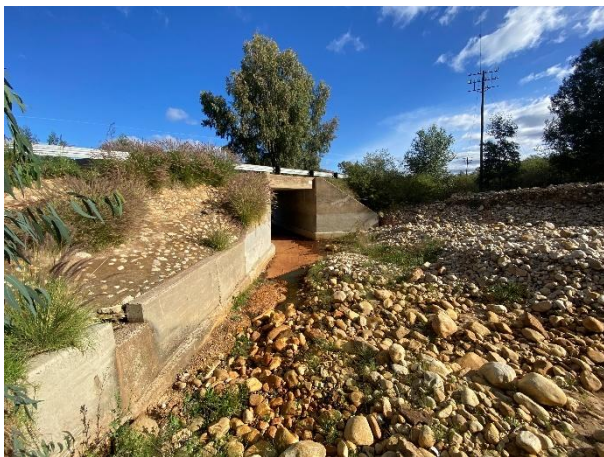
Condition of Culvert 10971.

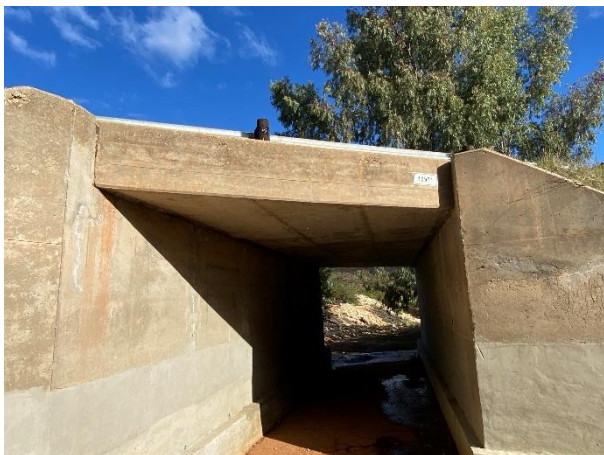
Replacement of the missing culvert number.

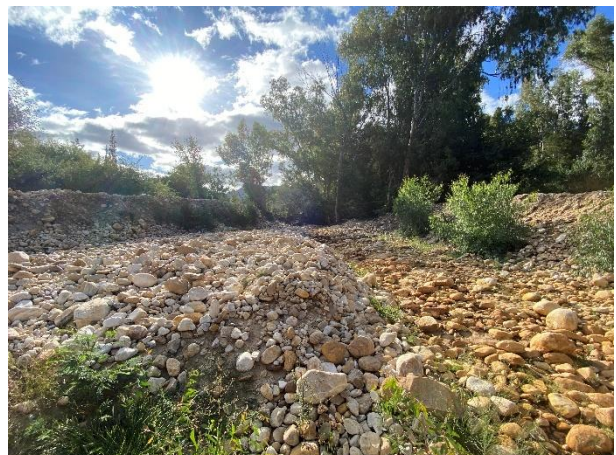
Condition of the vegetation surrounding the culvert.

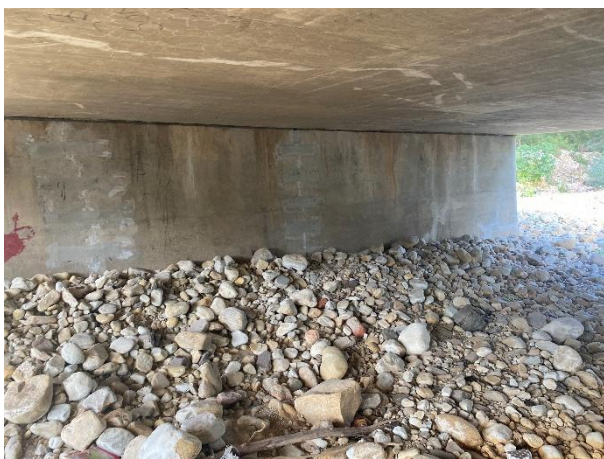
Removal of debris from the waterway.
