**PROPOSED REPAIR AND UPGRADE OF THE EXISTING  
DEGRADED STORMWATER INFRASTRUCTURE ALONG MAIN  
ROAD ("MR") 269 AT KM 4.95 AND KM 5.67 AND ALONG  
DIVISIONAL ROAD ("DR") 1257 AT KM 1.47, HEMEL & AARDE  
VALLEY, BETWEEN SANDBAAI AND CALEDON.**

**EXTERNAL ENVIRONMENTAL AUDIT REPORT IN TERMS  
OF REGULATION 34 OF THE NEMA EIA REGULATIONS,  
2014 (AS AMENDED).**

DEA&DP AMENDED EIA REF. NO.  
16/3/3/5/E2/15/1016/21

27 June 2025

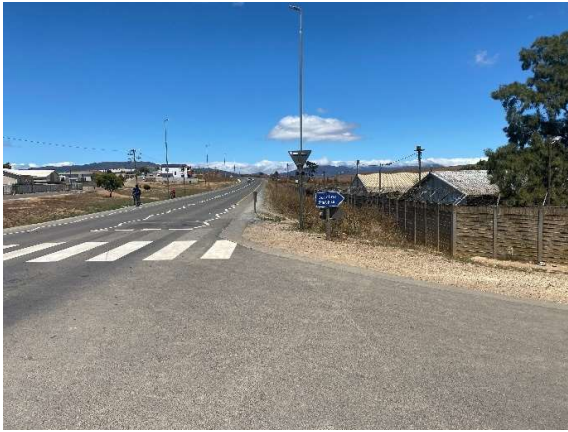
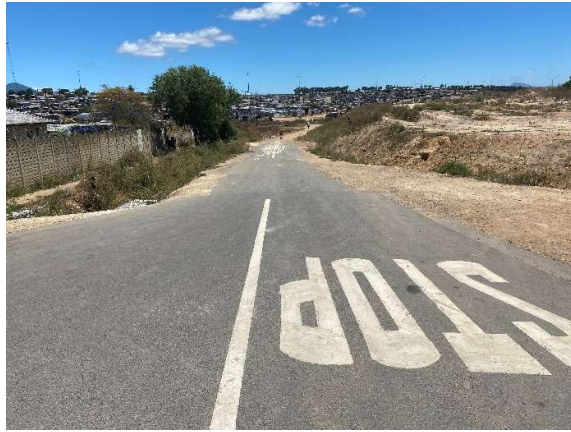
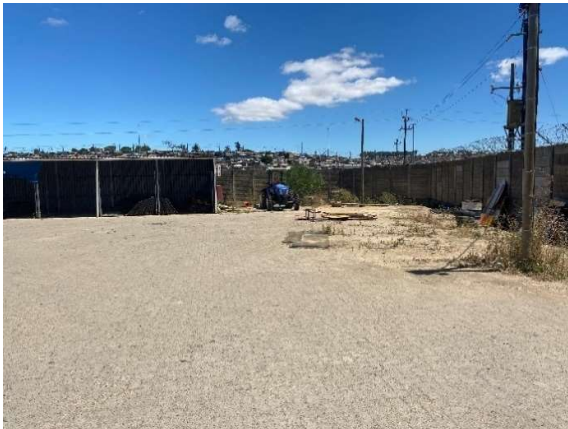
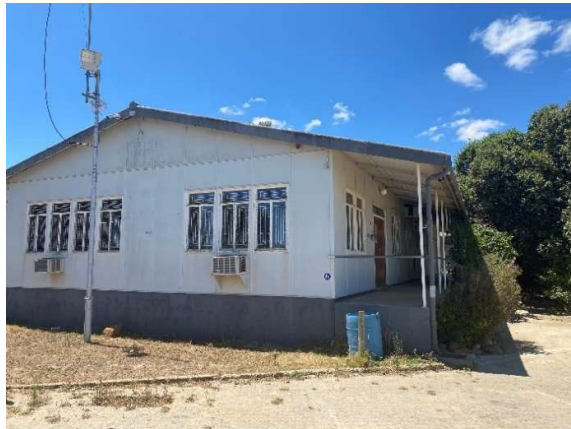
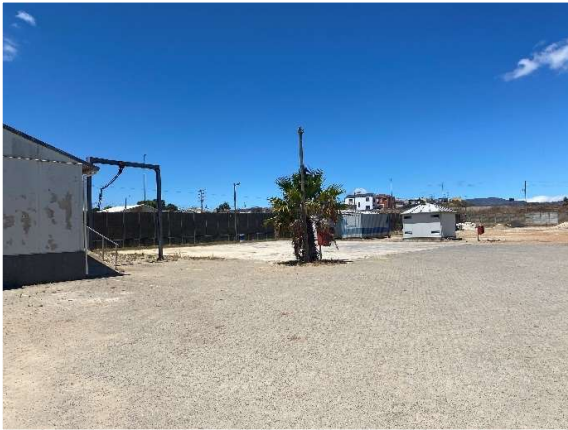
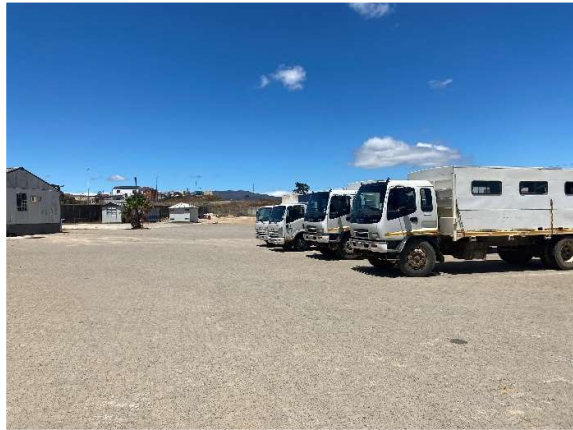
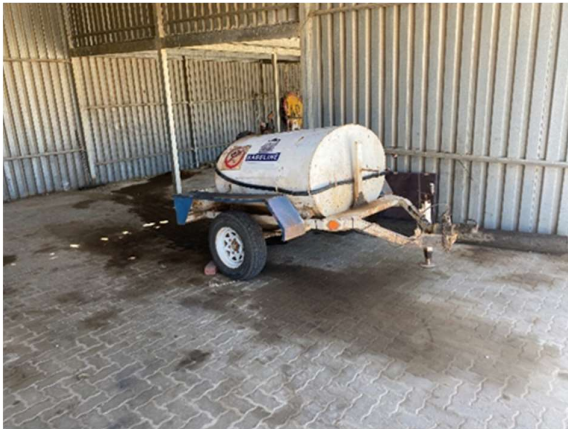
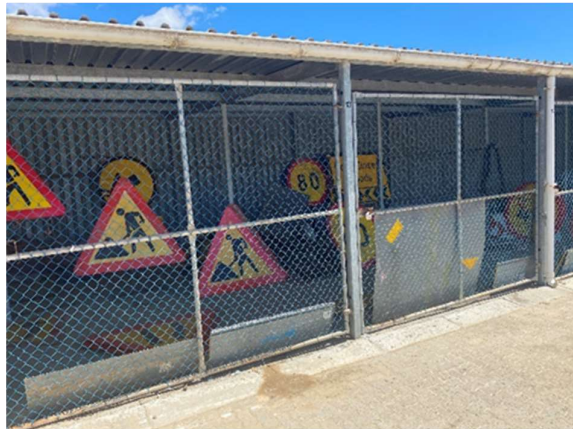
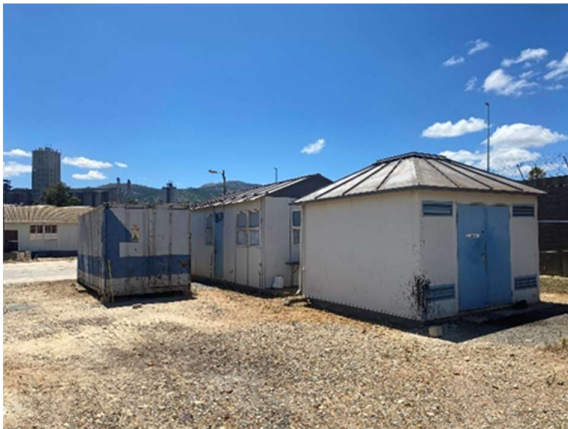
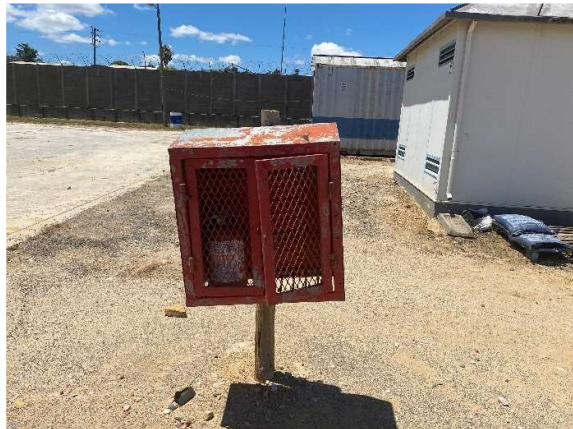
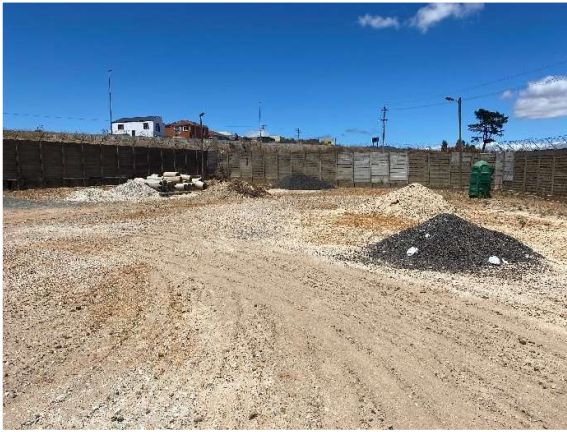
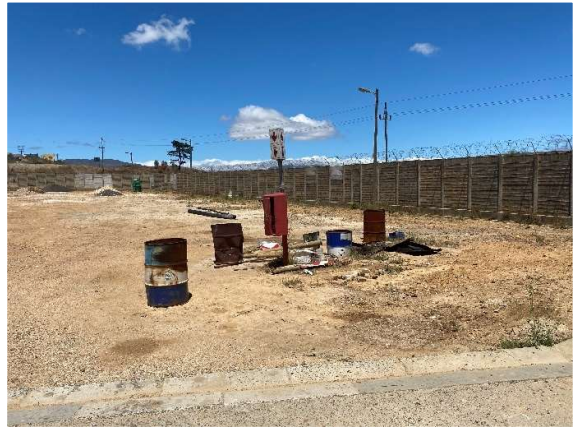
### Site Camp

The Site Camp is located off Hermanus Way at the northern end of the contract in Caledon. The site camp comprises an existing PGWC facility which includes storage areas and offices with all the required infrastructure permanently in place.

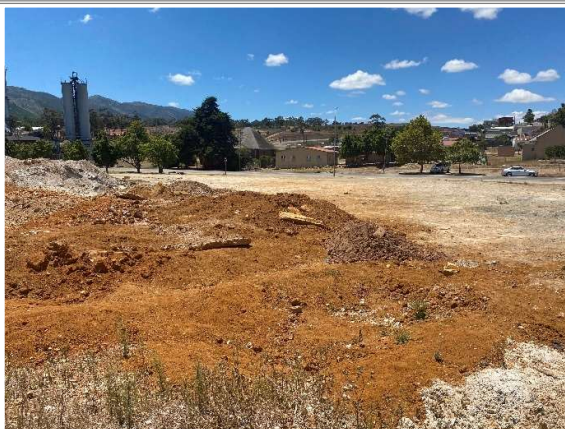
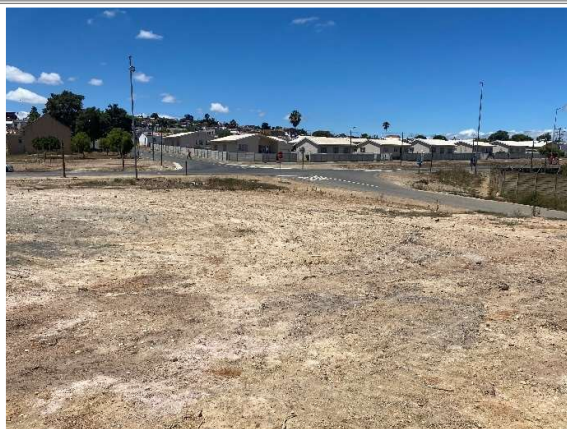
### Stockpile Area 1 on Hermanus Way

Stockpile area 1 is located immediately north of the site camp area off Hermanus Way. It is noted that this area has historically been utilized for material stockpiling of this nature.

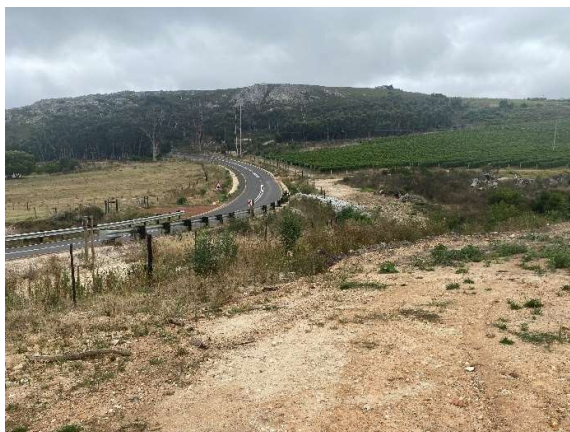
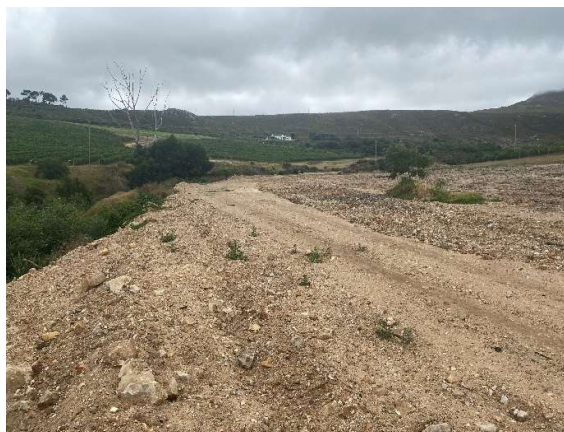
### Stockpile Area 2 at Culvert Km 5.67

Stockpile area 2 was located on existing agricultural fields along the Hemel and Aarde Road where the works were to be undertaken near the box culvert at Km 5.67. All stockpiled material has been removed, and the soil has been ripped as per the EMPr requirement.

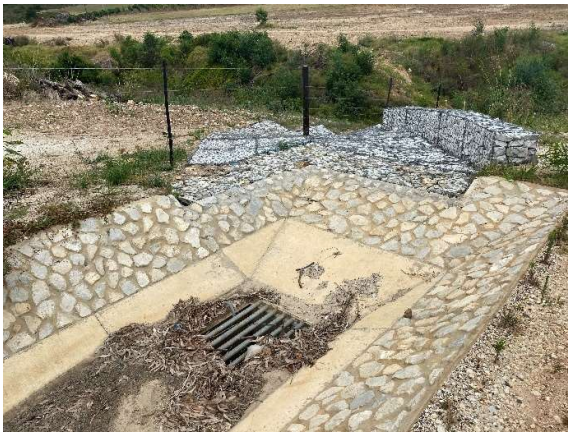
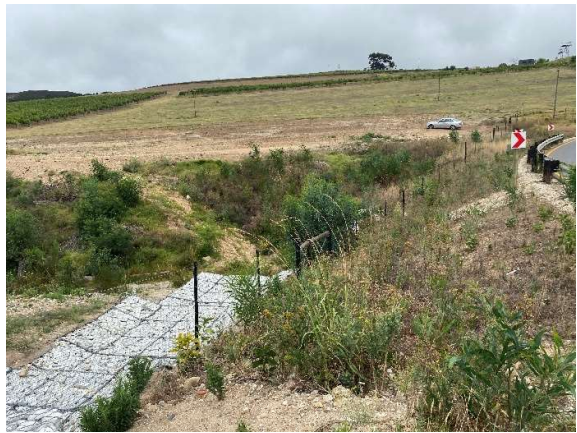
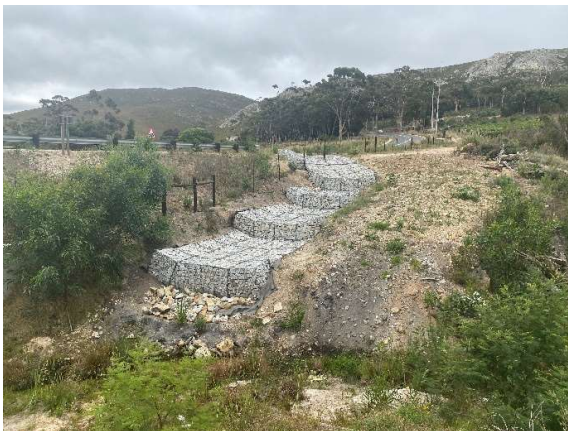
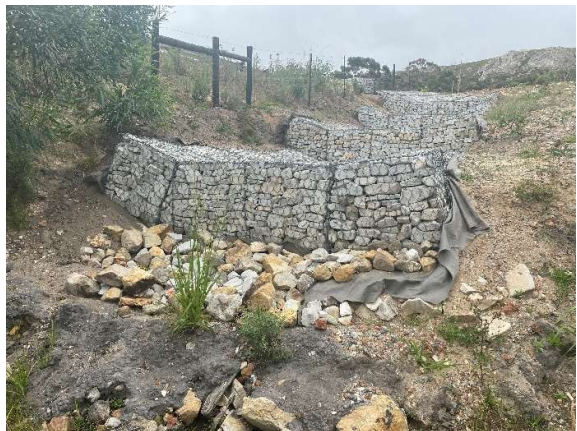
### **Culvert Upgrade at MR269 Km 5.67**

The culvert at Km 5.67 has been completed and the adjacent material stockpile has been removed and rehabilitated. The culvert has been extended, and guardrails have been installed at the culvert opening for enhanced road safety. Extensive gabion work has been completed both along the eastern and western road shoulders and at the inlets/outlets to stabilize the embankments and prevent flood-related erosion.
