## APPENDIX A – SITE PHOTOGRAPHS

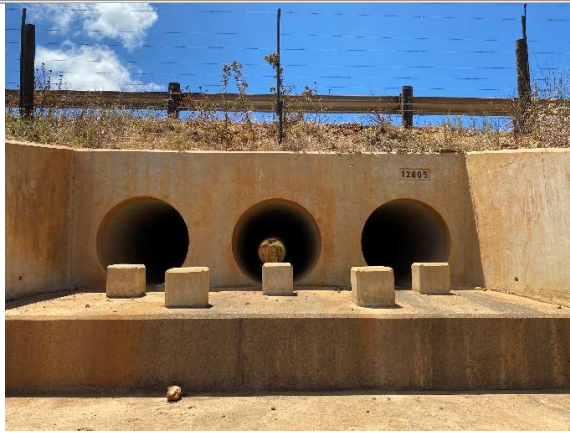
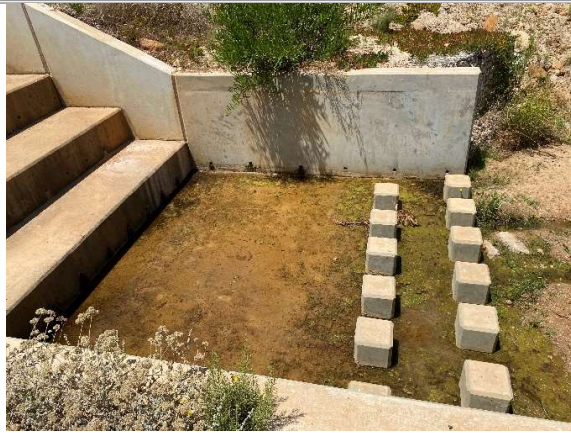
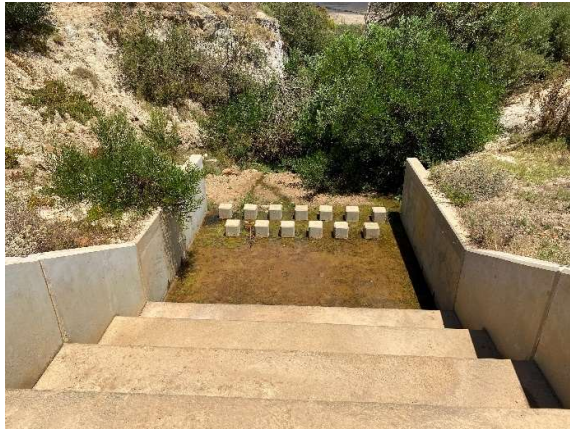
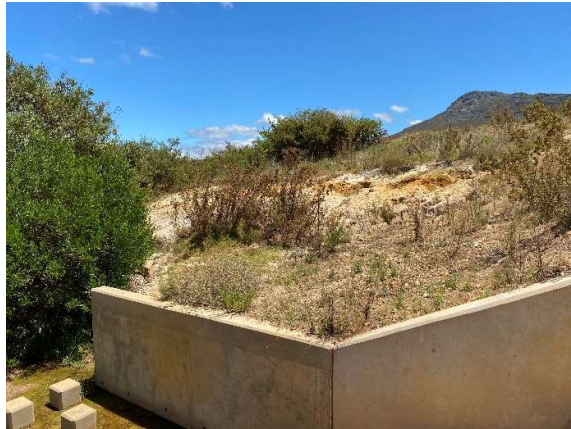
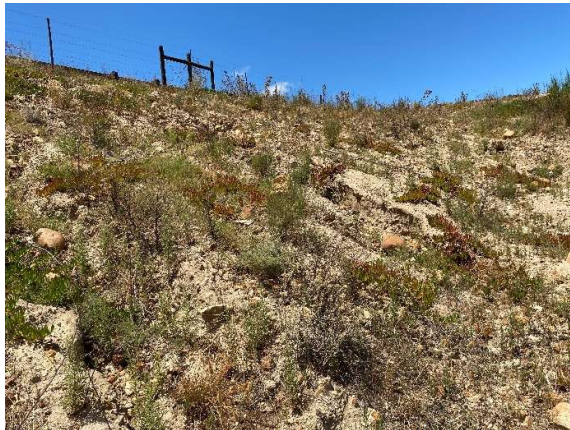
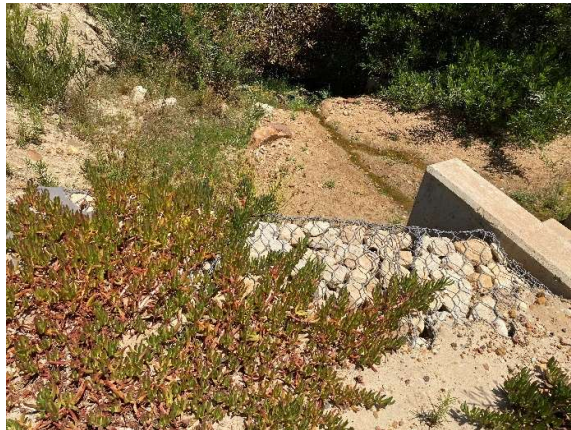
### **Culvert Upgrade and Rehabilitation at DR 1257 km 1.47**

The culvert along the DR 1257 has been upgraded and the cleared surrounding area has been rehabilitated with indigenous natural vegetation. The three 600mm diameter pipe culverts that failed structurally have been replaced with three 1050mm diameter pipe culverts and a stepped concrete energy dissipating structure at the outlet to manage water flow and prevent erosion. Gabions were installed at the toe of the outlet structure to protect the embankment from erosion.
