## APPENDIX A – SITE PHOTOGRAPHS

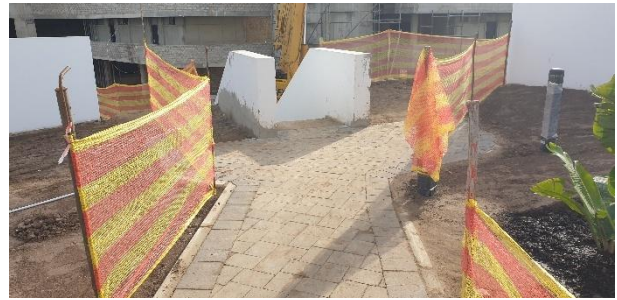
Demarcation in place surrounding the landscaping area and surrounding construction area.

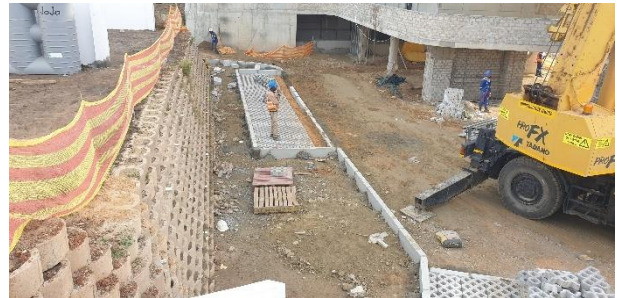
Demarcation in place around the construction of the apartment blocks.

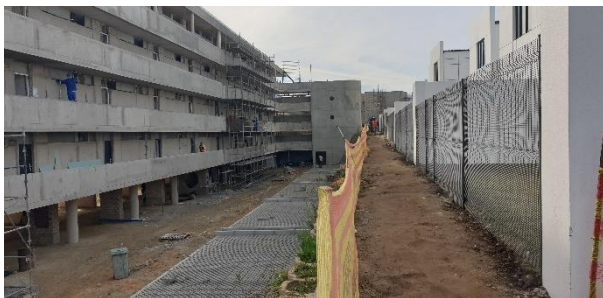
Demarcation netting is installed to prevent contractor falls at edges.

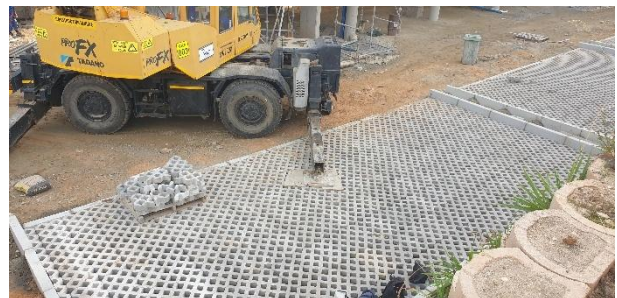
SUDS being installed.

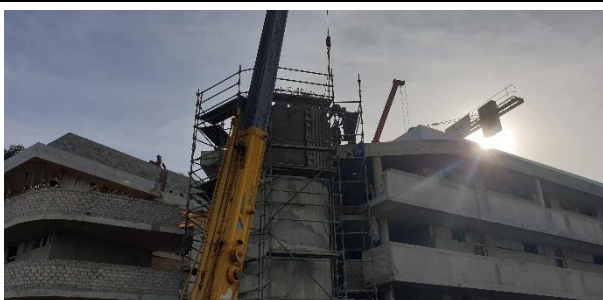
Construction of the apartment units.

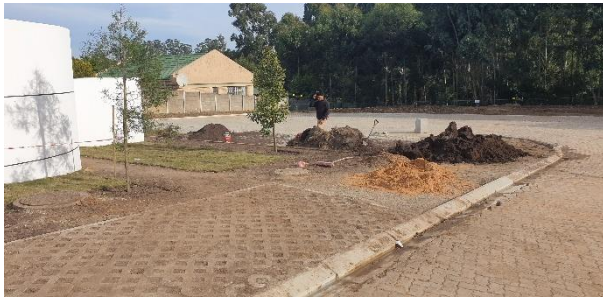
Landscaping of outside gardens in progress.

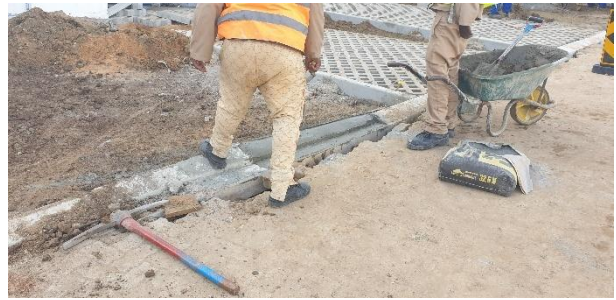
Curbs being installed.

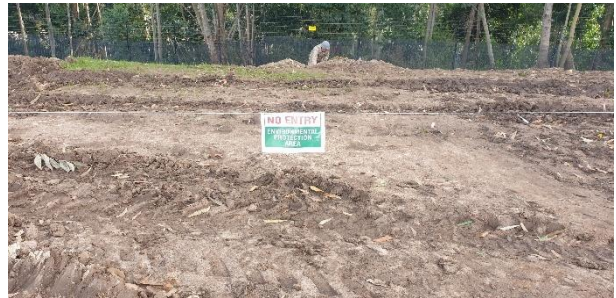
No-go demarcation in place along the entire Malgas River boundary.

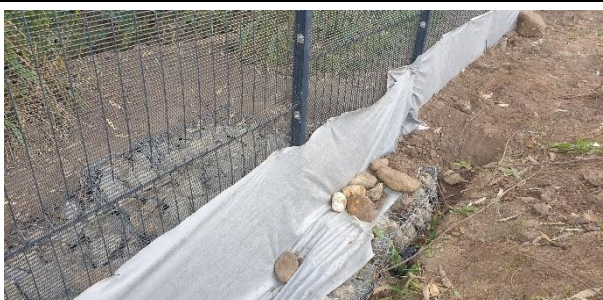
Gabion mattresses installed to prevent uncontrolled surface flow.

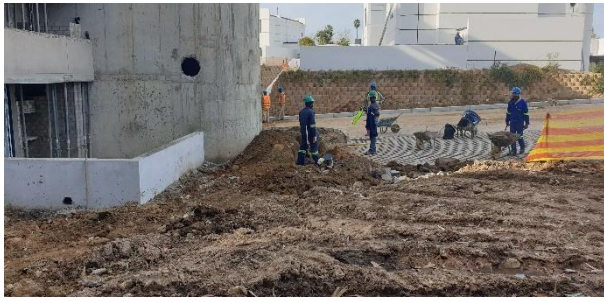
Civil services along the apartment block being installed.

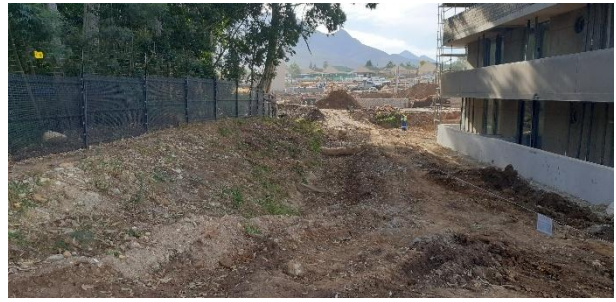
Temporary stormwater channels for surface flow.

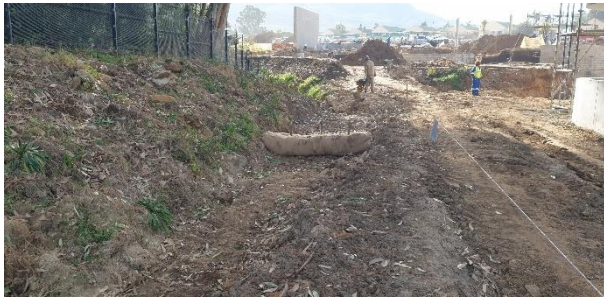
Temporary stormwater channels for surface flow with hay bales.

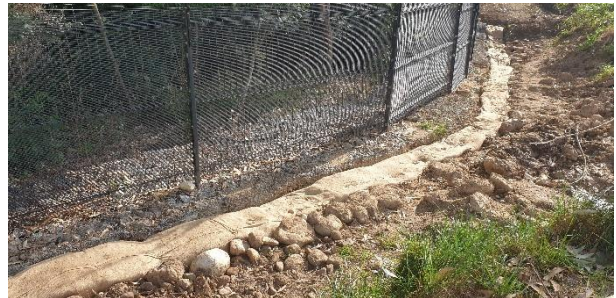
Installed hay bales along the security fence.

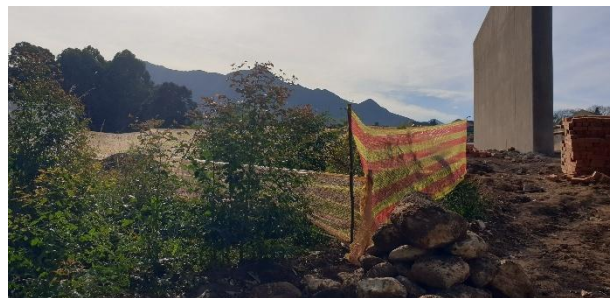
Demarcation surrounding the stormwater outline.

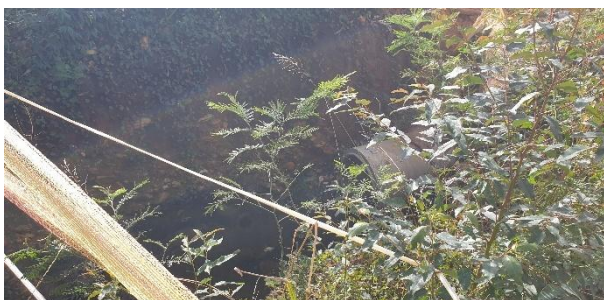
Stormwater outlet towards the riparian area.

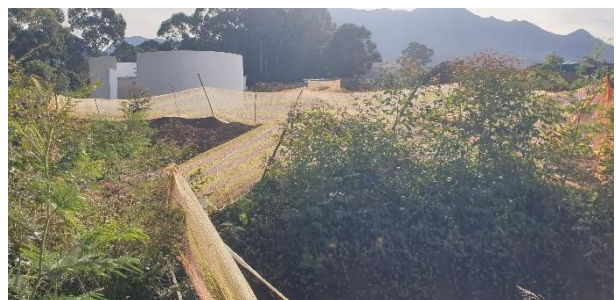
Demarcation surrounding the stormwater outline.

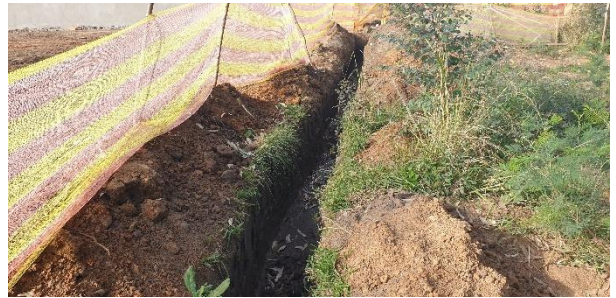
Electrical lines being installed.

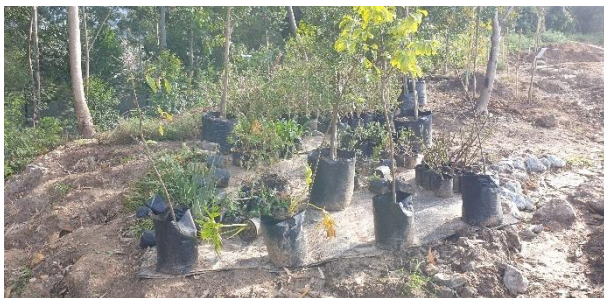
Indigenous plants being planted in the rehabilitation zone.

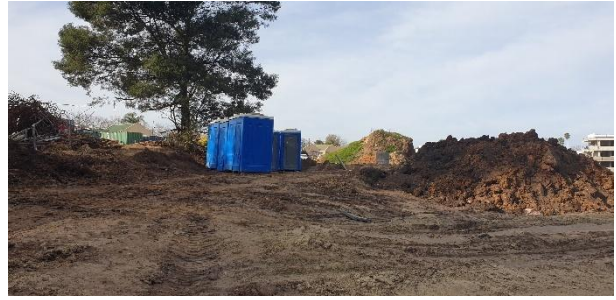
Chemical toilets in place along the construction areas.

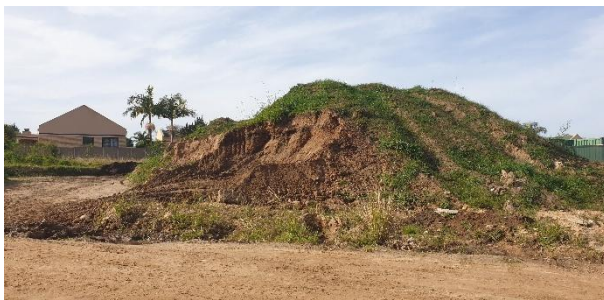
Topsoil and subsoil stockpiles were excavated after roadways were cleared.

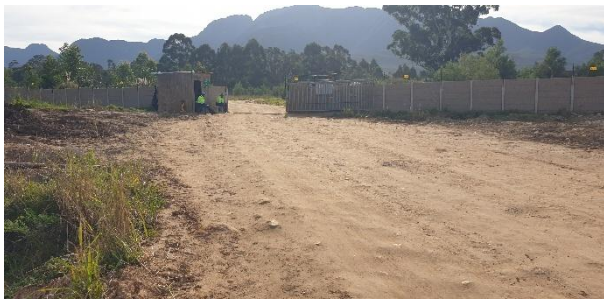
Temporary access road off plantation road.

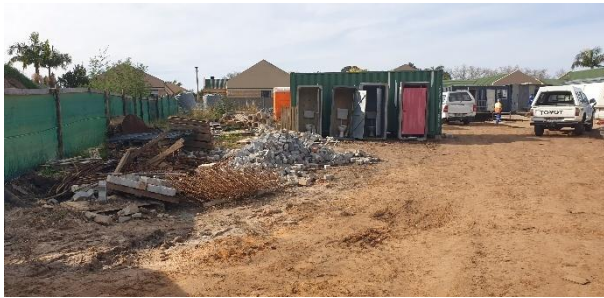
Construction site camp with build in toilets feeding into the sewage network on-site.

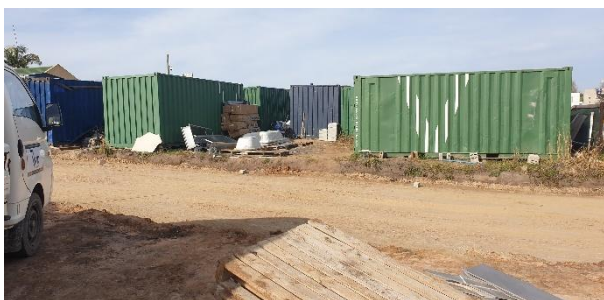
Lockable storage containers within the site camp.

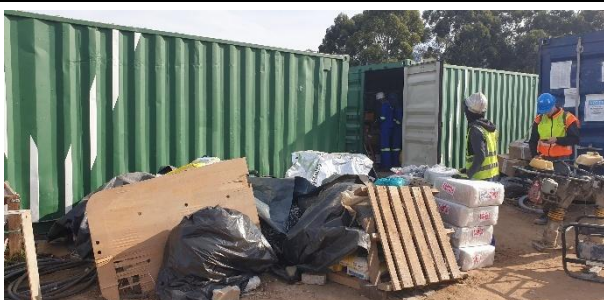
Lockable storage containers within the site camp.

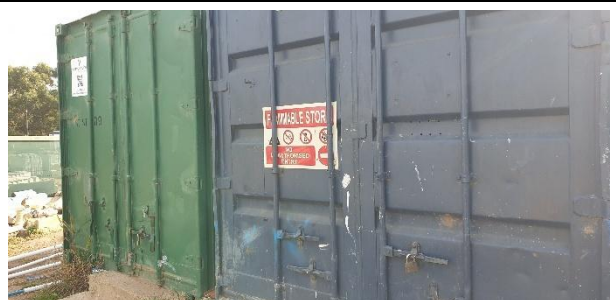
Appropriate signage in place indicating flammable content.

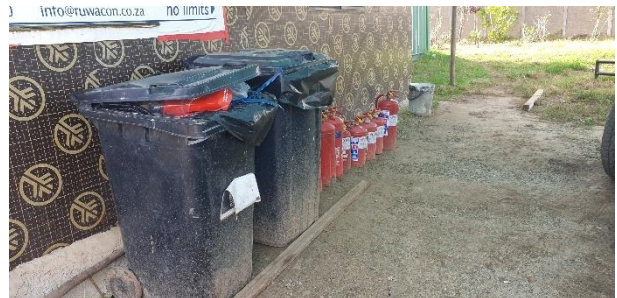
Fire extinguishers available at the site camp.

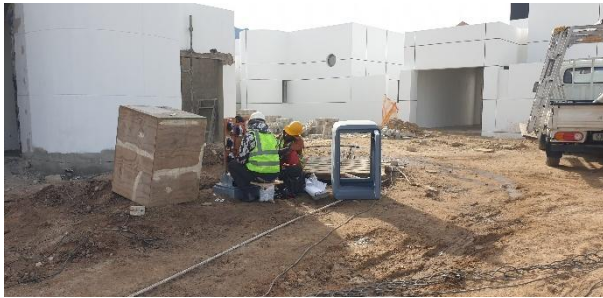
Electrical installations in progress at the individual units.
