**ENVIRONMENTAL MONITORING REPORT NO. 46**  
**FOR**  
**HARTLAND ON**  
**PORTION 11 OF FARM VAALE VALLEY 219, MOSSEL BAY**

**MOS25/1027/74**

**June 2025**

## ENVIRONMENTAL MONITORING REPORT NO. 46 – JUNE 2025

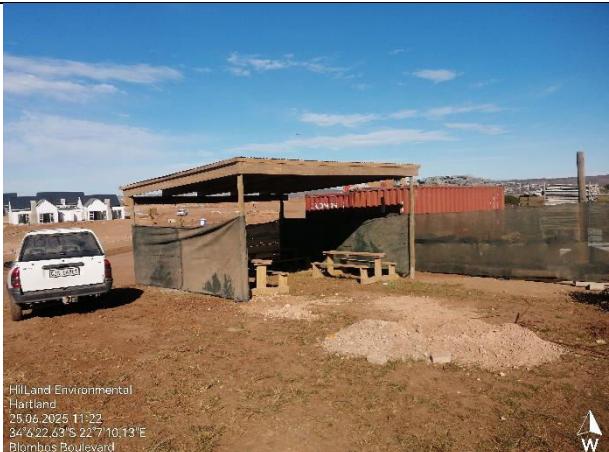
| EMPr requirements | Compliance notes | Comments / Findings | Photos (if applicable) |
|---|---|---|---|
| <p>10.2.1; 10.2.2; 10.3.5; 10.3.6 –<br/>The site camp must be set up prior to the start of construction and clearly demarcated to illustrate NO-GO areas.</p> <p>The site camp, storage facilities, stockpiles, waste bins, and any other temporary structures on site should be located in such a way that they will present as little visual impact to surrounding residents and road users as possible.</p> | In general, compliant | <p>The site camp is in the process of being moved to Phase O. The old site camp is still being used.</p> <p>The footprint area of the current site camp must be rehabilitated to the satisfaction of the ECO and developer once the move is complete.</p> | <p>Hilland Environmental<br/>Hartland<br/>25.06.2025 11:22<br/>34°02'22.63"S 21°17'10.13"E<br/>Blombos Boulevard</p> |

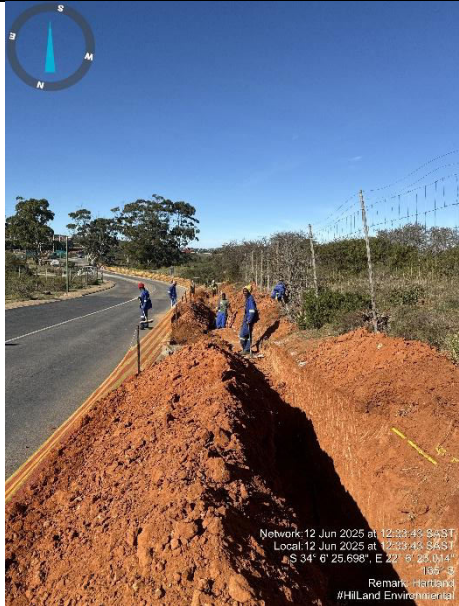
| <p>All sensitive areas, which must not be disturbed, must be demarcated using a 1.2m high fence constructed of shade cloth netting (<b>or similar product</b>), staked at regular intervals. Where a fence is considered impractical No-Go signs should be erected at frequent intervals along the edge of the no-go areas in consultation with the ECO.</p> <p>Demarcate protected trees on site.</p> <p>Demarcation of access points and haulage routes would also be important and need to remain in place for the full duration of the construction phase. This demarcation would also serve the purpose of informing and warning passing vehicular traffic of the construction activities taking place.</p> <p>All construction vehicles need to adhere to traffic laws. The speed of construction vehicles and other heavy vehicles must be strictly controlled to avoid dangerous conditions for other road users. As far as possible care should be taken to ensure that the local traffic flow pattern is not significantly disrupted.</p> <p>Use existing construction haul routes.</p> <p>Chemical toilets must be kept at the site camp, on a level surface and secured from blowing over.</p> | <p>In general, the contractor(s) are compliant. Attention should be given to the demarcation of the construction haul routes.</p> | <p>The working zone is pegged by the surveyor before construction starts - ongoing.</p> <p>The conservation area/natural vegetation adjacent to the Retirement village is demarcated with a suitable fence - ongoing.</p> <p>Indigenous hedgerow (southeast) of the school sport field has been surveyed – in terms of condition 20 of the EA existing hedgerows are to be retained, however in this case it would not be possible. An NFA license is required for the removal/disturbance of protected milkwood trees.</p> <p>Bulk electrical – within the road reserve (R102/Monte Christo Road/SANRAL) – indigenous vegetation (aloes) is avoided. No other protected vegetation was noted.</p> <p>Construction haul routes are currently not demarcated and it is a concern that there are several construction haul routes in close proximity. It should also be noted that the majority of the internal roads have been opened up and that these roads should be used for the construction haul routes instead.</p> <p><b>Haul routes to be demarcated to prevent unnecessary off-road driving or creating new haul routes.</b></p> <p>All construction haul routes must be rehabilitated to the satisfaction of the ECO and developer at completion of the phase.</p> <p>There is adequate ablution facilities located throughout the site and at the site camp – no</p> | |

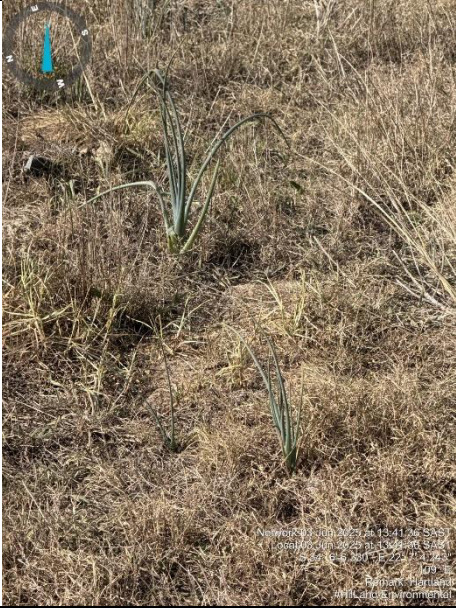
| <p>10.3.2-<br/>Plant identification must be done whereby they must be rescued and relocated to an appropriate location for later use in rehabilitation.</p> <p>The site must be cleared of all alien plants and trees during the construction phase, except for the Eucalyptus tree at 34°06'20.87"S 22°07'26.36"E in which the Jackal Buzzard pair has a nest, in the eastern portion of the assessment area adjacent to the natural dune vegetation. Jackal Buzzard use the same nest for up to five years or alternative between nest sites (Allan, 2005).</p> | <p>Ongoing</p> | <p>Development zone is the historic agricultural fields, <i>mainly grass</i>. <b>Geophytes are to be rescued</b> -they must be used in rehabilitation - ongoing.</p> <p>Ongoing – record to be kept of the plants that are rescued and submitted to the ECO for record keeping – <i>no record received during this reporting period</i>.</p> | |

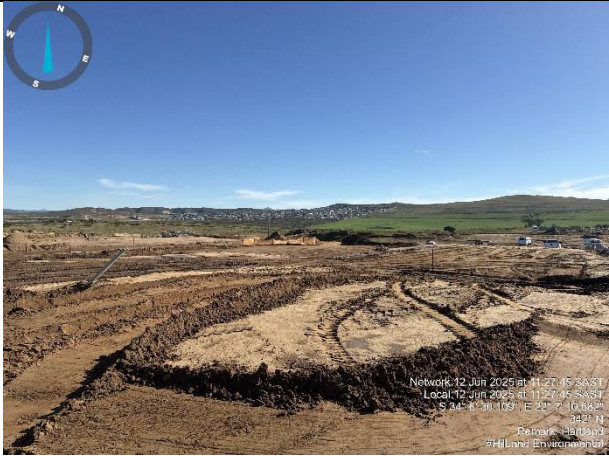
| No clearing outside of development and infrastructure footprint area to take place. | Ongoing | Clearing takes place within the demarcated development footprint / pegged working area. | |

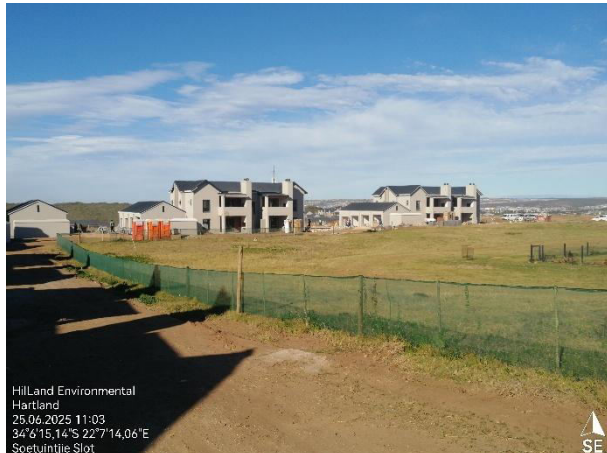
| EMPr Reference | Requirement / Environmental Aspect | Compliance (Yes/No/N.A.) | Observations / Comments |
|---|---|---|---|
| Section 10.2.1 | No-Go areas clearly demarcated and fenced off with signage | Yes | <p>Housing construction sites that border sensitive areas are demarcated. The site (8104/8105) has been demarcated.</p> <p>Fynbos Heuwels and the Retirement Village are demarcated with wire fences.</p> <p>Other construction sites are demarcated with wire fence or shade netting.</p> <p>Hilland Environmental<br/>Hartland<br/>25.06.2025 11:03<br/>34°6'15.14"S 22°7'14.06"E<br/>Soetuintjie Slot</p> |

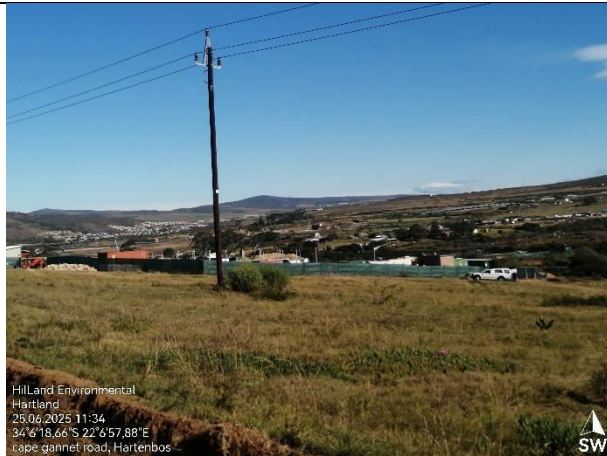
| EMPr Reference | Requirement / Environmental Aspect | Compliance (Yes/No/N.A.) | Observations / Comments |
|---|---|---|---|
| Section 10.2.2 | Site camp and materials storage areas placed outside sensitive/no-go zones | Yes | <p>The building contractor is in the process of moving the site camp to Phase O. The old site camp is currently still being used.</p> <p>The footprint area of the current site camp must be rehabilitated to the satisfaction of the ECO and developer once the move is complete.</p> |

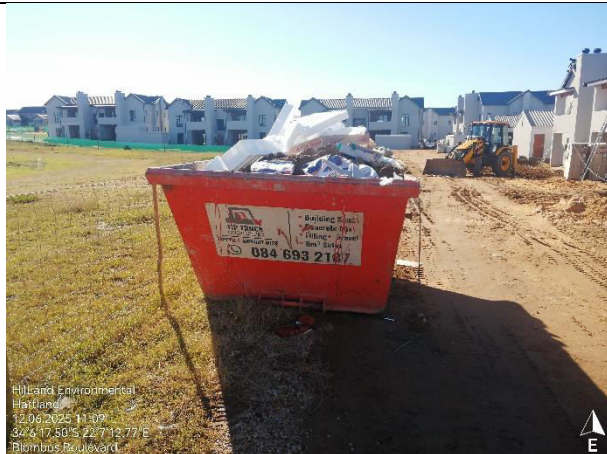
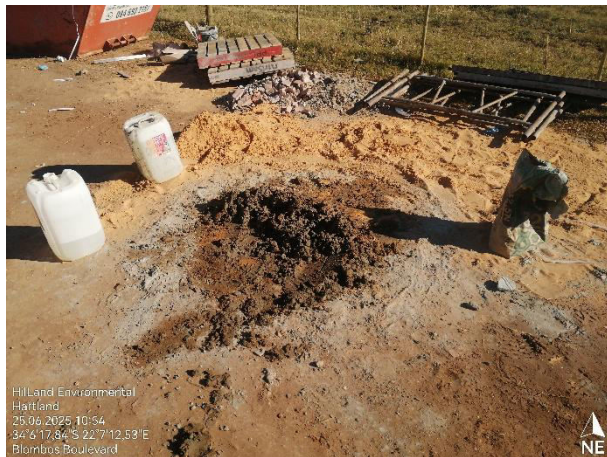
| | | | <p><b>Ongoing</b> - Wind-blown litter remains an ongoing construction related problem. Therefore, the contractor has a dedicated litter picking team conducting weekly litter picking.</p> <p>Either the bins must be cleaned out more frequently or the workers must be briefed on waste and litter weekly.</p> <p>The HOA has also appointed a dedicated litter picker.</p> <div data-bbox="1232 489 1836 946"><p>Hilland Environmental<br/>Hartland<br/>19.08.2025 14:23<br/>34°59'63"S 22°7'38,15"E<br/>Hartland Lifestyle Estate, 1 Kopleys Close, Hartenbos,<br/>6520</p><p>SE</p></div> |

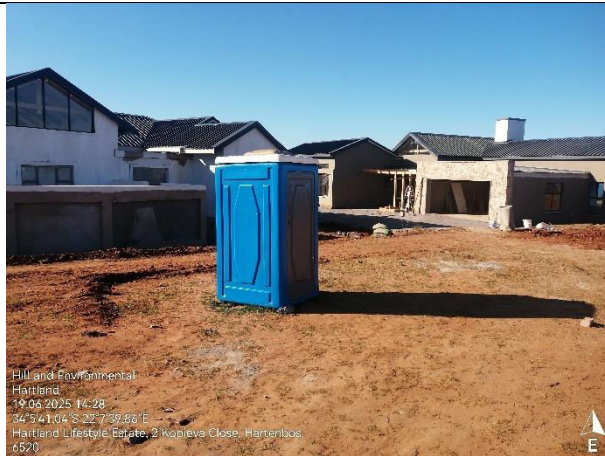
| Section 10.3.1 | Ablution facilities placed correctly and regularly serviced | Yes | <p>There are several portable toilets throughout the development zone.</p> <p>Toolbox talk to be done with construction staff. Natural veld may not be used for ablution activities.</p> |

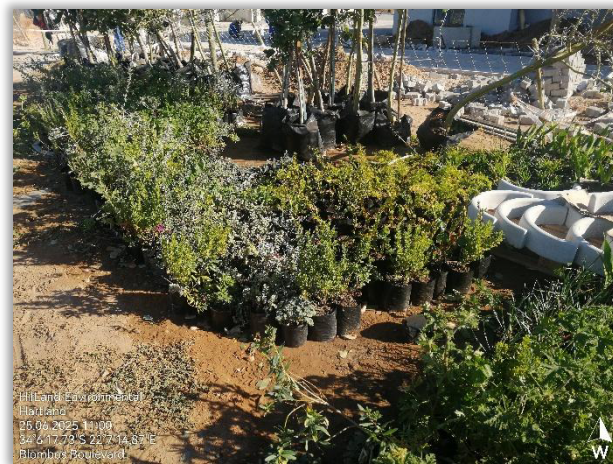
Indigenous plants for rehabilitation

Rehabilitation requirements are specified in the EMPr (**Section 10.4**). Some of which include all exposed and disturbed surfaces must be rehabilitated, compacted soil must be loosened, topsoil respread and seeded with indigenous grass seed mixture or rescued indigenous vegetation. Erosion protection will be required on the steeper slopes – small soil berms, silt fences, hay bales, logs etc. (as discussed and approved by the ECO).
