## APPENDIX A – SITE PHOTOGRAPHS

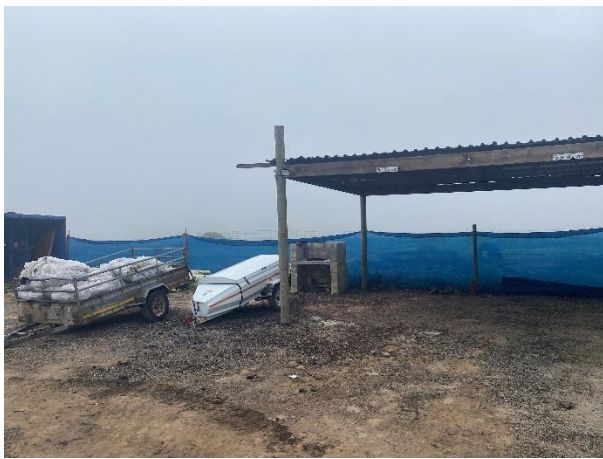
Site camp area with storage trailer, construction materials, and temporary shelter structure.

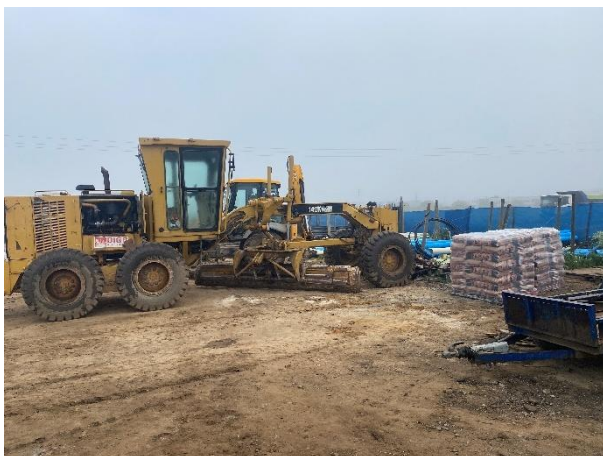
Asphalt paver located within the site camp.

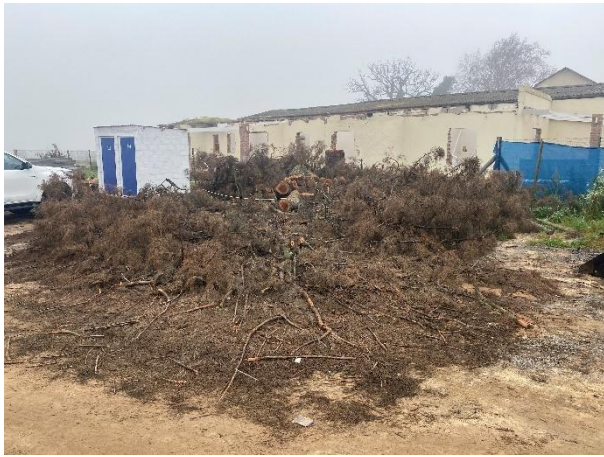
Toilets in place adjacent to the site camp. Vegetation debris surrounding the area.

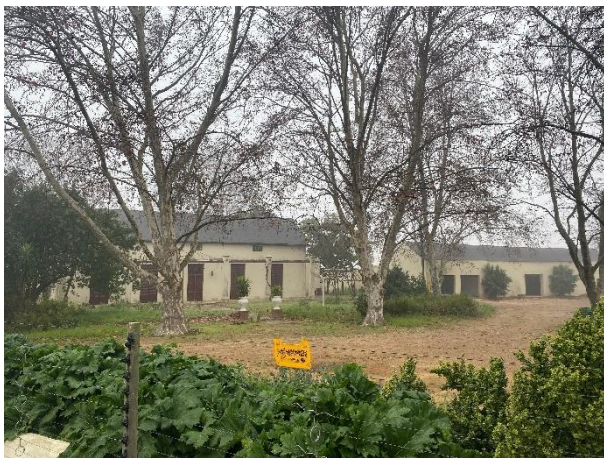
Workers' homesteads to be demolished and crushed; Firwoods Homestead to be retained.

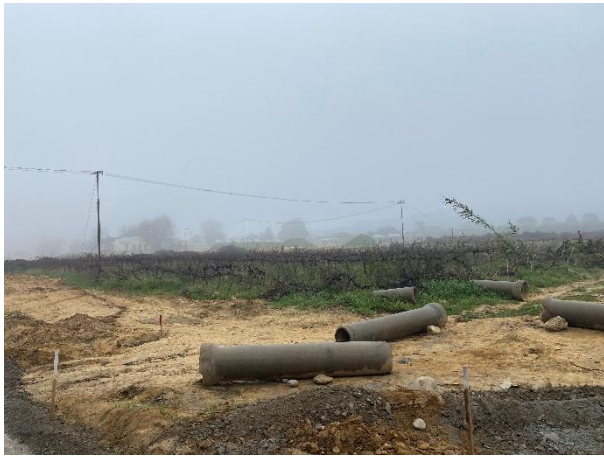
Stormwater pipeline material adjacent to the road being chipped and sprayed west of the Firwoods Homestead.

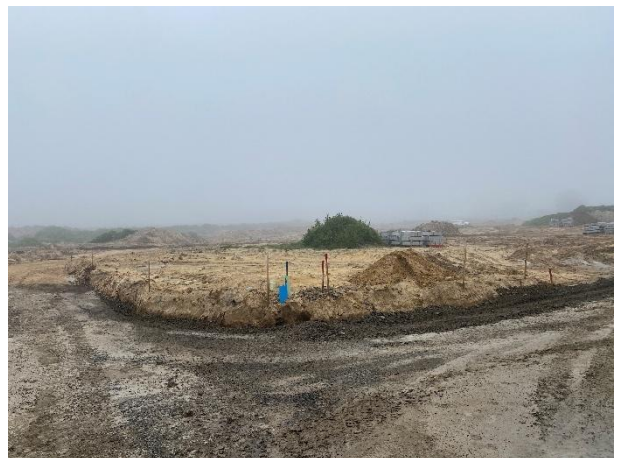
Towards the west, internal roads are being chipped and sprayed with material placed along the development.

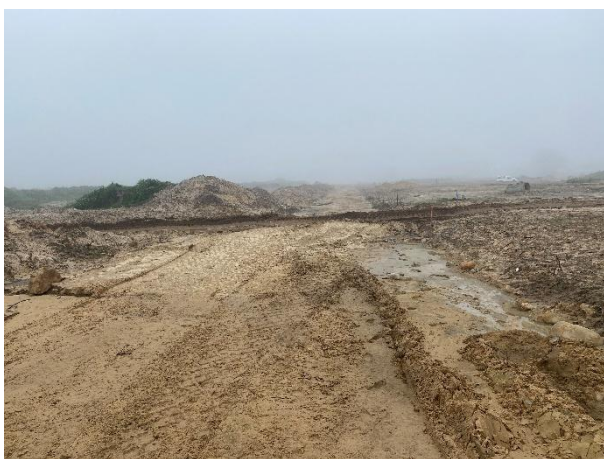
Road surfaces being prepared for asphalt.

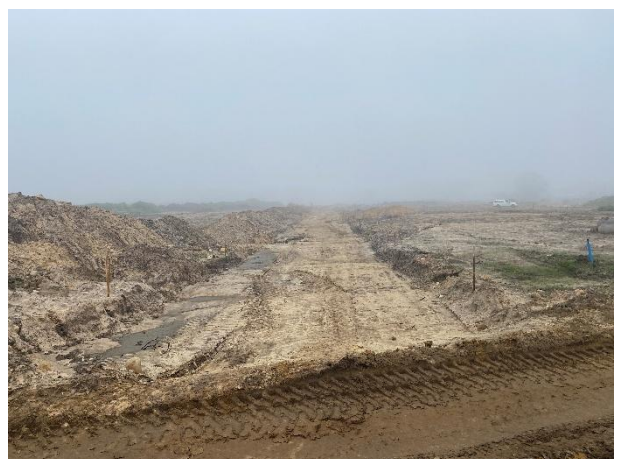
Road surfaces being prepared for asphalt

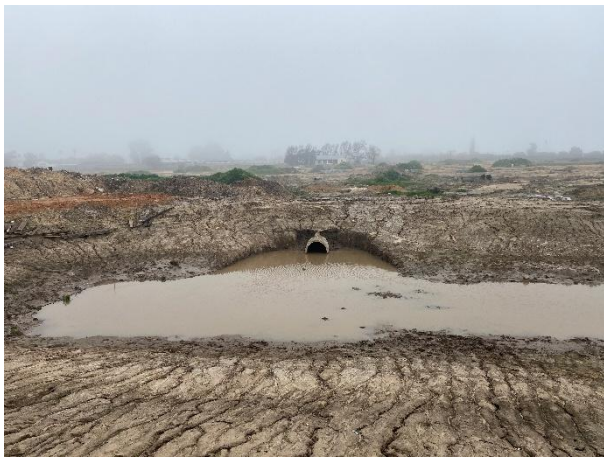
Stormwater pipeline installed in the large pond to direct water toward the main outlet along the Berg River.

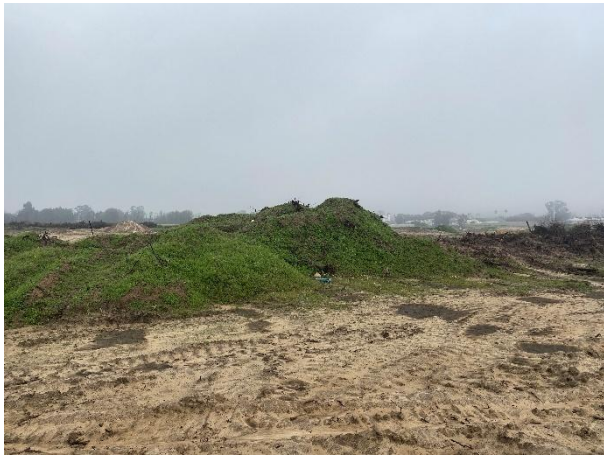
Topsoil stockpiles southwest of the large stormwater pond.

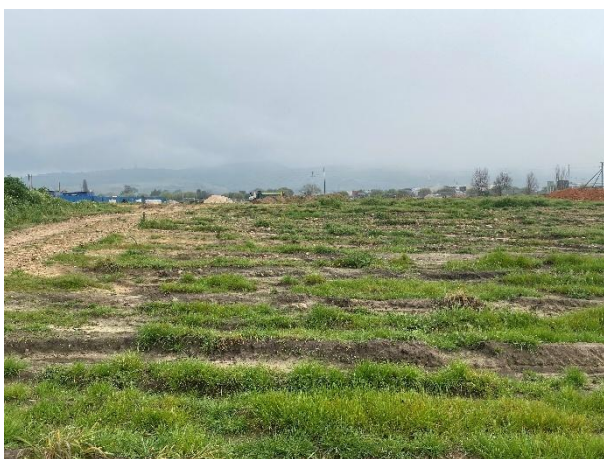
Cleared area towards the west where vineyards have been cleared.

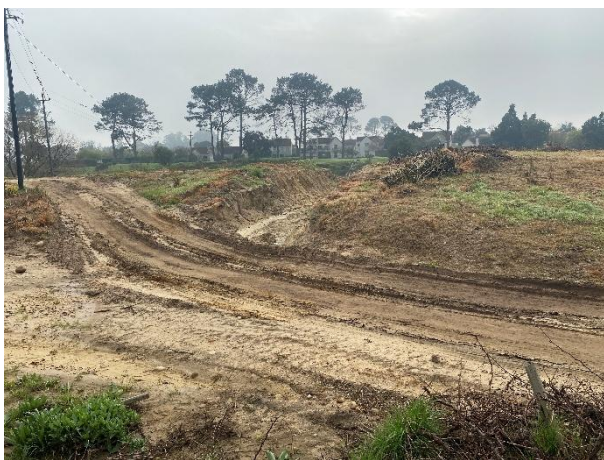
Excavated stormwater outlet channel north towards the Berg River.

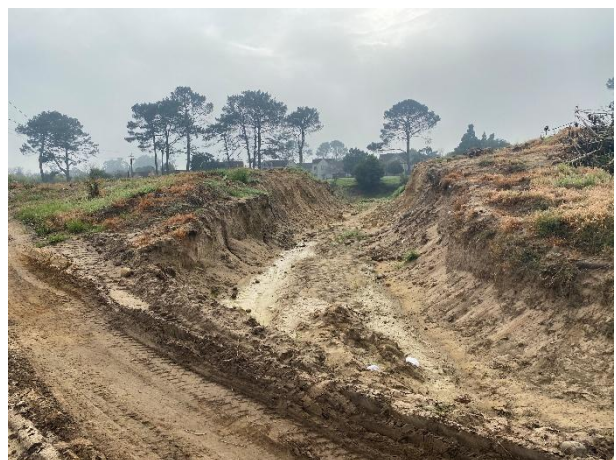
Excavated stormwater outlet channel north towards the Berg River.

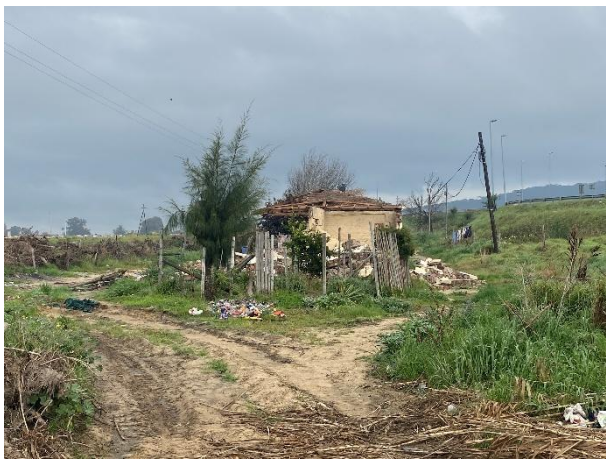
Workers' house still to be demolished and crushed.

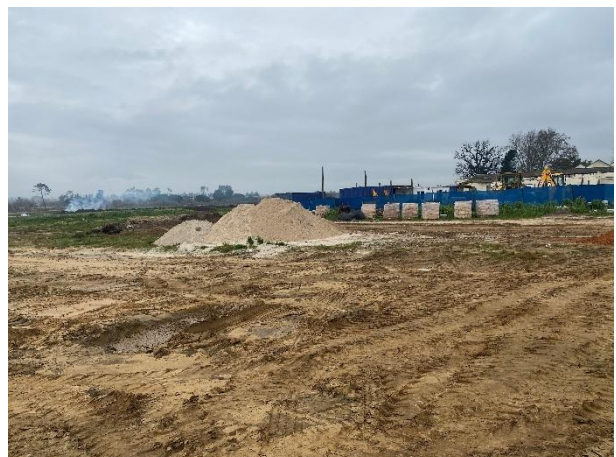
Stockpile material adjacent to the site camp towards the southwest.

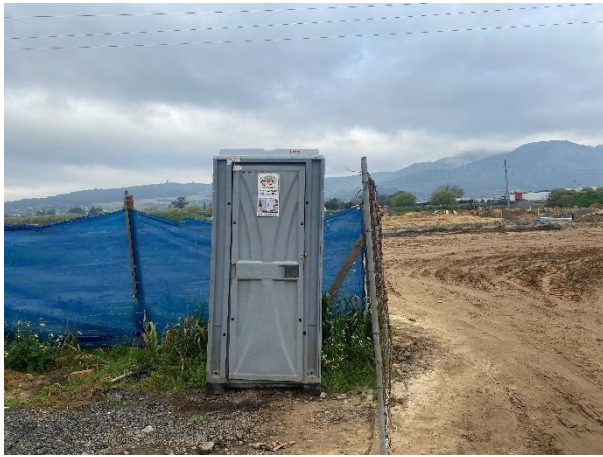
Chemical Toilet in place within the site camp.

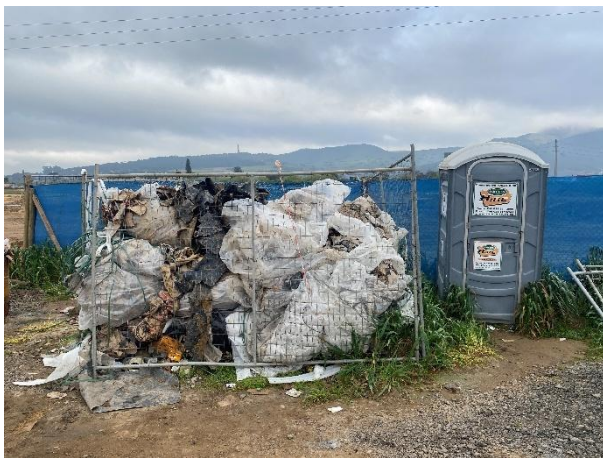
Wire structure available within the site camp for waste disposal.

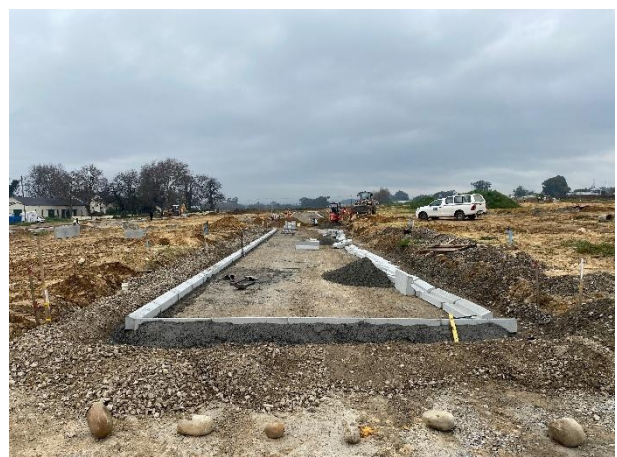
Civil services, kerbs, and road surface being prepared west of the site camp at the entrance to the site.

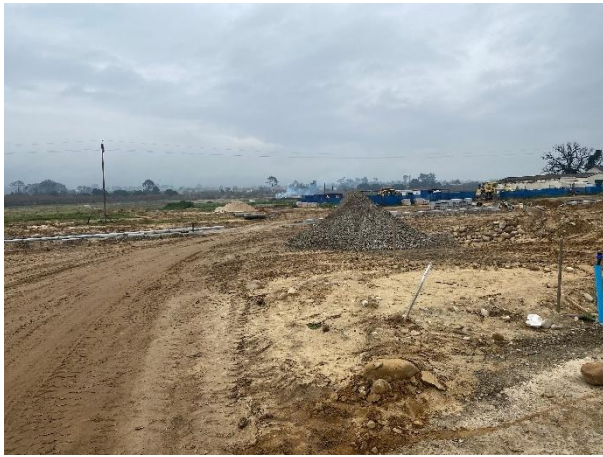
Internal road network being cut, shaped, and prepared.

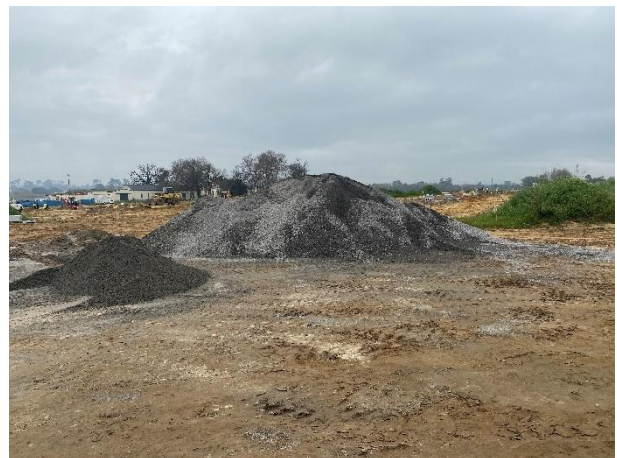
Asphalt material stockpiles adjacent to the site camp where roads are being chipped and sprayed.

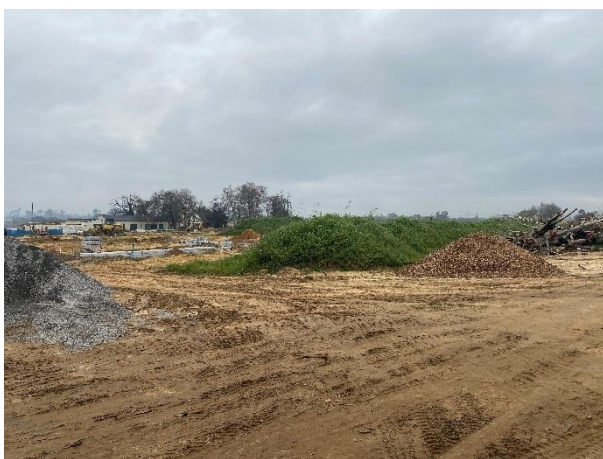
Topsoil and material stockpiles separated adjacent to the site camp.

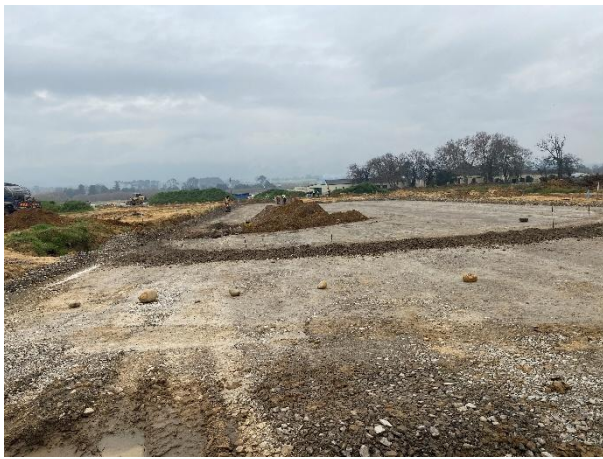
Civil services, kerbs, and road surface being prepared west of the site camp at the entrance to the site.

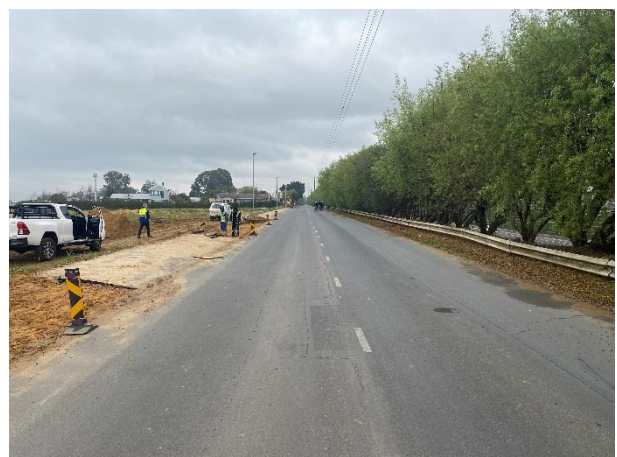
Fibre installations along New Eskdale Street.

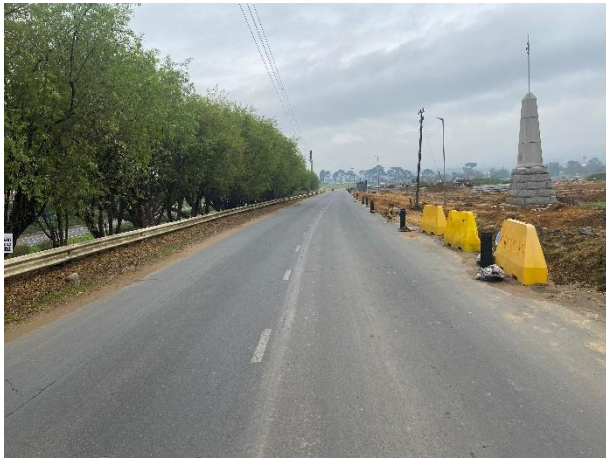
Condition of New Eskdale Street towards the North.

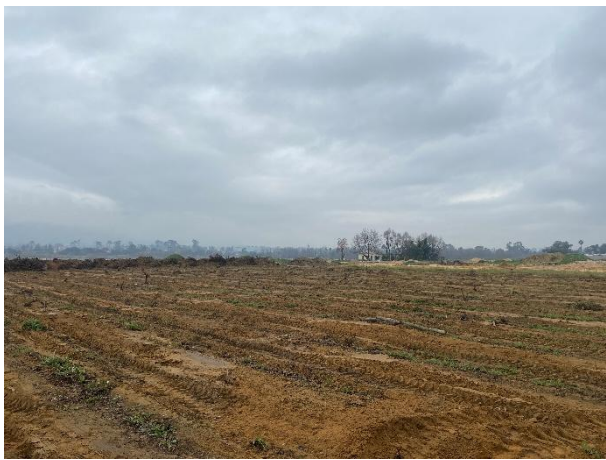
Cleared southern area where unproductive vineyards were removed, to be reinstated with new vines.

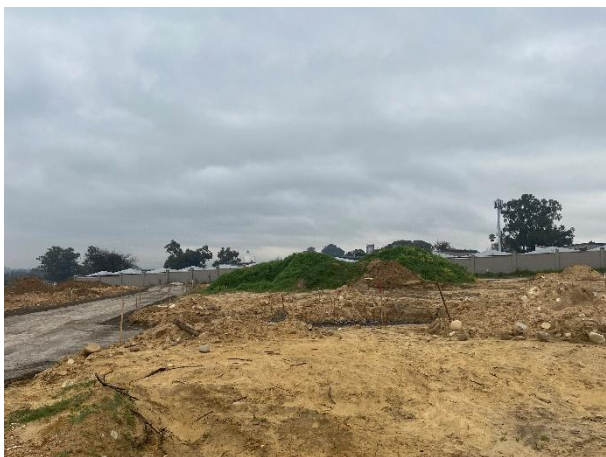
Topsoil stockpiles towards the southwest, adjacent to the foreman's house.

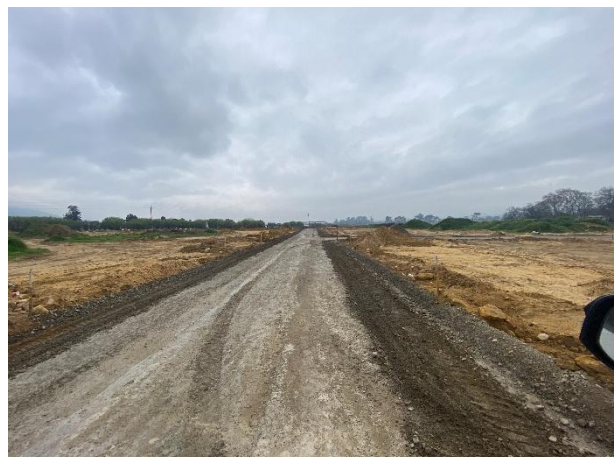
Roads being chipped and sprayed south of the foreman's house.

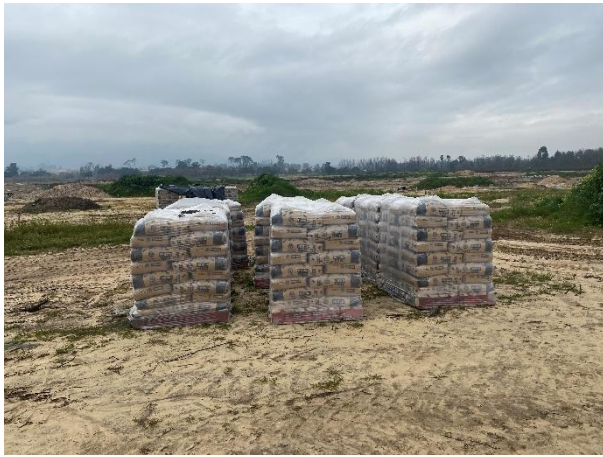
Ready mix cement for kerb installations.

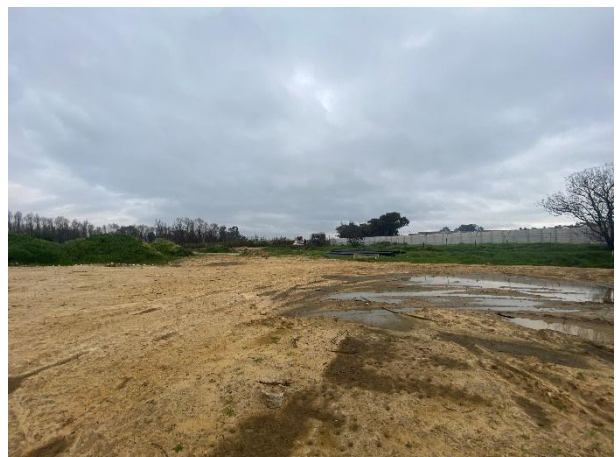
Stockpile area southwest of the site. Topsoil stockpiles have been revegetated.

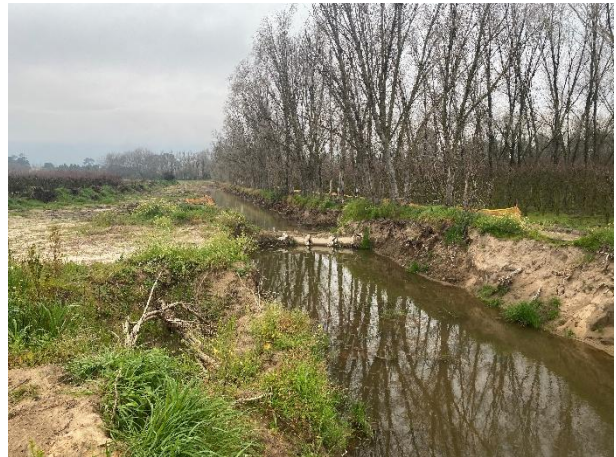
Collapsed stormwater channel with a new, formalised channel under construction.

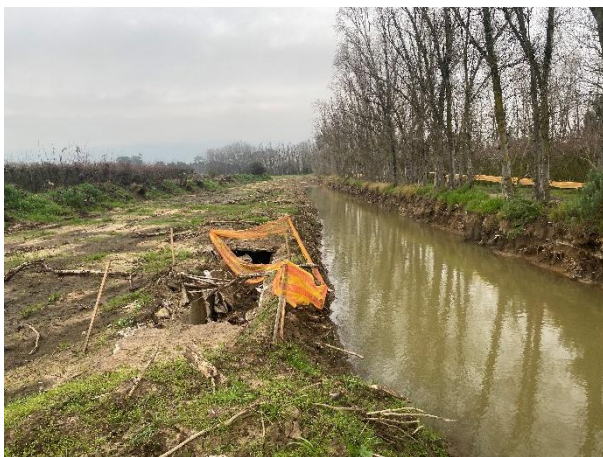
Stormwater channel being upgraded towards the southwest.
