## APPENDIX A – SITE PHOTOGRAPHS

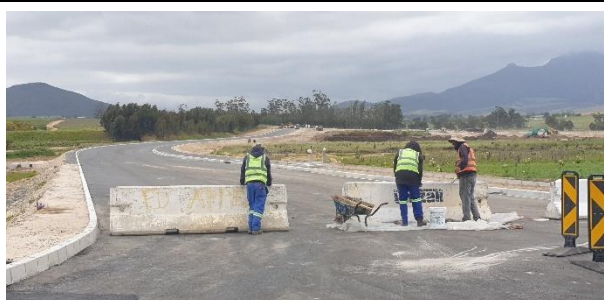
Construction of the main access road.

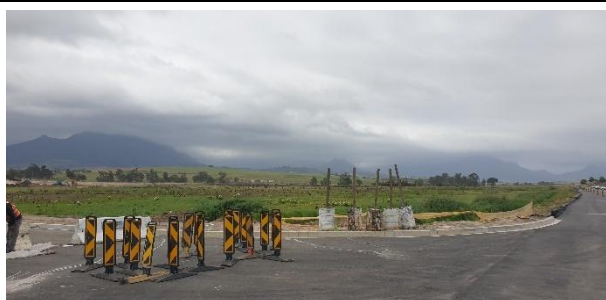
Construction of the main access road.

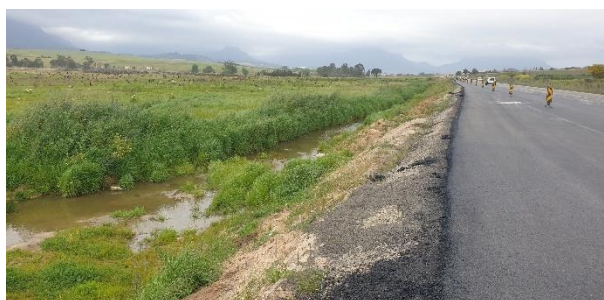
Drainage channel adjacent to the R44 to Stellenbosch.

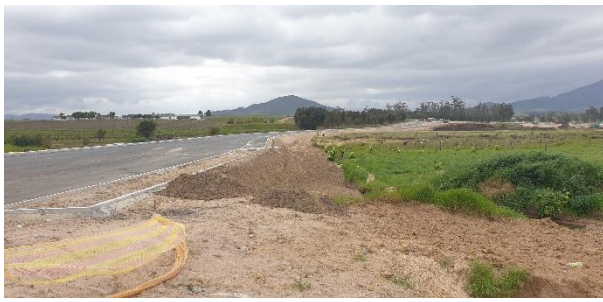
Shaped and sloped road embankment prepared for erosion control.

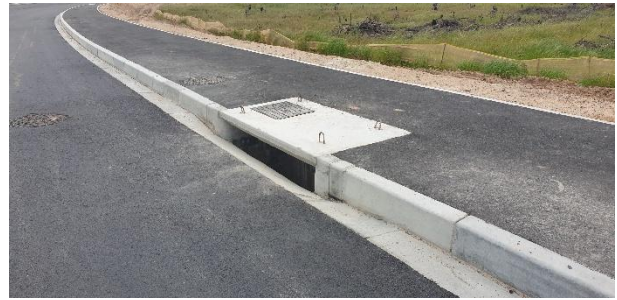
Stormwater inlet along the main access road.

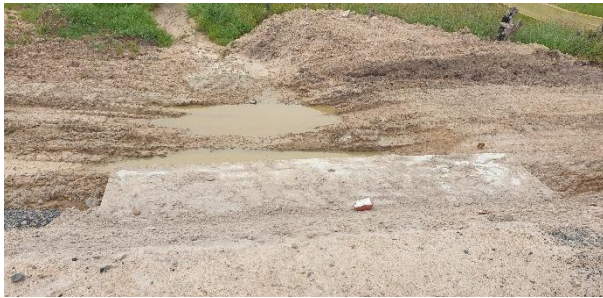
Box culvert installed beneath the main access road to facilitate stormwater flow.

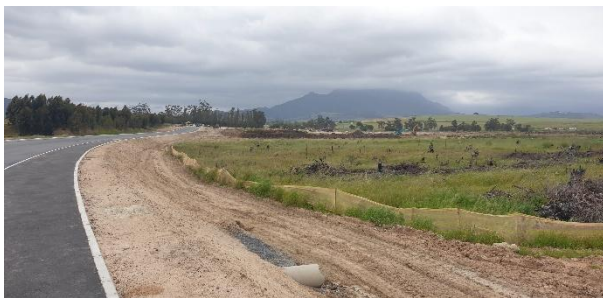
Demarcated wetland area along the main access road.

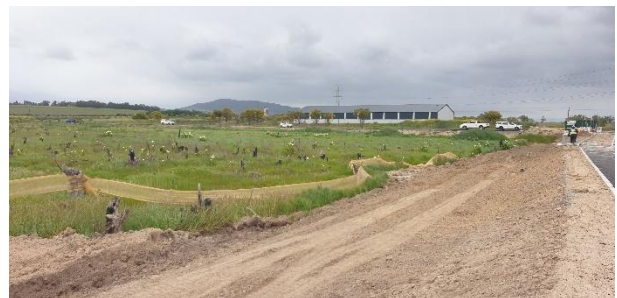
Demarcated wetland area along the main access road.

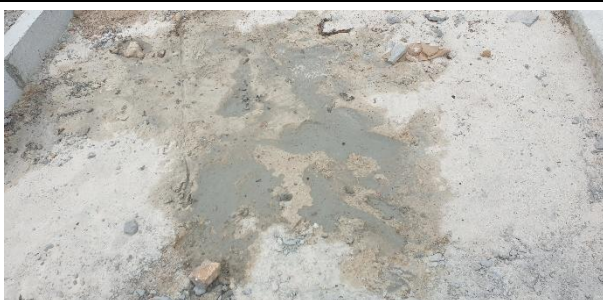
Pedestrian walkways under construction alongside the main access road.

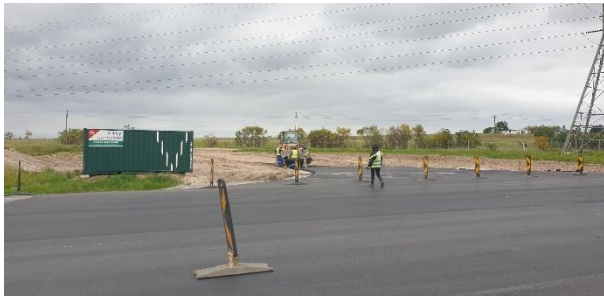
Main access road under construction, with adjoining access road upgrades in progress.

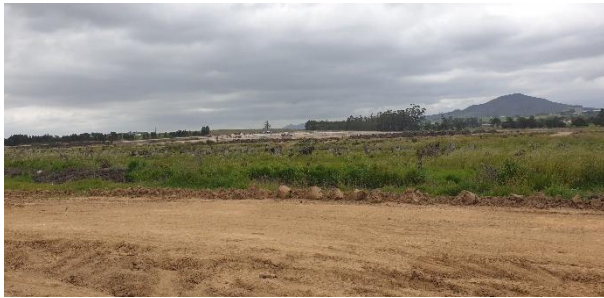
Condition of the wetland area towards the northeast.

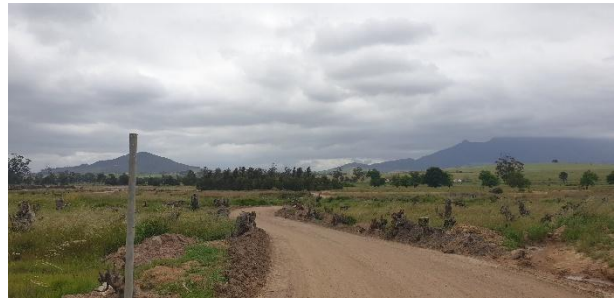
Haul roads demarcated from the access road towards the construction site.

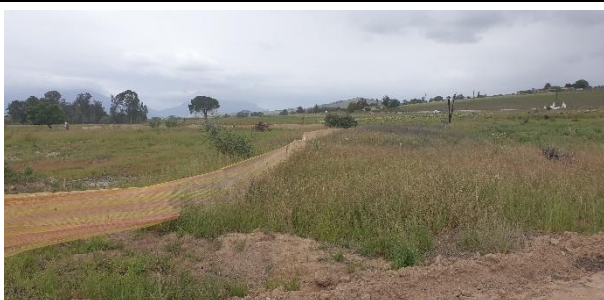
Buffer and wetland/rehabilitation areas have been demarcated with orange netting and danger tape.

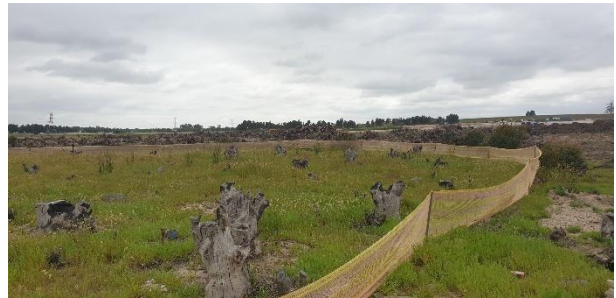
Buffer and wetland/rehabilitation areas have been demarcated with orange netting and danger tape.

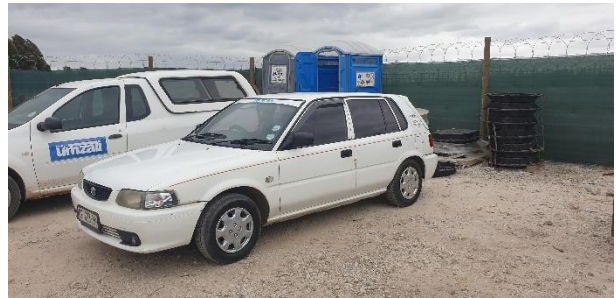
Chemical toilets present within the site camp.

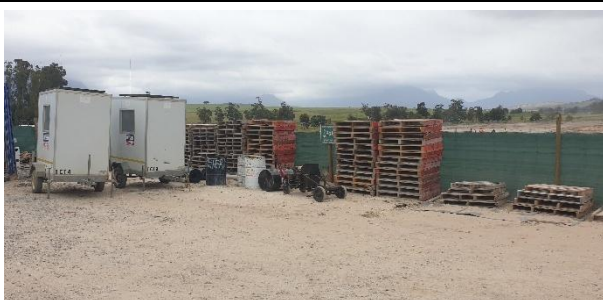
Condition of the site camp.

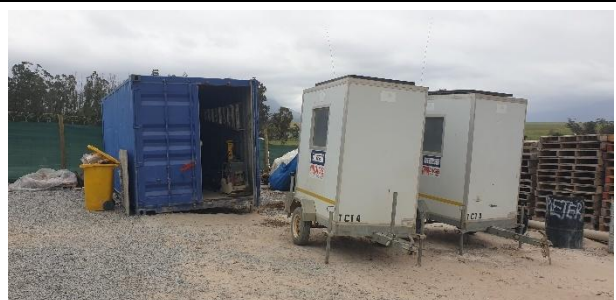
Condition of the site camp.

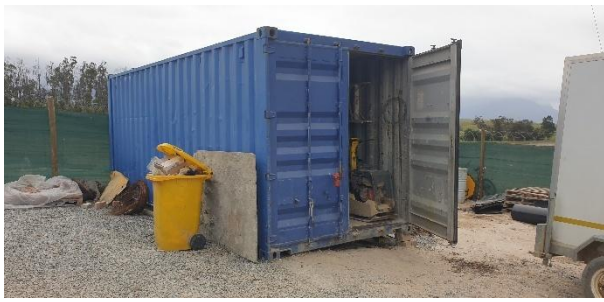
Storage containers and bins are available within the site camp.

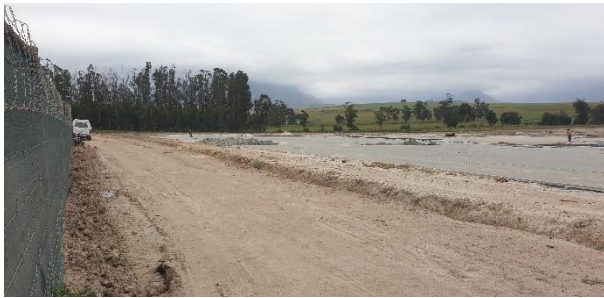
Bus and visitor parking being constructed towards the north.

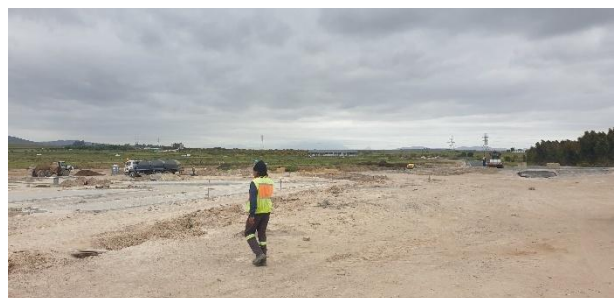
Bus and visitor parking being constructed towards the north.

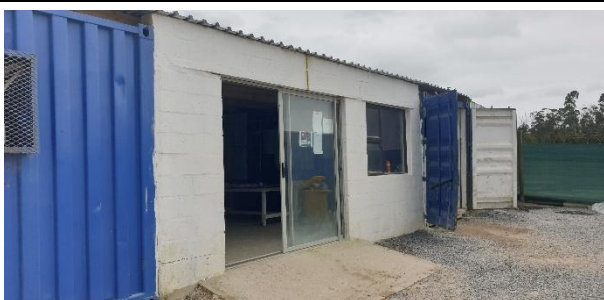
Site office within the site camp.

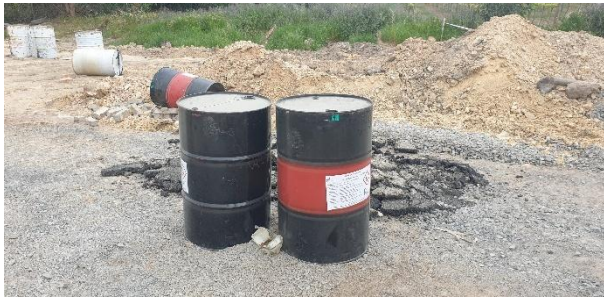
Empty bitumen emulsion cans located adjacent to the works area.

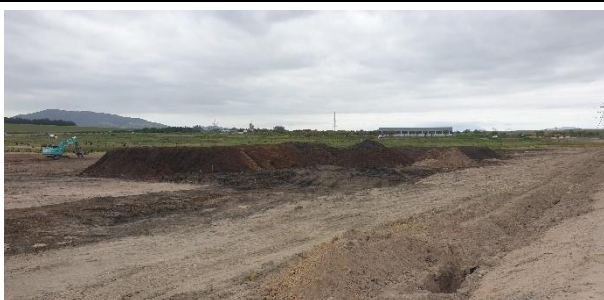
Stockpile area towards the northwest.

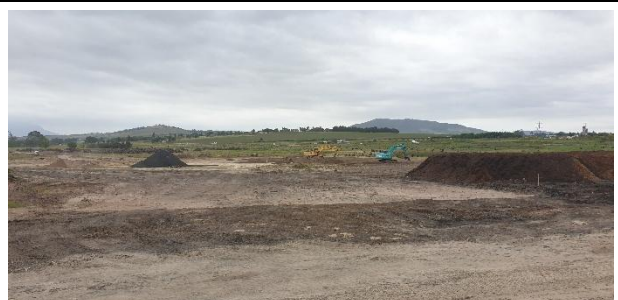
Stockpile area towards the northwest.

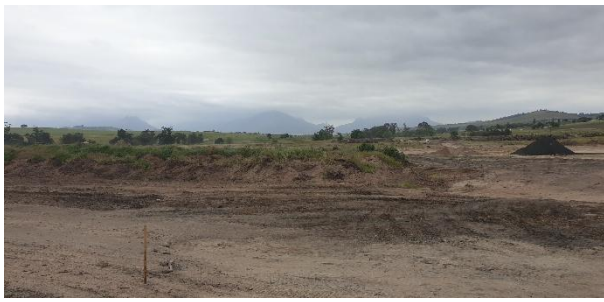
Cleared topsoil stockpiles towards the northwest.

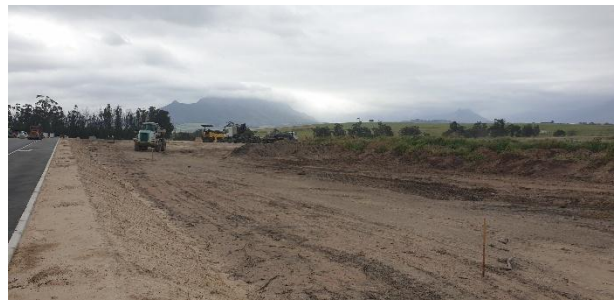
Cleared topsoil stockpiles towards the northeast.

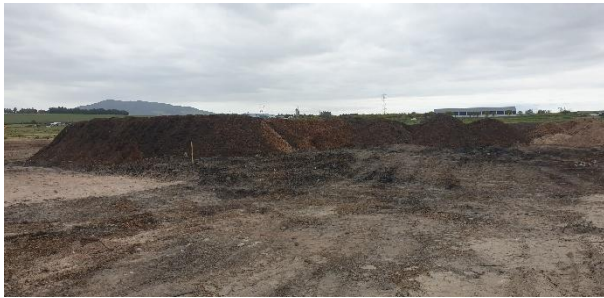
Stockpile area towards the northwest.

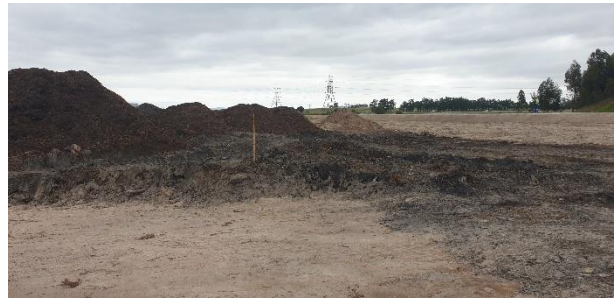
Stockpile area towards the northwest.

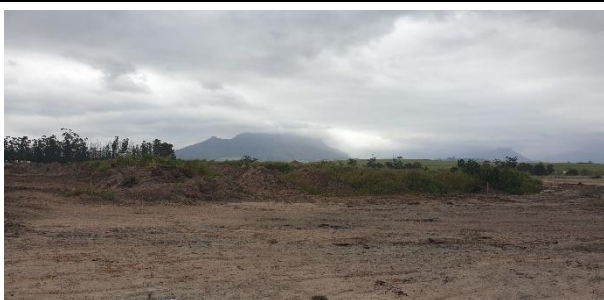
Cleared topsoil stockpiles towards the northeast.

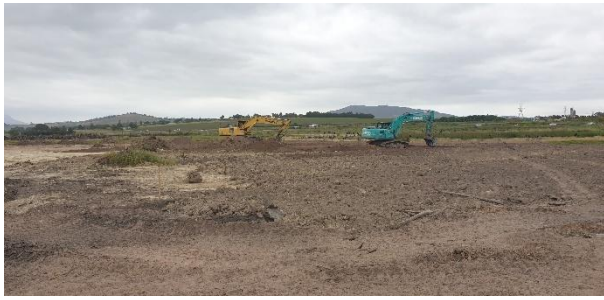
Location of the traditional headstone grave site. Topsoil and composting are being spread across the site.

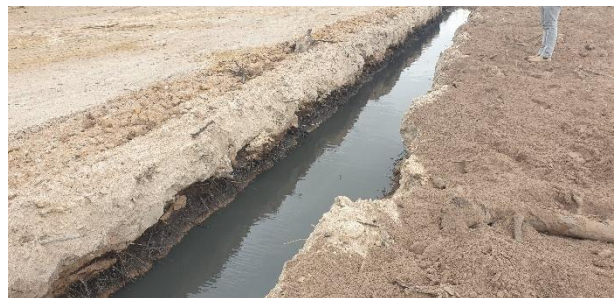
Drainage channels being shaped across the site.

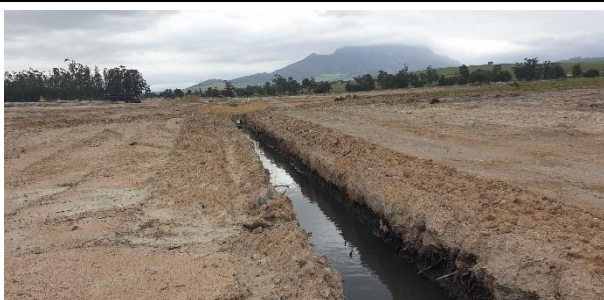
Drainage channels being shaped across the site.

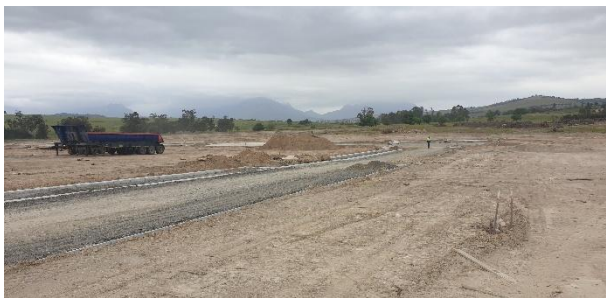
Civil services and internal roads being installed.

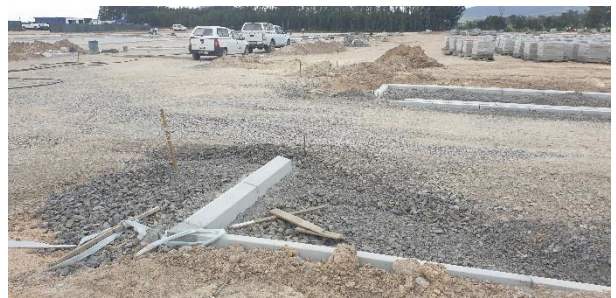
Kerbs being installed within the bus and visitor parking area.

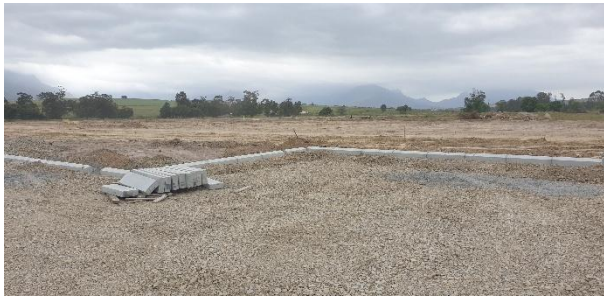
Kerbs being installed within the bus and visitor parking area.

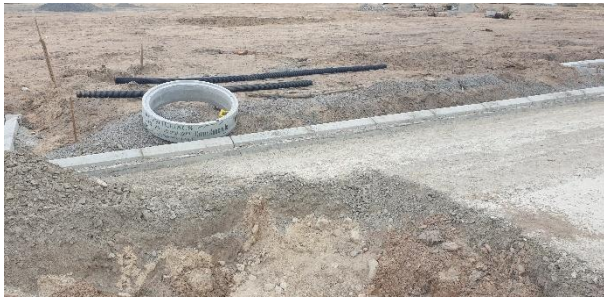
Civil services and internal roads being installed.

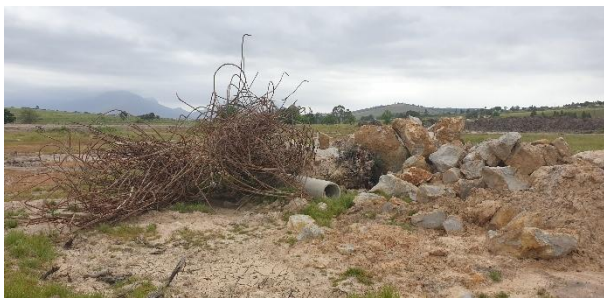
Construction rubble to be removed.

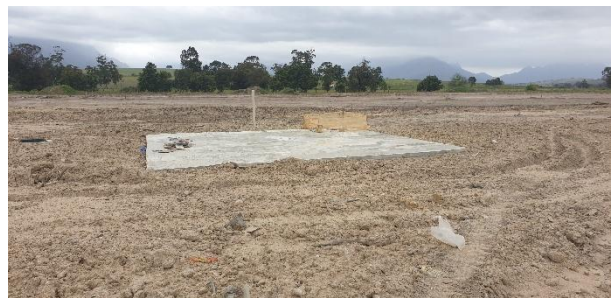
Concrete service chamber under construction as part of the site's civil infrastructure network.

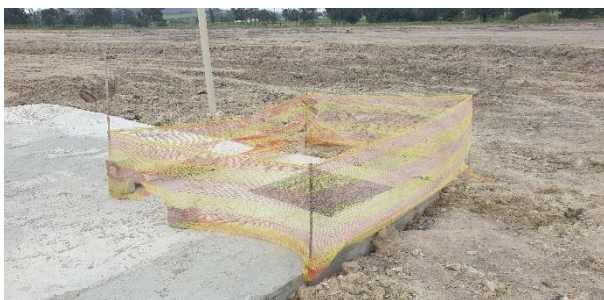
Concrete service chamber under construction as part of the site's civil infrastructure network.

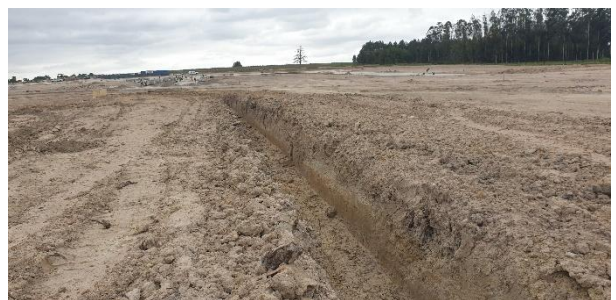
Drainage channels being shaped across the site.

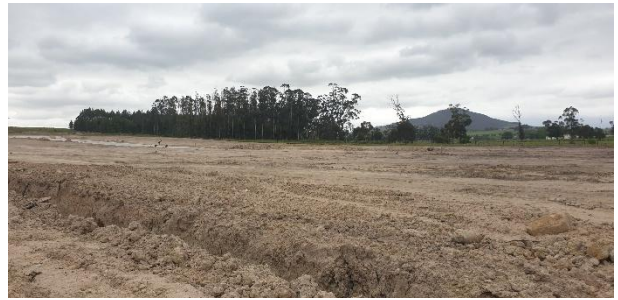
View towards the east, where the second section of traditional headstone graves will be located.

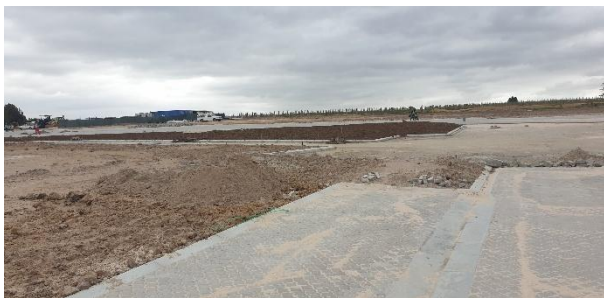
Gardens being landscaped at the parking area.

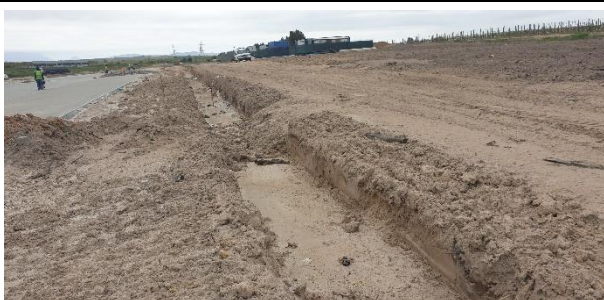
Drainage channels being shaped across the site.

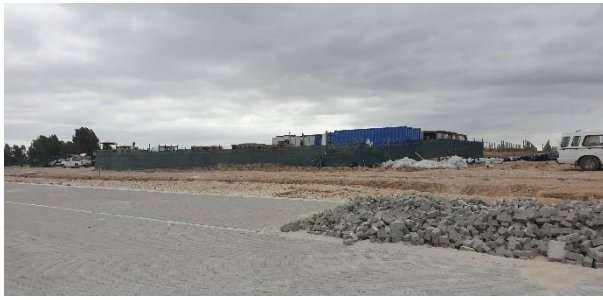
View of the site camp towards the north.

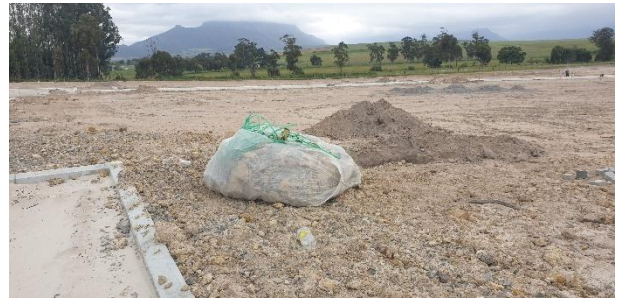
Empty cement bags securely wrapped in plastic sheeting to prevent dust dispersion.

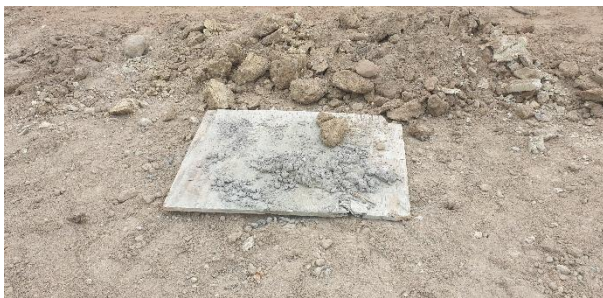
Cement batching occurring on site on the appropriate mortar boards.

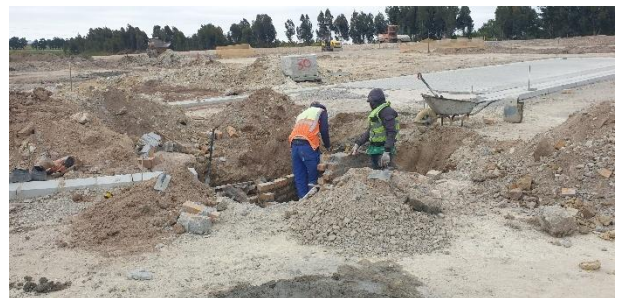
Stormwater inlet structures being constructed within the bus and visitor parking area.
