## APPENDIX A – SITE PHOTOGRAPHS

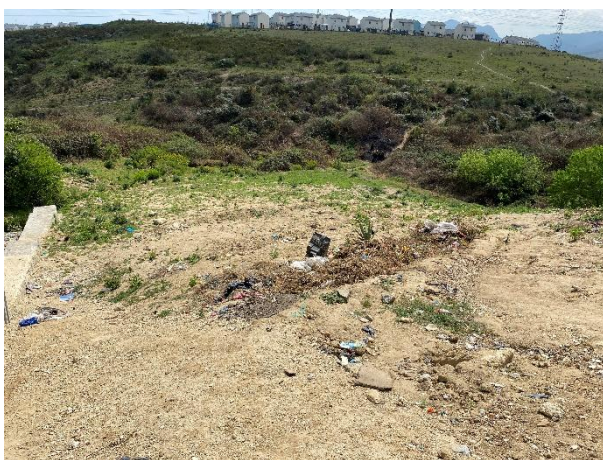
Backfilling and shaping of area adjacent to the works completed.

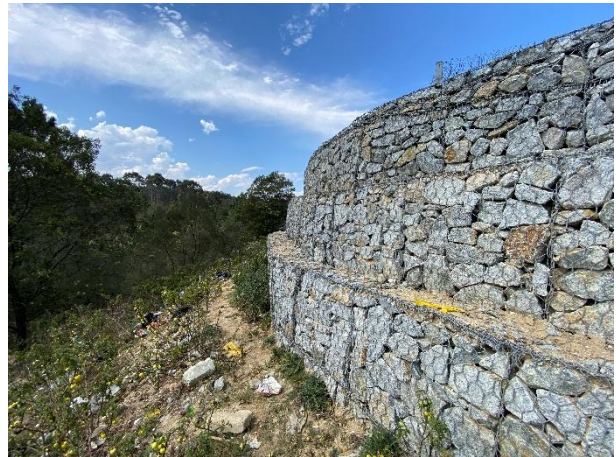
Completed reconstruction of gabion retaining wall.

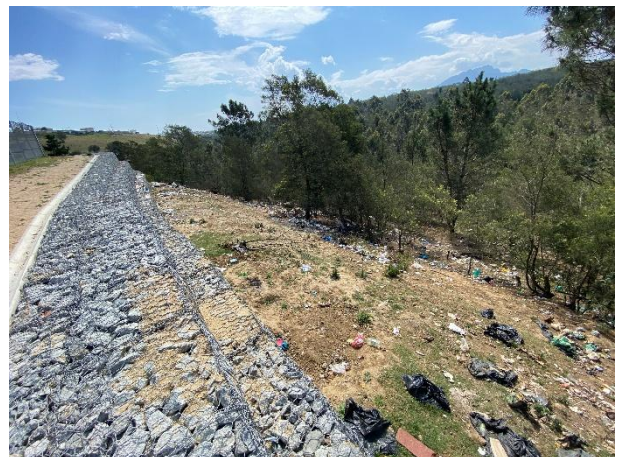
Completed reconstruction of gabion retaining wall. Slope below the retaining wall has been shaped.

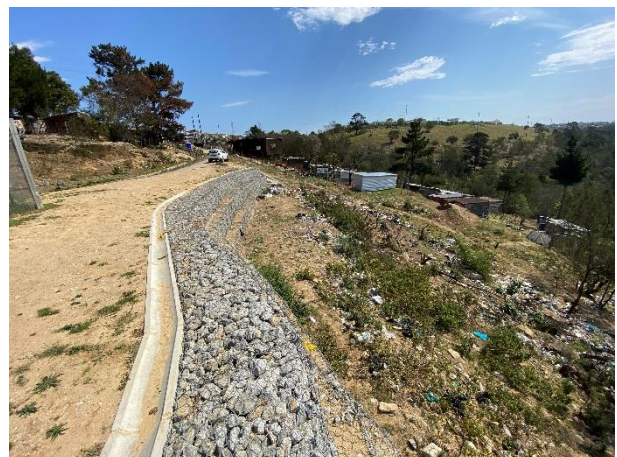
Backfilling completed with rehabilitation (topsoil and grass seed/sods) finalised.

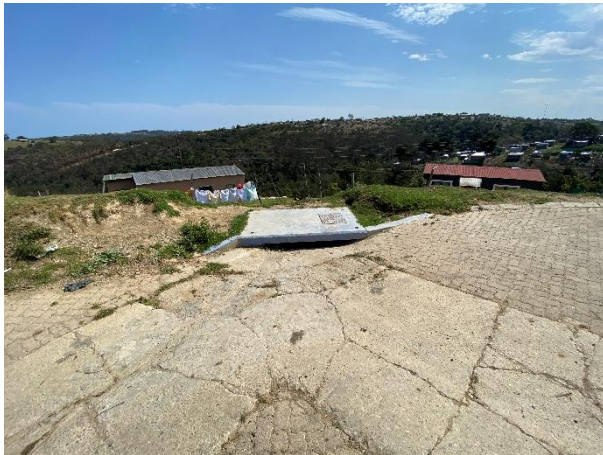
Newly constructed stormwater inlet infrastructure.

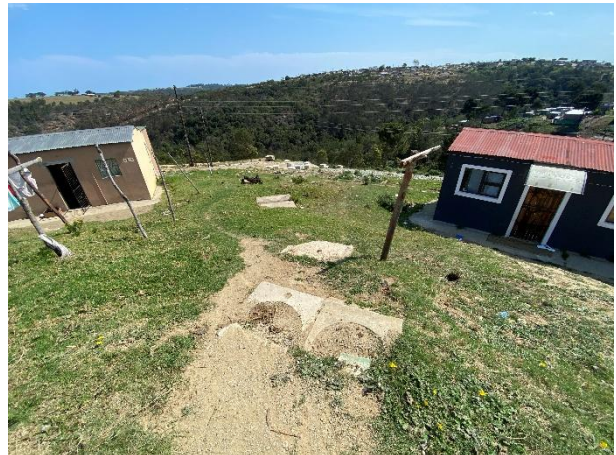
Newly constructed manhole infrastructure.

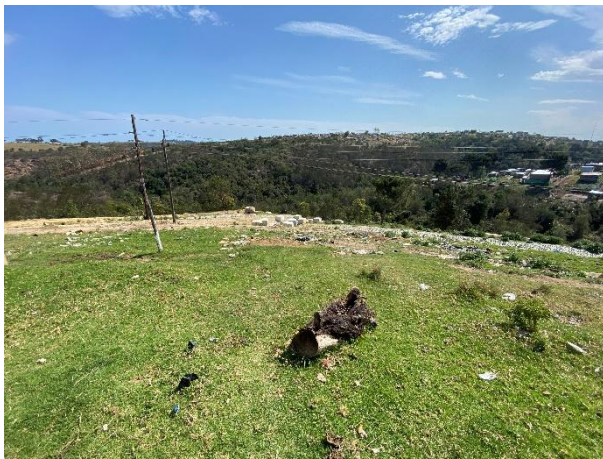
Slopes adjacent to the drainage channels have been shaped and rehabilitated, erosion backfilled.

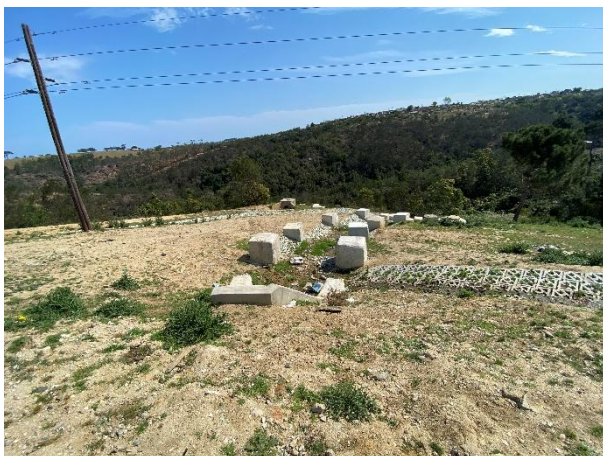
Completed armorflex stormwater channel and mitre drains.

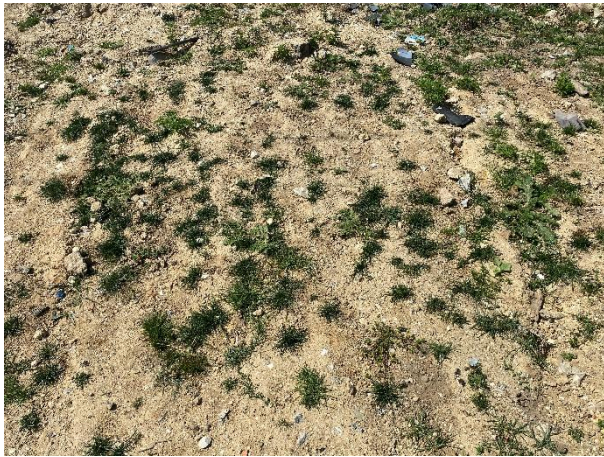
Slopes adjacent to the drainage channels have been shaped and rehabilitated, erosion backfilled.

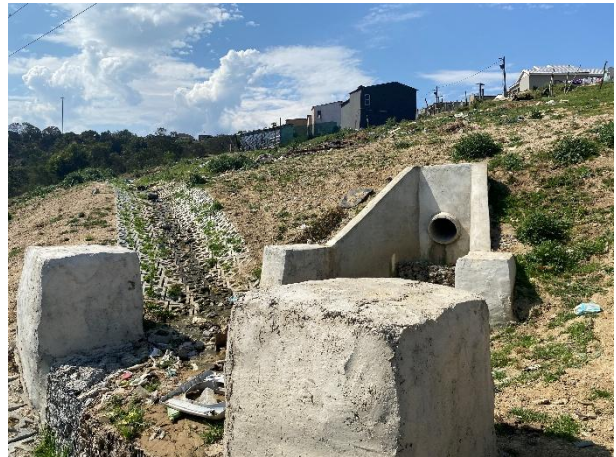
Newly construction stormwater outlet infrastructure.

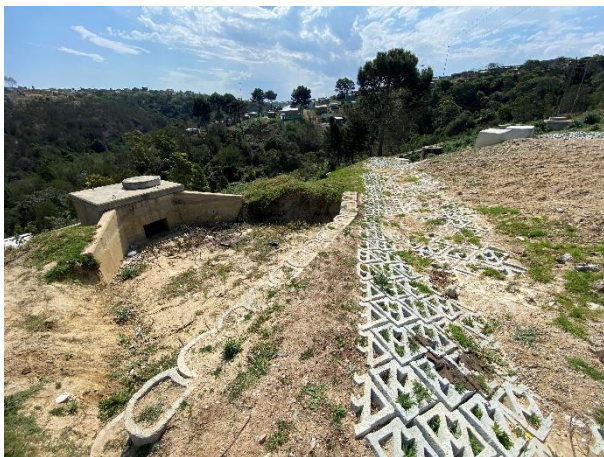
Completed armorflex stormwater channel, inlet and manhole infrastructure.

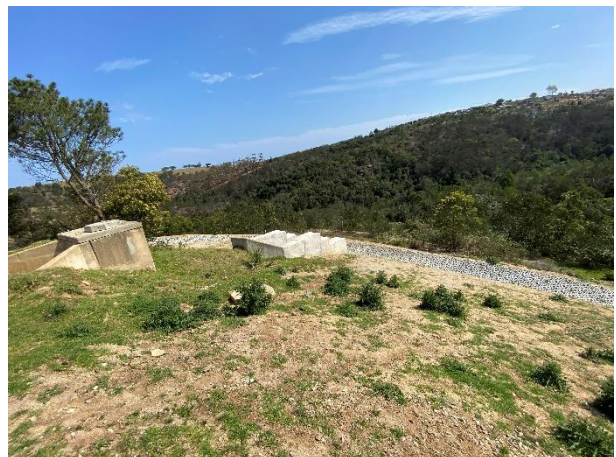
Completed armorflex stormwater channel.

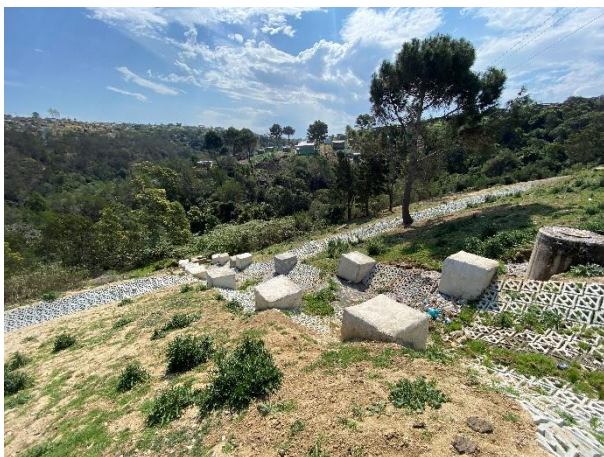
Completed armorflex stormwater channel.

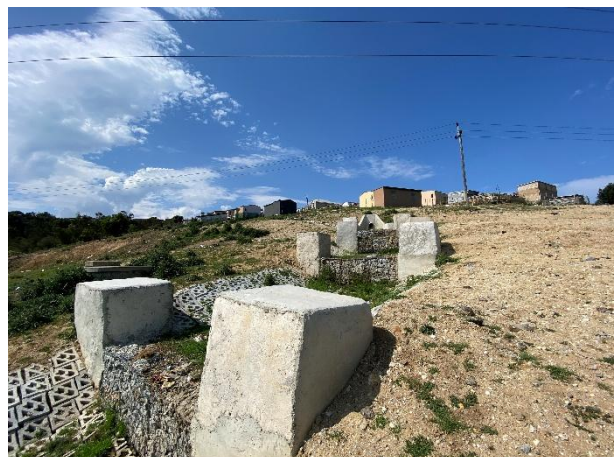
New terramesh and gabions constructed for main drainage channel

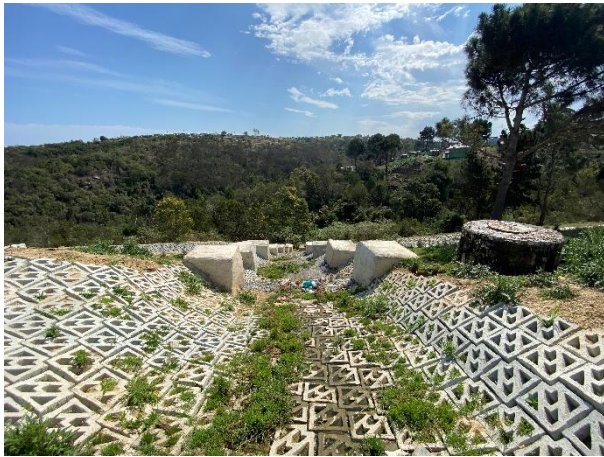
Completed armorflex stormwater channel.

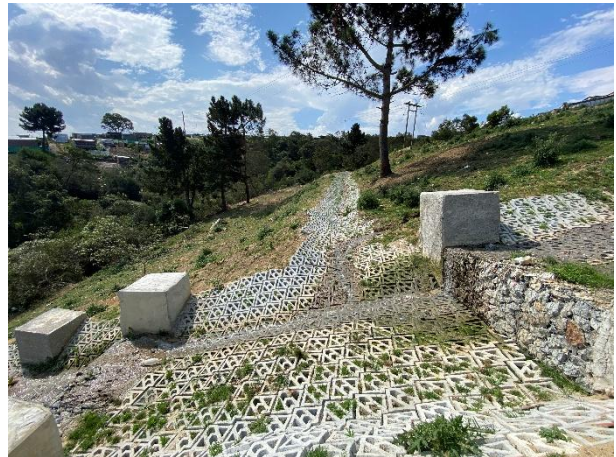
Completed armorflex stormwater channel and mitre drains.

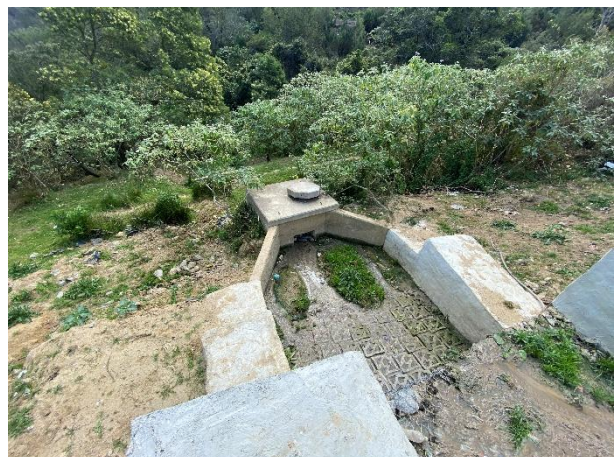
Replaced stormwater inlet infrastructure.

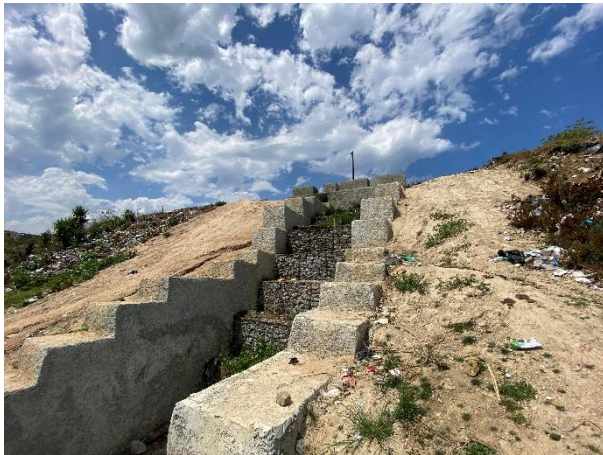
Backfilling and shaping of area adjacent to the works completed.

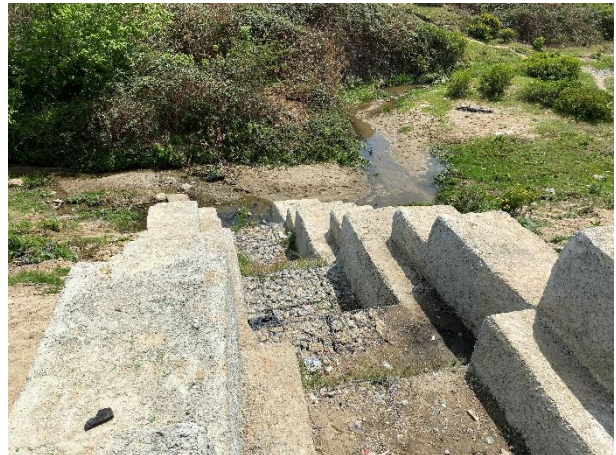
New gabion/mattress flood attenuation works completed.

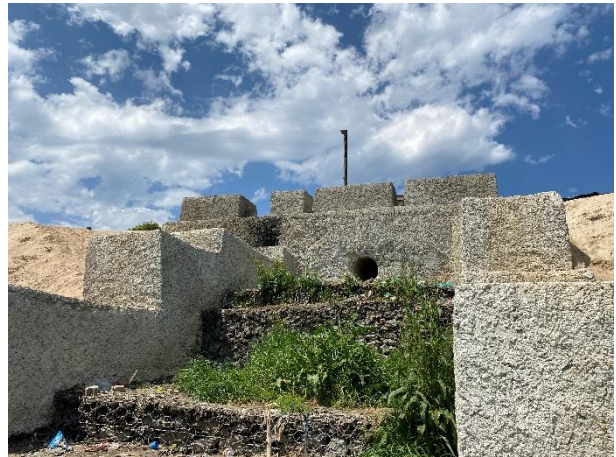
New gabion/mattress flood attenuation works completed.

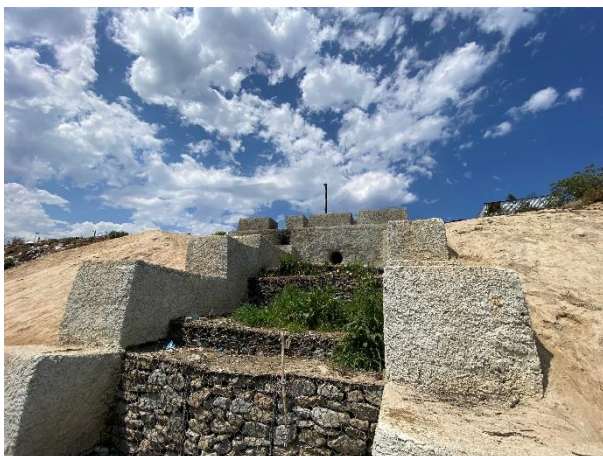
New gabion/mattress flood attenuation works completed.

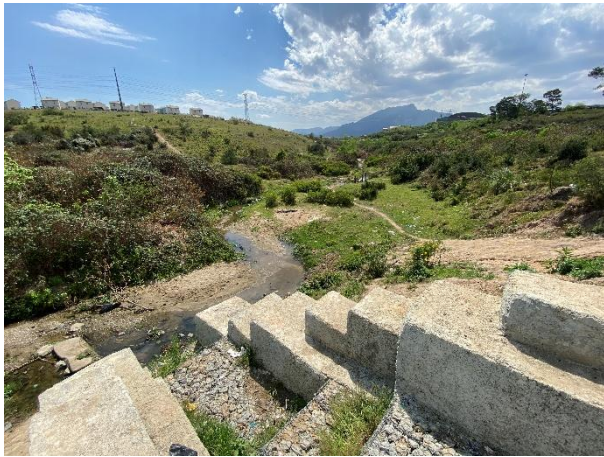
New gabion/mattress flood attenuation works completed.

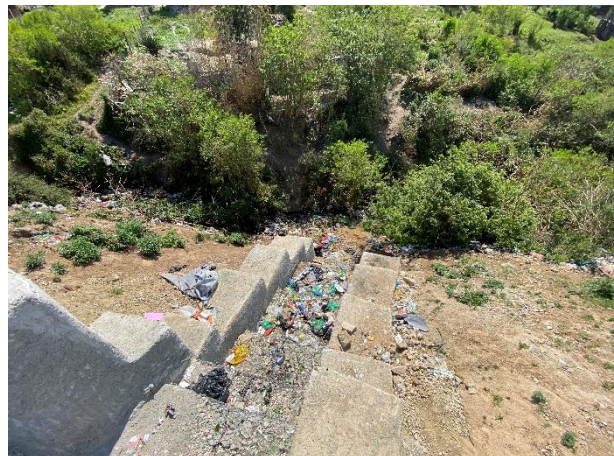
New gabion/mattress flood attenuation works completed. Local residents responsible for dumping.

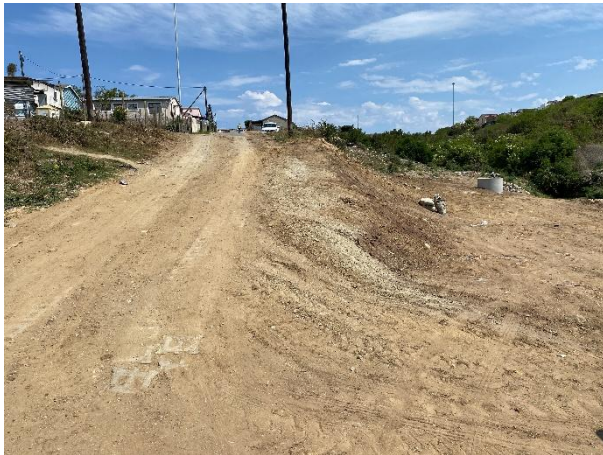
Access road towards the construction area.

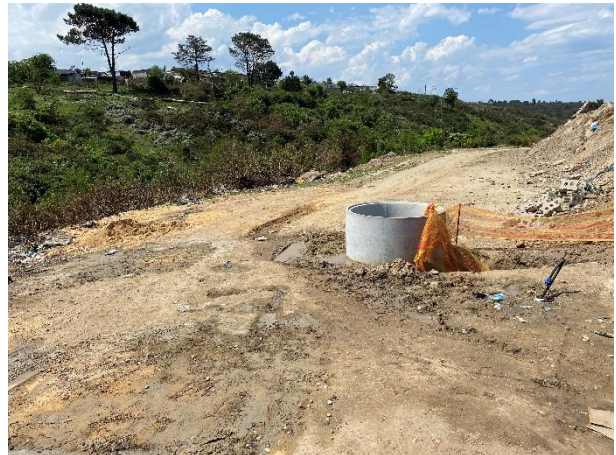
Replaced stormwater and manhole infrastructure.

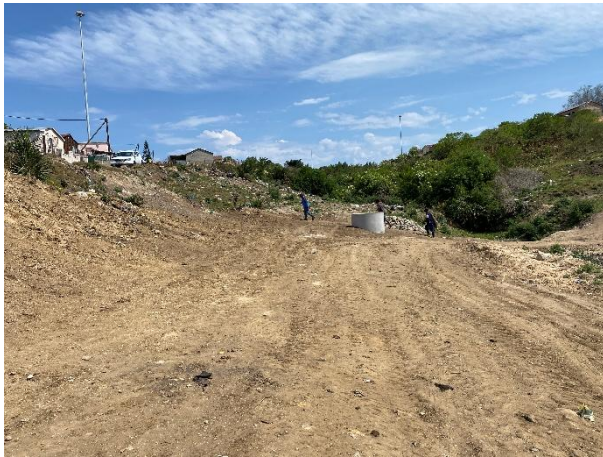
Replaced stormwater and manhole infrastructure.

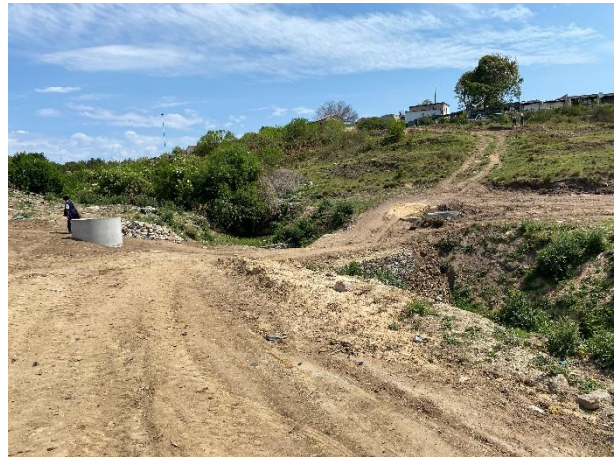
Replaced stormwater and manhole infrastructure.

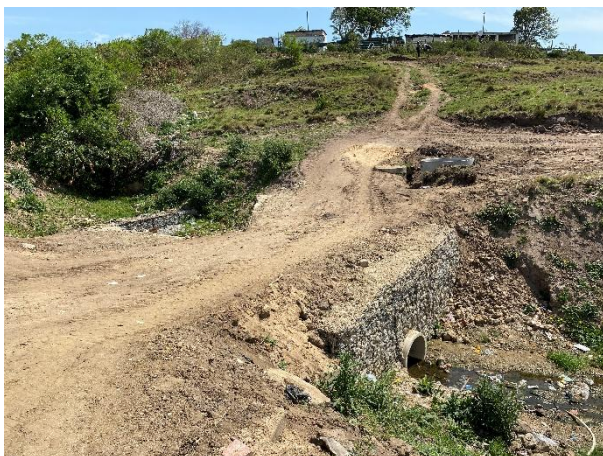
Access road adjacent to the works area.

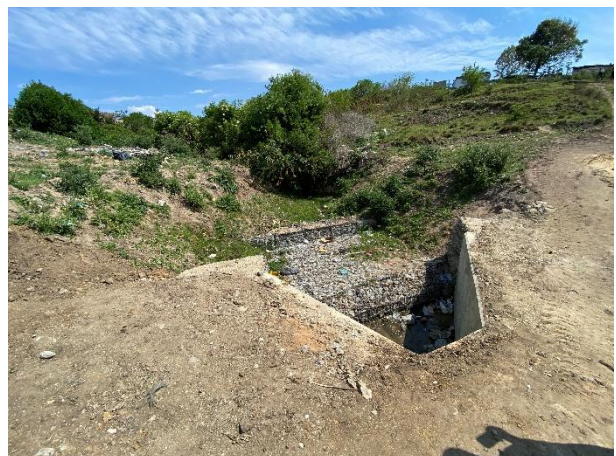
Upgraded stormwater outlet infrastructure.

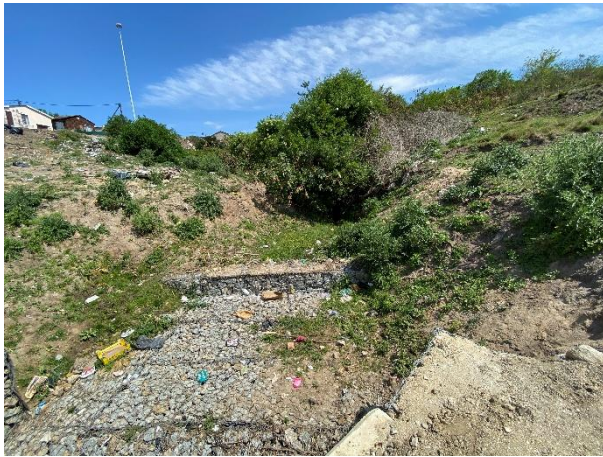
New gabion/mattress flood attenuation works outlet completed.

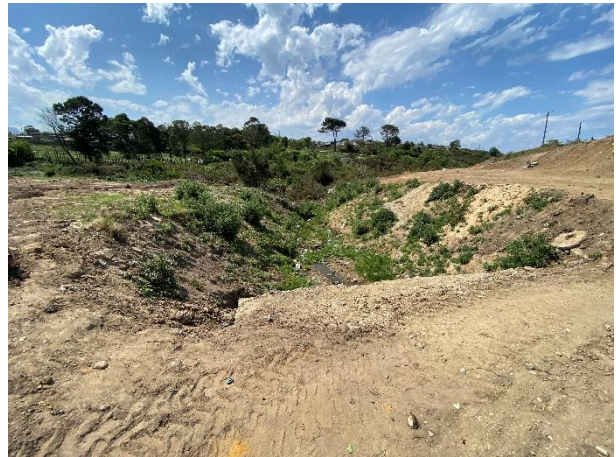
Upgraded stormwater outlet infrastructure.
