**THE MAINTENANCE ACTIVITIES OF TRUNK ROAD  
33/4 BETWEEN KM 4.6 AND KM 14.4 ALONG THE  
MEINRINGSPOORT PASS, WITHIN THE PRINCE  
ALBERT AND OUDTSHOORN LOCAL  
MUNICIPALITIES, WESTERN CAPE.**

**EXTERNAL ENVIRONMENTAL AUDIT **CLOSURE** REPORT  
IN TERMS OF REGULATION 34 OF THE NEMA EIA  
REGULATIONS, 2014 (AS AMENDED).**

DEFF REF. NO. 14/12/16/3/3/1/2226

**3 December 2025**

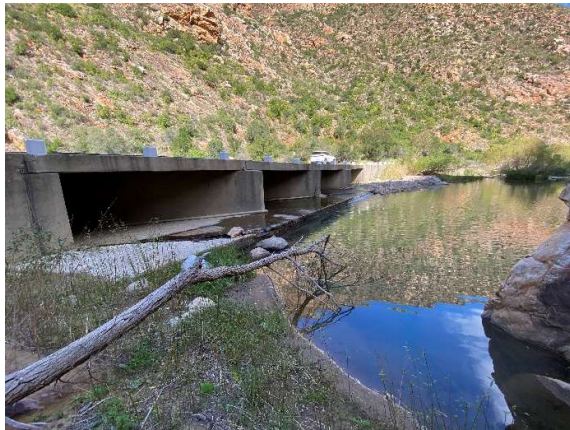
Repaired spalling and cracking observed downstream of Causeway No 4.

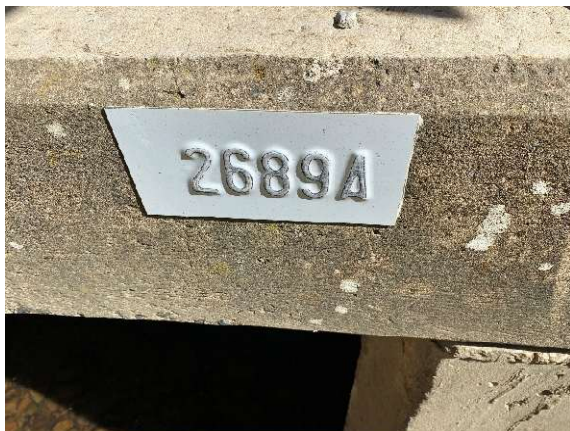
Newly installed structure number plates.

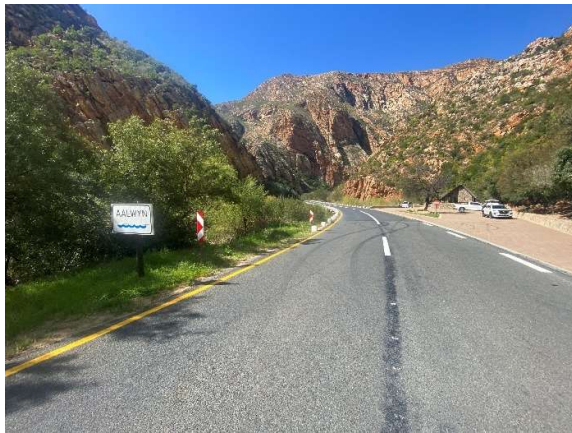
Visual of the bridge deck at causeway 6 as seen towards De Rust.

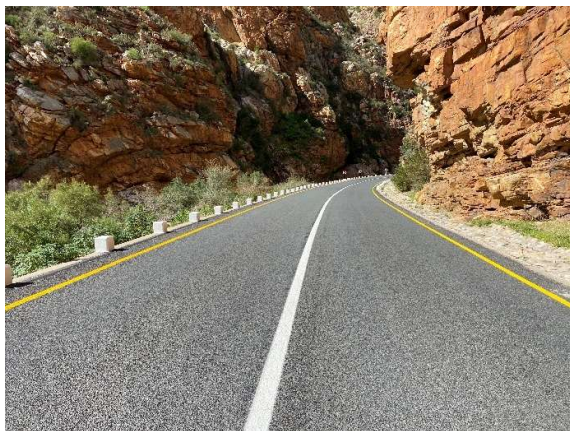
View of the road surface towards causeway no. 8.

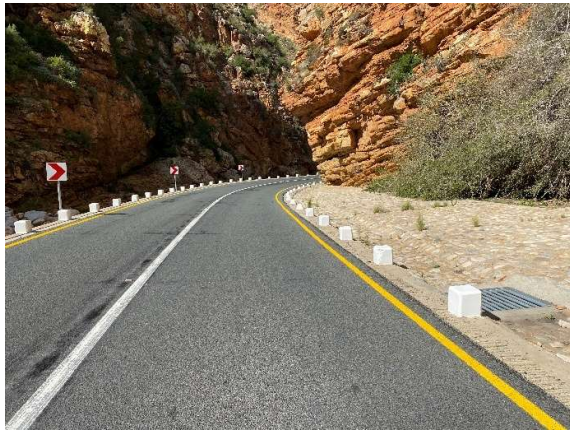
Newly installed stone-pitched side drains upstream of causeway 8.

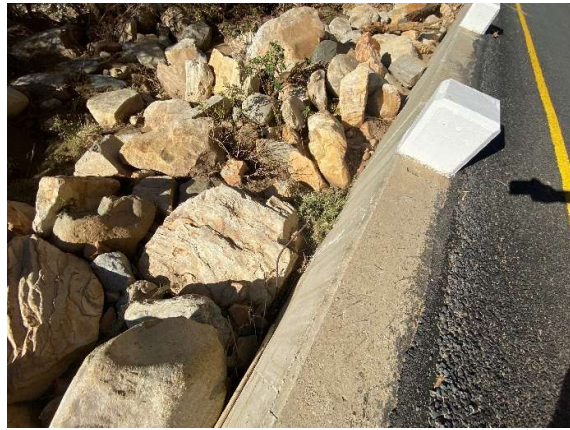
Repaired bridge edge breaks with stormwater and erosion control measures upstream of causeway 8.

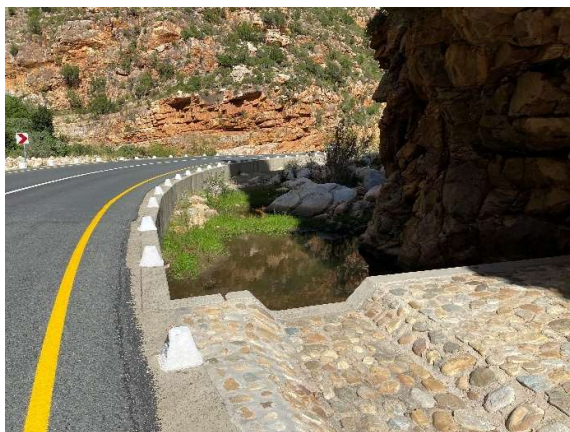
Newly installed stone-pitched side drains downstream of causeway 8.

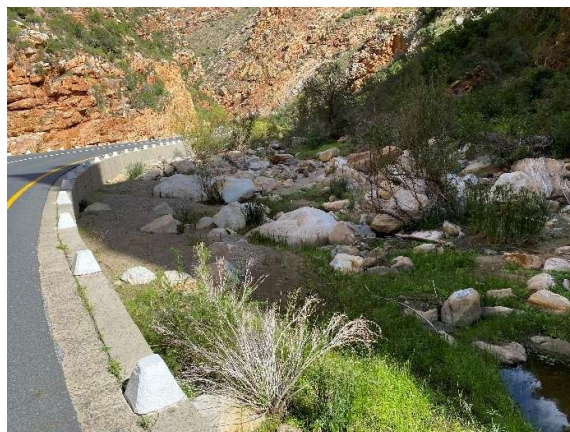
Damages of bollards repaired after the initial audit findings.

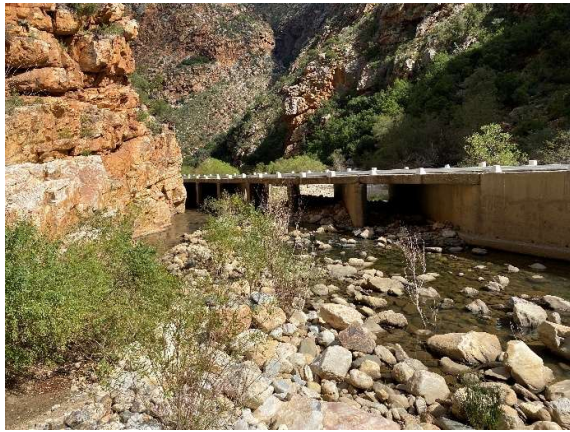
Maintenance of Causeway No 8 B2690 with cleared watercourse flow path.

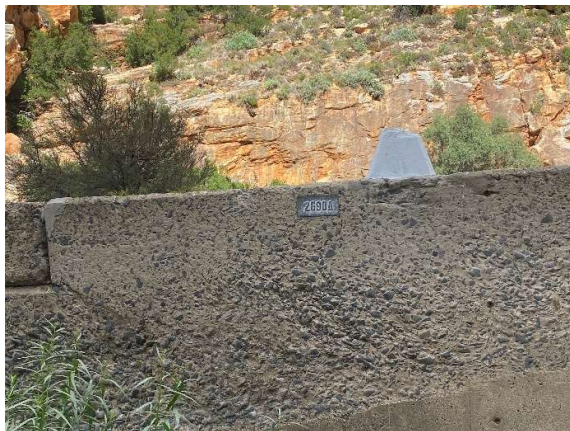
Newly installed structure number plate downstream of causeway 9.

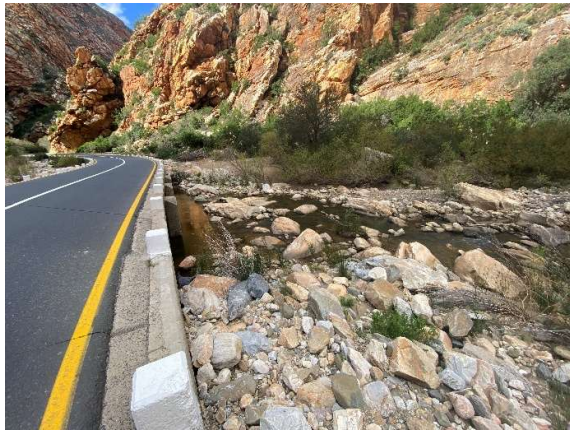
Visual downstream of causeway 9 with vegetation cleared.

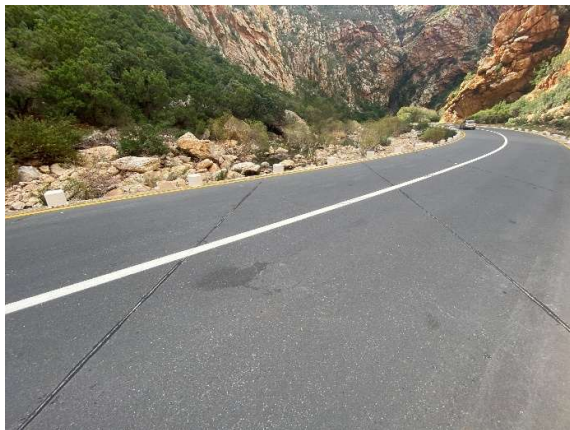
Evidence of strengthened bridge decks, reinstated cell joint fillers, and sealed deck expansion joints.

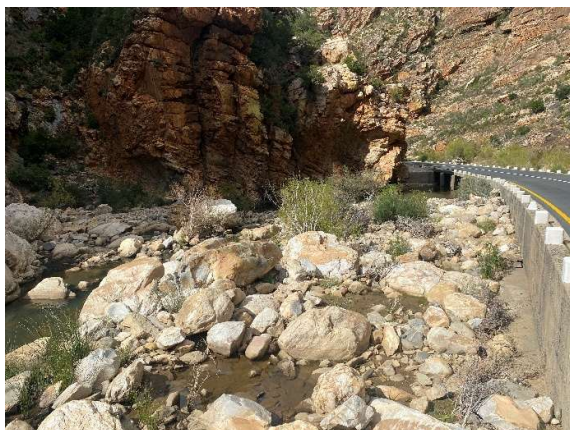
Upstream of the bridge deck at causeway 10 vegetation cleared and damages repaired.

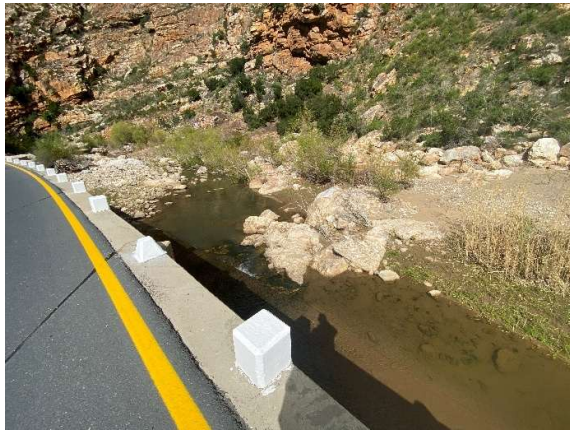
Upstream of causeway 10 where vegetation debris has been cleared.

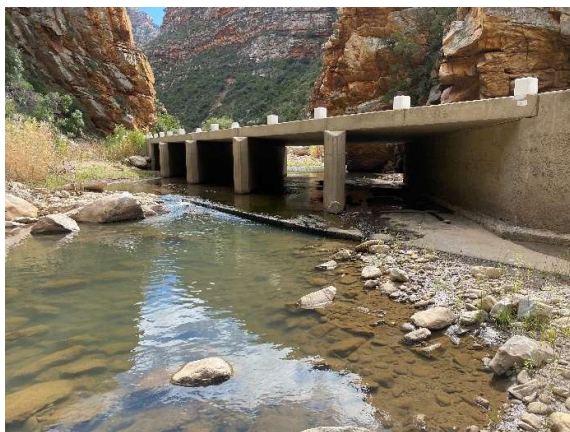
Downstream of Causeway No 10 with cleared watercourse flow path.

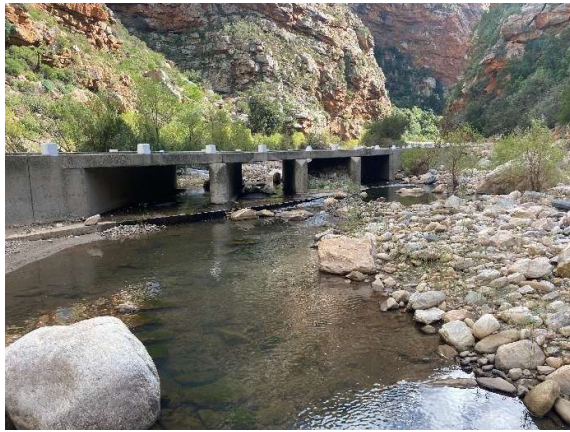
Downstream of Causeway No 11 with cleared watercourse flow path.

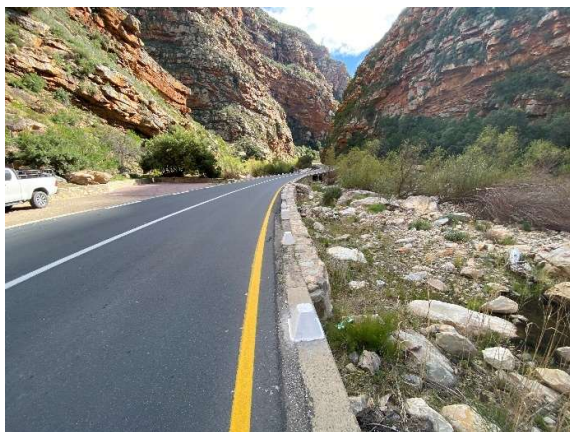
Repaired side of the road where material was displaced.

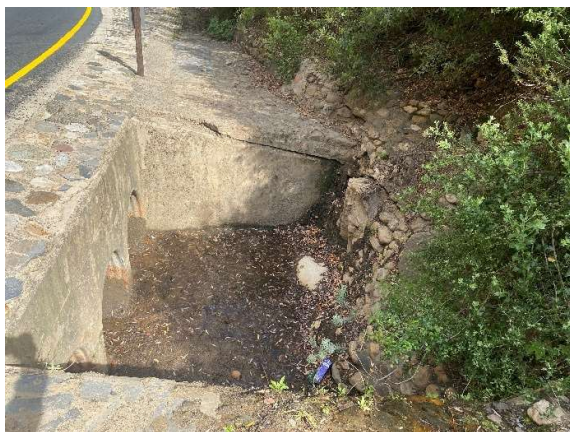
Cleared pipe culvert adjacent the causeway.

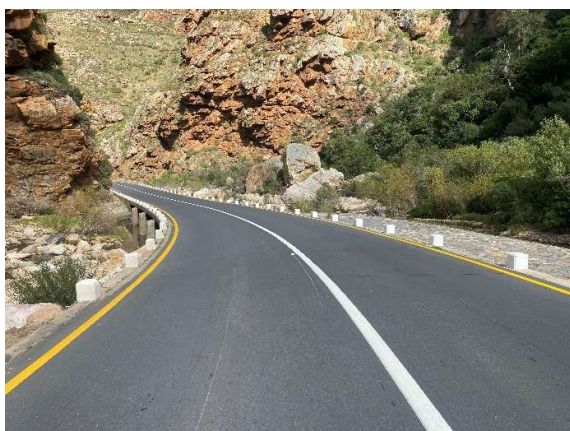
Upstream of causeway 12 debris cleared.

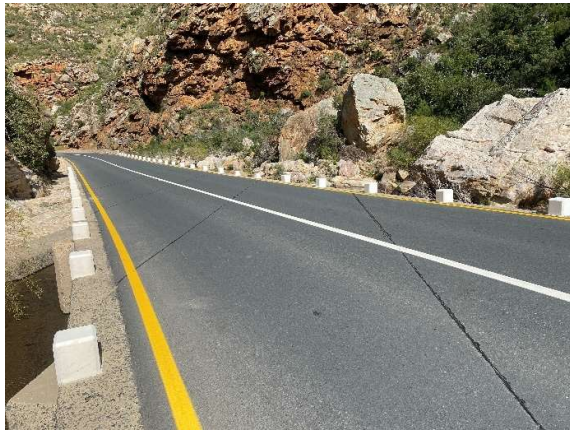
Repaired deck edge breaks and cell joint fillers upstream of causeway 12.

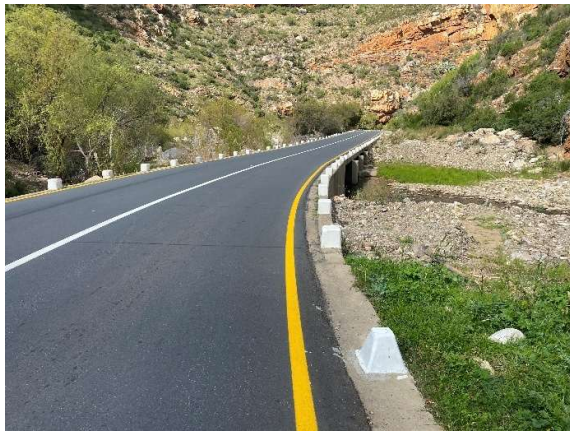
Downstream of causeway No 13 B2692A with cleared watercourse flow path and repair works evident.

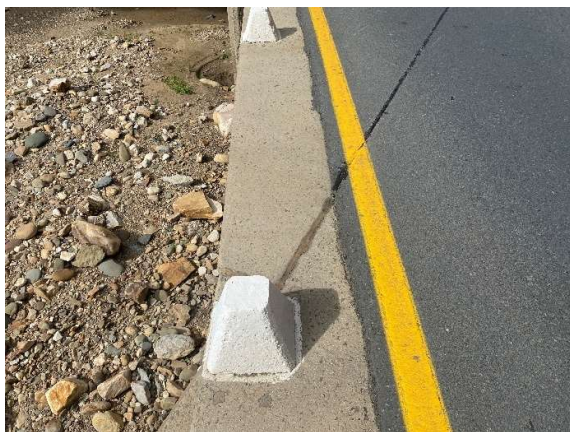
Bridge decks and expansion joints were strengthened at causeway 14.

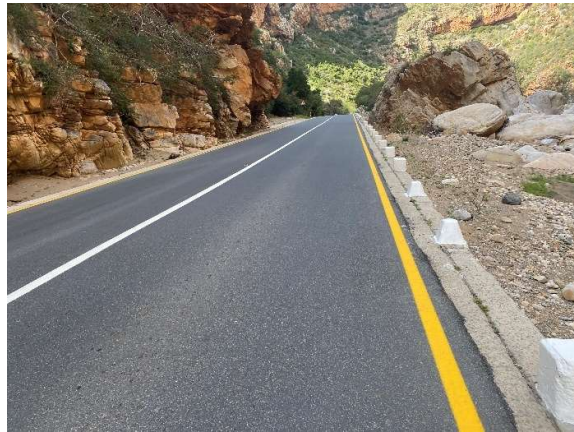
Visual of the road surface across causeway 14.

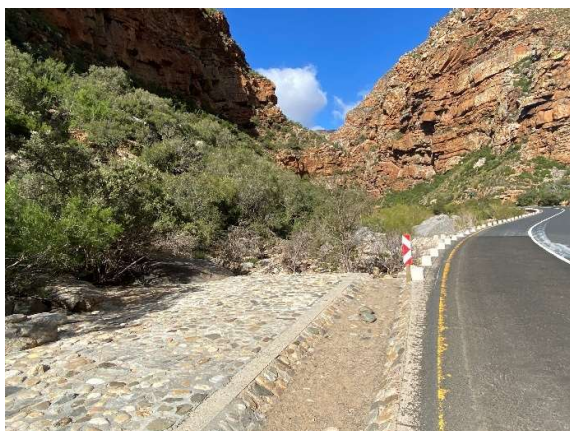
Stone-pitched side drains downstream of causeway 15.

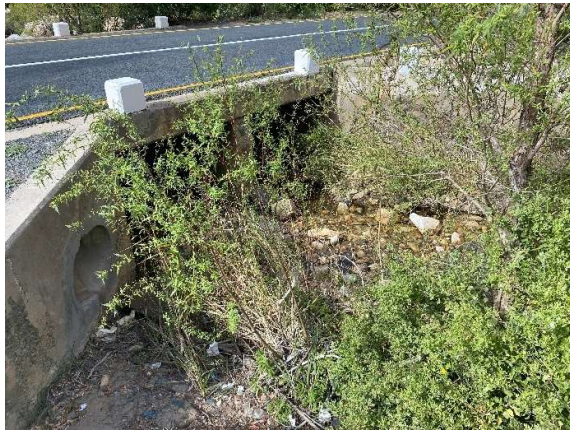
Cleared and revegetated culvert along causeway 15.

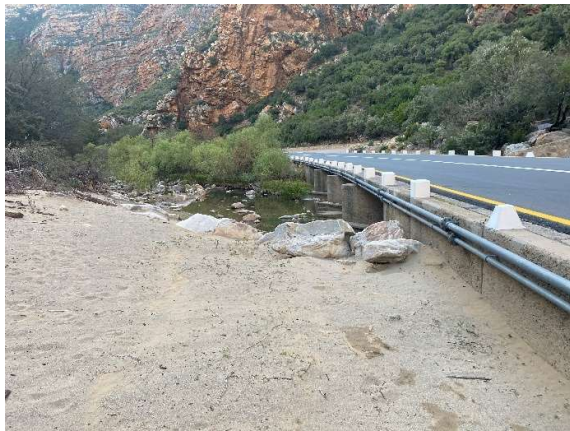
Potable water pipeline downstream of causeway 16 still in good condition. Some sedimentation present.

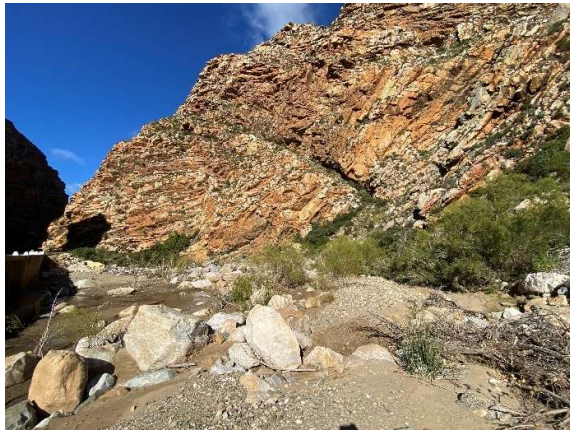
Condition causeway 18, sedimentation has been removed.

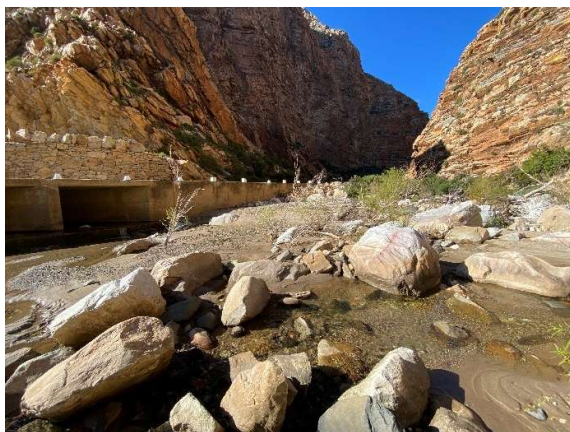
Downstream of causeway No 18 B2696 with cleared watercourse flow path.
