ANNEXURE A – SITE PHOTOGRAPHS

Site Camp and Stockpiles @ km 25

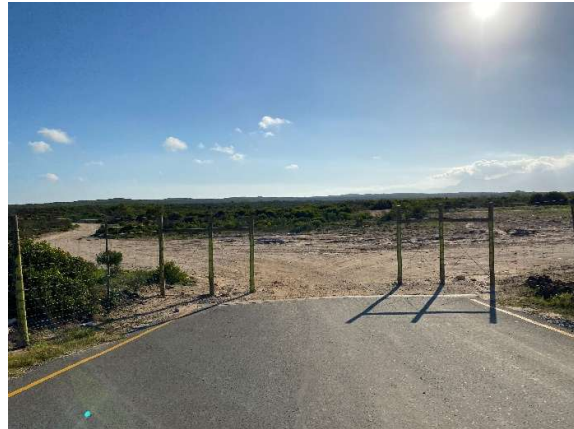
The entrance off R43 towards stockpile area 3 and the site camp.

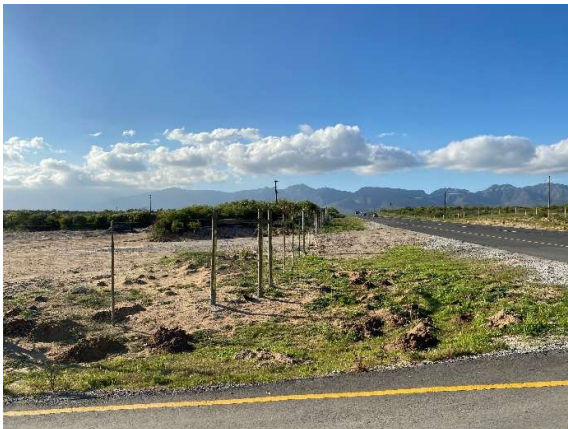
The access off R43 towards stockpile area 3 and the site camp as seen towards the north.

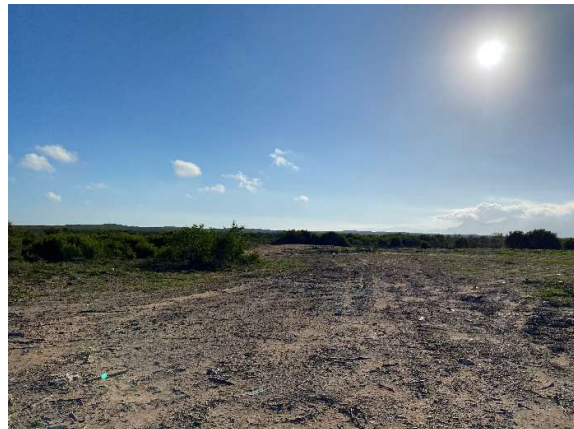
Stockpile area 3, at approximately km 27.

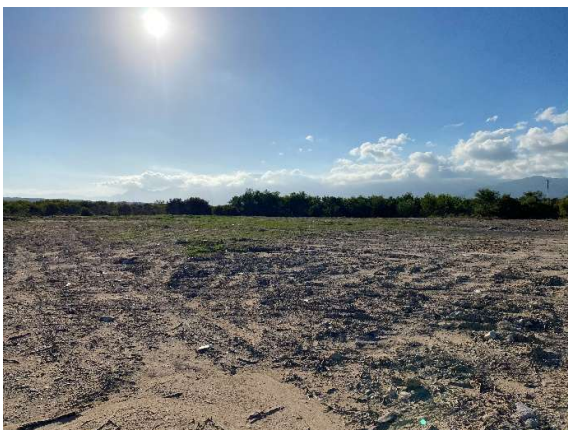
Stockpile area 3, at approximately km 27.

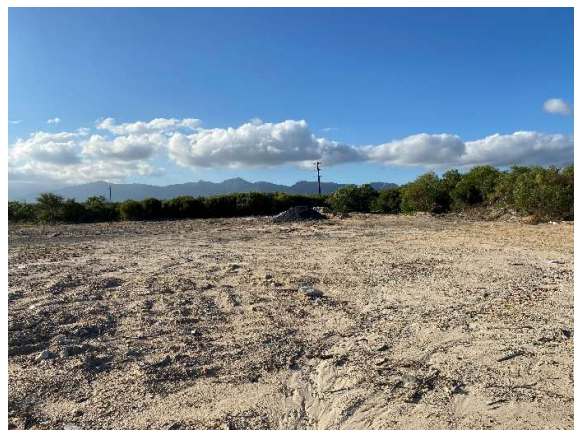
Stockpile area 3, at approximately km 27.

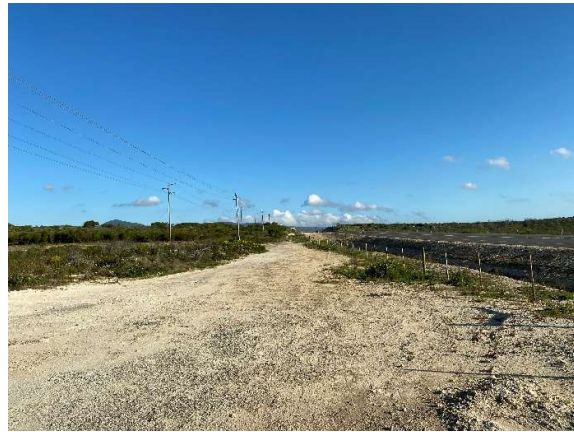
Access road to stockpile area 2.

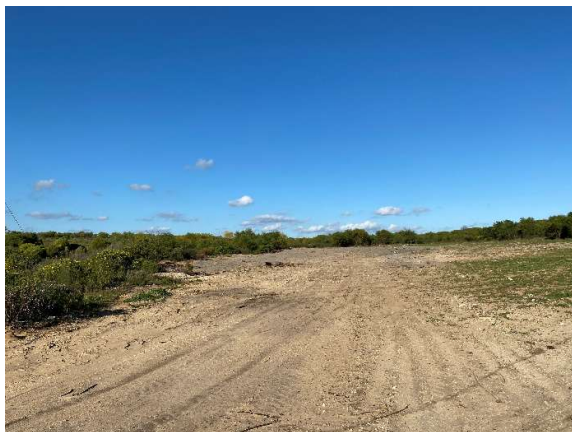
Stockpile area 2, at approximately km 27.5 where all stockpiled material has been removed and the area ripped.

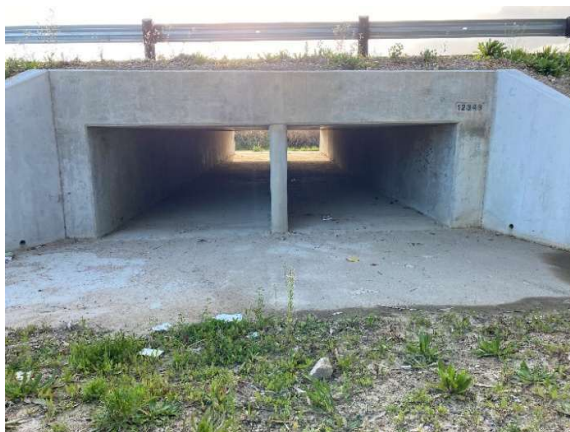
Box culvert 12349 as seen from the east towards the west (downstream).

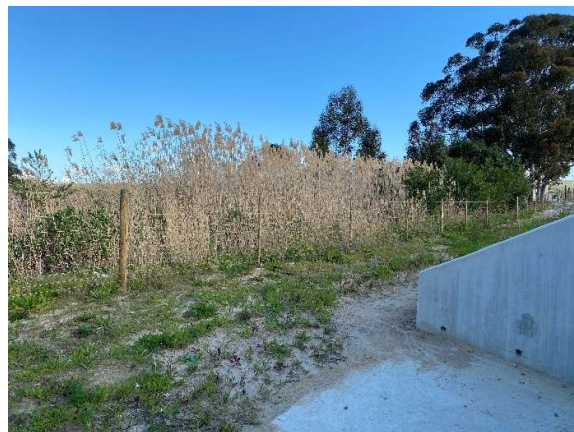
Upstream towards the east as seen from box culvert 12349.

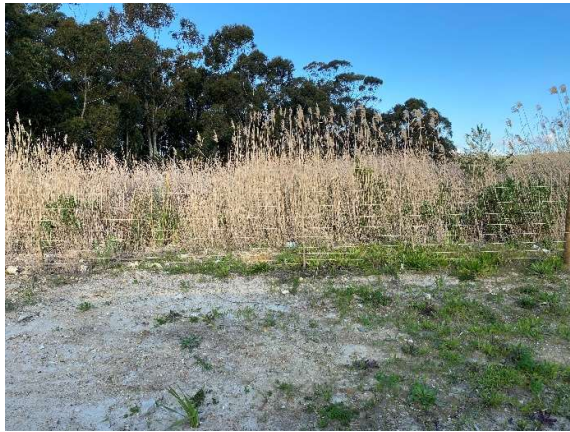
Upstream towards the east as seen from box culvert 12350.

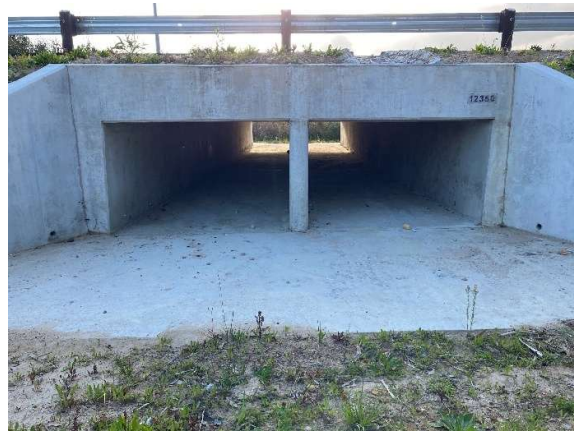
Box culvert 12350 as seen from the east towards the west (downstream).

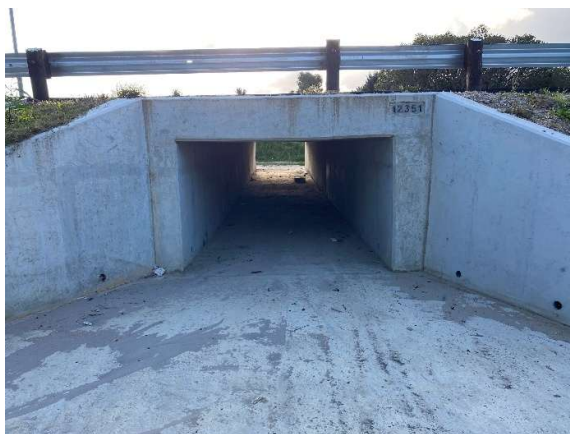
Box culvert 12351 as seen from the east towards the west (downstream).

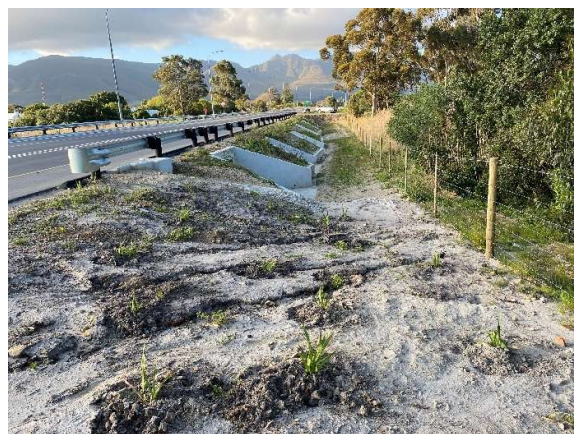
Completed landscaping along the road shoulder towards the south of the completed box culverts at km24.

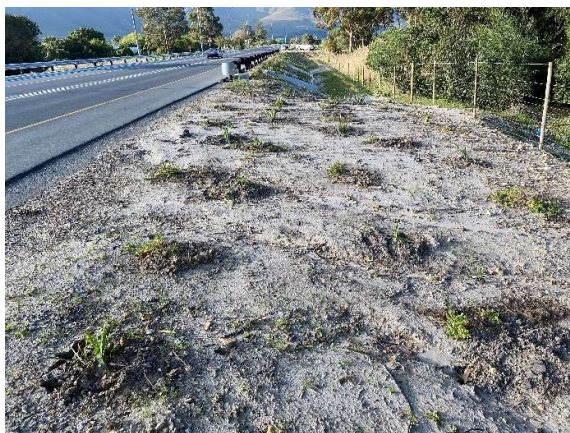
Completed landscaping along the road shoulder towards the south of the completed box culverts at km24.

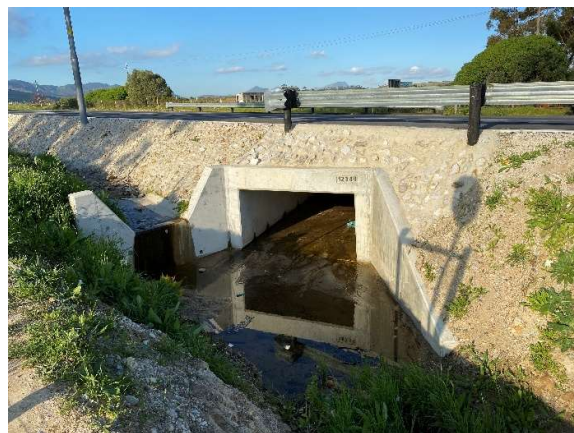
Box culvert 12340 along the west of the road as seen towards the north at km24.

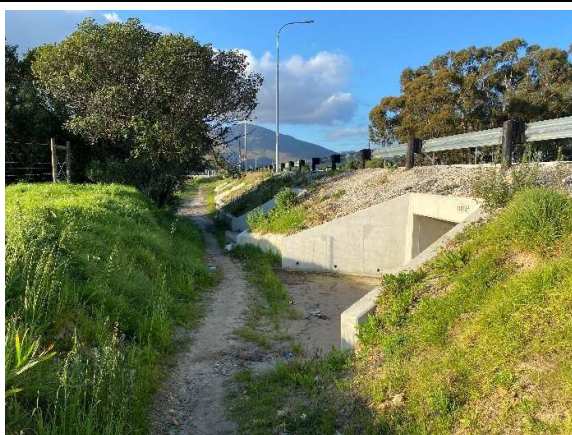
Along the west of the completed box culverts at km24 as seen towards the north.

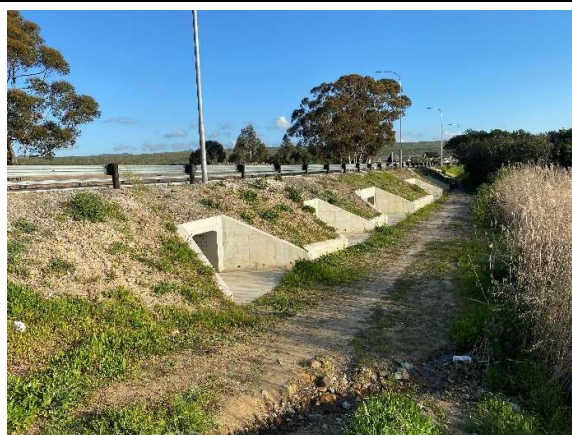
Along the west of the completed box culverts at km24 as seen towards the south.

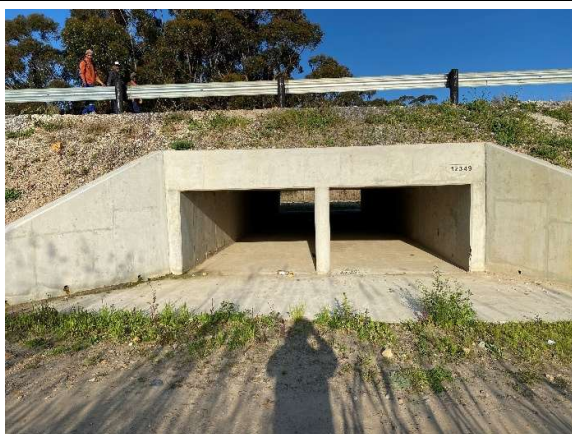
Box culvert 12349 as seen from the west of the road towards the east (upstream).

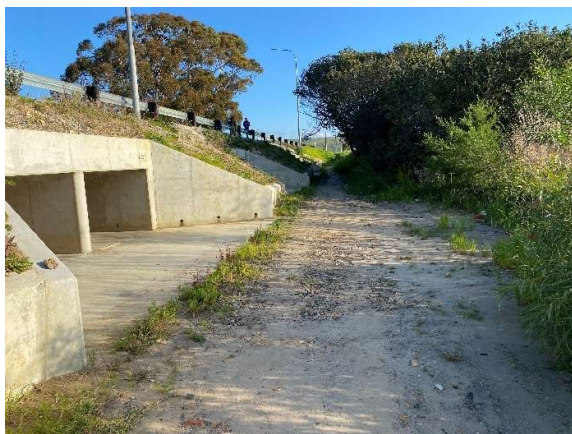
Box culvert 12350 as seen from the west of the road towards the south.

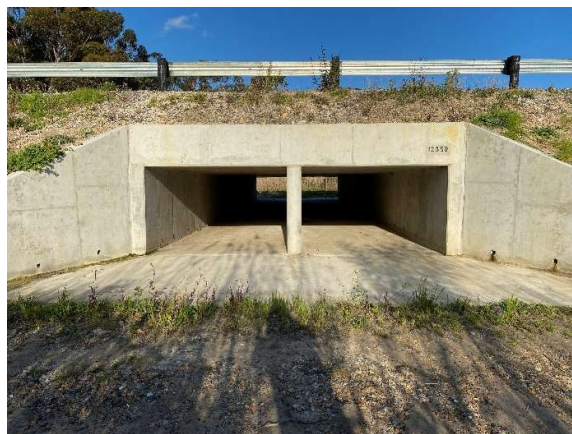
Box culvert 12350 as seen from the west of the road towards the east (upstream).

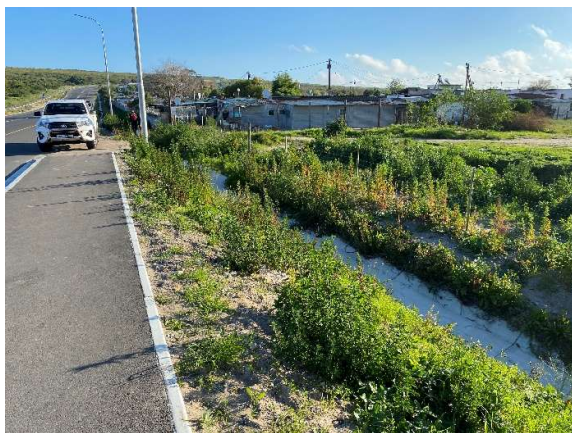
Side drains completed along the west of the road at km25.

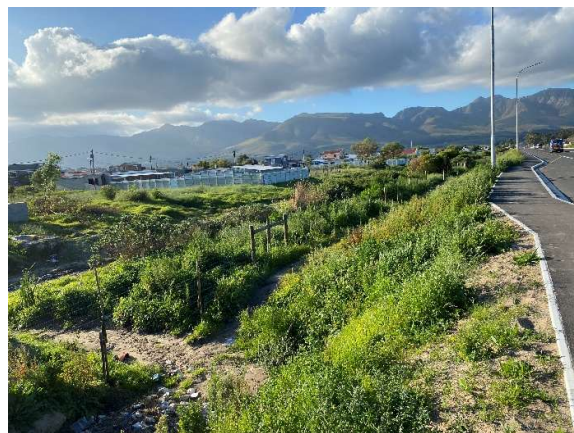
Pipe culvert with headwall completed along the west of the road at km25 as seen towards the north.

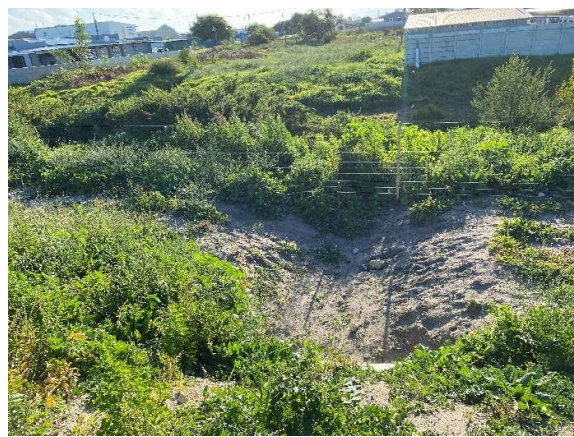
Pipe culvert with headwall completed along the west of the road at km25 as seen towards the west.

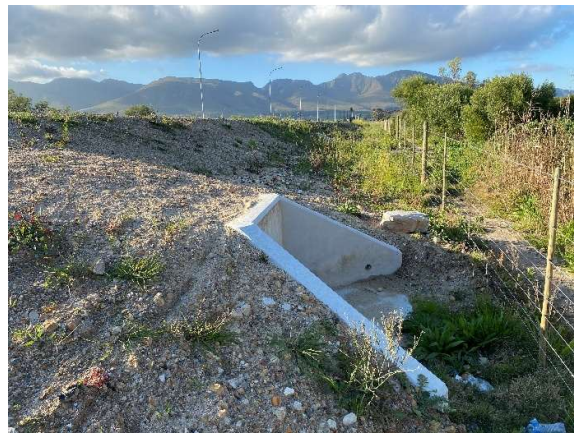
Pipe culvert with headwall completed along the east of the road at km25 as seen towards the north.

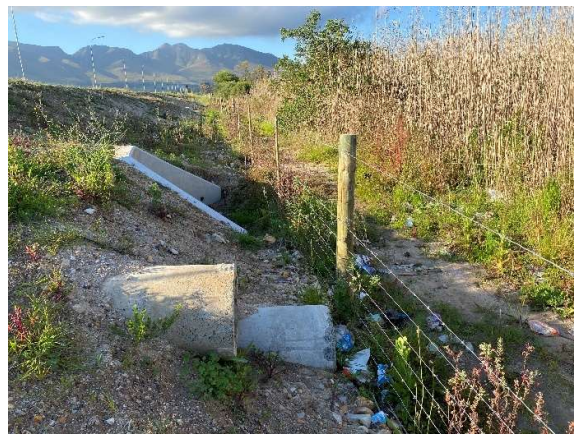
Pipe culvert with headwall completed and another pipe culvert retained along the east of the road at km25 as seen towards the north.

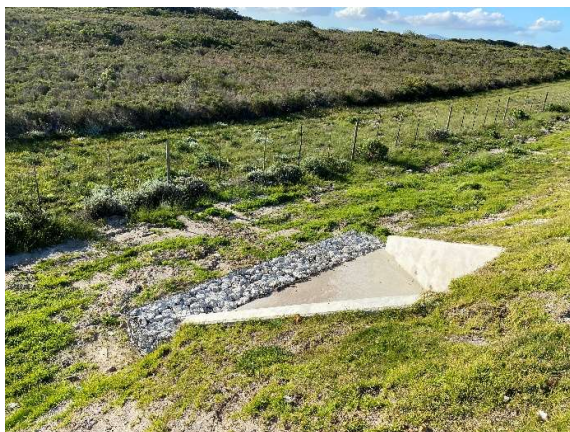
Completed culvert with headwall and mattress downstream at km 35 as seen from the road shoulder towards the northwest.

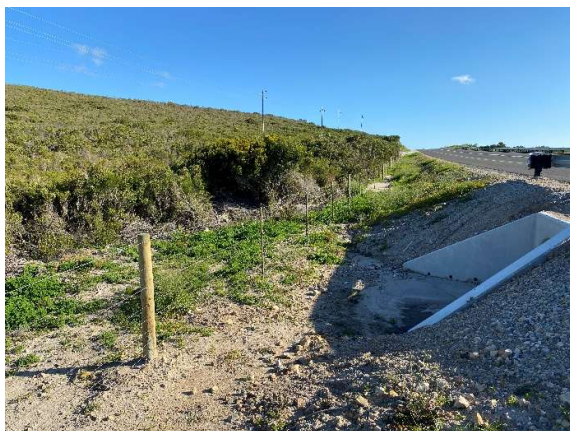
Completed culvert with headwall upstream at km 35 as seen towards the south.

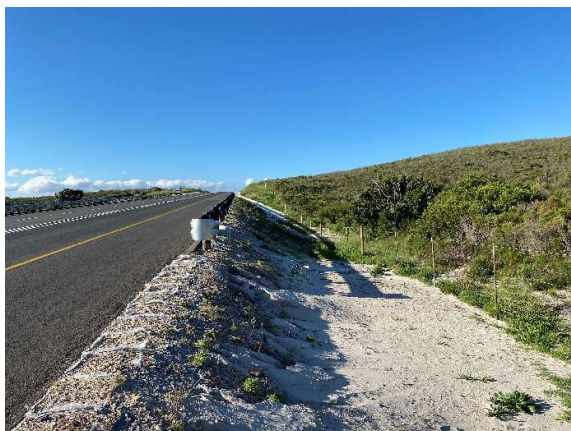
Completed culvert with headwall upstream at km 36 as seen towards the north.

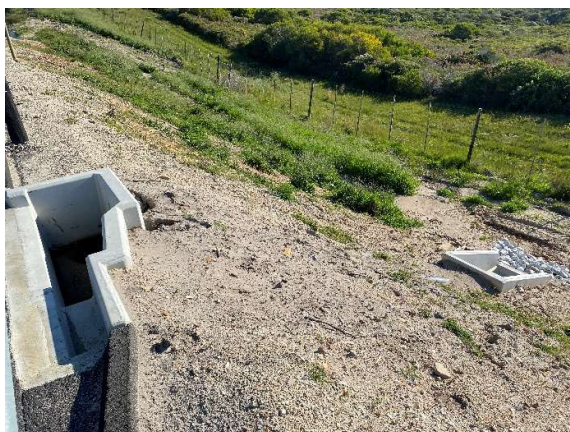
Road shoulder catchment inlet with culvert outlet downstream at km 36.

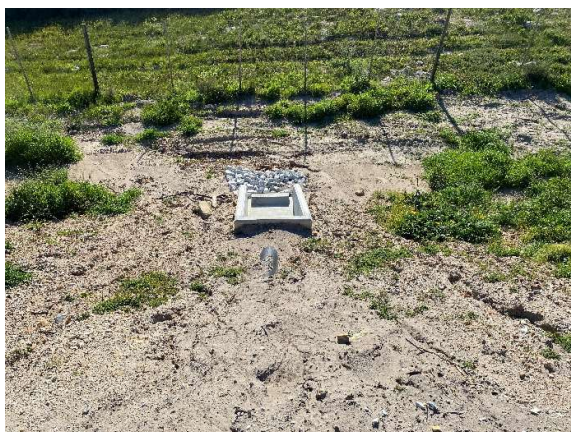
Completed culvert outlet with litter trap and mattress downstream at km 36.

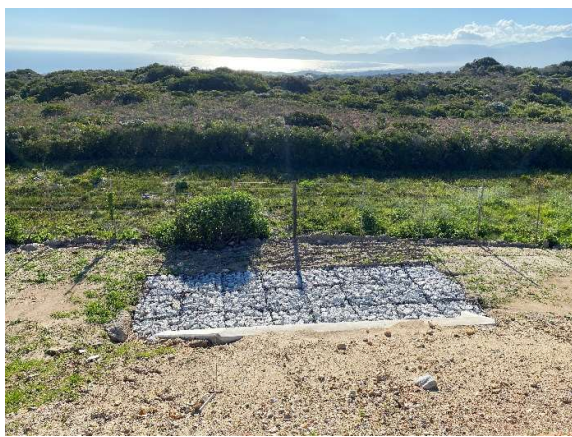
Completed culvert with headwall and reno mattress downstream at km 36.

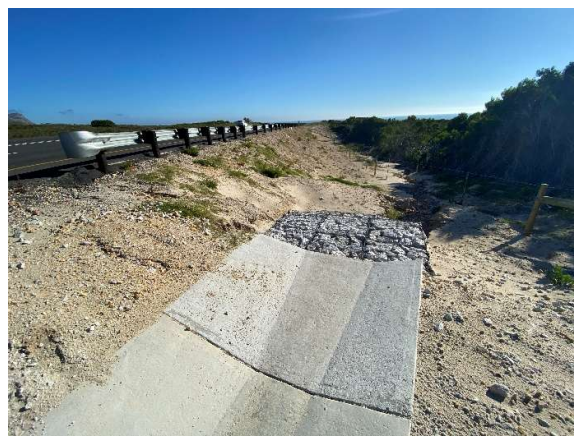
Completed sidedrain channel outlets @km 37 with gabions at the outlet for energy dissipation to prevent erosion.

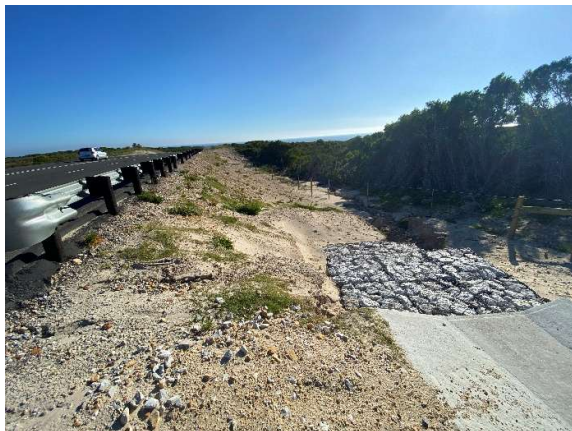
Completed sidedrain channel outlets @km 37 with gabions at the outlet for energy dissipation to prevent erosion.

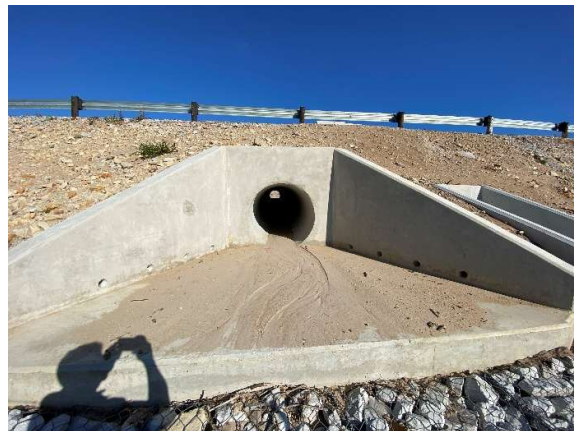
Completed culvert outlet with wingwall and mattress downstream at km 37.84

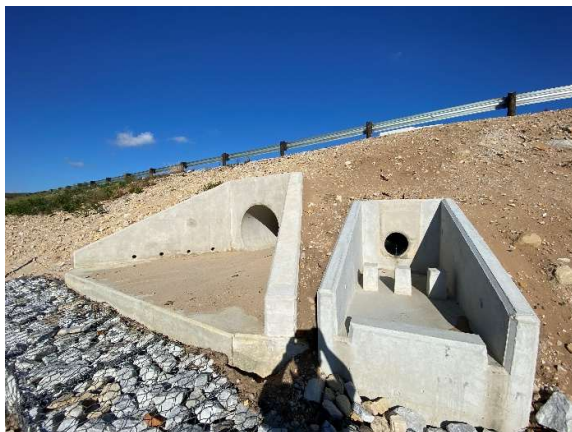
Completed culvert outlet with wingwall and mattress and litter trap downstream at km 37.84.

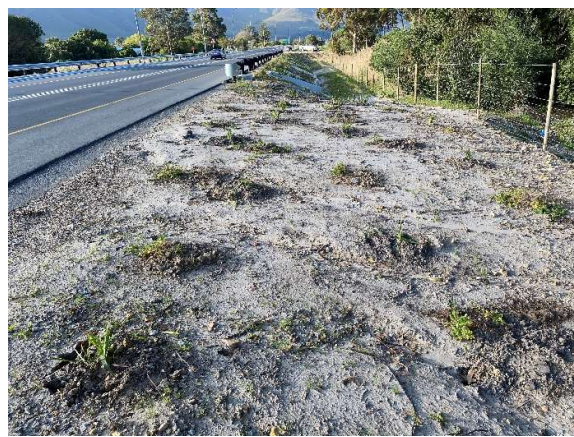
Completed rehabilitation along the eastern road shoulder at km24.

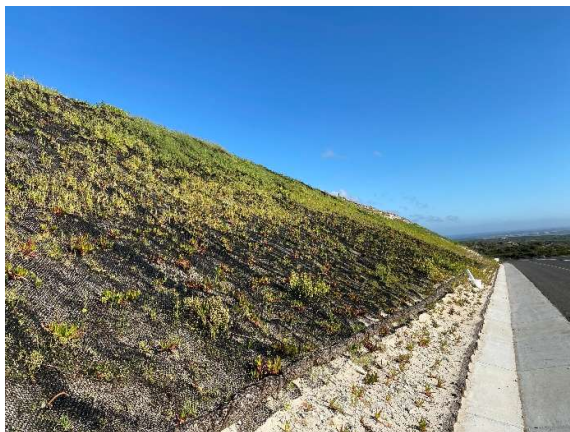
Completed large scale rehabilitation at the larger and steeper cuttings along the R43.

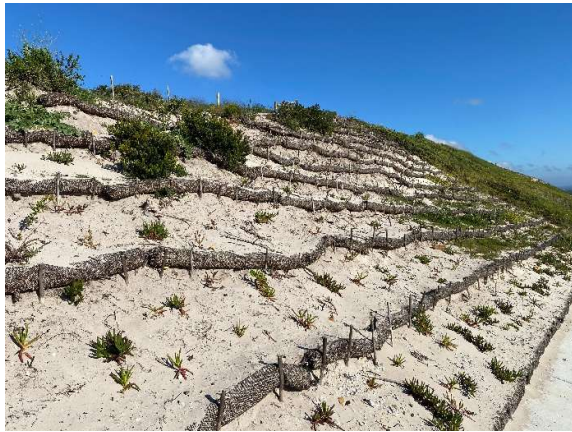
Completed large scale rehabilitation at the larger and steeper cuttings along the R43 at km 3.

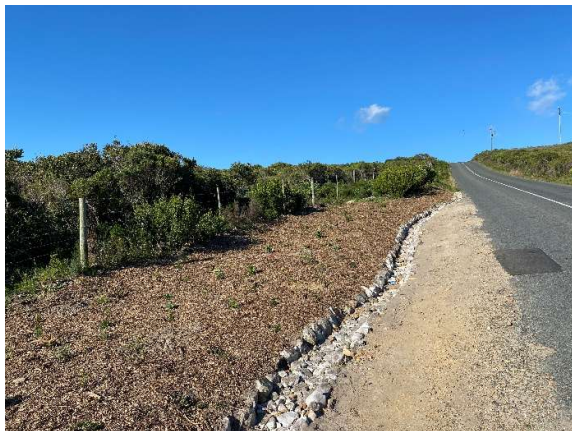
Completed planting and rehab at the Grootbos turnoff complete with stone pitched stormwater drainage.

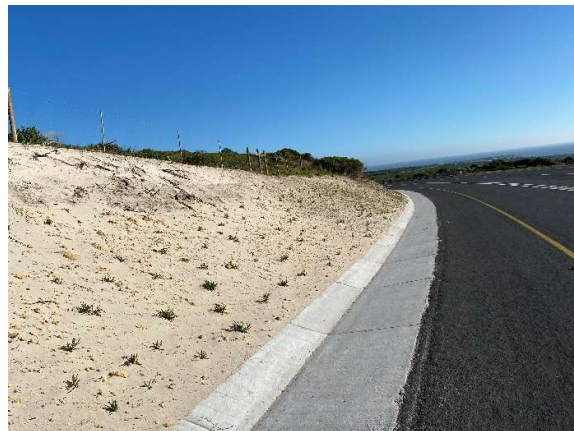
Completed planting and rehab along the sandy exposed slopes as seen towards the south.

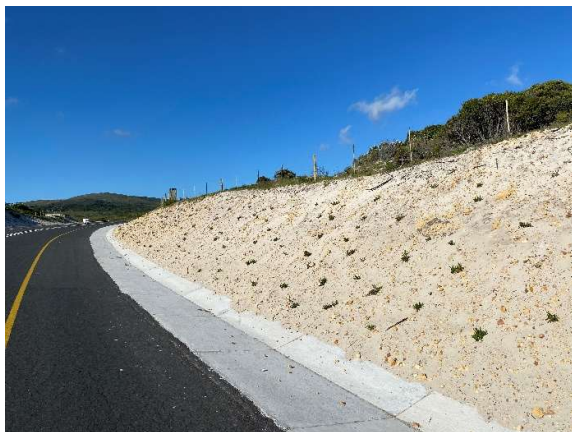
Completed planting and rehab along the sandy exposed slopes as seen towards the north.

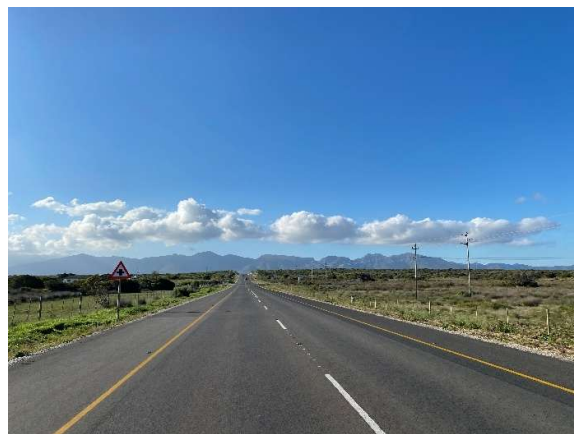
Completed road surface near km 28 seen towards the north.

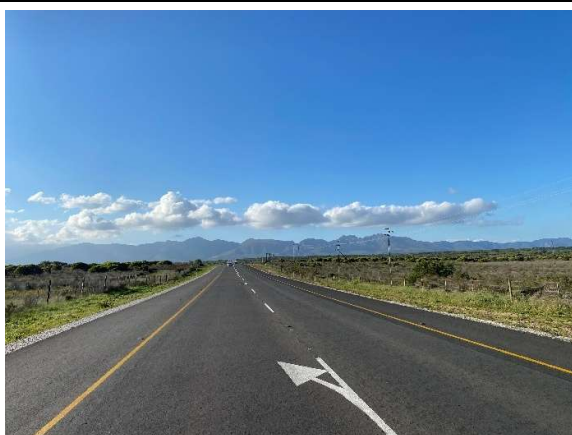
Completed road surface near km 29 seen towards the north.

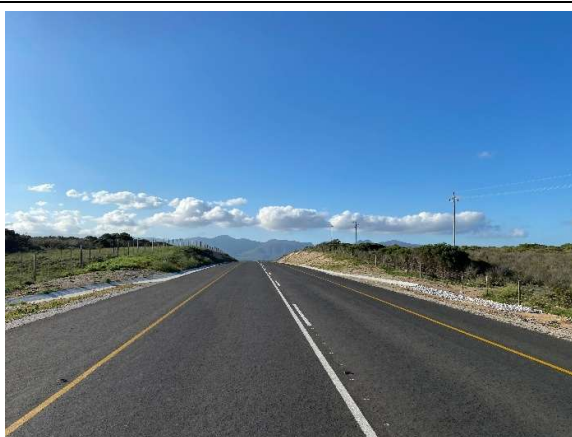
Completed road surface near km 30 seen towards the north.

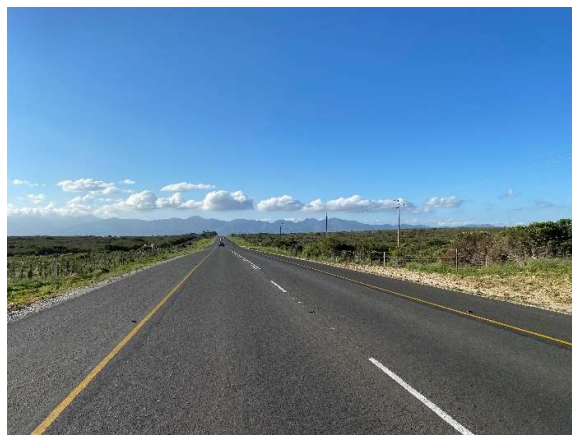
Completed road surface near km 33 seen towards the north.

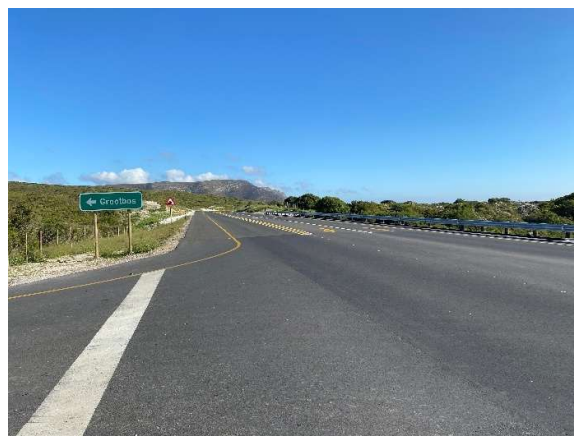
Completed upgraded intersection with dedicated turn lanes at the Grootbos Nature Reserve at km 36.

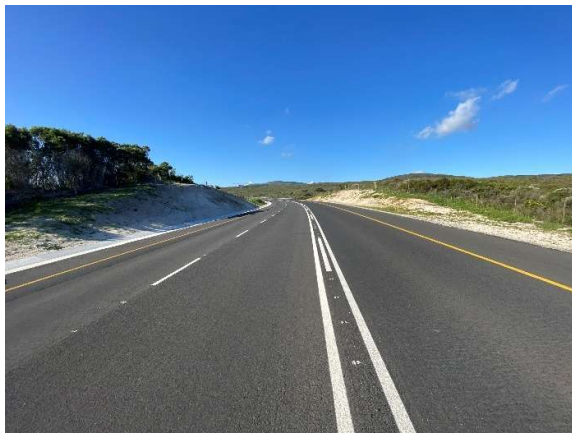
Completed road surface near km 37 seen towards the north.

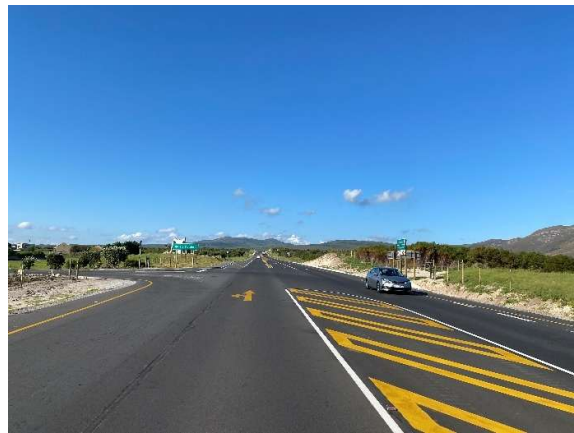
The upgraded intersection at the De Kelders turnoff at km 40.

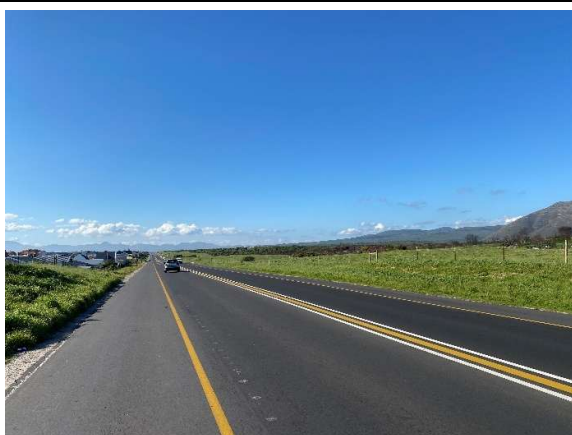
Completed road surface near km 42 seen towards the north.

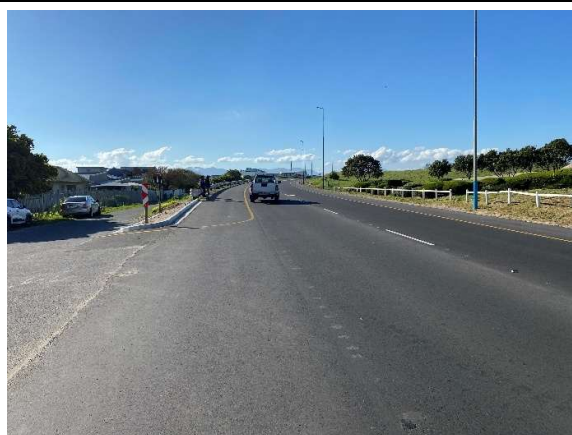
Near the end of the contract at the entrance into Gansbaai at km 43.

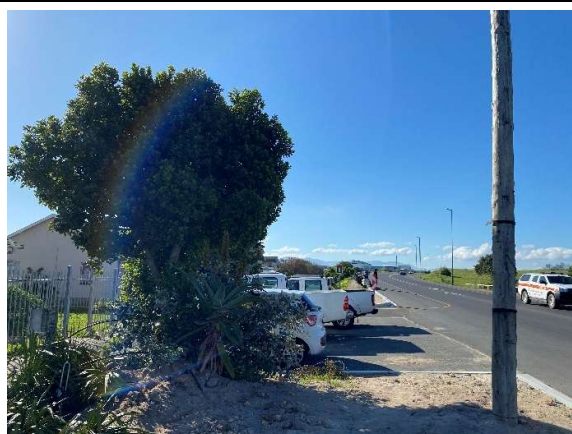
Protected Milkwood tree along the western edge of the road in Gansbaai at km43.
