**ENVIRONMENTAL MONITORING REPORT No. 12**  
**FOR**

***The Development of the Garden Walk on the Remainder of Portion 58  
of the Farm Hartenbosch 217, Hartenbos***

**February 2026**

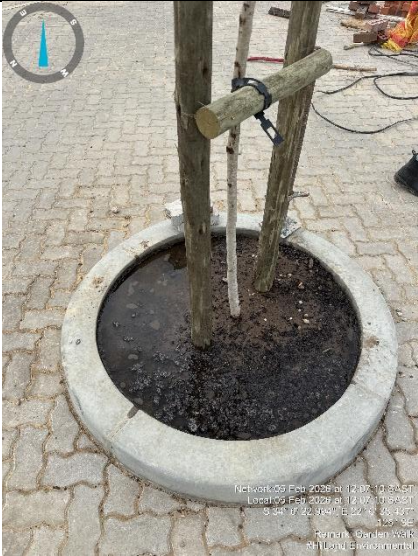
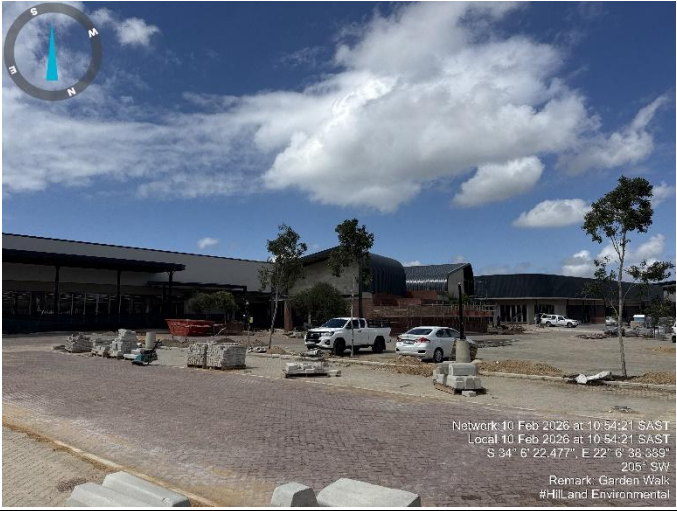
| <p>Reinstate the vegetation in accordance with the Landscape Master Plan.</p> <p>All landscaping areas to be planted and maintained.</p> | <p>Ongoing</p> | <p>Rehabilitation / revegetation of the retaining wall / embankment has been done (phase 1)<br/>– refer to the ECO rehabilitation monitoring report.</p> <p>Landscape in process.</p> | <div><p>Nakwon: 24 Feb 2026 at 11:02:57 SAST<br/>Local: 24 Feb 2026 at 11:02:57 SAST<br/>S 34° R 23.952° E 22° G 36.953°<br/>108° E<br/>Remarks: Garden Walk<br/>#Hilland Environmental</p></div> <div><p>Nakwon: 24 Feb 2026 at 11:02:57 SAST<br/>Local: 24 Feb 2026 at 11:02:57 SAST<br/>S 34° R 23.952° E 22° G 36.953°<br/>108° E<br/>Remarks: Garden Walk<br/>#Hilland Environmental</p></div> |

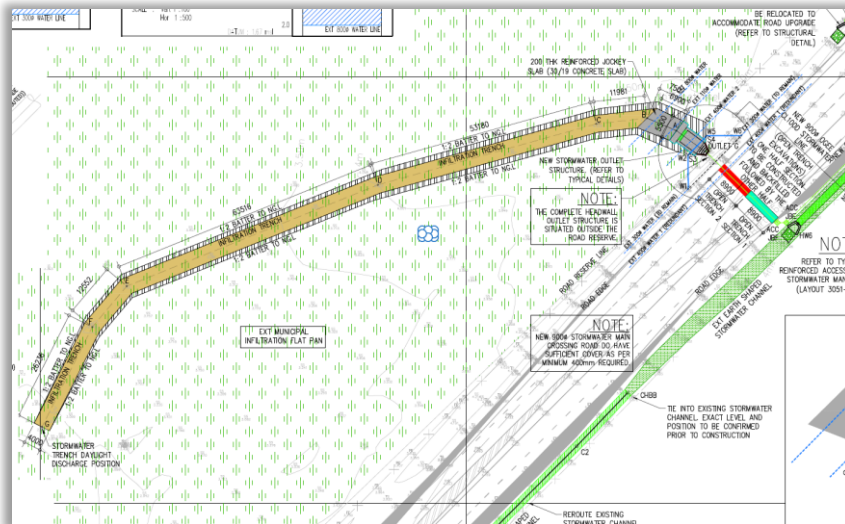
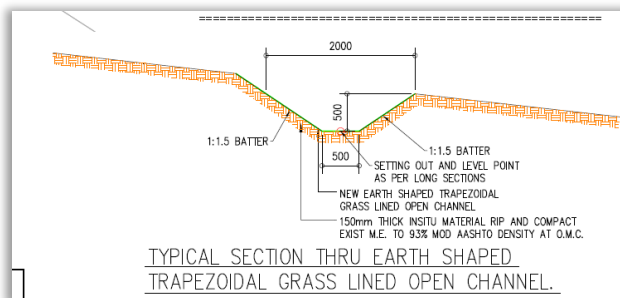
- The stormwater master plan was circulated to the ECO at the end of January 2026. As per the service level agreement with Mossel Bay Municipality, the stormwater outlet is located on RE/101/217 (municipal stormwater detention area). All care must be taken to prevent siltation of this area. The stormwater inlets must be kept free of sand, sediment, and debris to ensure that the stormwater infrastructure functions effectively.
  - The stormwater outlet earth channels must be shaped and rehabilitated with indigenous vegetation and grasses.
  - Hay-bale silt protection is recommended in this earth channel.

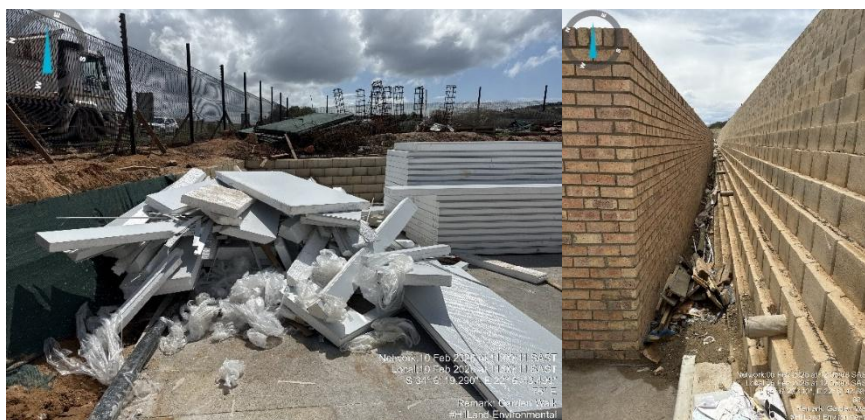
- The rehabilitation area (above the retaining wall) must be regarded as No-Go area.
- General house-keeping and regular litter picking is required.
