## ENVIRONMENTAL MONITORING REPORT No. 1

*The Development of the Garden Walk on the Remainder of Portion 58  
of the Farm Hartenbosch 217, Hartenbos*

**January and February 2025**

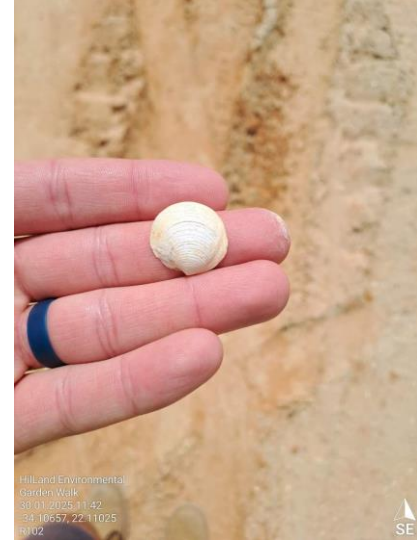
| Although not anticipated, should it be suspected that an object or structure of heritage value has been uncovered during earthworks or the clearing of vegetation (including but not limited to bones, burial sites, structures older than 50 years, stone tools, shell middens, pottery etc.), then all work is to immediately cease, and the ECO is to be contacted to inform Heritage Western Cape (HWC). Work shall not recommence until HWC have visited the site, inspected the object in question and advised on how to proceed. | Compliant | <p>The ECO discovered a shell during ECO site inspection (30 January 2025).</p> <p>A professional archaeologist was consulted and confirmed that the find is not significant as it is out of context and that no further action is required.</p> | <p>Heritage Environmental<br/>Garden Walk<br/>30.01.2025 11:42<br/>31.10657, 22.11025<br/>10192</p> <p>SE</p> |
