## ENVIRONMENTAL MONITORING REPORT No. 2

*The Development of the Garden Walk on the Remainder of Portion 58  
of the Farm Hartenbosch 217, Hartenbos*

**Report period: March 2025**

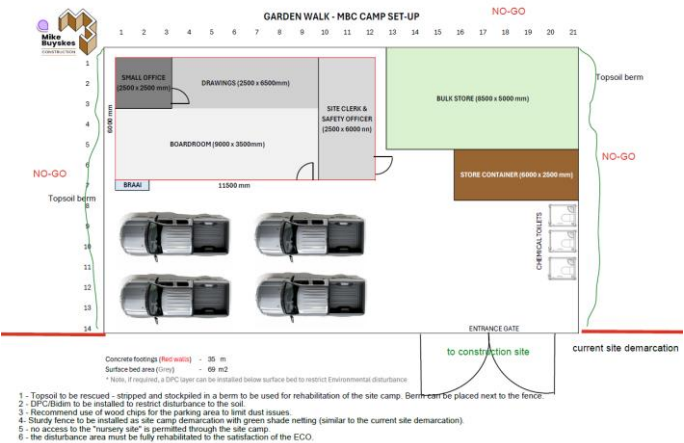
Earthworks contractor site camp

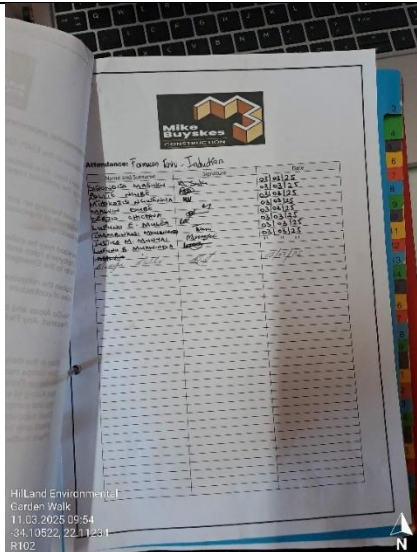
| <p>All construction staff should be briefed by the ECO/DEO in an environmental education programme.</p> | <p>Compliant</p> | <p>Environmental induction was done with all staff on site on 16 January 2024 (Jordan construction).</p> <p>Induction was done with the main contractor (MBC) management team done on 11 February 2025.</p> <p>DEO does inductions with new staff as they arrive on site.</p> | <p><b>Induction done with MBC</b></p> |

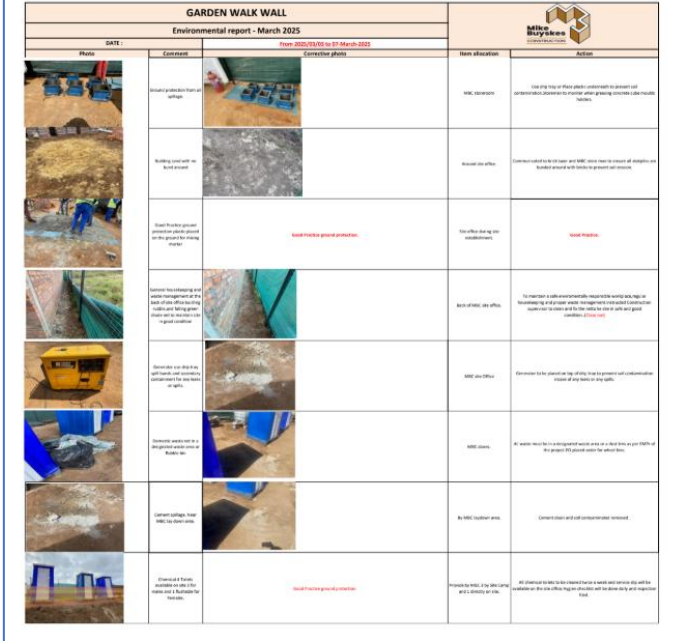
| The main contractor shall appoint a responsible agent to ensure that they comply with this EMPr and all its conditions. | Compliant | SHE - Aphiwe Mteyise – MBC<br>SHE - Tinashe Kurwaisimba– Jordan Construction | <p><b>SHE officers environmental report in the environmental file</b></p> |
