## ENVIRONMENTAL MONITORING REPORT No. 5

*The Development of the Garden Walk on the Remainder of Portion 58  
of the Farm Hartenbosch 217, Hartenbos*

**June 2025**

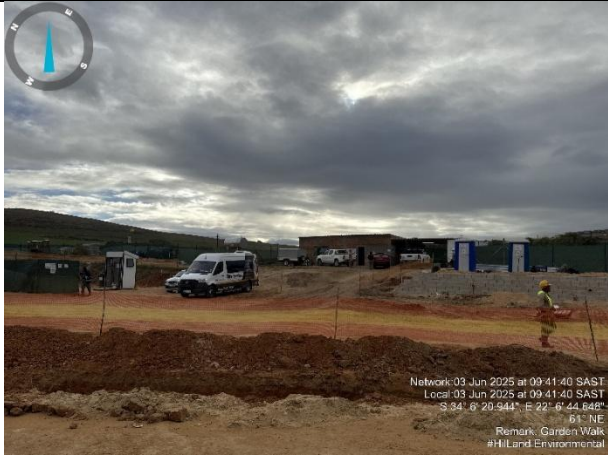
| EMPr Requirement | Level of Compliance | Comments / Findings | Photo's (if applicable) |
|---|---|---|---|
| The site camp area must be indicated and approved by the ECO. | DONE | <p>The site camp method statement (MBC) was approved by the ECO. The site camp is set up on RE/219 as per the method statement. Based on the survey data, the area in front of the site camp is also on RE/219, refer to non-compliance notification mentioned above.</p> <p>Civil contractor: The site camp is within the fenced off development footprint.</p> | <p> <small> Hilland Environmental<br/> Garden Walk<br/> 25.06.2025 10:22<br/> 34°42'28.62"S 22°43'34.61"E<br/> R-02 </small> </p> <p><b>Civil contractor site camp</b></p> |

| | | | <p>Network: 03 Jun 2025 at 09:41:40 SAST<br/>Local: 03 Jun 2025 at 09:41:40 SAST<br/>S 84° 6' 20.944" E 22° 6' 44.846"<br/>61° NE<br/>Remark: Garden Walk<br/>#Hilland Environmental</p> |

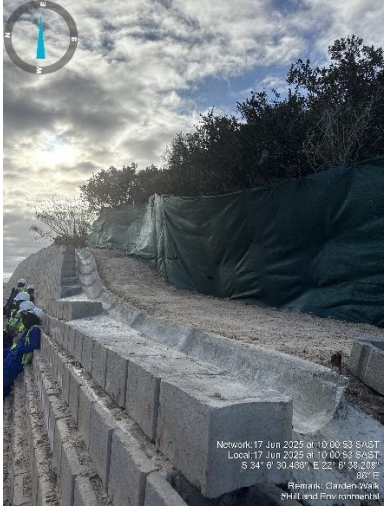
| <p>No-Go areas will be required to be demarcated by the contractor to ensure that they are visible at all times, to all personnel.</p> | <p>Compliant</p> | <p>The working area is demarcated with a 1.8m wire fence and shade netting.</p> | <p><b>Demarcation of the working zone with green shade netting</b></p> |

| <p>The total footprint of a building zone / phase should be demarcated with 1.5 m (height) shade cloth for the entire period of the construction.</p> | <p>Compliant</p> | | |

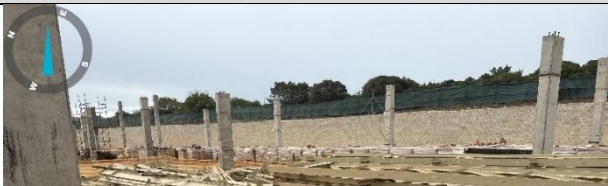
| <p>All stockpile sites to be approved by the ECO and/or landowner, prior to the commencement of stockpiling.</p> | <p>Compliant &amp; ongoing</p> | <p>Current construction material stockpile area is within the demarcated zone.</p> <p>Topsoil stockpiled in Outeniquasbosch (landowner approval letter to be submitted to the ECO for record keeping).</p> | |

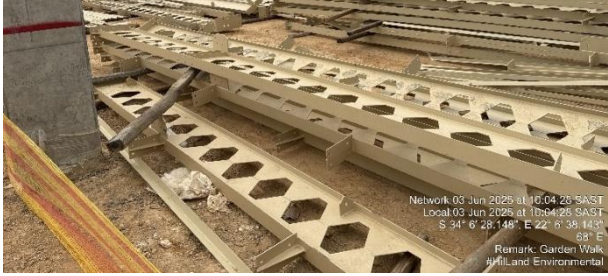
| <p>All stockpile sites within the development area are to be demarcated with silt-fences and/or danger tape, where necessary.</p> | <p>Compliant &amp; ongoing</p> | <p>The construction material stockpile in the development zone is demarcated with orange netting fencing.</p> | |
