## ENVIRONMENTAL MONITORING REPORT No. 5

*The Development of the Garden Walk on the Remainder of Portion 58  
of the Farm Hartenbosch 217, Hartenbos*

**June 2025**

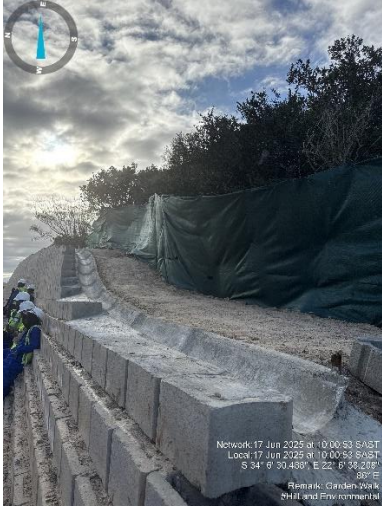
| <p>The total footprint of a building zone / phase should be demarcated with 1.5 m (height) shade cloth for the entire period of the construction.</p> | <p>Compliant</p> | | |
