## APPENDIX A – SITE PHOTOGRAPHS

## External Audit

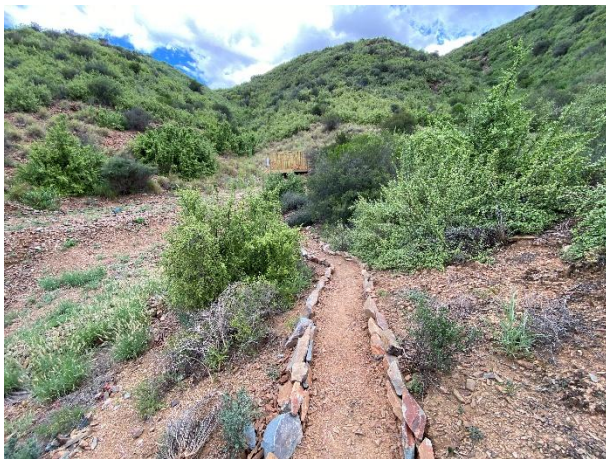
Walkway towards the chicken coop deck.

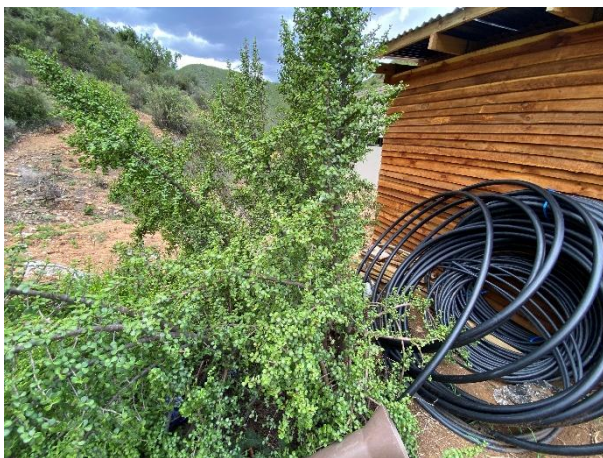
Outhouse adjacent to the main house.

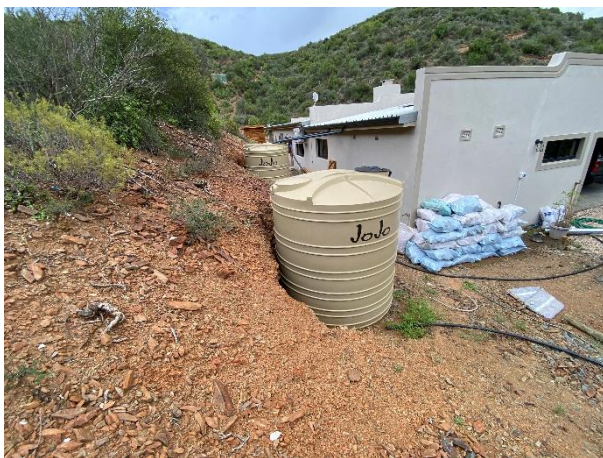
Jojo tank along the southwestern boundary of the main house.

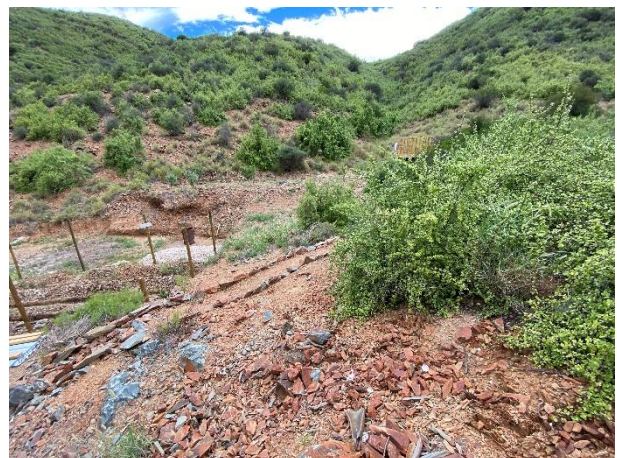
View of the garden and proposed greenhouse location as seen from the house towards the southeast.

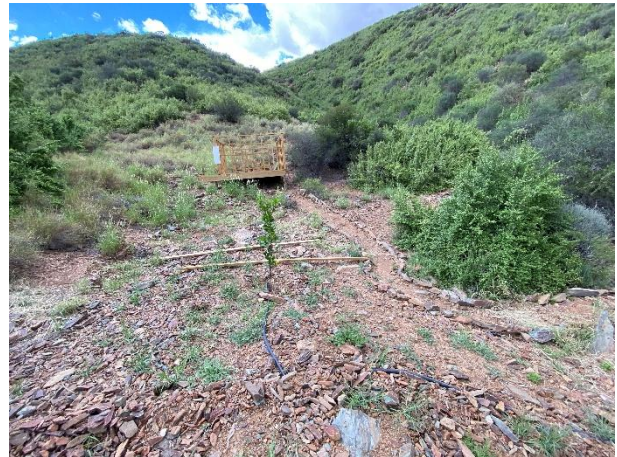
View of the chicken coop deck towards the northwest from the garden.

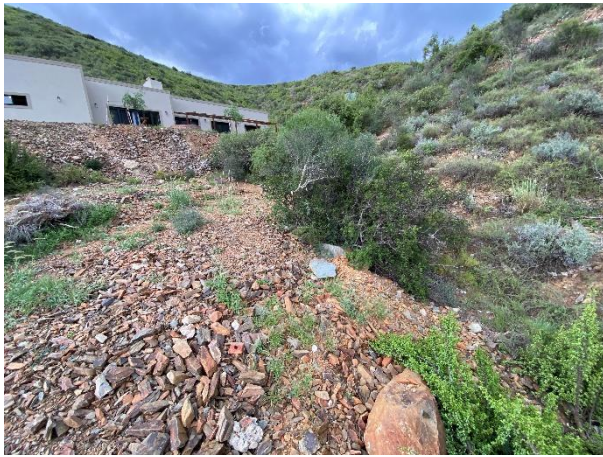
Property boundary at 33°29.6425' S; 21°36.9680' E.

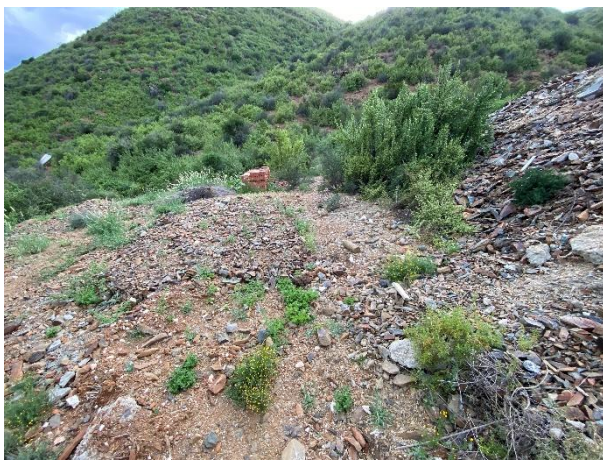
Property boundary at 33°29.6439' S; 21°36.9605' E.

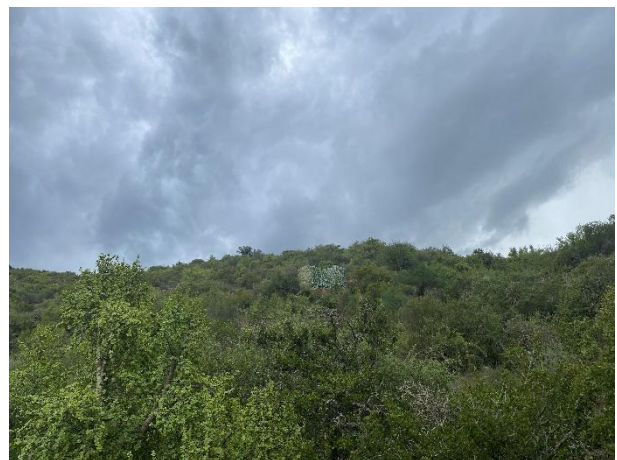
View northwest towards the water tank.

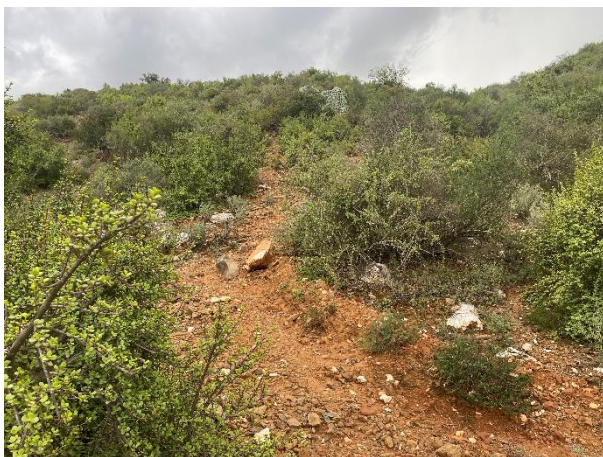
Footpath towards the water tank.
