## REHABILITATION REPORT

**THE PROPOSED MOUNT VIEW RESIDENTIAL DEVELOPMENT ON  
THE REMAINDER OF FARM 869, FARM 1262, REMAINDER OF  
FARM 866, REMAINDER OF FARM 1054, PORTIONS 2 AND 3 OF  
FARM 1054 AND PORTION 2 OF FARM 870, SIR LOWRY'S PASS,  
WESTERN CAPE.**

Guillaume Nel Environmental Consultants

**November 2020  
Amended March 2021**

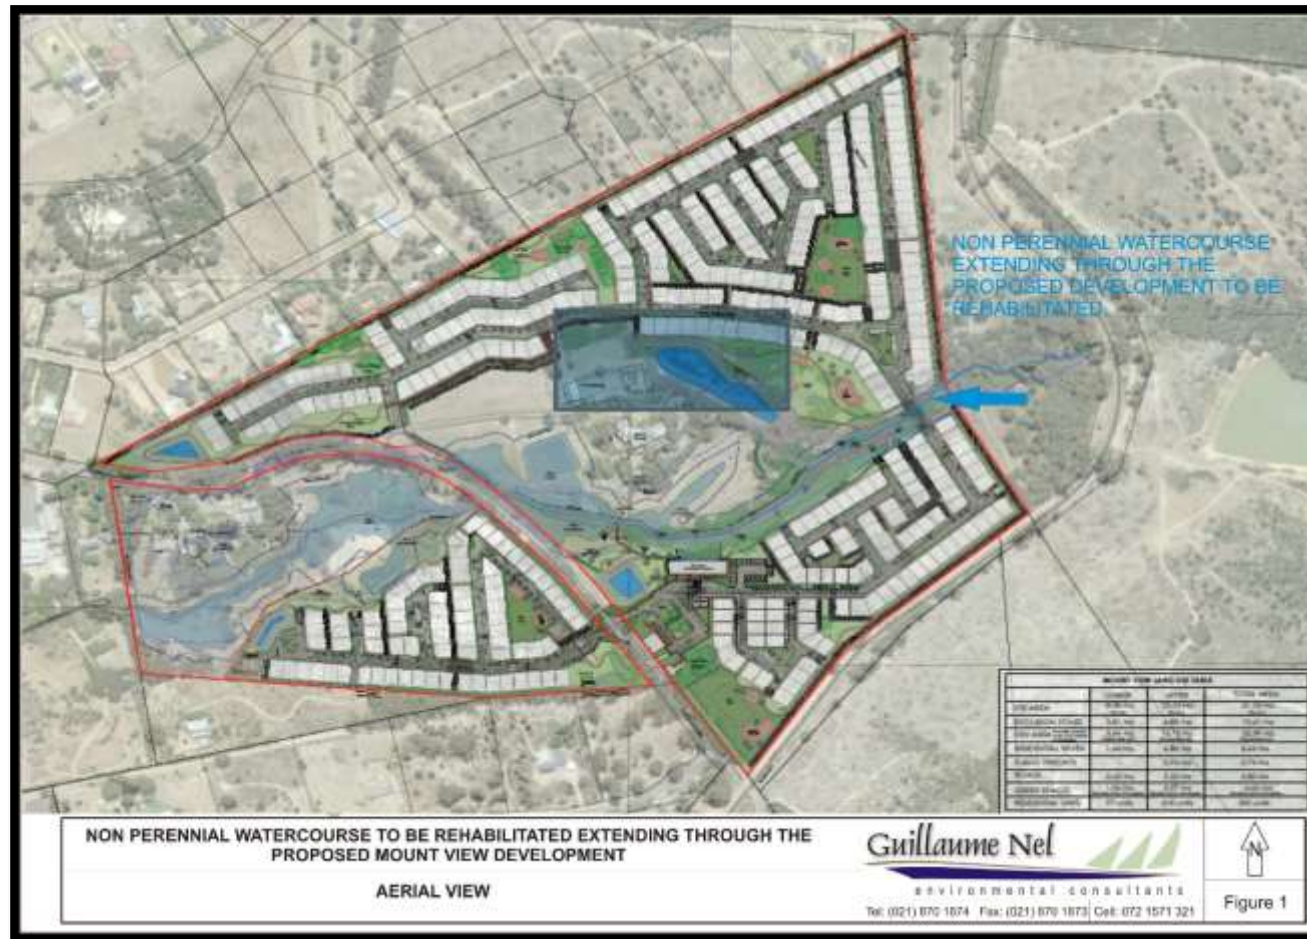
FIGURE 2: LOCALITY MAP LOCALITY OF THE NON-PERENNIAL WATERCOURSE TO BE REHABILITATED.

*Please refer to Figure 2 below for the locality map of the non-perennial watercourse to be rehabilitated.*

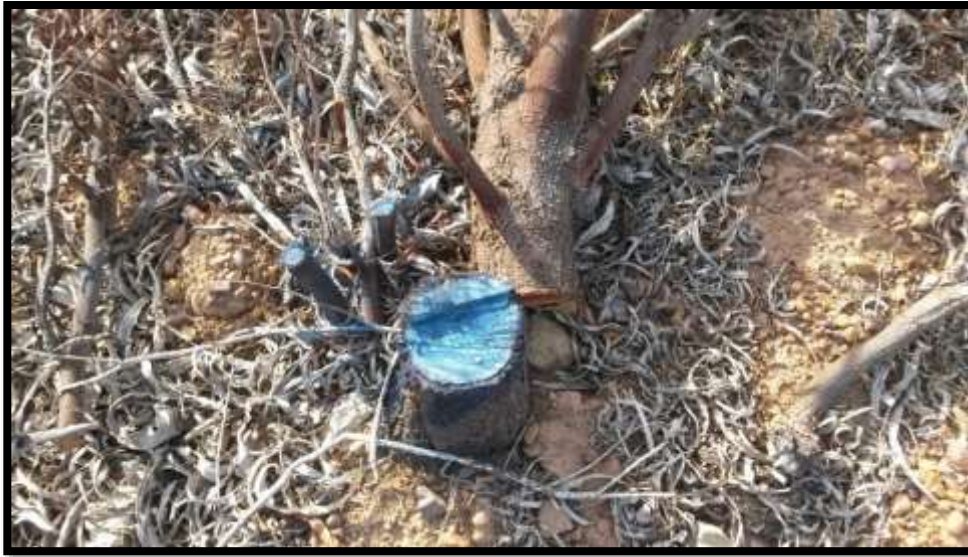
FIGURE 23: A CUT STEM TREATED WITH A COLOURED SYSTEMIC HERBICIDE.

Invasive alien plants must be cut and painted with herbicide where they are too difficult to pull out by hand. Invasive trees must be cut so as to leave a stem of 10cm. The remaining stems must be painted with a systemic herbicide. The systemic herbicide must be coloured to ensure that all the cut stems are treated. Care should be taken not to spill systemic poison when painting the stems. The systemic poison is intended to infiltrate the cut stems thus killing the roots and preventing the invasive tree from re-sprouting again. Cut material must be removed from the site to the nearest licensed landfill to prevent the spread of seeds.

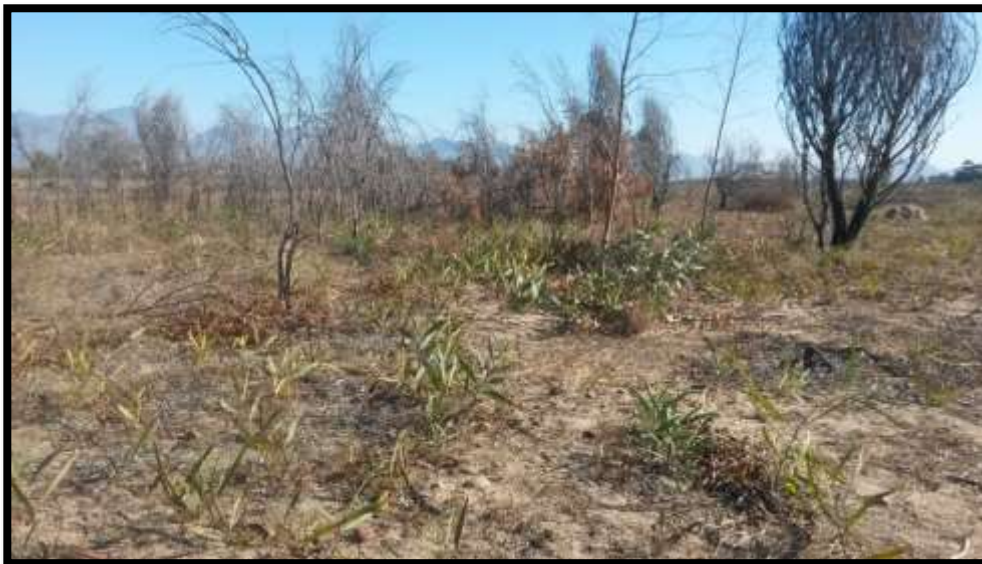
FIGURE 24: AN EXAMPLE OF SMALL PLANTS OF INVASIVE SPECIES IDEAL FOR HAND PULLING.

Since the area is in close proximity to a watercourse, no spot spraying of invasive species must be allowed since the herbicidal drift might negatively impact upon the unnamed tributary of the Sir Lowry's Pass River. Smaller plants of invasive species must be hand-pulled. This is the most effective and environmentally- friendly way to eradicate smaller plants of invasive species.

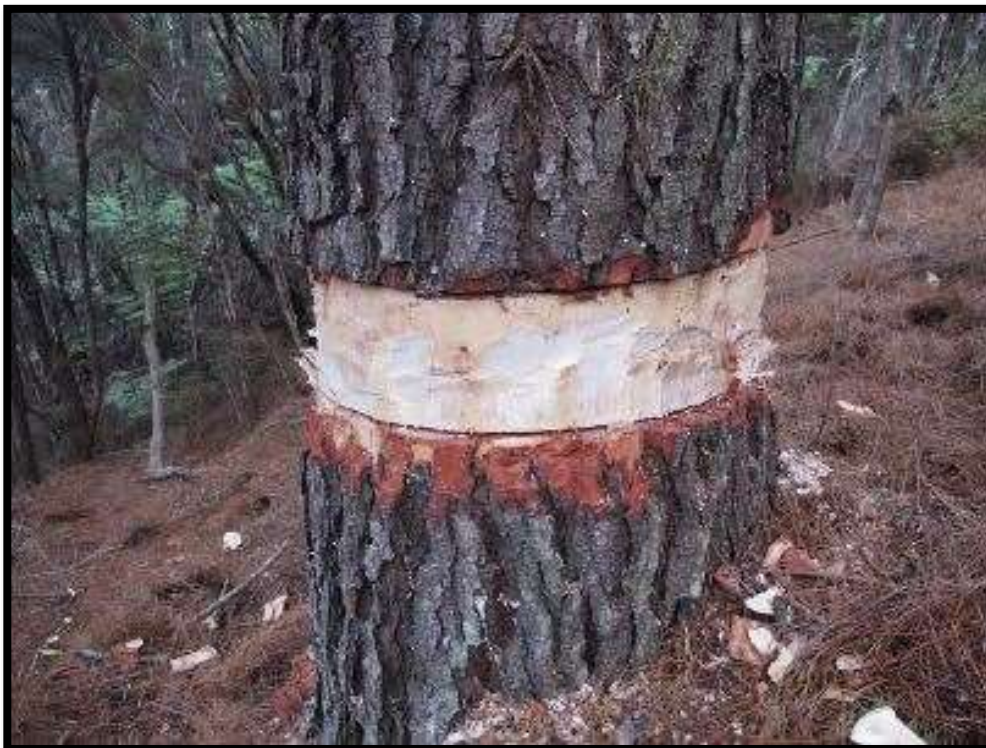
FIGURE 25: EXAMPLE OF RING BARKING LARGER INVASIVE TREES.

Ring barking is a technique that involves removing a ring of bark around a tree trunk. Ring barking interferes with the circulation of the tree and results in it slowly dying. Remove a 30 to 40 cm strip of bark around the base of the tree trunk to ground level. Ring-barking removes the cambium/phloem, a layer just beneath the bark, which carries food from the leaves down to the roots. The roots will eventually die thereby killing the tree. The ring barked area can then be painted with a systemic poison.
