### REHABILITATION AND ALIEN CLEARING MANAGEMENT PLAN FOR A SECTION OF THE BERG RIVER ALONG THE PROPOSED RESIDENTIAL DEVELOPMENT ON ERF 8892, FIRWOODS, PAARL, WESTERN CAPE.

Guillaume Nel Environmental Consultants

**25 October 2021**

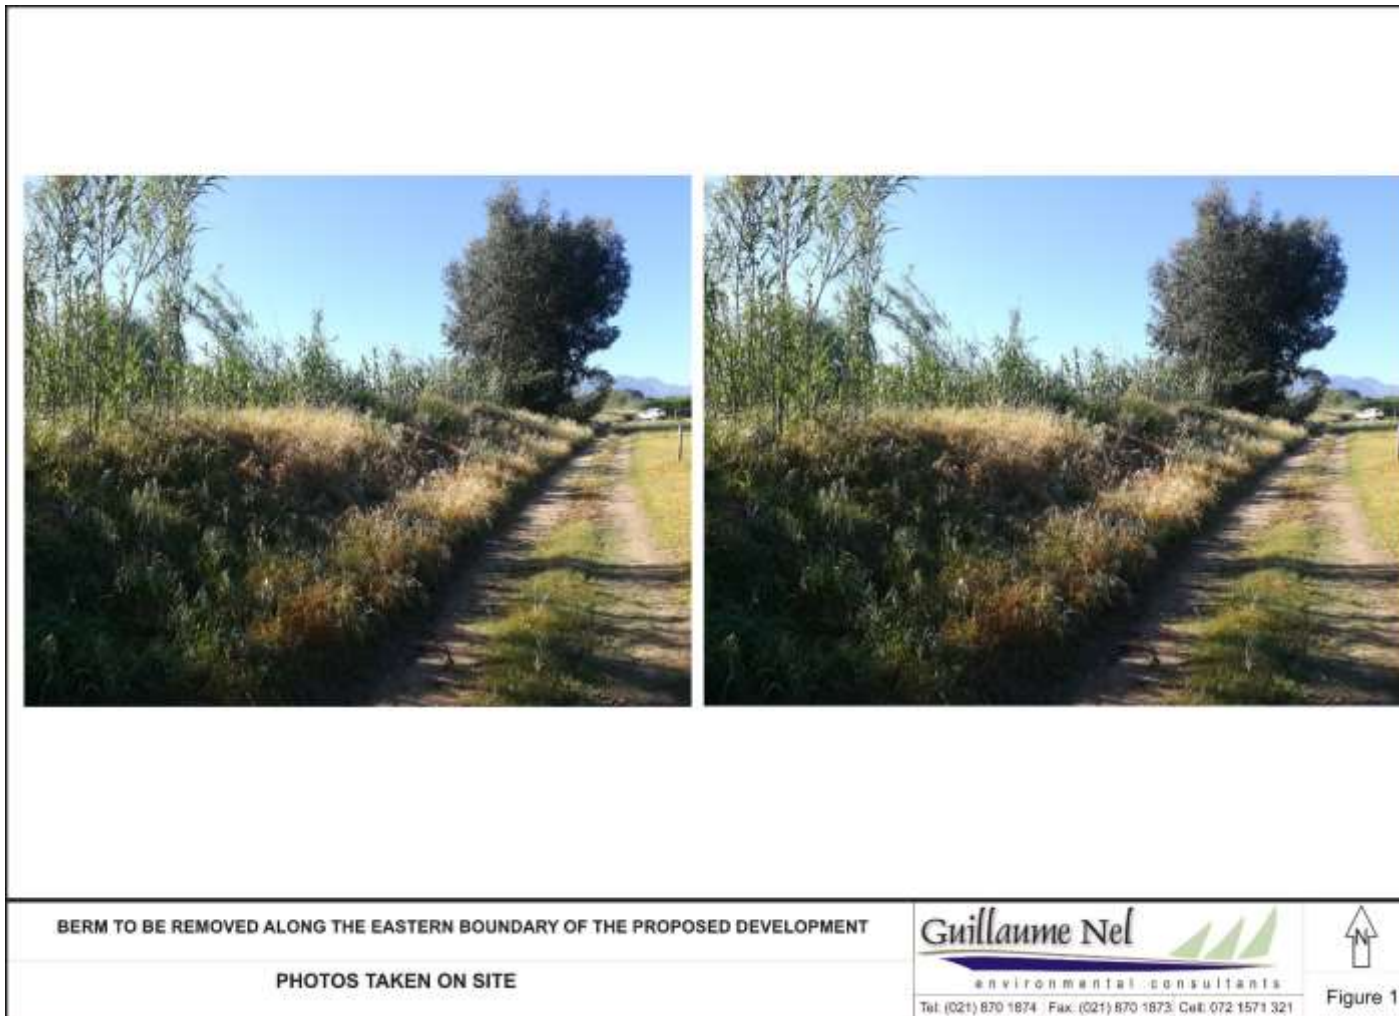
Figure 4: Berm identified along the eastern boundary of the proposed development to be removed as per Freshwater Impact Assessment Report.

As per Freshwater Impact Assessment's recommendation, the existing berm identified along the Western embankment of the Berg River and along the eastern boundary of the proposed development need to be removed, as removal of the berm will allow for better drainage of the area in a flood event and reduce the general constriction and hence flood width of the system. This was included in the Stormwater Management Plan and in principle support from the Department of Water and Sanitation was granted.

*Please refer to Figure 4 below: Berm identified along the eastern boundary of the proposed development to be removed as per Freshwater Impact Assessment Report.*

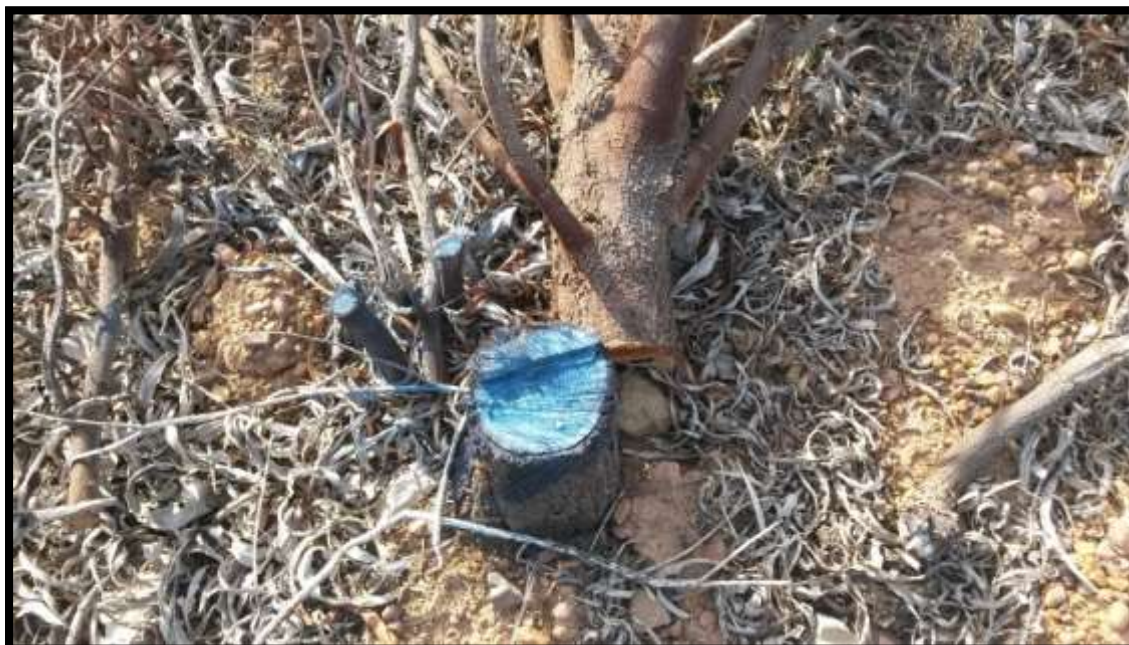
Figure 6: Example of a cut down stem treated with a coloured systemic herbicide.

Applicable where the invasive species are too difficult for hand pulling. Invasive trees need to be cut leaving a stem of 10cm. The remaining stem needs to be painted using a brush with a systemic herbicide. The systemic herbicide need to be coloured to ensure that all the cut stems be treated. Care should be taken not to spill systemic poison when painting the stems. The systemic poison will infiltrate the stem killing the roots, and prevent the invasive tree from re-sprouting again. Cut down invasive trees need to be removed from site to the nearest licensed landfill site to prevent the spread of seeds.

***Systemic Poison, Enviro - Glyphosate; 2% Application. (Registered for use near waterbodies)***

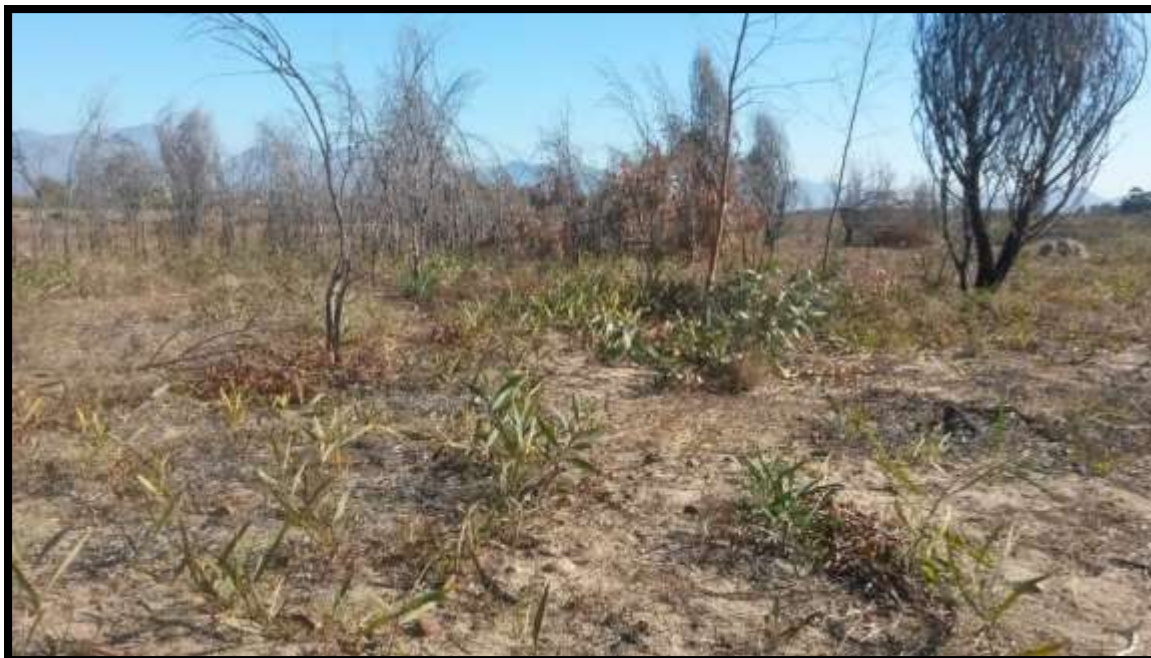
Figure 7: Example of smaller species ideal for hand pulling.

It is suggested that smaller invasive species be hand pulled with manual labour. This is the most effective and environmental friendly way to eradicate smaller invasive vegetation.

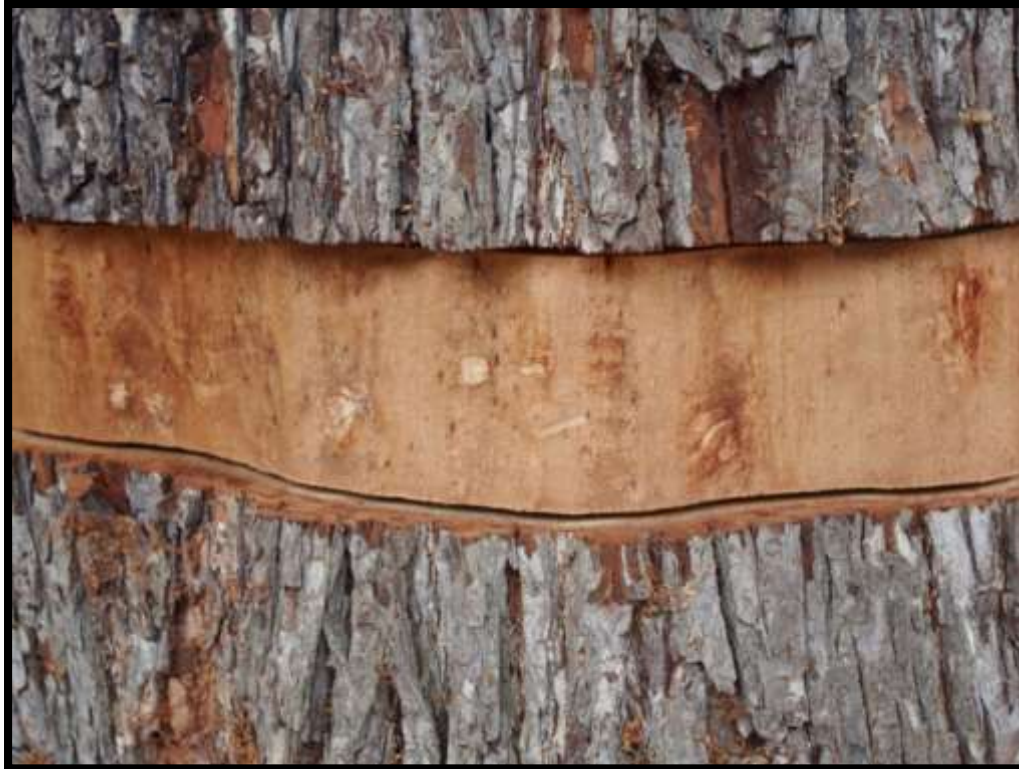
Figure 8: Example of ring barking larger invasive trees.

Ring barking is a technique that involves removing a ring of bark around a tree trunk. Ring barking interferes with the circulation of the tree and results in it slowly dying. Remove a 30 to 40 cm strip of bark around the base of the tree trunk to ground level. Ring-barking removes the cambium/phloem, a layer just beneath the bark, which carries food from the leaves down to the roots. The roots will eventually die thereby killing the tree. The ring barked area can then be painted with a systemic poison.

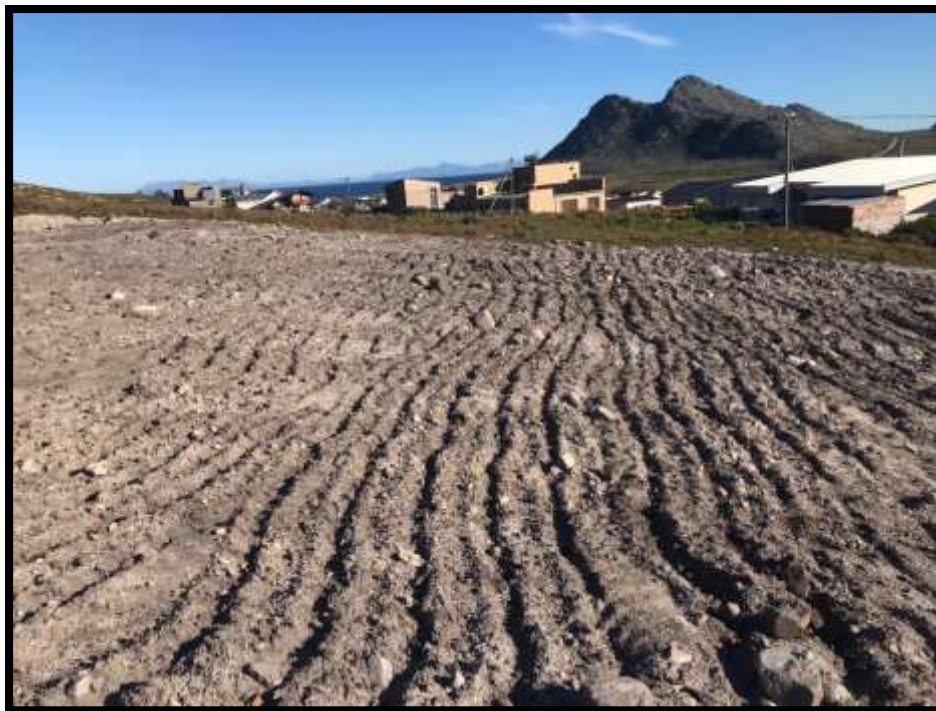
**Figure 9: Example of a previously compacted area that has been ripped, shaped and topsoil spread over the affected area prior to rehabilitation.**

All compacted areas need to be ripped/loosened, protected topsoil need to be spread, and area needs to be shaped in such a way that it blends in with the natural contour and drainage lines of the site.

- That all compacted areas be loosened and aerated;
- Will ensure better infiltration of precipitation and less erosion;
- Will make planting during rehabilitation easier;
- Will stimulate natural rehabilitation by means of seed germination; and
- Will positively contribute to the visual and aesthetic value of the site.

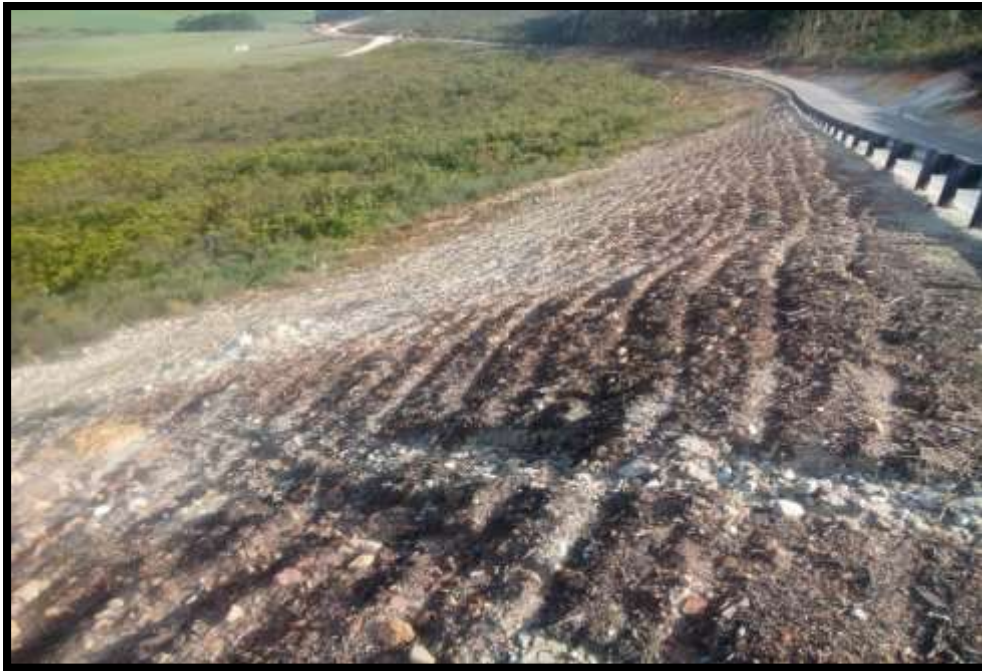
Figure 10: Example of horizontal terracing to reduce down slope erosion.

Should an embankment be too steep for planting, erosion control, along with preservation of the topsoil would be very important for rehabilitation. Stabilization should be done by ensuring that the velocity of surface runoff is reduced through naturally aligned terracing. Terracing can be done by using hand labour to create natural horizontal terraces. If necessary biodegradable sausages can be placed within the created naturally aligned terraces to help with slope stabilization.

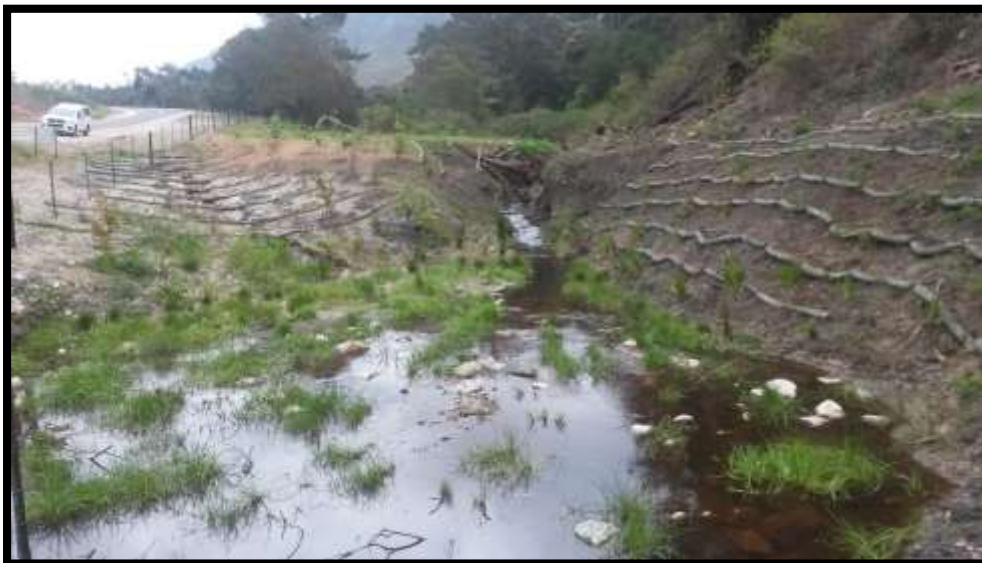
Figure 11: Example of horizontal terracing with biodegradable sausages to reduce down slope erosion.

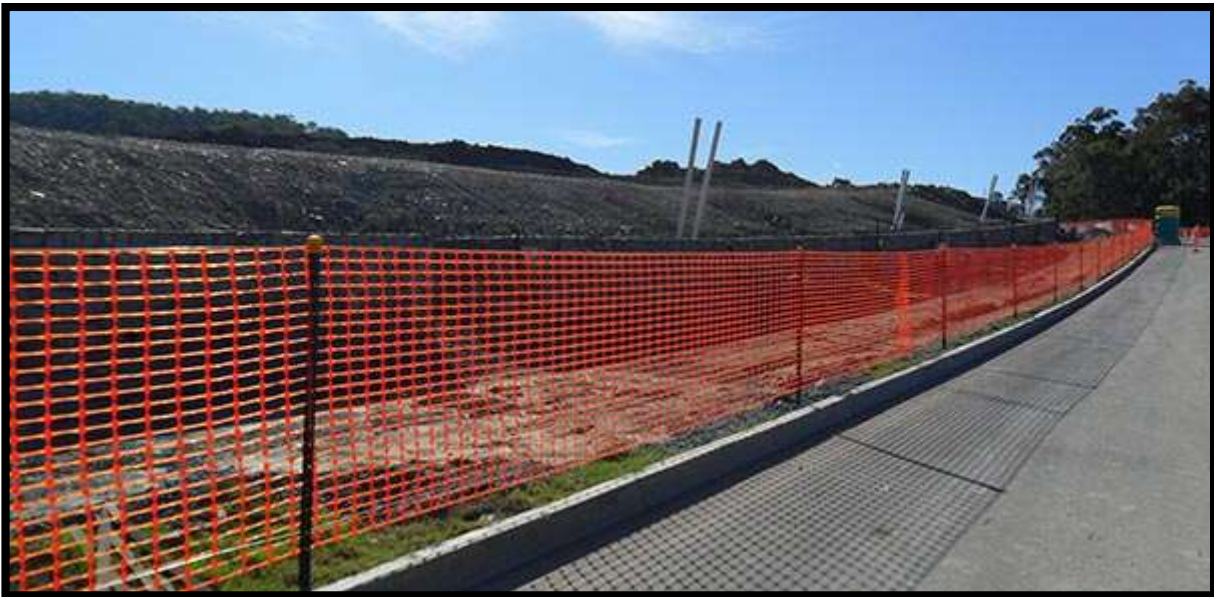
The area can be staked and cordoned off with danger netting

Figure 13: Example of a rehabilitated area cordoned off with danger netting.

After rehabilitation the area need to be clearly cordoned off to ensure that no damage is done to the rehabilitated area. Trampling of the areas will:
