# REHABILITATION REPORT

## REHABILITATION REPORT FOR PROTEA ROAD (KM 0.00 – KM 8.79) AND RELATED CULVERTS AT KM 1.3112, KM 2.312, Km 4.326, Km 5.102, PAARL, WESTERN CAPE.

DEA&DP: 16/3/3/6/7/1/B3/28/1157/18

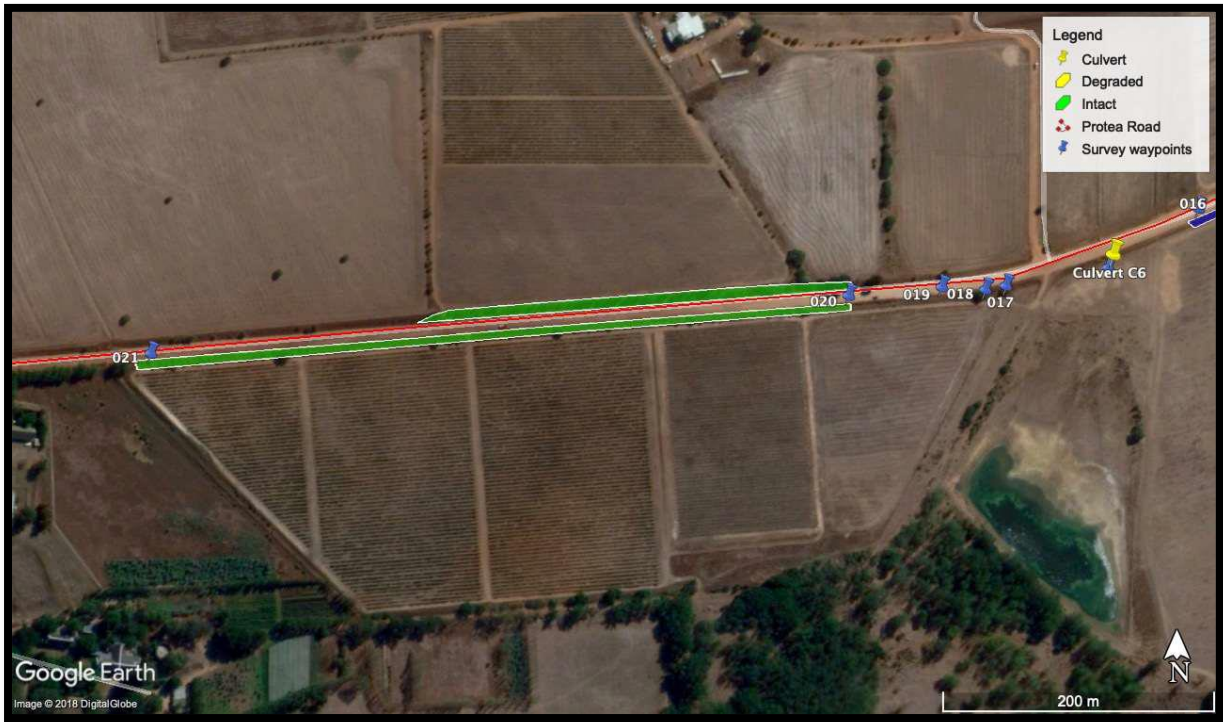
**FIGURE 6: AERIAL IMAGE SHOWING THE SURVEY WAYPOINTS.**

1. Intact vegetation on both sides of Protea Road located between waypoint 020 and 021.

LHS/RHS: Intact natural vegetation dominated by wild olive trees at waypoint 020 (33°48'33.61"S; 18°48'55.61"E).

The habitat contains higher numbers of wild olive and *Cliffortia ruscifolia*.

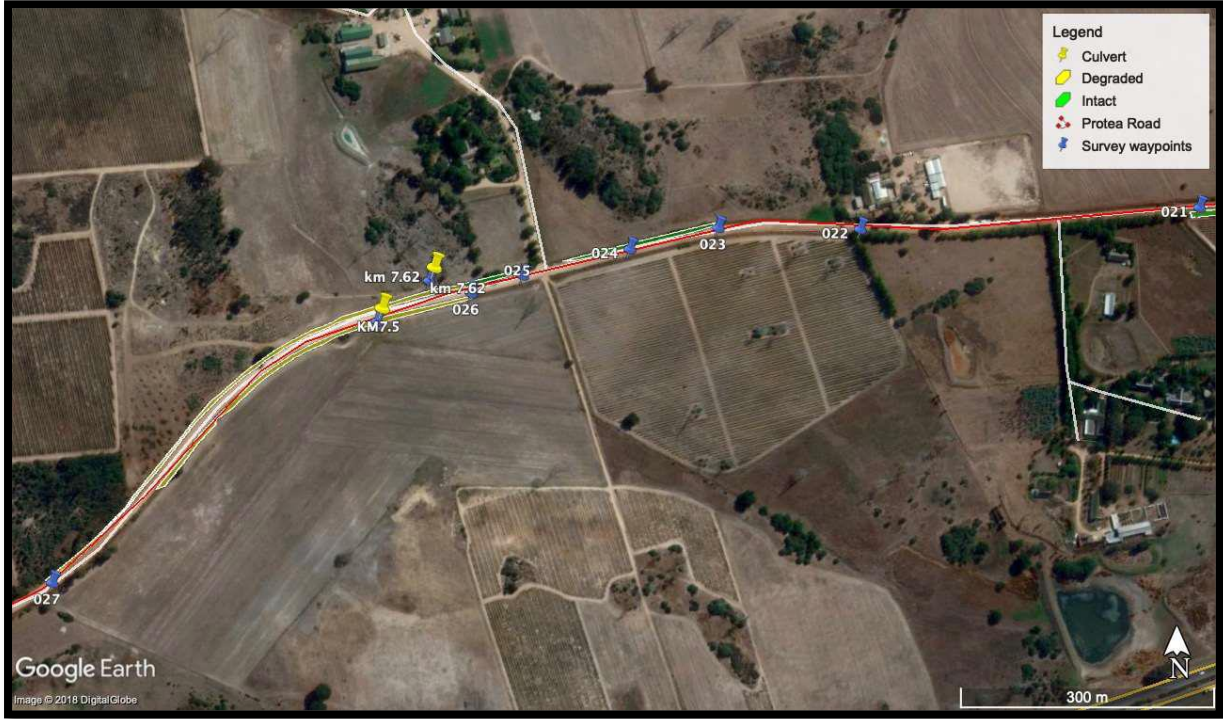
**FIGURE 8: AERIAL IMAGE SHOWING THE SURVEY WAYPOINTS.**

3. Degraded vegetation located on both sides of Protea Road between waypoint 026 and 027.

LHS/RHS: degraded natural vegetation occurs along this section, with dominant species including *Elytropappus rhinocerotis*, *Cliffortia ruscifolia*, *Passerina corymbosa*, *Olea europaea* subsp. *africana* and *Searsia laevigata*.

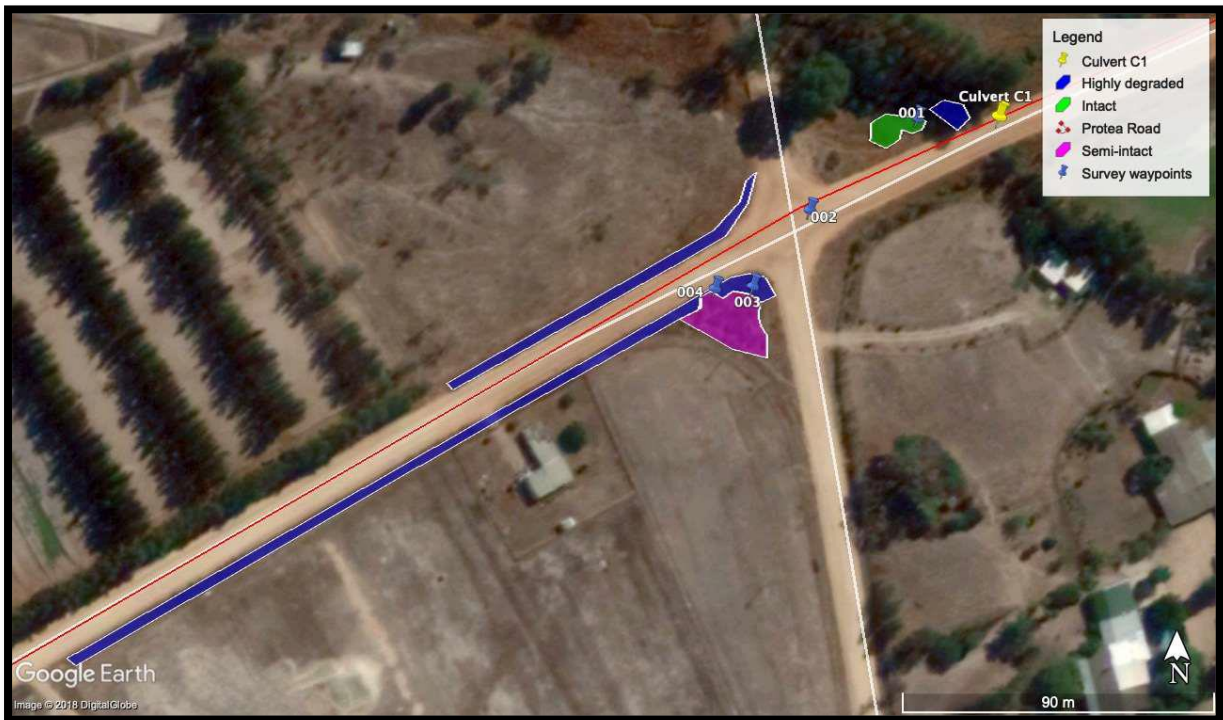
**FIGURE 11: AERIAL IMAGE SHOWING THE SURVEY WAYPOINTS.**

5. Semi-intact vegetation at the intersection along Protea Road at waypoint 004.

LHS: At waypoint 004, renosterveld vegetation, dominated by renosterbos (*Elytropappus rhinocerotis*), occurs within 1m of the road edge. The roadside vegetation between waypoint 004 and waypoint 005 (33°47'39.35"S; 18°51'1.39"E) consists of alien grasses and high numbers of *Athanasia trifurcata*, an indigenous species indicative of heavy disturbance. Additional species include *Senecio polyanthemoides* and *Stoebe plumosa*.

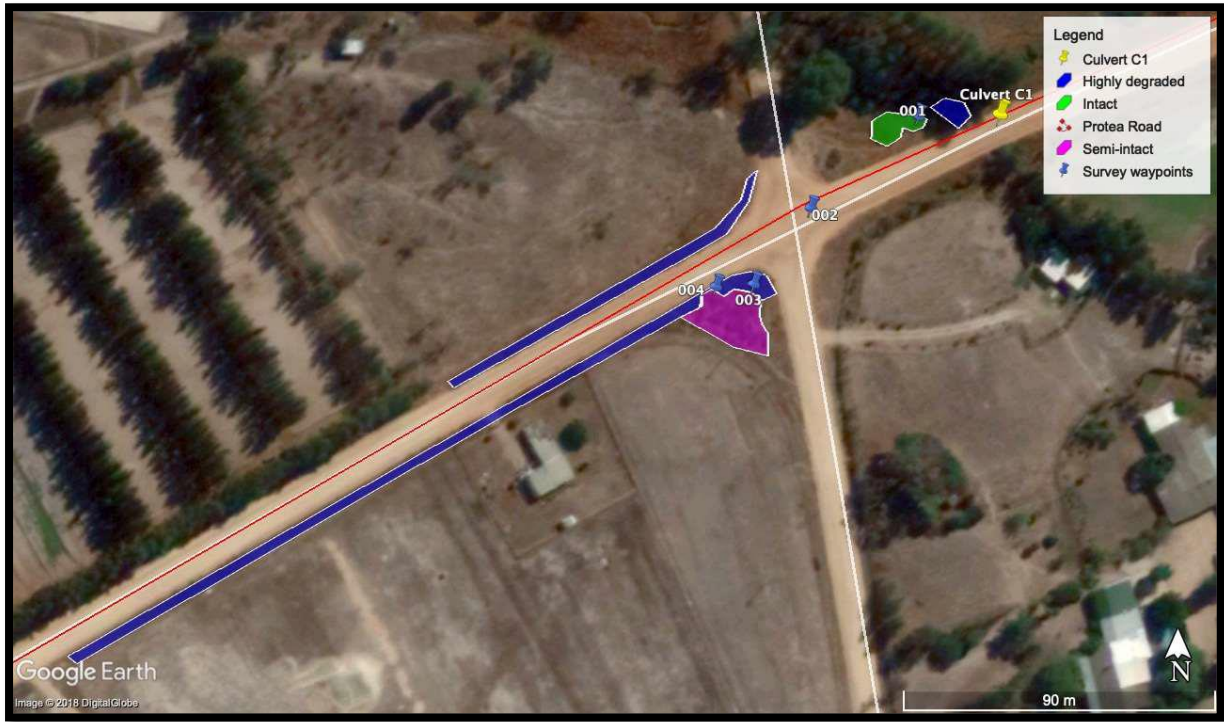
**FIGURE 12: AERIAL IMAGE SHOWING THE SURVEY WAYPOINTS.**

6. Wild olive trees (*Olea europaea* subsp. *africana*) close to Culvert C1 at waypoint 001.

Three mature wild olive trees (*Olea europaea* subsp. *africana*) occur at waypoint 001 (33°47'24.89"S; 18°51'33.10"E)

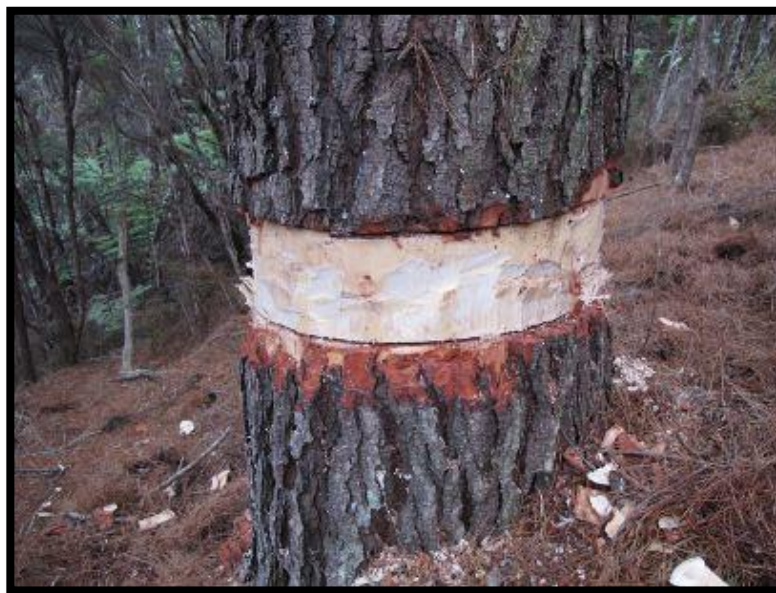
Ring barking is a technique that involves removing a ring of bark around a tree trunk. Ring barking interferes with the circulation of the tree and results in it slowly dying. Remove a 30 to 40 cm strip of bark around the base of the tree trunk to ground level. Ring-barking removes the cambium/phloem, a layer just beneath the bark, which carries food from the leaves down to the roots. The roots will eventually die thereby killing the tree. The ring barked area can then be painted with a systemic poison.

**FIGURE 13: EXAMPLE OF RING BARKING OF LARGER INVASIVE SPECIES. .**

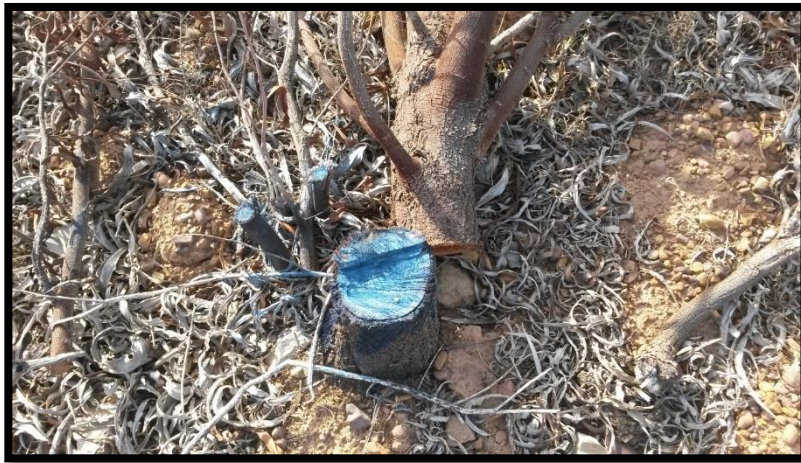
Invasive trees needs to be cut leaving a stem of 10cm. The remaining stem needs to be painted using a brush with a systemic herbicide. The systemic herbicide needs to be coloured to ensure that all the cut stems be treated. Care should be taken not to spill systemic poison when painting the stems. The systemic poison will infiltrate the stem killing the roots, and prevent the invasive tree from re-sprouting again. Cut down invasive trees needs to be removed from site to the nearest licensed landfill site to prevent the spread of seeds.

**FIGURE 14: EXAMPLE OF A CUT DOWN STEM TREATED WITH COLOURED SYSTEMIC HERBICIDE.**

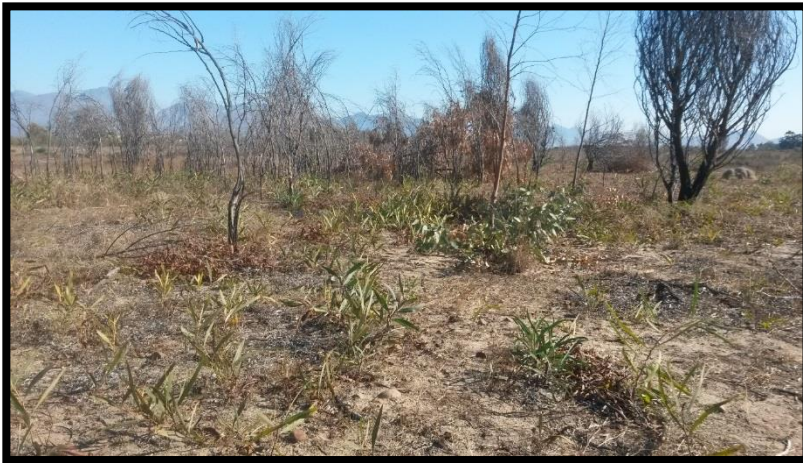
Hand pulling can be done when invasive vegetation is still small and easy to remove. This is the most environmental friendly method to use for smaller individuals. .

FIGURE 15 EXAMPLE OF SMALLER SPECIES IDEAL FOR HAND PULLING.

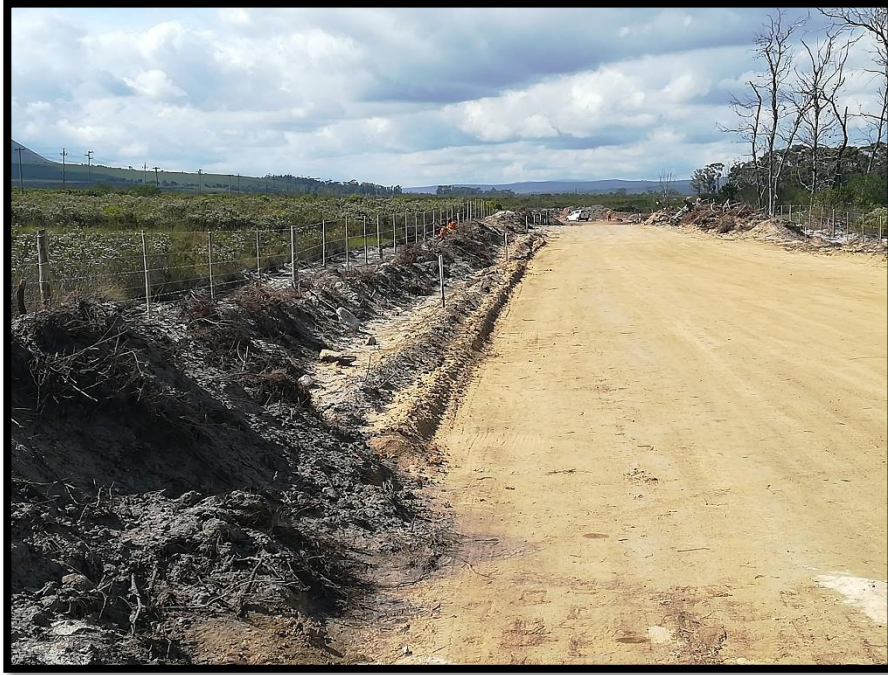
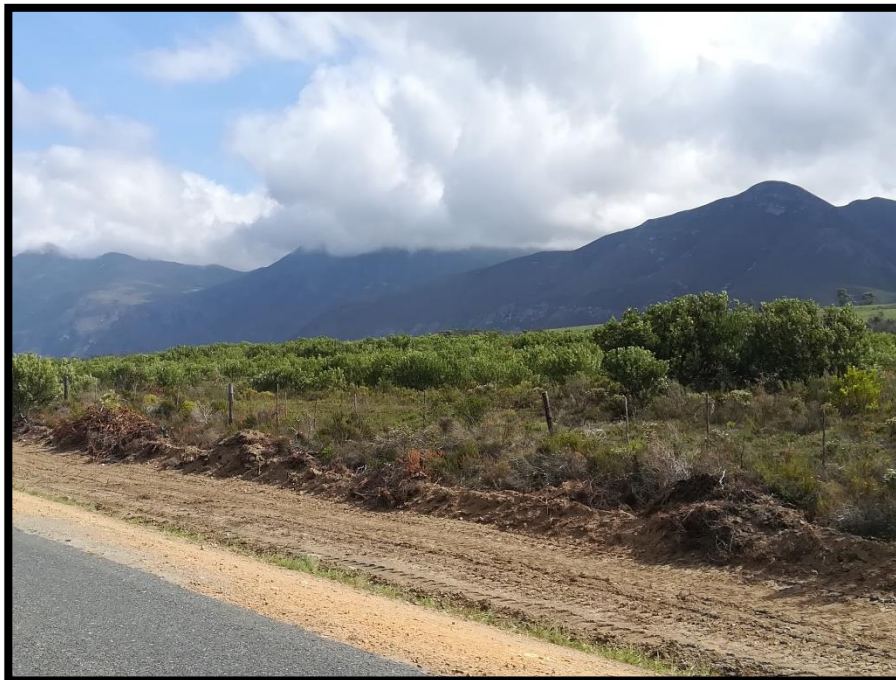
- Limit the handling of the topsoil.
- Prevent the damage and loss of topsoil.
- Prevent the contamination of topsoil with invasive vegetation.
- Will ensure that the topsoil of different vegetation types be place back in the exact same location. (Prevent mixing of topsoil from different vegetation types)
- Prevent the mixing of dryland and wetland topsoil.

**FIGURE 16: EXAMPLE OF WINDROWED TOPSOIL**

**FIGURE 17: EXAMPLE OF WINDROWED TOPSOIL**
