**THE CONSTRUCTION OF A 66KV OVERHEAD POWERLINE FROM THE TRANSHEX  
SUBSTATION TO THE WORCESTER INDUSTRIAL SUBSTATION ON THE REMAINING EXTENT  
OF ERF NO. 1, ERVEN 13518, 13519, 13433 AND 5, WORCESTER**

DEA&DP Reference: 16/3/3/1/B2/32/1021/23

**FORMAL ECO AUDIT REPORT**

16 October 2024

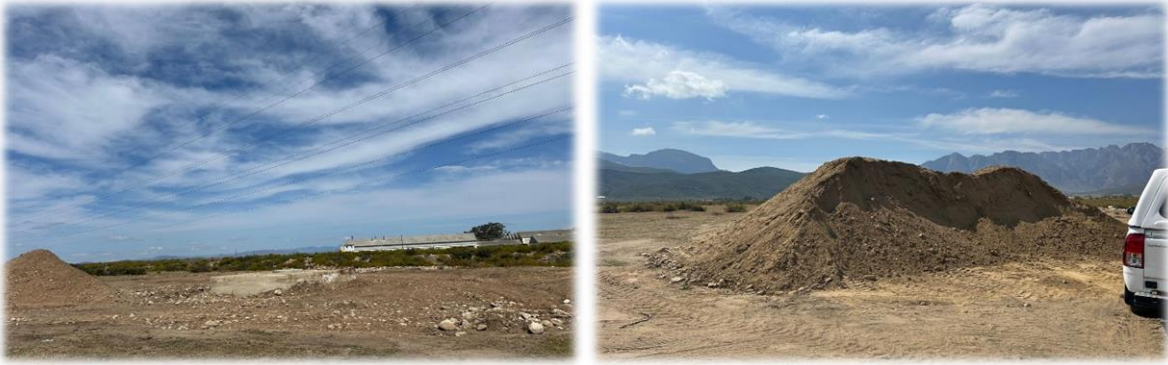
The topsoil was not demarcated during the audit, and the development footprint was not demarcated during the audit, the contractor is advised to please demarcate the footprint of each pylon with droppers.

| | Finding | Close Out Recommendation |
|---|---|---|
| 4 | <p><b>Demarcation</b></p> <p>The entire development footprint of each of the pylons must please be demarcated as per the EA</p> | The contractor should please demarcate the construction footprint at each of the pylons with droppers |

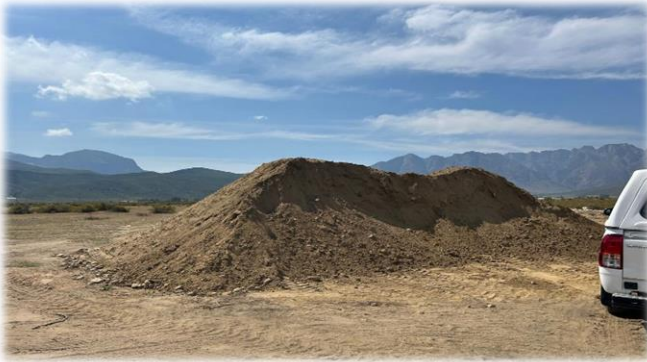
The topsoil on site should please be seen as a no go area, and **no stockpiling may be done within the delineated watercourses or the applicable buffer area.**

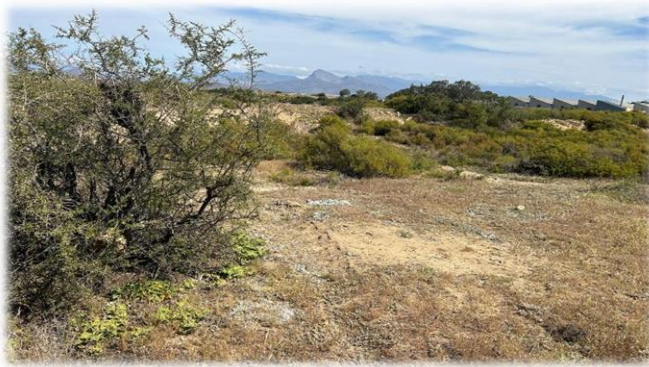
Batching was not active during the audit, but batching remains were noted at the pylon excavation, the contractor is advised that all remains should be picked up and disposed of. All batching should please be done on an impermeable area.

| | Finding | Close Out Recommendation |
|---|---|---|
| 3 | <p><b>Concrete remains</b></p> <p>Concrete remains were seen during the audit</p> | The contractor is advised to please remove the concrete remains from site |

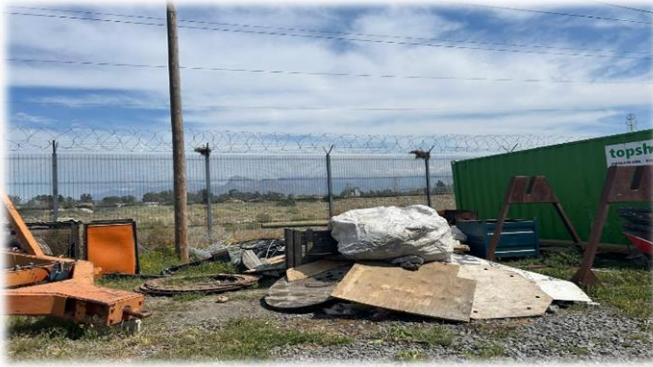
A lot of illegally dumped litter was seen on site, the contractor is advised to please remove the litter in the areas that they are working even if it is not of the contractor.

Some litter was seen in the site camp and should please be disposed of.

Please forward all litter disposal receipts to the ECO for record keeping.

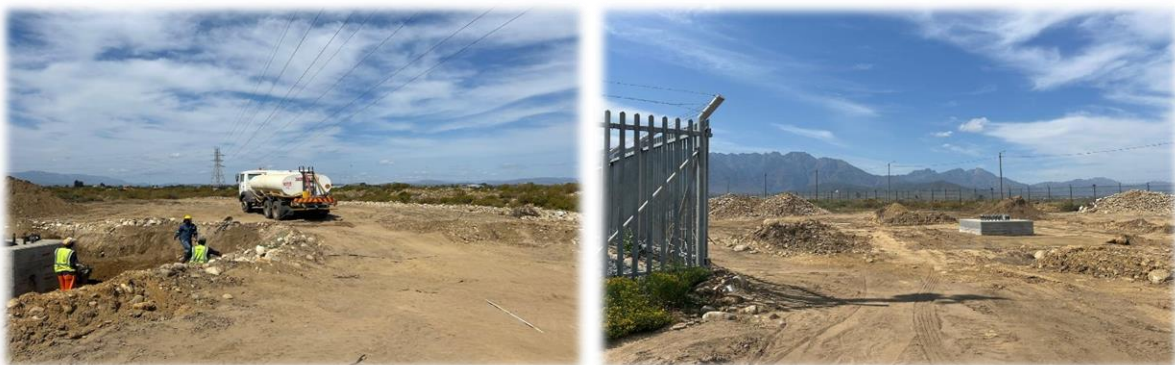
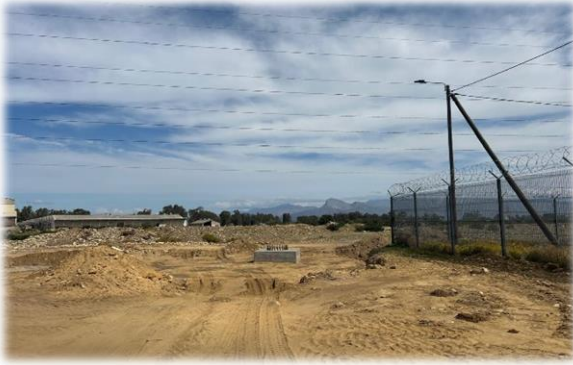
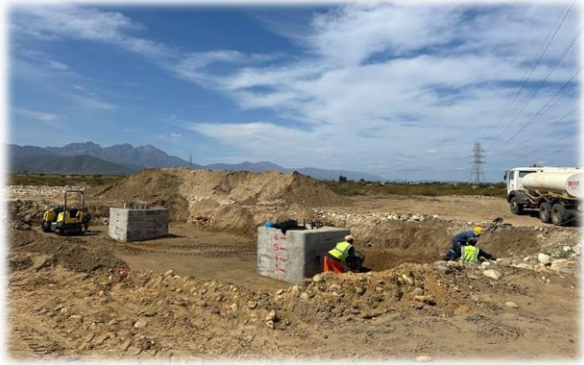
The contractor is progressing well on site all the pylons have been casted up to Transhex during the audit, the contractor for the excavation of the pylons will almost be leaving the site.
