**ESTABLISHMENT OF A RESIDENTIAL DEVELOPMENT AND ASSOCIATED INFRASTRUCTURE  
ON PORTION 2 OF FARM GOEDE VERWACHTING NO. 870, REMAINDER OF FARM NO. 869,  
FARM NO. 1262, REMAINDER OF FARM NO. 866, REMAINDER OF FARM NO. 1054, AND  
PORTIONS 2 AND 3 OF FARM NO. 1054, SIR LOWRY'S PASS VILLAGE.**

DEA&DP Reference: 16/3/3/1/A3/53/2005/22

**FORMAL ECO AUDIT REPORT**

29 July 2024

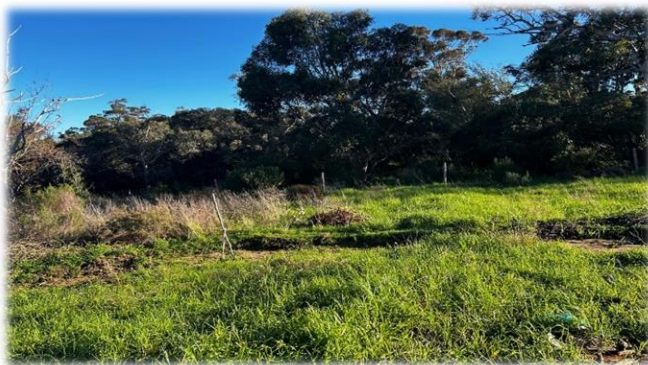
The watercourse area has been demarcated with droppers, the contractor should please supply more evident demarcation of the area.

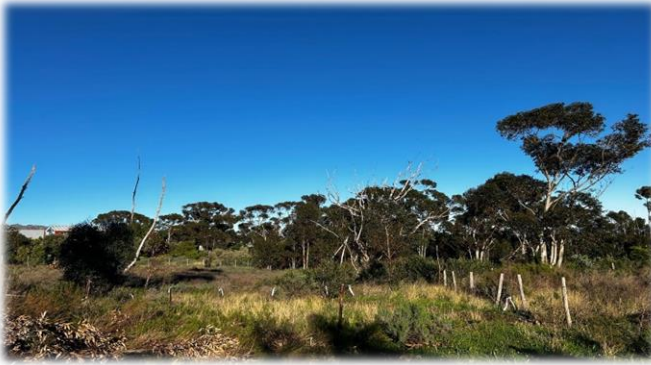
The southwestern corner of the site has been demarcated, thank you for that.

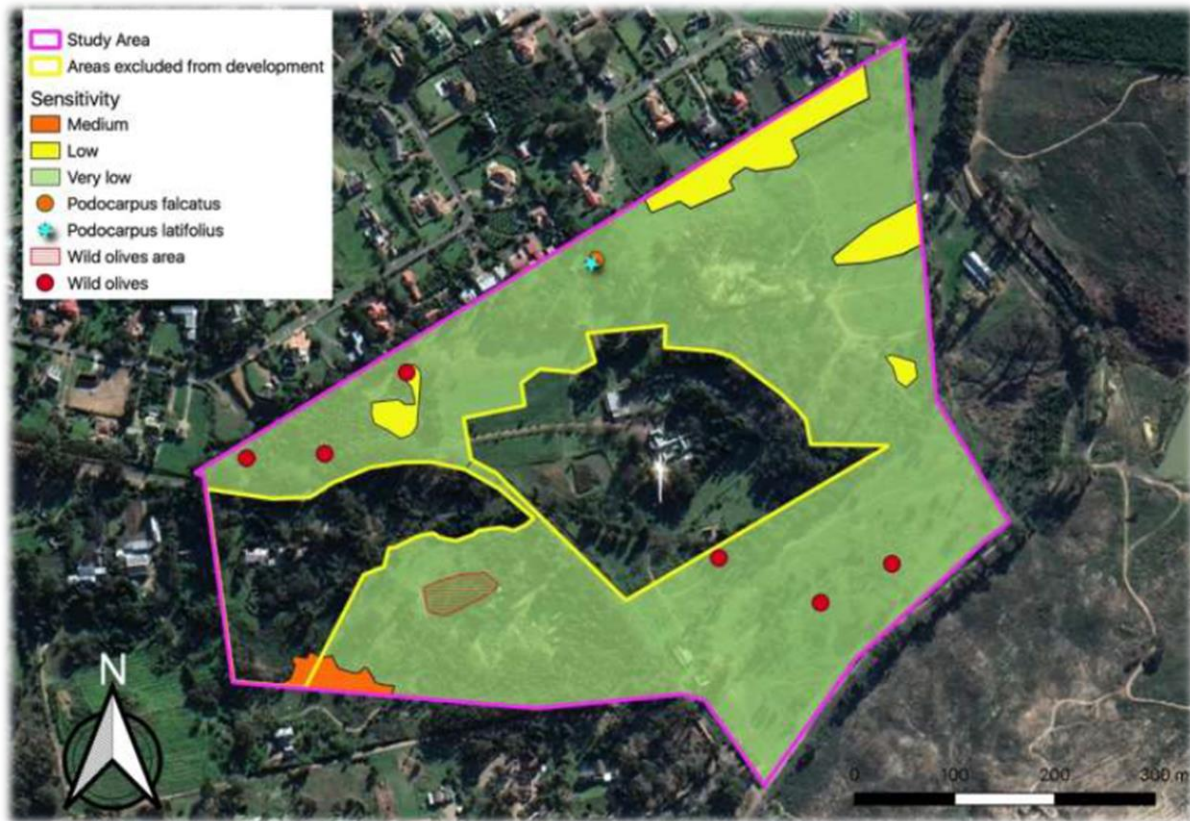
The contractor is also advised that there are two protected trees on the site as listed on the below map, the trees should please be retained or a permit should be obtained should it be removed.

The trees are located on the below map at the *Podocarpus latifolius* and *Podocarpus falcatus* pins.

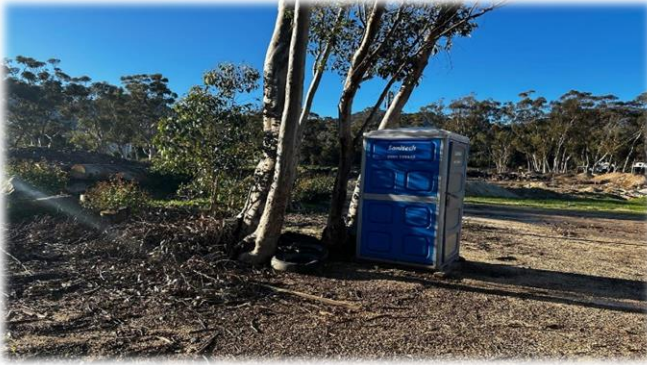
Toilets were noted on site, within close proximity to where the works took place. The contractor is advised to please secure the toilets to the ground.

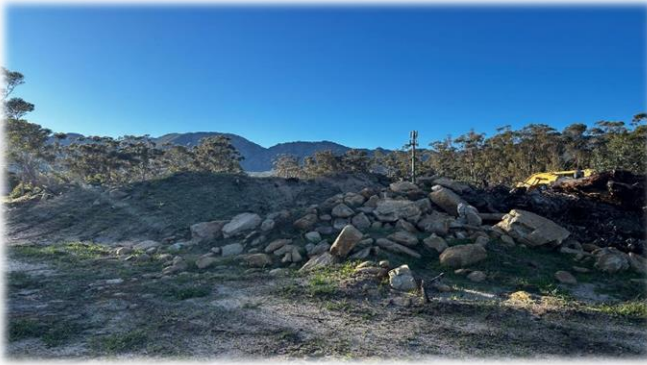
The topsoil on site should please be seen as a no go area, and no stockpiling may be done within the delineated watercourses or the applicable buffer area.

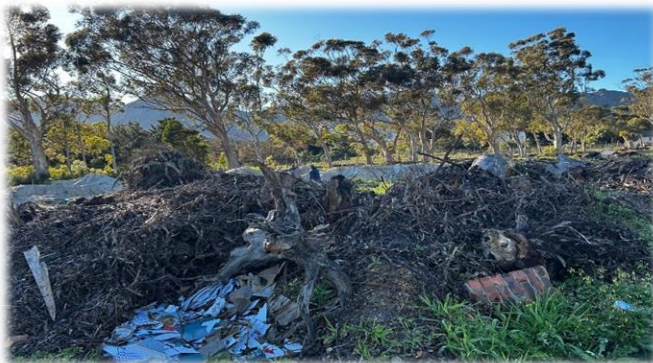
| | Finding | Close Out Recommendation |
|---|---|---|
| 3 | <p><b>Litter</b></p> <p>Some excavated litter was seen on site</p> | <p>The litter should please be removed from site</p> |

Some litter was excavated from site, the contractor is advised to please remove the litter from site.

The contractor is advised to please place bins/skips or a litter structure on site for litter.

Please forward all litter disposal receipts to the ECO for record keeping.

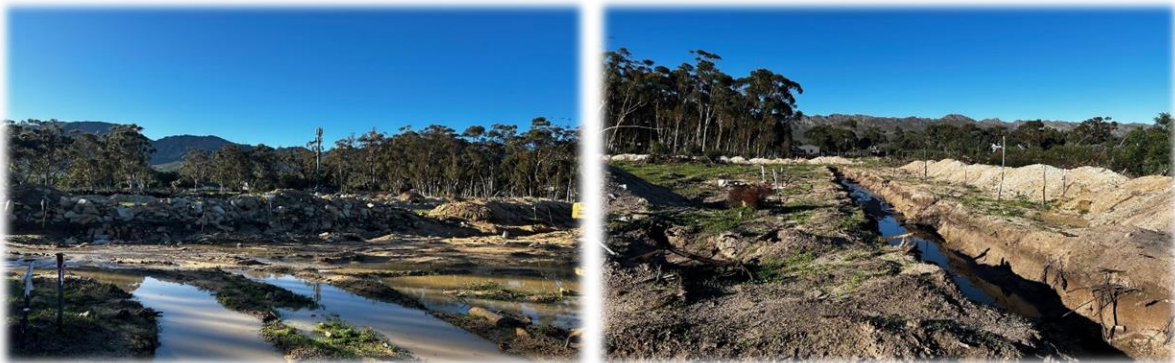
The contractor has just started on site with the clearance and civil services on the site. But was a bit delayed during the audit because of the recent floods.
