**ESTABLISHMENT OF A RESIDENTIAL DEVELOPMENT AND ASSOCIATED INFRASTRUCTURE  
ON PORTION 2 OF FARM GOEDE VERWACHTING NO. 870, REMAINDER OF FARM NO. 869,  
FARM NO. 1262, REMAINDER OF FARM NO. 866, REMAINDER OF FARM NO. 1054, AND  
PORTIONS 2 AND 3 OF FARM NO. 1054, SIR LOWRY'S PASS VILLAGE.**

DEA&DP Reference: 16/3/3/1/A3/53/2005/22

**FORMAL ECO AUDIT REPORT**

1 October 2024

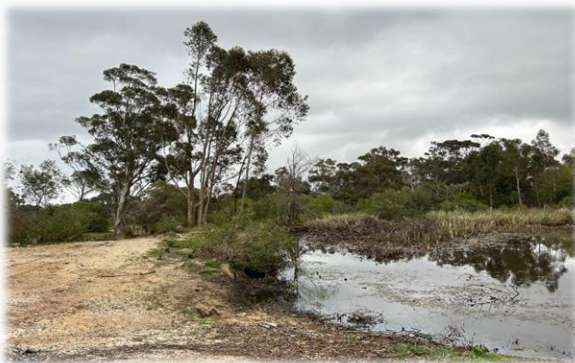
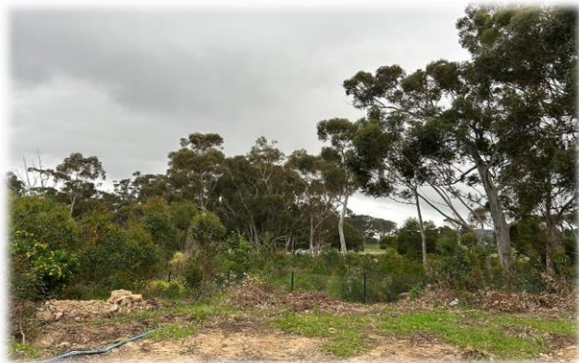
The watercourse area has been fenced with Clearview fencing, the dam should please be demarcated or temporarily fenced

| | Finding | Close Out Recommendation |
|---|---|---|
| 4 | <p><b>Demarcation</b></p> <p>The Dam should please be demarcated until rehabilitation can commence within that area</p> | The Dam should please be demarcated until rehabilitation can commence within that area |

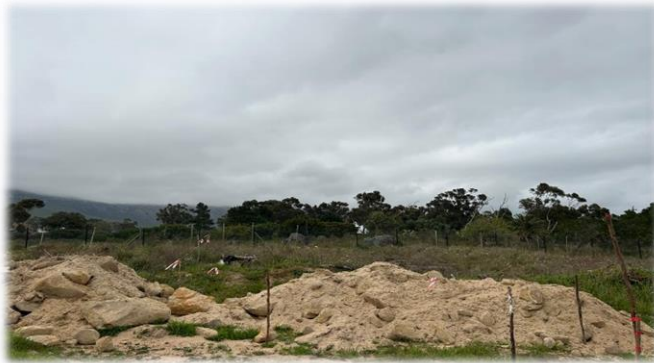
The southwestern corner of the site has been demarcated, but some material was noted inside the area, the contractor should please remove the material by hand and ensure nothing enters the no go area.

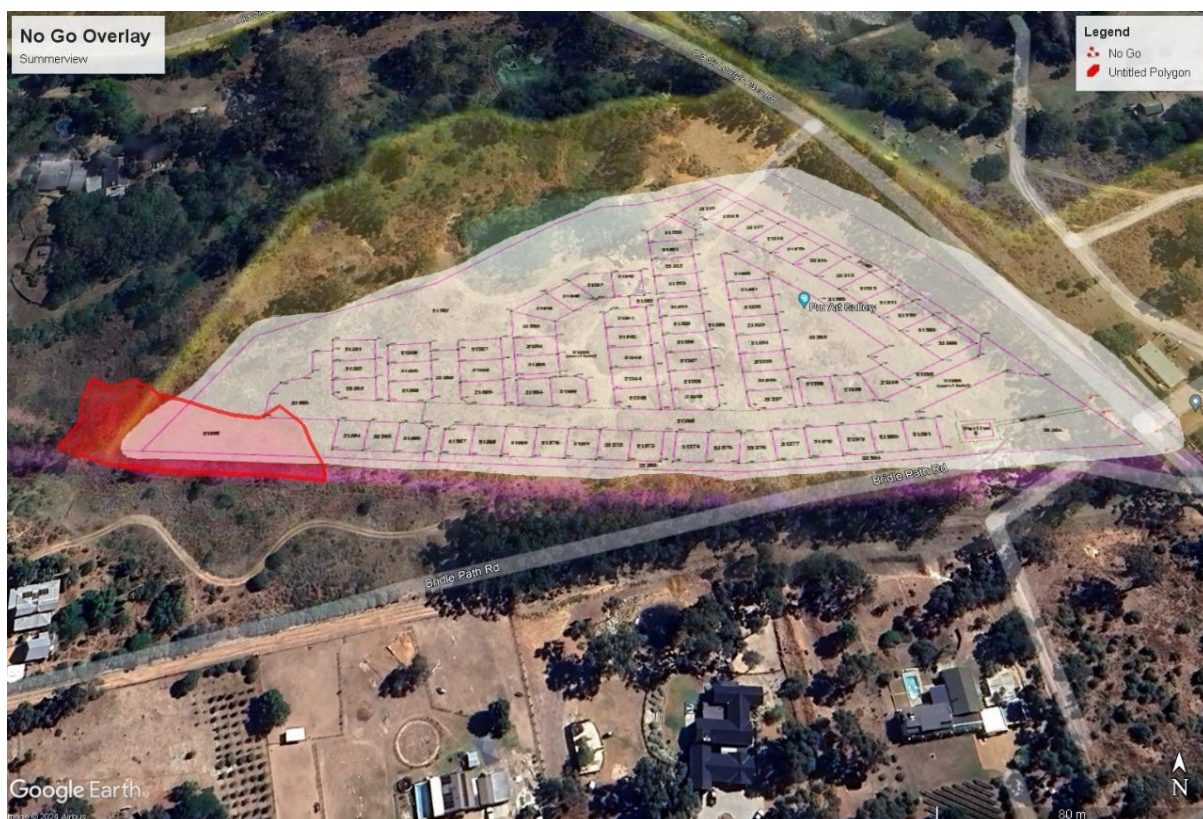
The contractor was advised that the following red area on the overlay map should please be demarcated.

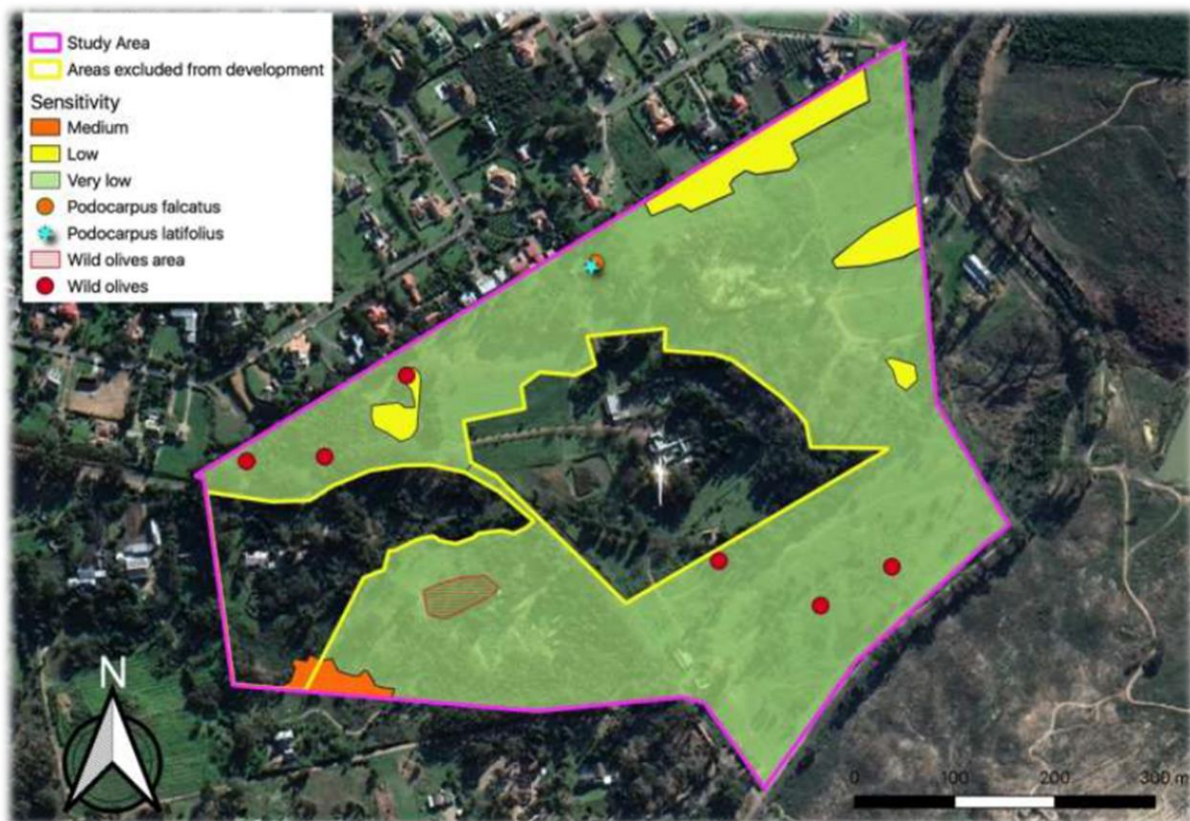
The contractor is also advised that there are two protected trees on the site as listed on the below map, the trees should please be retained or a permit should be obtained should it be removed.

The trees are located on the below map at the *Podocarpus latifolius* and *Podocarpus falcatus* pins.

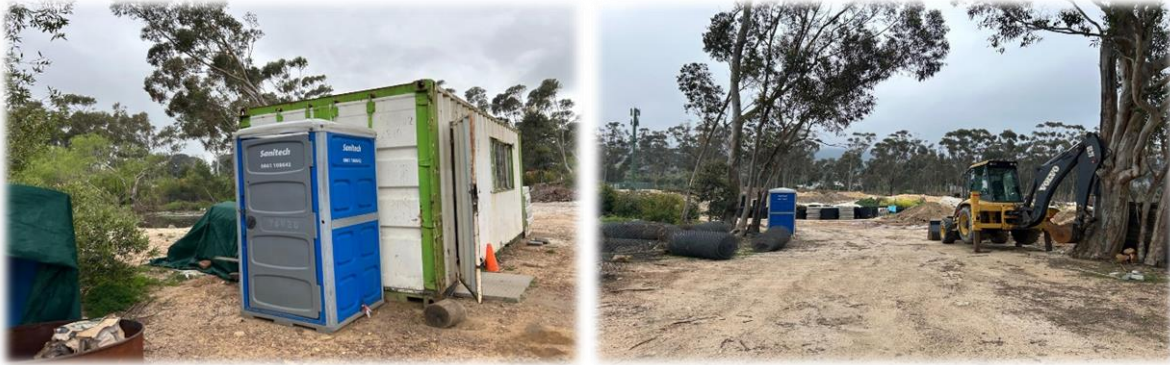
Toilets were noted on site, within close proximity to where the works took place. The contractor is advised to please secure the toilets to the ground.

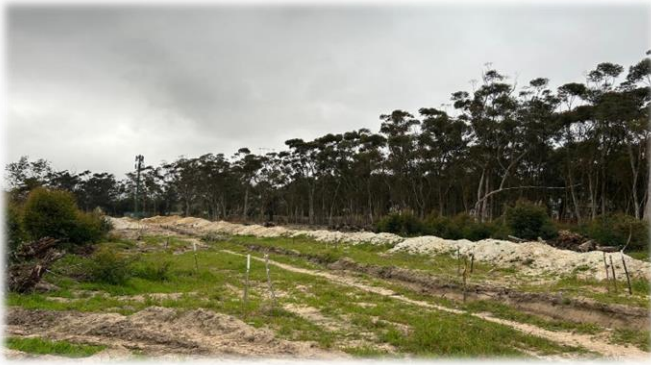
The topsoil on site should please be seen as a no go area, and no stockpiling may be done within the delineated watercourses or the applicable buffer area.

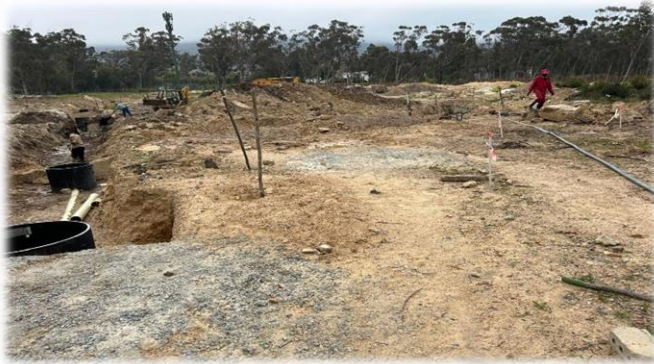
Batching was not active during the audit, but cement remains were noted on site, the contractor was advised to please remove the remains, and that no batching may be done directly on the ground.

| | Finding | Close Out Recommendation |
|---|---|---|
| 3 | <p><b>Cement remains</b></p> <p>Cement remains were noted on site</p> | No batching must be done directly on the ground. The cement remains should please be removed |

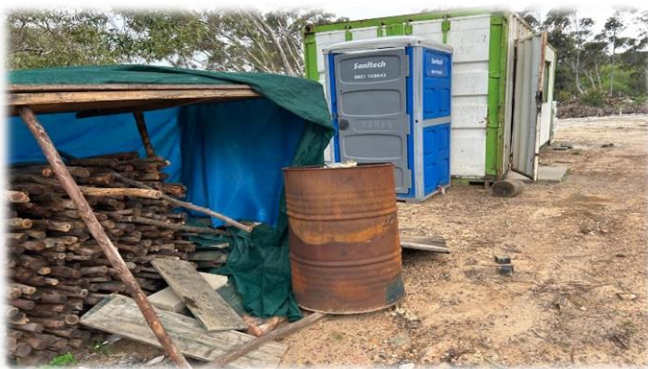
The contractor placed a bin on site.

A litter structure has been constructed on site, thank you for that.

Please forward all litter disposal receipts to the ECO for record keeping.

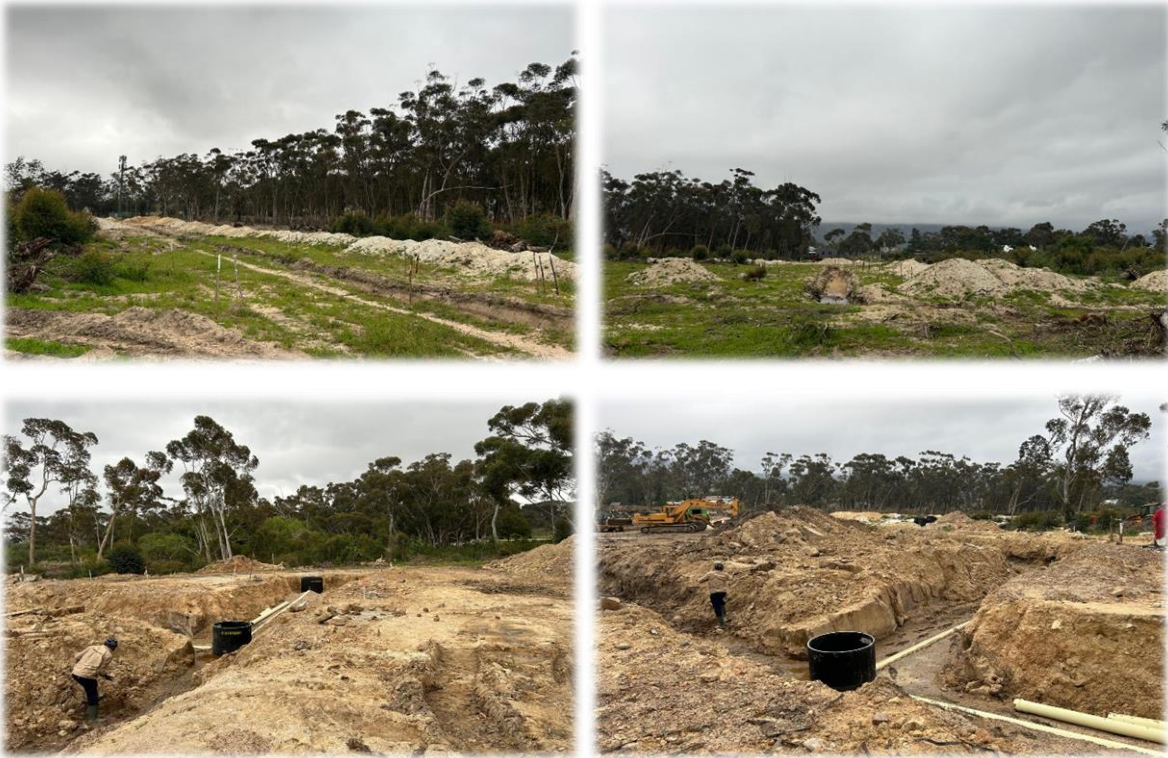
The contractor was busy with the stormwater and sewer installations on site, laying the pipes and started with the manholes.
