**THE PERIODIC MAINTENANCE OF TRUNK ROAD 16/8 AND TRUNK ROAD 16/9  
BETWEEN MURRAYSBURG AND THE NORTHERN CAPE BORDER**

Contract No: C1213

**FORMAL ECO AUDIT REPORT**

31 January 2025

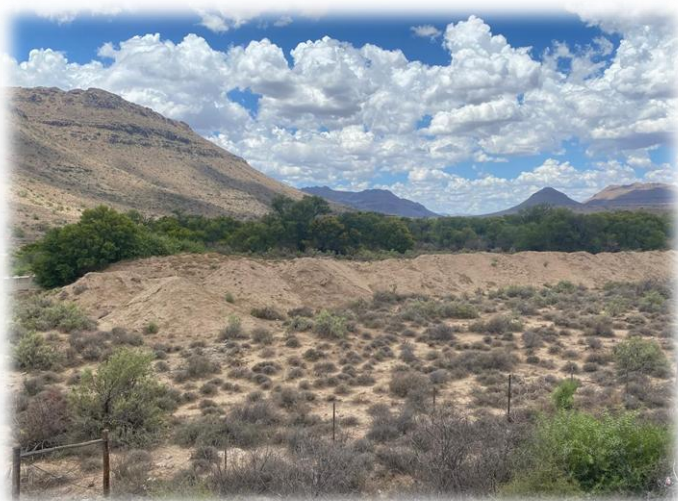
Demarcation is required at the bottom of the bridges where no fence is present.

The contractor was advised to please limit the footprint at the two approaches to the proposed bypass, stockpiles were noted within the vegetation along the fence. Only the footprint of the approach road is authorised and not any additional vegetation clearance.

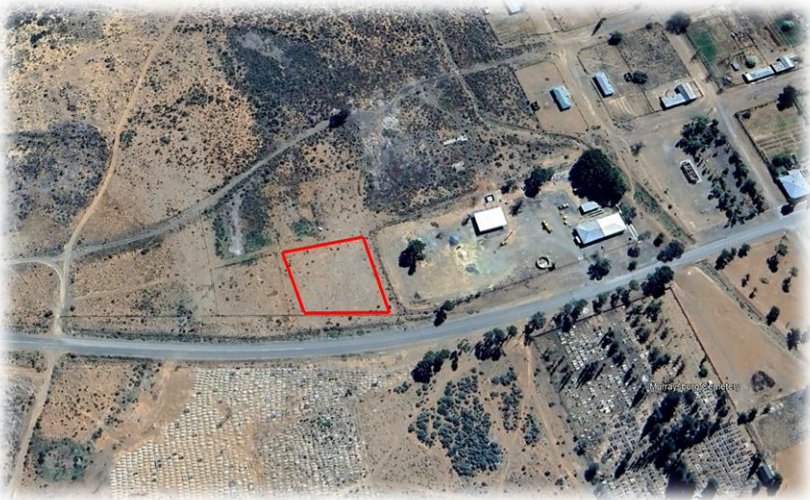
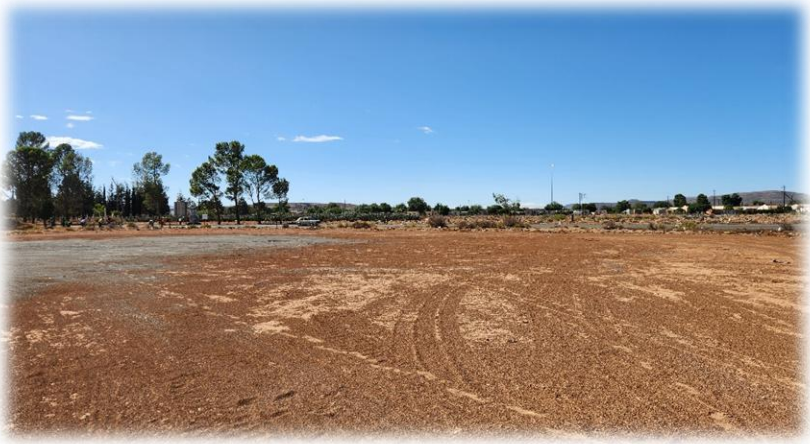
| Stockpile Area No. | Comment | ECO Recommendation |
|---|---|---|
| 1. | <p><b>Stockpile Area 1 (next to Municipal yard)</b></p> <p>An area previously disturbed with limited vegetation available was identified for the 1<sup>st</sup> stockpile area. The area was not in use during the audit, but will be used during the surfacing of the road.</p> | The area is ideal due the proximity as well as due to the area being previously disturbed. |

| | <br> | <p>A permission letter, must please be send to the ECO for record keeping, and happy letter, after completion of the works, is required from property owner.</p> |

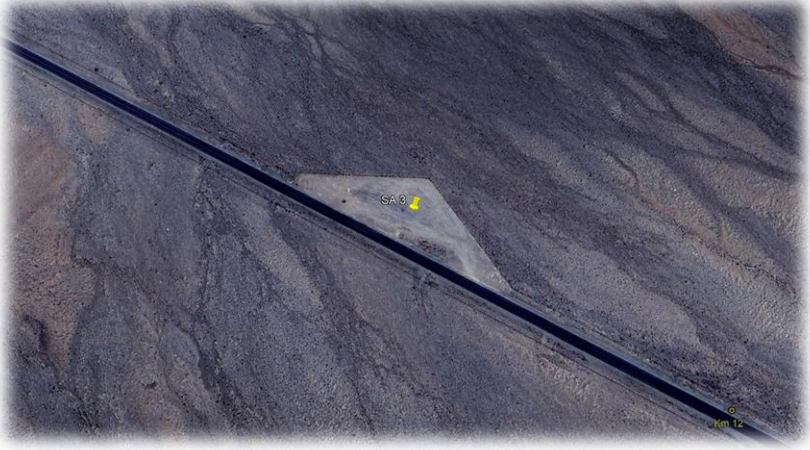
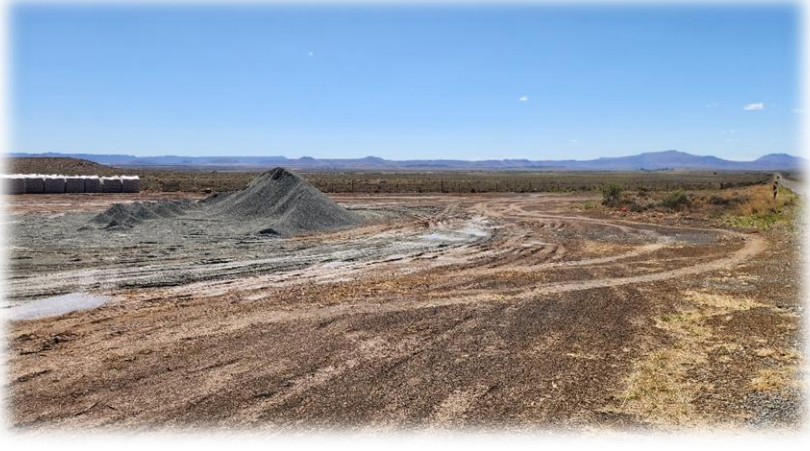
| <p>2.</p> | <p><b>Stockpile Area 2 at approx. km 11.8 on TR16/9 (Stockpile area 3 as part of EIA process)</b></p> <p>An existing cleared area used a rest area within the road reserve. The area is used to stockpile surfacing stone and will be used for the pre-coating of the stone.</p> | <p>The area is ideal due the proximity as well as due to the area being previously disturbed and within the road reserve.</p> |

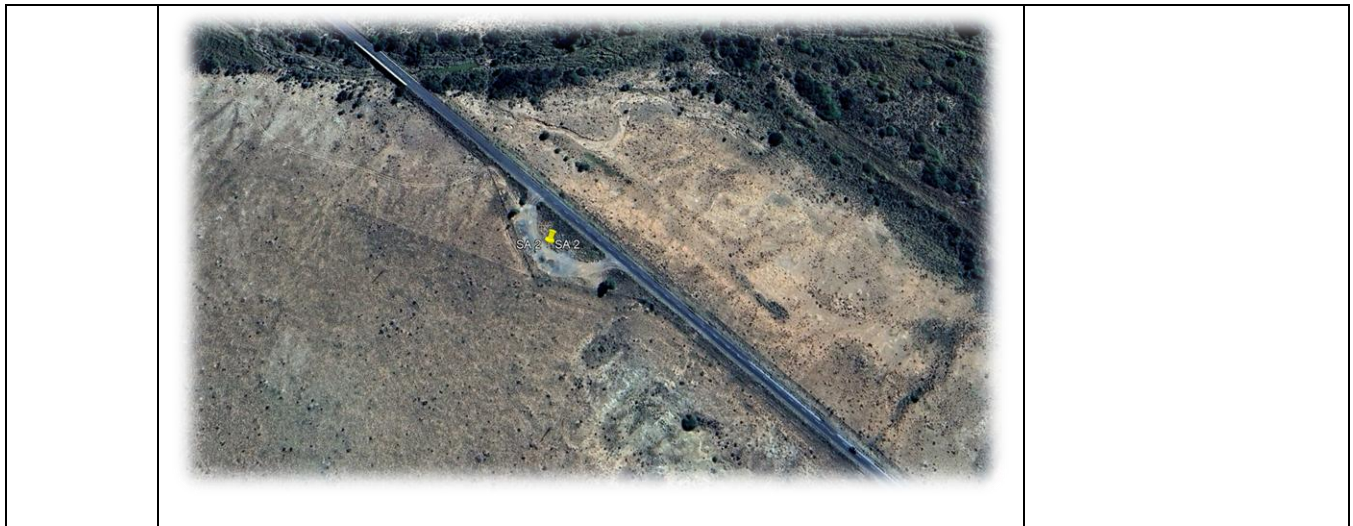
| <p><b>3.</b></p> | <p><b>Stockpile Area 3 at approx. km 46.4 on TR16/8 (Stockpile area 2 as part of EIA process)</b></p> <p>An existing cleared area used a rest area and stockpile area of the maintenance teams, within the road reserve. The area will be used to stockpile surfacing stone and will be used for the pre-coating of the stone.</p> | <p>The area is ideal due the proximity as well as due to the area being previously disturbed and within the road reserve.</p> |

The contractor is advised to please inform the ER and ECO of potential stockpile areas prior to the start of using the area.

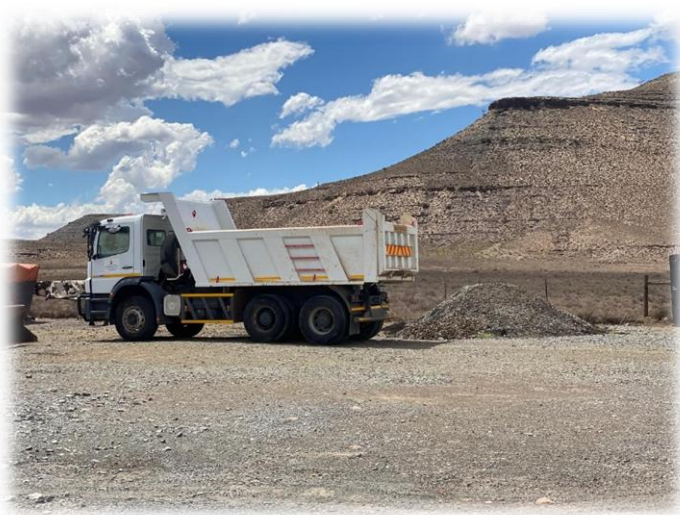
No bitumen static was noted on site.

All asphalt remains must please be removed from all stockpile areas.

| | Finding | Close Out Recommendation |
|---|---|---|
| 1. | <b>Bitumen handling area</b><br>Asphalt remains noted at the stockpile areas. | All asphalt remains must please be removed from all stockpile areas. |

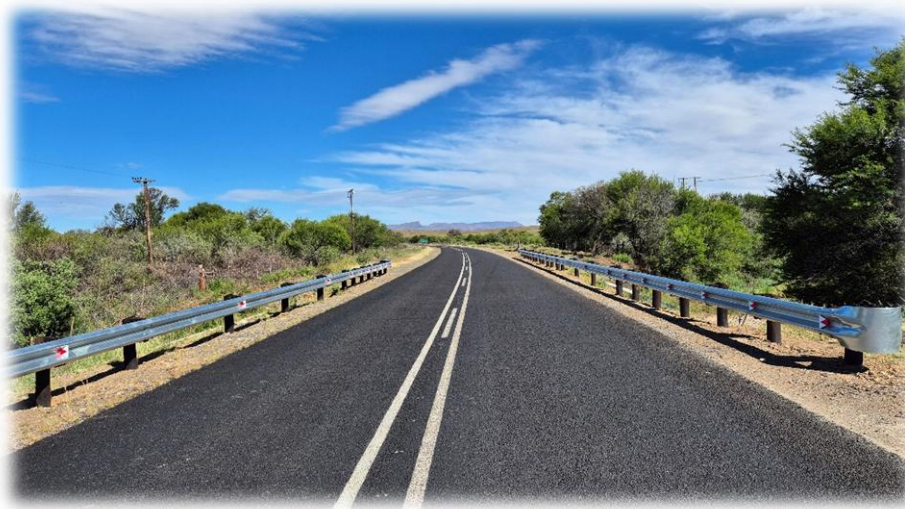
The surfacing of the two roads as part of the contract has been completed.
